6 FEBRUARY 2023 KAHRAMANMARAŞ – TÜRKİYE EARTHQUAKES: A GENERAL OVERVIEW

C. Gokceoglu¹

¹ Dept. of Geological Engineering, Hacettepe University, 06800 Beytepe Ankara, Turkey - cgokce@hacettepe.edu.tr

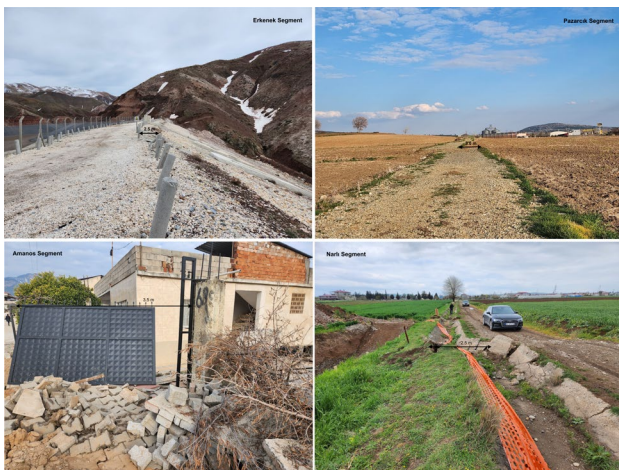
ruptured the Pazarcık (2-6 in Figure 3) and Erkenek (2-5 in Figure 3) segments of EAFZ towards NE and the Amanos segment (2-7 in Figure 3) towards SW. This earthquake produced left-lateral surface ruptures and the displacements reached to 4 m (Figure 4).

Figure 4. Some views from the left lateral displacements occurred during the Pazarcık Earthquake.

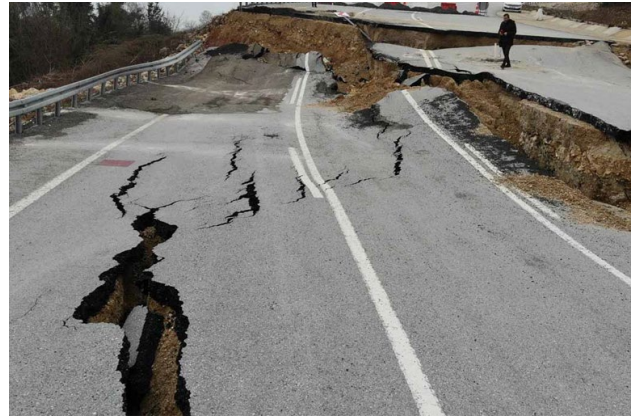
The surface ruptures resulted in highway and railway damages and the transportation to the earthquake region was blocked. The Tarsus-Adana-Gaziantep Motorway (TAG) was cut by the displacement of the Amanos segment around Nurdağı (Figure 5).

Figure 5. The TAG Motorway cut by the surface rupture (TRT Haber, 2023)

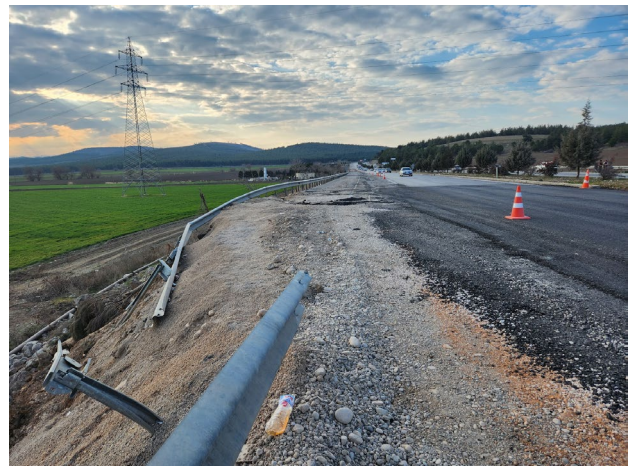
The other important state road cut by the surface rupture is Gaziantep – Kahramanmaraş State Road (Figure 6). Access to the earthquake region was provided by secondary roads due to the highway and the state roads that were cut and damaged by the surface ruptures, which caused delays in the search and rescue efforts for the first few days after the earthquake.

Figure 6. The Gaziantep – Kahramanmaraş State Rod cut by the surface rupture

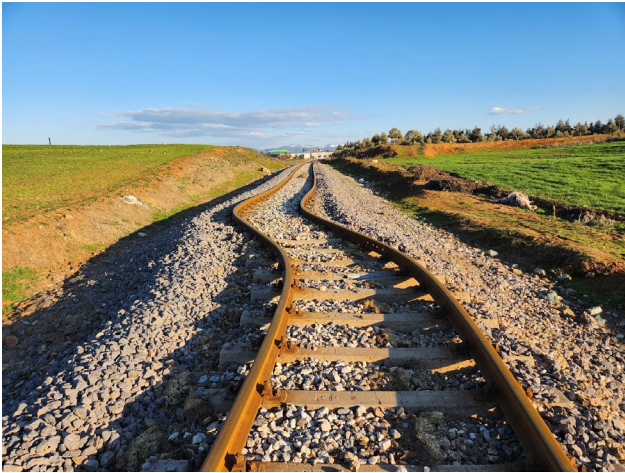
The railway system under service was constructed in the period of 1927-1937 (Nohab Saabye and Lerche Kampax, 1937). The surface ruptures were cut by various locations (Figure 7).

Figure 7. A view from a railway cut by the surface rupture

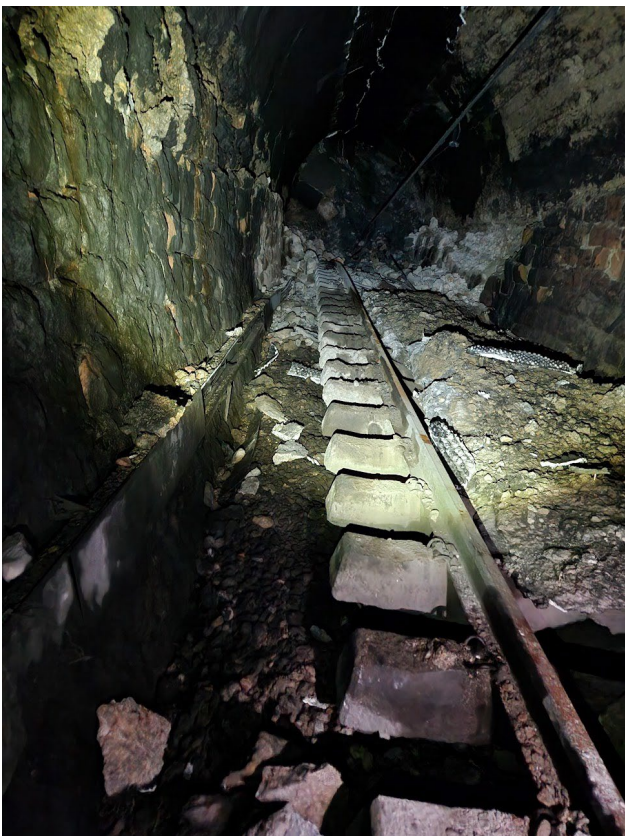
The T3 railway tunnel between Gölbaşı and Malatya was cut by surface rupture of the Erkenek segment. The fault cut the tunnel at the 80th m from the portal of Erkenek side and approximately 150 m part of the tunnel collapsed completely (Gokceoglu and Karahan, 2023) (Figure 8). The failure of this tunnel prevented the railway transportation between Malatya and Gaziantep.

Figure 8. A view from the collapsed T3 tunnel

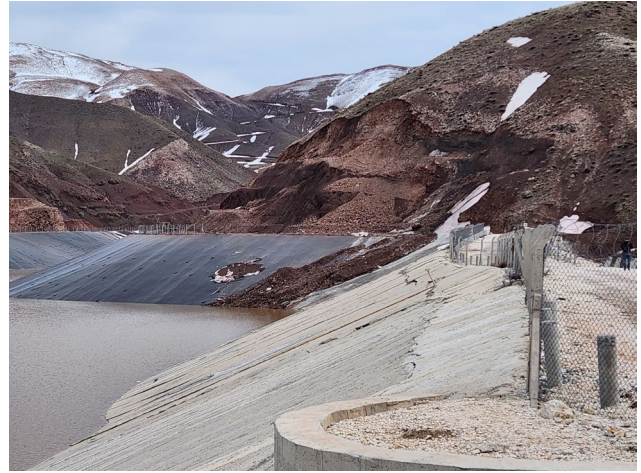
The dam body of the Erkenek dam was cut perpendicular by the Erkenek segment (Figure 9). The dam was damaged heavily but, it is not collapsed. As soon as occurrence of the Pazarcık earthquake, the water in the reservoir was discharged by the authorities. This precaution prevented the occurrence of a secondary hazard.

Figure 9. A view from the Erkenek dam body cut by the surface rupture

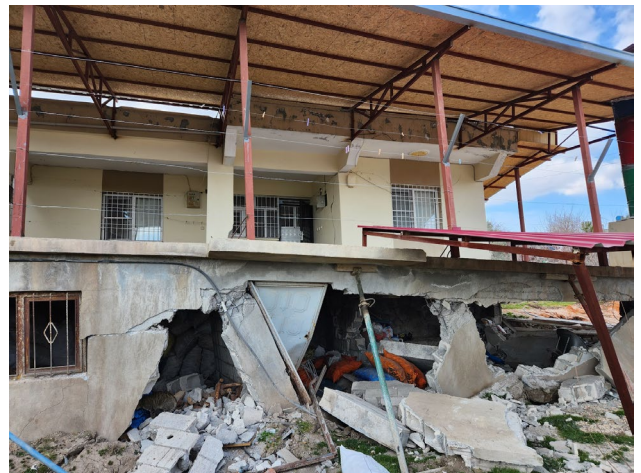
In addition to the engineering structures cut by the surface ruptures, surface ruptures caused heavy damage to many buildings and caused their collapse completely (Figure 10).

Figure 10. A view from a double stories building cut by the surface rupture (Tetirlik village, Pazarcık)

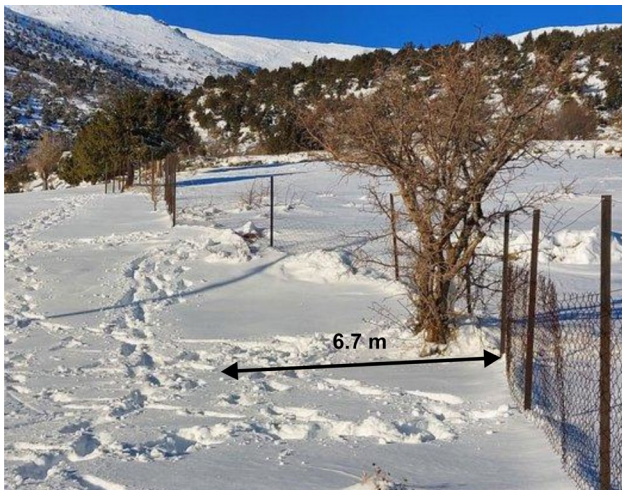
During the Elbistan earthquake, the Çardak segment (226 in Figure 3) and the Sürgü segment (227 in Figure 3) ruptured. These segments also produced surface ruptures and the maximum displacement was measured as 6.7 m by Taylan Sancar (Figure 11).

Figure 11. The maximum displacement measured by Taylan Sancar (modified after Özacar et al., 2023).

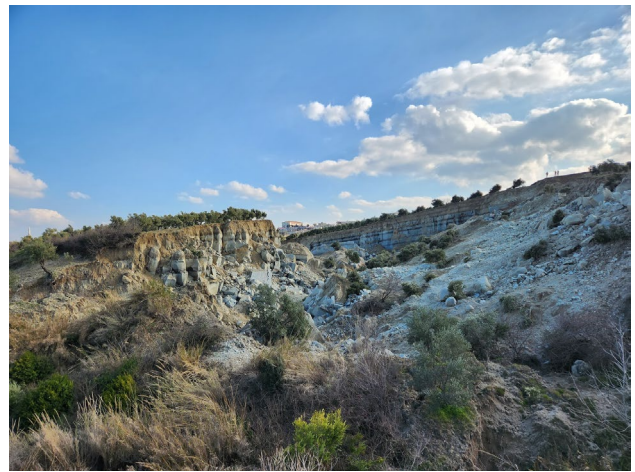
Figure 13. A view from the Tepehan planar failure triggered by the earthquake

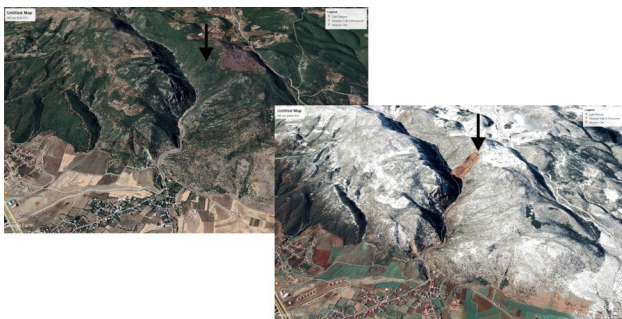
During the earthquake sequence, more than 2500 landslides were triggered. The south part of the Amanos mountains are generally free from landslides but several landslides in the Amanos mountains were triggered. A landslide dam around Islahiye occurred, and the GoogleEarth images before and after the Earthquake sequence is given in Figure 12. Another large and planar landslide occurred around Tepehan (Figure 13) and such type failures were also observed around this region. In this region, the failure surface was observed clearly (Figure 14). A sakung with a volume of around 70M m² occurred near Ekinözü during the Elbistan earthquake (Figure 15). Especially in the northern parts of the earthquake region such as Çelikhán, Kahta, Gölbaşı, Besni, Nurhak and Tut, many landslides were triggered by the earthquakes.

Figure 12. The GoogleEarth images before and after the earthquakes (west of Islahiye, Degirmencik)

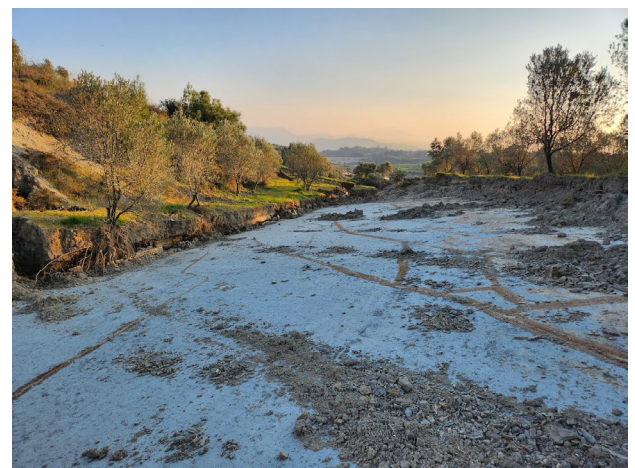
Figure 14. A view from the failure surface of the planar failure

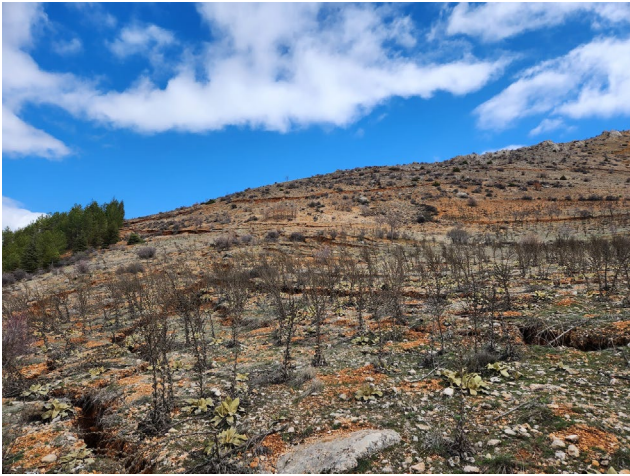
Figure 15. A view from the sakung near Ekinözü

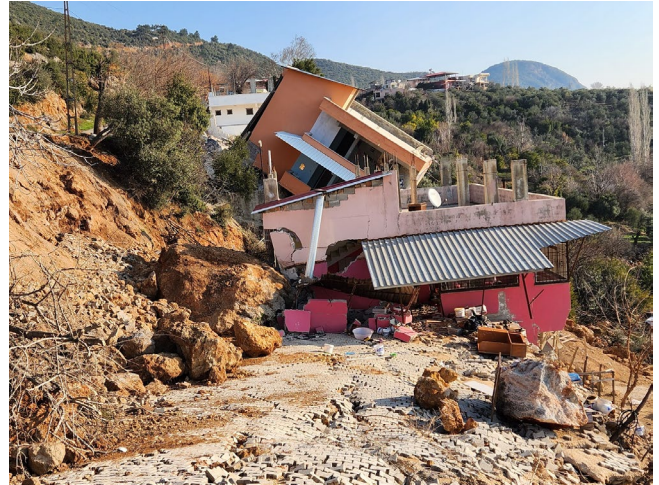
The rockfalls were observed commonly in the mountainous areas of the earthquake region. Especially roads and railways were affected by the rockfalls (Figures 16 and 17). In addition to roads and railways, some villages such as Bektaşlı village, Kırıkhan were damaged by rockfall (Figure 18). The rockfall in Bektaşlı village resulted in death of 50 person.

Figure 18. A view from the rockfalls in Bektaşlı village, Kırıkhan

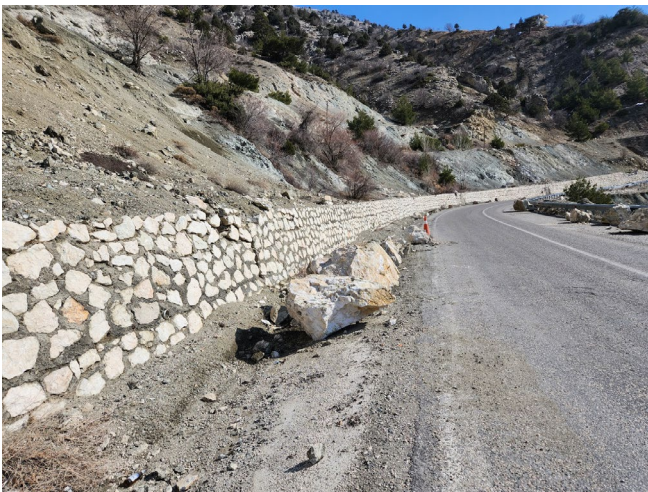
Figure 16. A view from the rockfall on the Gölbaşı – Nurhak road

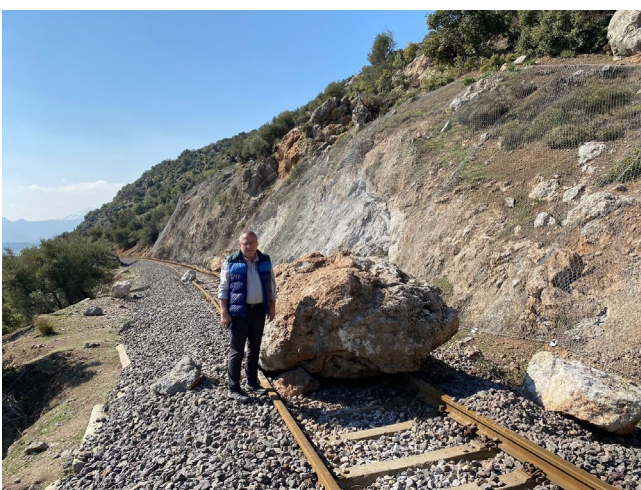
Figure 17. A view from the rockfall at the south of Fevzipaşa Railway Station

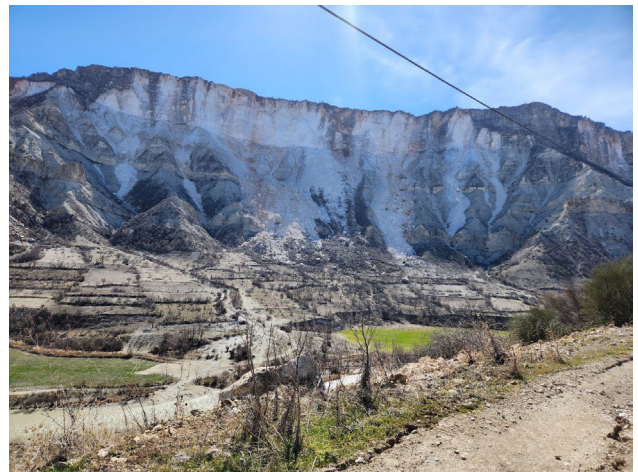
In addition to rockfalls, the rock avalanches were observed during the 6 February 2023 Türkiye Earthquakes. Rock avalanches result from rapid fragmentation of very fast-moving, initially intact rock masses during transport (Hung et al., 2001). Especially, along the east slopes of the Göksu river, east of Tut, Adiyaman, several rock avalanches were triggered (Figure 19). These failures are observed clearly by comparing before and after earthquake orthophotos presented on the HGM Küre platform of the General Directorate of Mapping (HGM, 2023) (Figure 20).

Rock avalanches observed near Nurhak and Tut did not cause loss of life or great damage in this earthquake, because rock avalanches triggered by the 6 February 2023 Earthquakes took place in locations far from settlements. However, this slope failures should be considered during the site selection efforts.

Figure 19. A view from the rock avalanches along the east slopes of the Göksu river

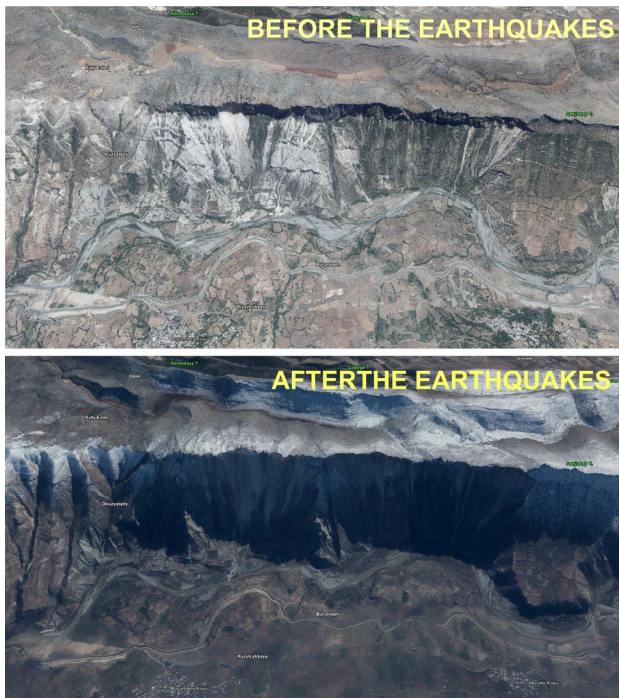
Figure 20. The HGM Küre images before and after earthquake (along the east slopes of the Göksu river)

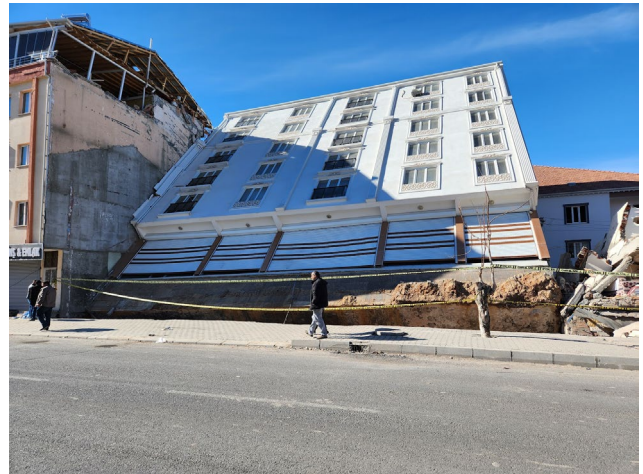
In Gölbaşı, liquefaction damaged the buildings, roads and railways severely (Figure 22), because the main lithology of this region is lake sediments.

Figure 22. A toppled building due to liquefaction in Gölbaşı

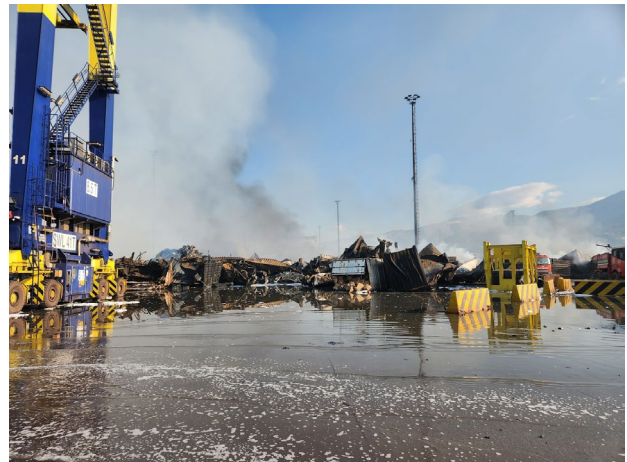
Along the İskenderun coastline, severe liquefactions occurred, and as a result of liquefactions, the İskenderun Port was damaged heavily (Figure 23), and a serious fire was initiated. In addition, the İskenderun coastline settled more than 1.5 m (Figure 24).

Figure 23. A view from the İskenderun Port after the earthquake

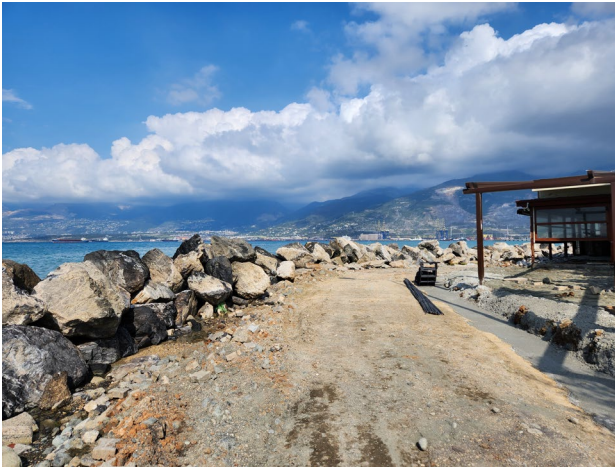
Figure 24. The settled coastline of İskenderun

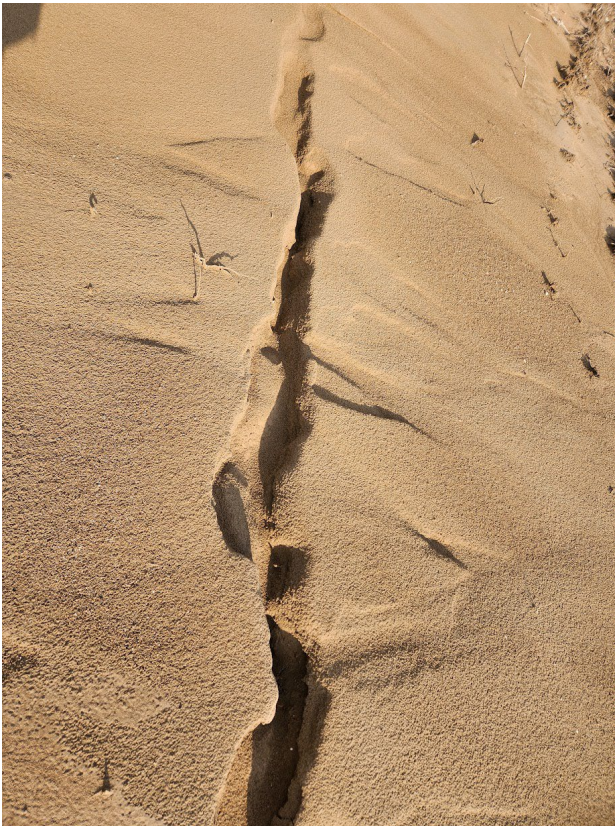
In the Amik Plain, severe liquefactions and lateral spreadings were also observed (Figure 25). The liquefactions in this plain damaged the Antakya – Cilvegözü road, and the runway of the Hatay Airport (Figure 26).

Figure 25. A typical view from liquefaction occurred in the Amik Plain

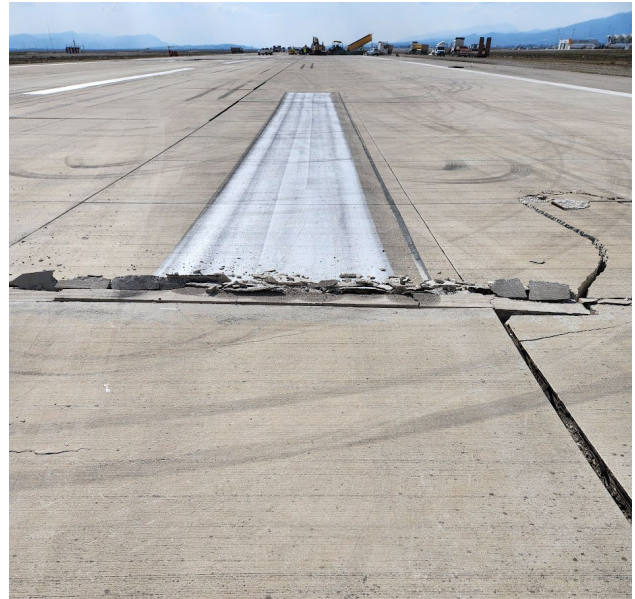
Figure 26. A view from the runway damages of the Hatay Airport
