A large landslide in Zigui County, Three Gorges area

F.C. Dai, J.H. Deng, L.G. Tham, K.T. Law, and C.F. Lee

Abstract: On 13 July 2003, a landslide with a volume of approximately $20 \times 10^6 \text{ m}^3$ occurred on the left bank of the Qinggan River, Zigui County, Hubei Province, China. As a result, 14 people died and 10 people are missing. A landslide dam was formed, blocking the Qinggan River. A channelized diversion was constructed for prevention of upstream flooding and damage downstream caused by dam breaching. The landslide was a typical translational rockslide in weathered shale and sandstone, a block of which slipped down along the bedding plane. It is estimated that the landslide was caused by the combined effect of the following factors: (i) a bedding plane between incompetent weathered shale and competent sandstone that daylighted at or is shallowly buried at the bottom of the Qinggan River; (ii) a thin layer of clayey soil acting as the slip plane that is likely a preexisting shear surface; (iii) excavation of the shale as raw material for brick fabricating on the slope; and (iv) a combination of prolonged rainfall and reservoir impounding.

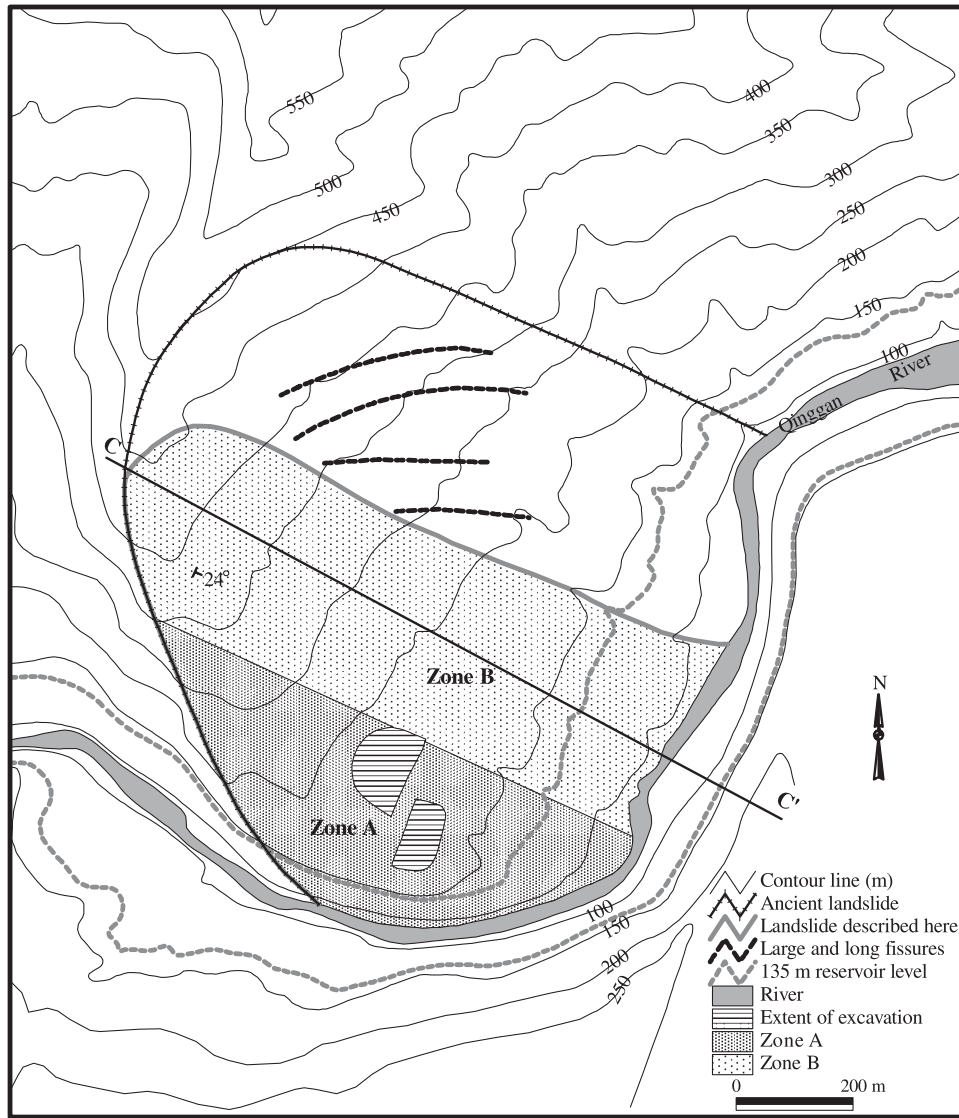
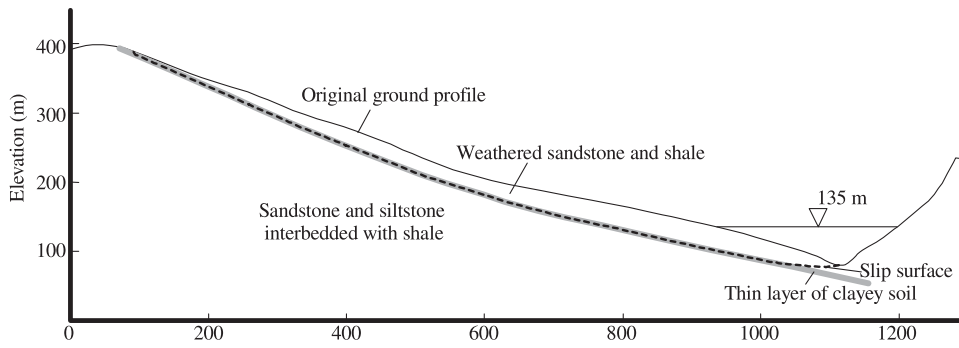
Fig. 2. (a) Sketch map showing the extent of the landslide. (b) Cross section at C-C' in (a).

At around 0:20 am (Beijing time) on 13 July 2003, a large landslide occurred on the left bank of the Qinggan River (Figs. 2, 3). Witness accounts showed that it took less than 5 min to complete the whole process of landsliding. The landslide has a volume of 20×10^6 m³, with a maximum width of 800 m and maximum length of 1100 m. It is estimated that the maximum failure depth is approximately 30 m. The landslide can be classified as a translational rockslide, following Cruden and Varnes (1996). The displaced block of weathered sandstone and shale slipped down along the bedding plane, following the dip direction of the bedding plane, and formed both a main scarp and a surface of rupture.

landslide with a volume of about $6 \times 10^6 \text{ m}^3$, as indicated as zone A in Fig. 2, slid down along the bedding plane. It is estimated that for this event the slip plane may daylight at the riverbed, resulting in a high-speed rockslide. The rock mass block travelled a distance of about 240 m. The frontal part of the rock mass ran up the opposite bank of the reservoir, generating a wave. The wave of water was pushed up the opposite steep bank, leaving a trace on the vegetation cover at an elevation of about 150 m (Fig. 4a), and then bounced back to the landslide mass and swept away all erodible materials, including a house, grass, and superficial deposits with a maximum elevation of about 165 m (Fig. 4b). The walk-over survey, however, indicated that vegetation at an elevation of approximately 175 m fell to the ground due to the wave of water (Fig. 4c). This event blocked the Qinggan River completely and formed an irregular landslide dam (Fig. 3). The landslide debris entering the river was shifted downstream due to obstruction of the steep slope. The landslide dam above the 135 m water level had maximum and minimum heights of about 178 and 149 m, respectively. In the second event, the left portion of the landslide (zone B in Fig. 2) slid down along the bedding plane with a maximum travel distance of approximately 180 m. Field observations showed that for this slide event, surface features such as houses and highways tilt backward against the landslide scar (Fig. 5). This may indicate that the second slide event was less translational than the first slide event. Other evidence includes extensive fissures in the frontal part of the slide mass, indicating extensive deformation in this area. This block of the landslide mass did not dam the Qinggan River.

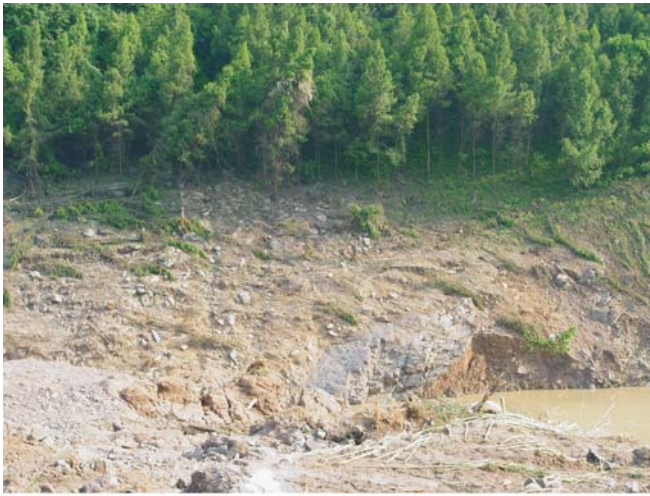
The wave of water generated by the landslide overturned five boats located upstream and 17 boats downstream, with 10 people missing.

Fig. 4. (a) A trace left on the vegetation by the wave of water on the opposite bank of the Qinggan River. (b) Erosion caused by the wave of water on the frontal part of the landslide. (c) Fallen vegetation caused by the wave of water.

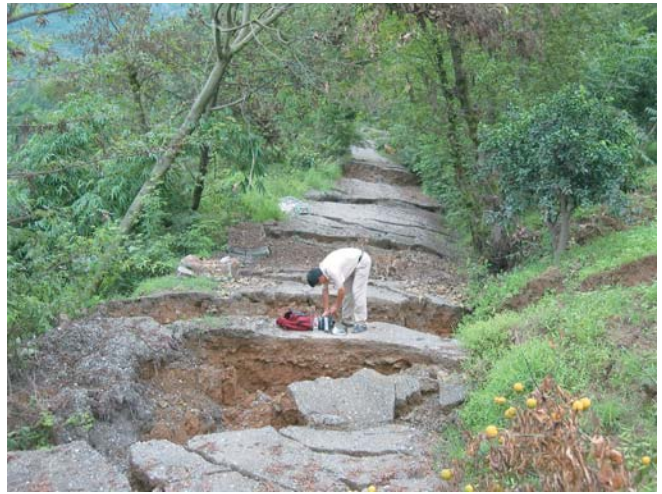
Fig. 5. Ground cracks and tilting observed on the right portion of the landslide.

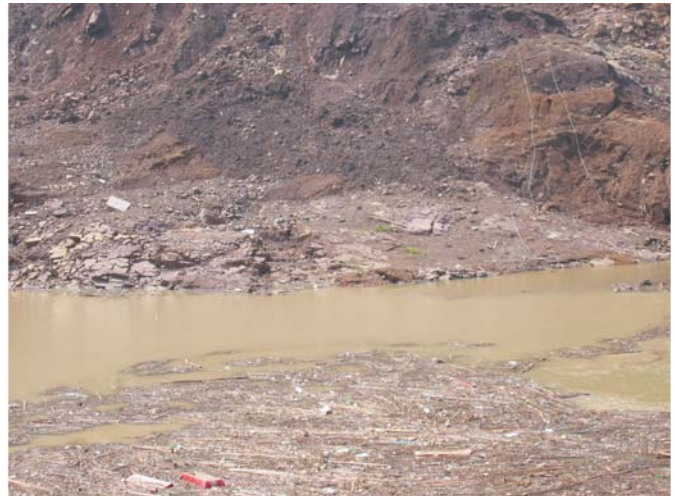
The debris deposits consisted mainly of angular coarse clasts surrounded by finer fractions intensely disintegrated from the shale. Though the rock in the debris accumulation is highly fractured, the accumulation retains its bedding plane with an opposite dip compared with that of its original bedding (Fig. 6a). The pebble deposits can be observed on the top of the landslide debris (Fig. 6b). This indicates that the surface of rupture was below the bed of the river and thus the landslide pushed the preslide bed toward the opposite side of the river.

Fig. 6. (a) Landslide debris deposited on the opposite bank of the Qinggan River. The bedding plane can be seen below the landslide debris. (b) Pebble deposits on the top of landslide debris accumulation.

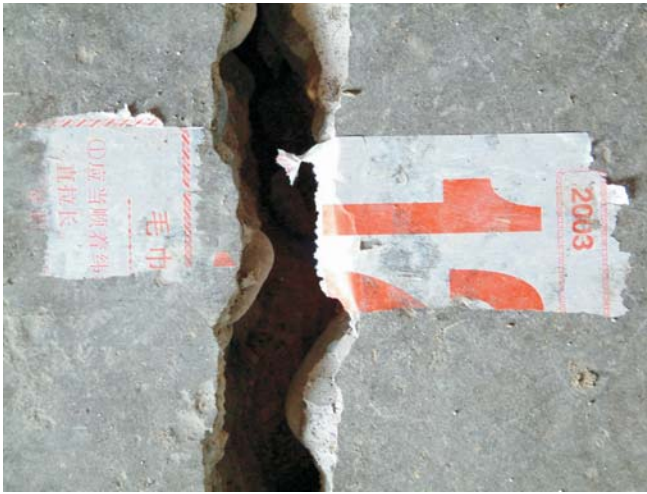
Fig. 7. Paper pasted across a fissure. The paper was torn into two pieces when the fissure started to widen.

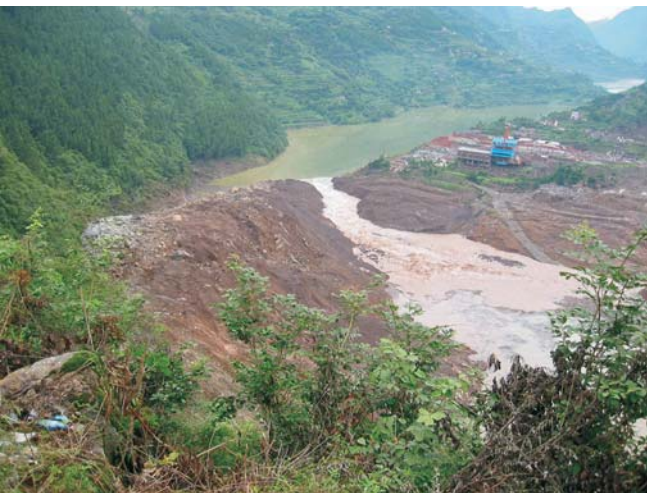
Fig. 8. A channelized diversion excavated for prevention of up-stream flooding and possible damage downstream.

At 5:00 pm on 20 July, a channelized diversion with a width of 13 m was successfully excavated at the saddle of the dam (Fig. 8). The total volume of landslide debris excavated for the diversion was about 3360 m³. This prevented upstream flooding and any possible damage downstream that could be caused by dam breaching.

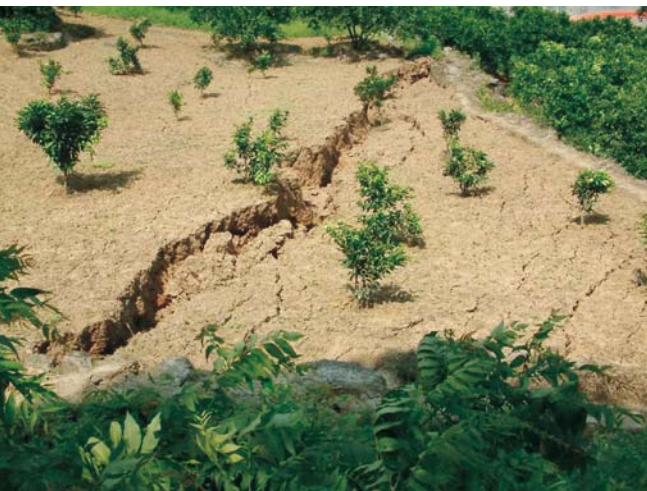
Fig. 9. A long fissure observed on the remaining slope on the left side of the landslide.

After the landslide, an extensive distribution of tension cracks was observed within a zone 1200 m long and 500 m wide on the remaining slope on the left side of the landslide, as shown in Fig. 2 (see also Fig. 9). Some simple observations on three major cracks were initiated to understand the

changes in these cracks. The horizontal widths of these three major fissures increased from 28.5, 53, and 86 cm at 12:10 pm on 15 July when the observations were initiated to 29, 54, and 96 cm, respectively, at 6:40 pm on the same day. Because of concern over the possibility of new landsliding, the local government decided that the 34 people living in this zone should be evacuated.

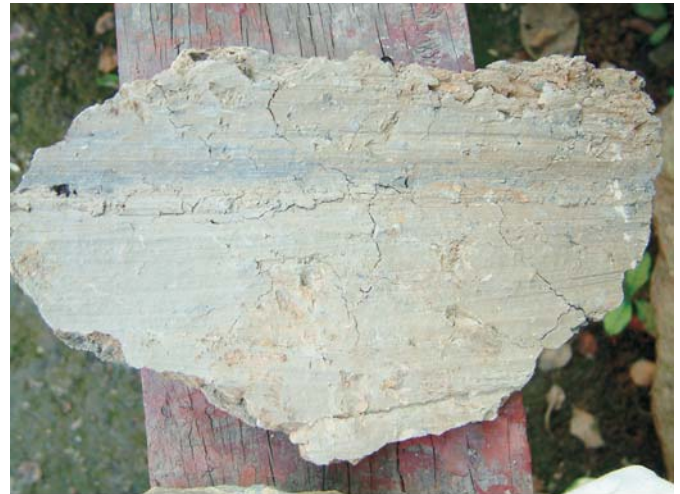
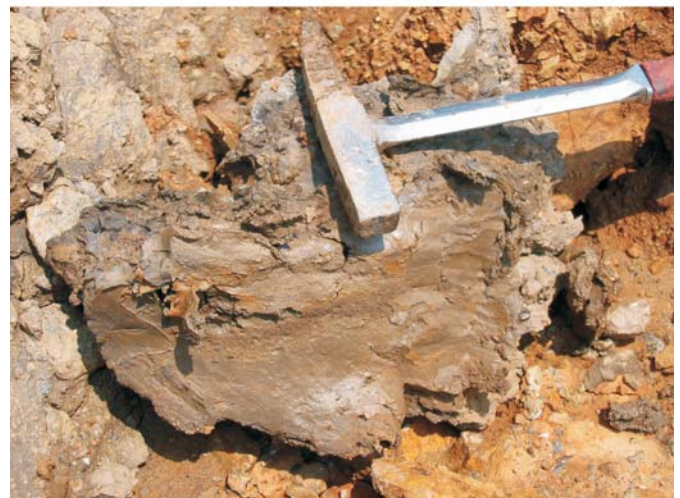
Fig. 10. (a) Slickensided shear surface. (b) Slickensided clayey soil.

planes of the lithology and daylighting or shallow burial of the bedding plane in the bed of the Qinggan River render the slope prone to failure. Field observations revealed that the slip plane was along a thin layer of clayey soil with a thickness of several centimetres underlying the weathered sandstone and shale. The bedrock underlying the slip plane is in a relatively intact state compared to the overlying weathered sandstone and shale. It is also important to mention that the present slide is likely a reactivation of an old translational rockslide whose scarp is evidenced by the old scarp shown on the topographic map. The slip zone may have low shear strength as a preexisting shear plane. The weathered sandstone and shale might have acted as highly permeable material that led to the formation of a perched groundwater table in the slip zone above. The slip surface is smooth and slickensided (Fig. 10).

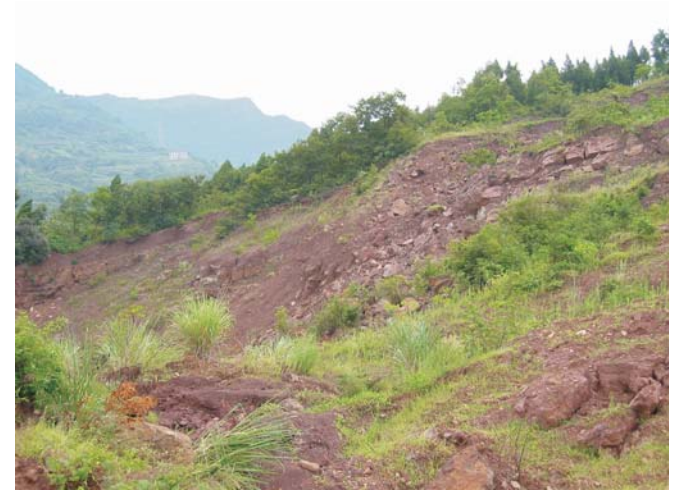
Fig. 11. Site of the excavation of shale as raw materials for brick fabrication.

Excavation of the shale as raw material for brick fabrication (Fig. 11) at the middle part of the slope is also a factor contributing to the slope failure. The excavation was carried out in zone A, as shown in Fig. 2, with a depth ranging from 2 to 8 m. The excavation removed the support and created tension cracks on the upper slope. These cracks, wide open joints, and loose overburden on the slope facilitated percolation of water into the slope, thus increasing the pore-water pressure.

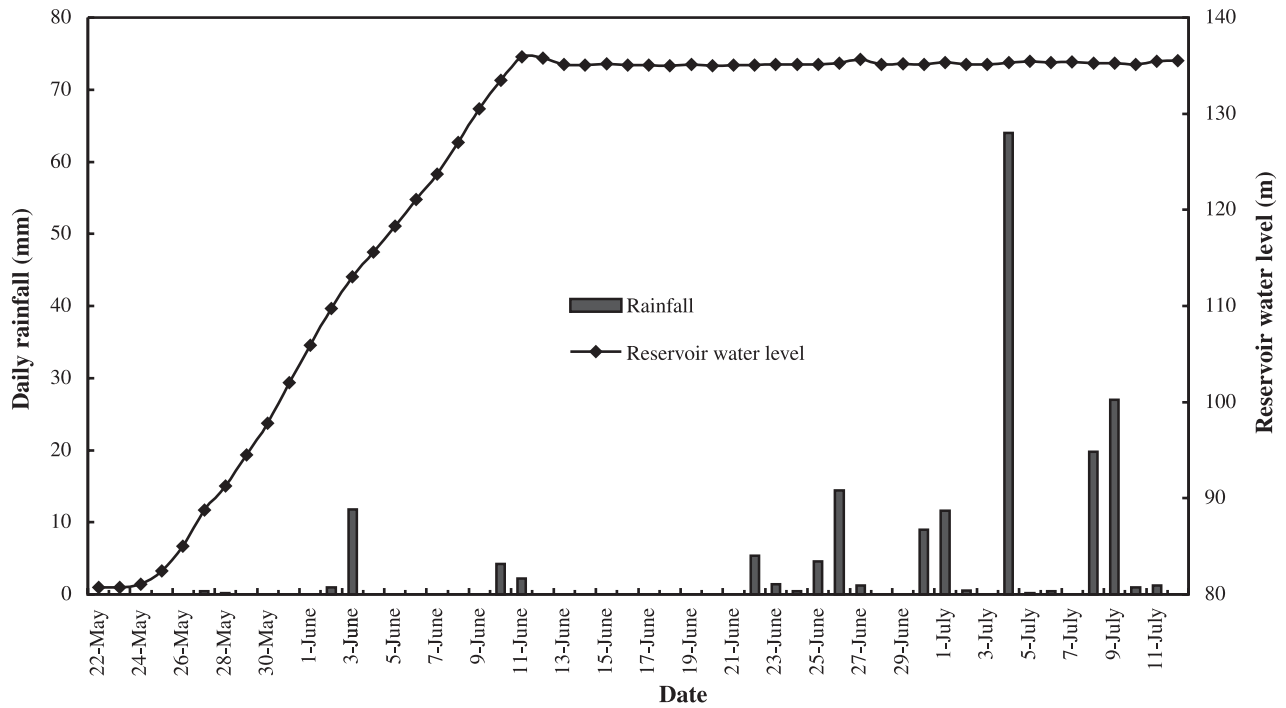
Fig. 12. Daily rainfall and reservoir water level change recorded at Xietao.

Rainfall was a major trigger of this failure. In the period between 22 June and 11 July, the rainfall recorded at Xietan, located 5.5 km north of the landslide site, was 162.1 mm (Fig. 12). The prolonged seepage of water through the weathered rock could have increased the pore-water pressure and critically reduced the shear strength of the rock mass along the slip plane. Field observations carried out 1 week after the failure showed that groundwater was seeping out from the bedrock underlying the slide mass (Fig. 13). This could have produced an upward seepage force and high pore-water pressure at the slip plane. The initial impounding of the Three Gorges reservoir raised the water level to 135 m on 10 June at a rate of approximately 3.3 m/day (Fig. 12). The rise in reservoir water level drove up pore pressures in the lower part of the shale layers, reducing its strength. It is estimated that a combination of prolonged rainfall and reser-

voir impounding are the main causes of the landslide because the rainfall was not heavy compared with previous rainfall events at the landslide site.

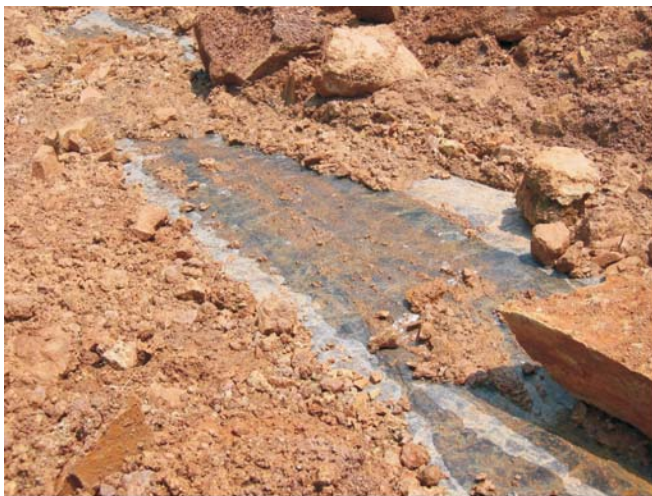
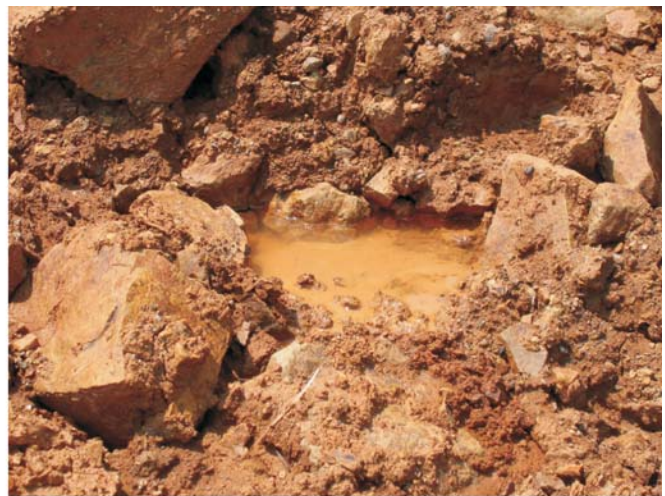
Fig. 13. (a) Groundwater seeping out from the bedrock underlying the slide mass. (b) Small pond of water observed in the landslide debris.
