# A Soil-Structure Interaction Analysis of a Damaged Building

R.F. Wilson-Fahmy

**SYNOPSIS:** A twenty years old reinforced concrete building suffered from fracture of one of its ground floor corner columns. The extent of damage resulting from fracture of the column is examined. Plane frame structural analysis is used in the interpretation of the signs of damage of the building. Soil compressibility is incorporated in the analysis by assuming the footings to rest on Winkler type subgrade. The theoretical analysis is assessed by comparing the results with the actual behaviour of the structure.

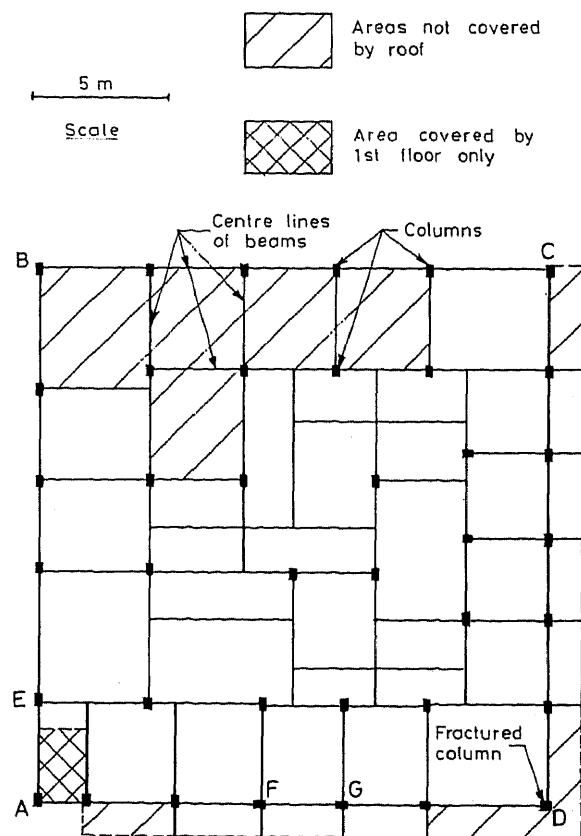
Fig.1 Locations of Columns and Beams

The building suffered from fracture of the ground floor corner column marked D in Fig. 1 after about 20 years in service. After the incident, the first floor was extensively supported by timber props to stop further deterioration of the building resulting from the column fracture.

Inspection of the fractured column indicated that it was weakened due to drilling of several relatively deep and large holes through the concrete for the purpose of fixing a heavy steel door.

Visible cracks in the reinforced concrete elements were limited. Serious cracks appeared only in the column marked B in Fig. 1 which is located at the farthest point from the fractured column. The cracks could be seen in all the floors just below the intersection of the column with the beams.

Settlement of the ground inside the building area was another sign of damage. The settlement was particularly irregular near side AD, Fig. 1. In the zone between columns F and G, the ground settlement was greater than in the surrounding area by about 150 mm. This figure may be indicative of the order of magnitude of the settlement and differential settlement of the foundations.

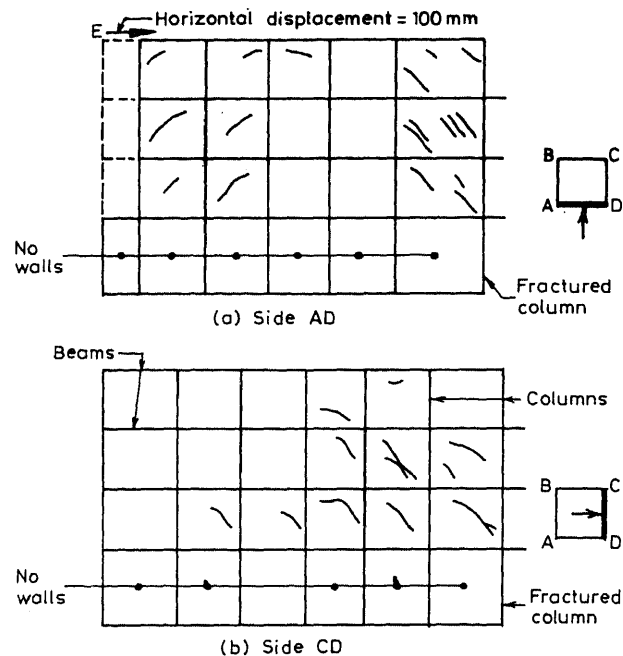
Fig.2 Cracks in Exterior Walls

The whole building was affected by the column fracture as evidenced by the wall cracks appearing everywhere in the building. Fig. 2 shows the pattern of cracks in the exterior walls at the faces AD and CD of the building. The inclination of the cracks indicates that the walls were subjected to shear deformations. As with the exterior walls, most cracks in the interior walls were also inclined. The crack width exceeded 10 mm in various parts of the building.

Inspection of facade AD (Fig. 1 and 2a) indicated that the building was leaning towards the fractured column. The horizontal movement of the point marked E in Fig. 1 and 2a at the roof was nearly 100 mm measured with reference to the adjacent building. The movement decreased downwards to reach a zero value at ground floor.

The predicted results shown in Fig. 6b for the wall panels in frame AD follow in general the same trend as those of frame CD. The observed crack pattern shows, however, some difference. Cracks are absent in panel P3 and P4 and the inclination of the crack in Panel P2 (Fig. 2a) contradicts that predicted. This is probably due to the high differential settlement between the columns in this zone. As previously mentioned, ground settlement in the region between columns F and G, Fig. 1 is greater than that in the surrounding area. Higher settlement of the columns in this zone with respect to the neighbouring columns could cause shear strains of signs opposite to those predicted in Fig. 6b and hence could be responsible for any local deviation from the overall pattern of deformations of the frame. It may be noted that the predicted direction of crack in wall panel P1 is in agreement with that observed, again, at low values of the modulus of subgrade reaction.

that the direction of the cracks in these panels would have been at right angle to those observed if related only to the deflection of the supporting beams which are acting more as cantilever beams after column fracture. This shows that the walls are probably subjected to the deformation mode shown in Fig. 5c as a result of the horizontal sway suffered by the building.

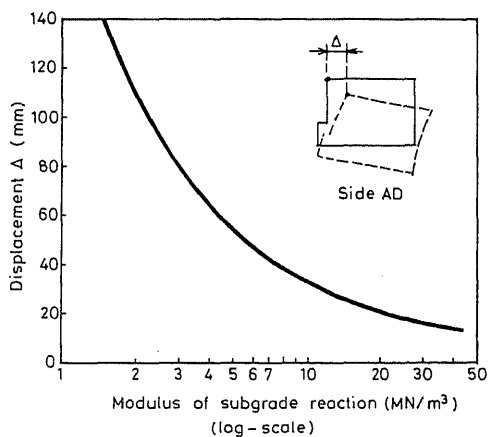
Fig.4 Relationship Between Modulus of Subgrade Reaction and Horizontal Displacement of Frame AD at Roof Level

The predicted relationship between the horizontal movement at the top of frame AD and the modulus of subgrade reaction  $k$  after column fracture is given in Fig. 4. It can be seen that the horizontal movement decreases greatly with the increase of the modulus of subgrade reaction  $k$ . The limiting case corresponding to unyielding supports gives a value of 6.5 mm only which is considerably smaller than the measured value (100 mm). Referring to Fig. 4, the modulus of subgrade reaction corresponding to this latter value is 2.2 MN/m<sup>3</sup>. The corresponding predicted settlements at nodes  $i$  and  $j$ , Fig. 3a are 2.7 and 13.2 mm respectively. These values are of the same order of magnitude of the observed ground settlement inside the building area.

The predicted horizontal movement at the roof level in the plane of frame CD is less than that in the plane of frame AD at all values of  $k$ . For example at  $k$  equal to 2.2 MN/m<sup>3</sup>, the former value is 51 mm while the latter is 100 mm. Unfortunately, verification of the ratio between the horizontal movement of frames AD and CD was not possible since no measurement was made of the movement in plane CD. Surveying instruments would have been required for taking the measurement.

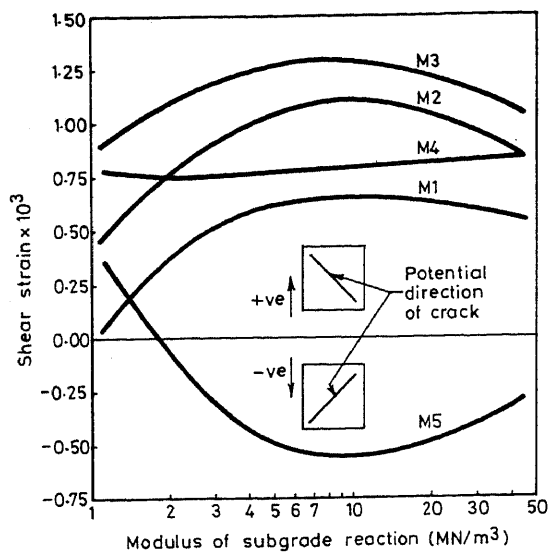
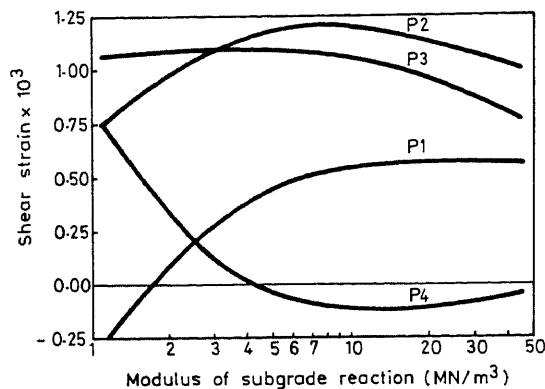
Fig. 6 Relationships Between Modulus of Subgrade Reaction and Shear Strains in Walls

Referring to Fig. 6a, it can be seen that the shear strain is greatly dependent on soil compressibility. The shear strain sign and hence the potential crack direction may differ according to the value of  $k$ . Comparison with Fig. 2b indicates that the potential crack directions become in accordance with the actual crack pattern as soil compressibility tends to high values. Agreement between predictions and observations of horizontal movement is also obtained at high soil compressibility as previously noticed. As the modulus of subgrade reaction decreases, the shear strain of panel M5, for example increases until it changes its sign, thus leading

to the same direction of crack as that observed. Also the shear strain of panel M1 decreases sharply which conforms with the absence of cracks in this panel.
