**Ageing of Silicone Rubber Composite Insulators on 400 kV
Transmission Lines**

IEEE Trans DEI 14 Issue 1 (2007) 130-136

S M Rowland, Y Xiong, J Robertson, S Hoffman

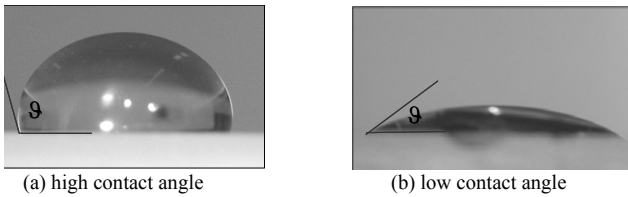
Figure 2. Two extreme examples of contact angles.

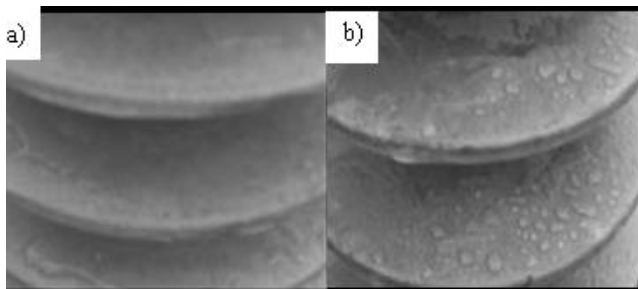
In general, visual observations on site revealed the discolored material to be hydrophilic with a contact angle of less than 90 degrees and sheens of water forming, whereas the material with brown or green deposits was found to be more hydrophobic with a greater contact angle and water readily forming droplets. Figure 3 illustrates the difference in water drop formation on the south and north facing sides of the insulator: 3a) shows large continuous areas of water being formed, whereas distinct small droplets are evident in 3b).

Figure 3. Illustrations of water droplet formation on the: a) hydrophilic south side and b) hydrophobic north side of the insulator.

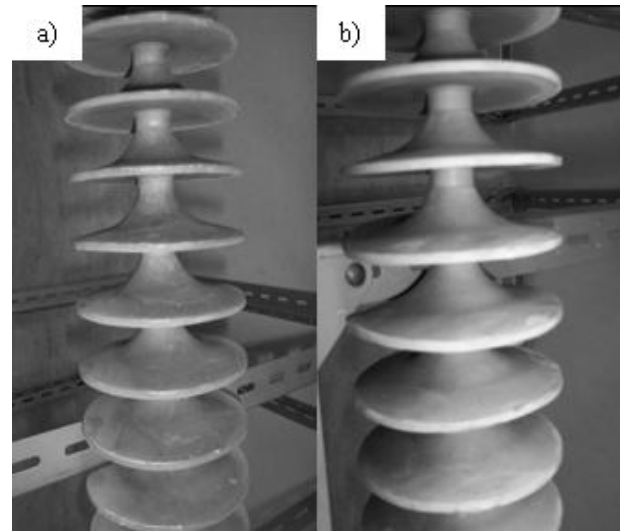
Figure 4. Two photographs of the same insulator: a) the dirtier north-facing side, b) the bleached south-facing aspect. The white rim can be seen on the underside of the sheds in the top of both of the pictures.

To illustrate the changes in color, Figure 4a shows the accumulated algae which was present on the sides of the sheds facing the hills of the valley, and Figure 4b shows discoloration on the side of sheds which have been exposed to the sun. Figure 5 identifies a particularly dirty set of sheds with crazing of the surface of the silicone rubber. The very light edges on the sheds to the front of the picture are due to the process of removal from the tower; effectively these areas have been scraped clean.

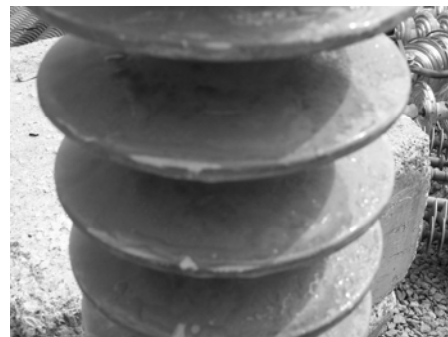
Figure 5. Dirty sheds. Nearest the camera are regions of crazed surface. The light areas at the very front were probably cleaned off during removal of the insulator from the tower.

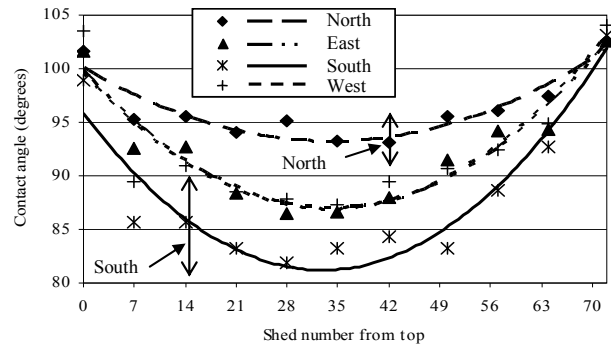
Figure 6. Average contact angle along the core of each insulator in each of the compass directions (position A, Figure 1).

The insulator core would not have seen direct effects of sunlight and UV radiation, due to the shading effect of the sheds. Nonetheless the insulator core facing the south has the lowest contact angles. However, despite the reduced contact angles there is little sign of discoloration of the polymer insulation in this region, although there is some evidence of white residue. It is therefore suggested that the ageing of the insulator core is primarily due to surface discharge activities.

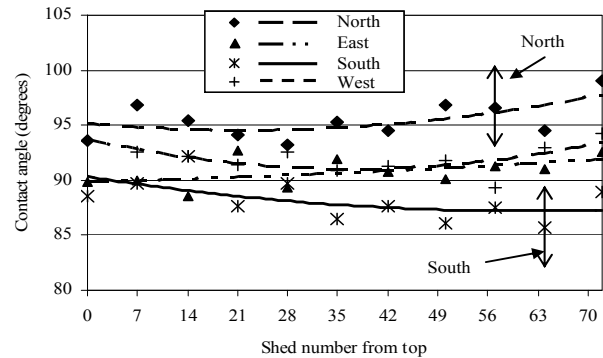
The hydrophobicity of the sheds tends to a minimum in the centre of the string rather than at the HV end. This is particularly true for the core measurements. The top surface measurements presented in Figure 7 suggest minimal variation along the length, with the exception of the south side which appears more aged at the top LV end. Previously a strong decrease in hydrophobicity has been reported toward the HV end on EPDM [13] and silicone materials [14,15], although such a dependency is not always observed [16,17,18].

Figure 7. Average contact angle on the top surface of the sheds in each of the compass directions (position B, Figure 1).

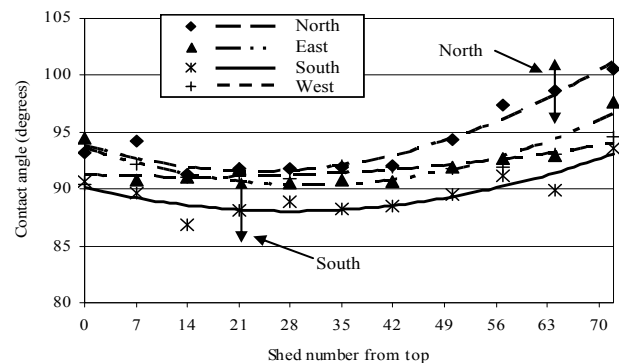
Figure 8. Average contact angle distribution on the outer edge of the bottom surface of the sheds in each of the compass directions (position C, Figure 1).

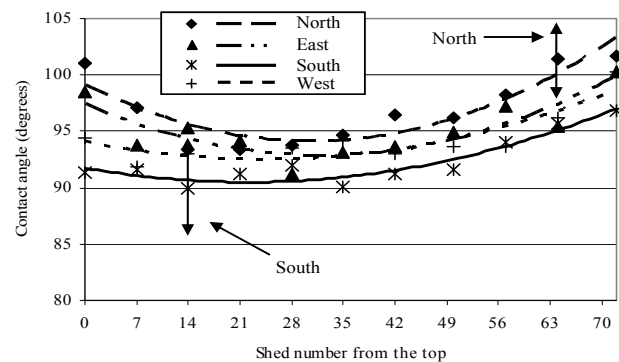
The insulators were installed with corona rings at both ends, which will have reduced the stress at the very top and bottom of the string. This may explain the extreme 'bath tub' shape of the curves seen in Figures 6 and 9. Also the top of the uppermost shed, the underside of the bottom shed and the core below it are more exposed to wind, salt spray and the natural elements. In particular, the uppermost shed will see more direct sunlight than the rest of the insulator. It may be for these reasons that the core has a particularly high contact angle at the top and bottom of the strings as shown in Figure 6. This is not reflected in a similarly high value on the top surface of the top shed in Figure 7, perhaps due to the impact of sunlight. However, the inner, underside of the bottom insulator does appear to reflect this effect in Figure 9.

The contact angle measurements on the bottom surfaces of sheds near the insulator core, shown in Figure 9, are similar in magnitude and behavior to those on the insulator core, in Figure 6, on the north side. However, there are significant

Figure 9. Average contact angle distribution on the inner bottom surface of the sheds down the string in each compass direction, (position D, Figure 1).

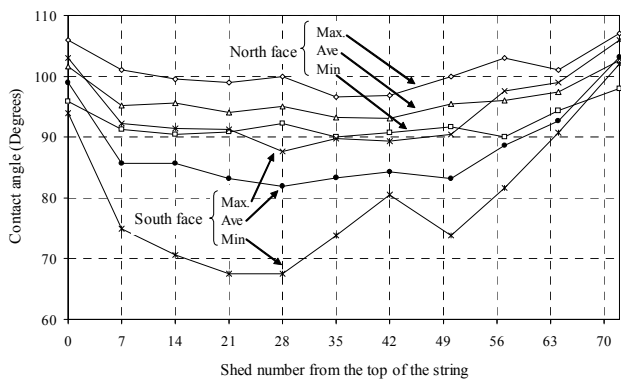
Figure 10 shows the typical spread of results on the core in more detail by illustrating the maximum and minimum values recorded on the north and south faces. It can be seen that the spread of results can be significant and small changes in average values of a few degrees do not imply consistency between every insulator, and may not imply a real difference. Nonetheless the case displayed here shows the difference between the north and south core faces is substantial, the maximum contact angle on the south core face being similar to the minimum seen on the north face for the 18 insulators measured. The two faces become indistinguishable at the high voltage end where the contact angles are greater and ageing less pronounced.

Figure 10. An example of the spread of data between the 18 insulators. The maximum and minimum of the contact angles for two faces of the core is shown for the 18 insulators examined.

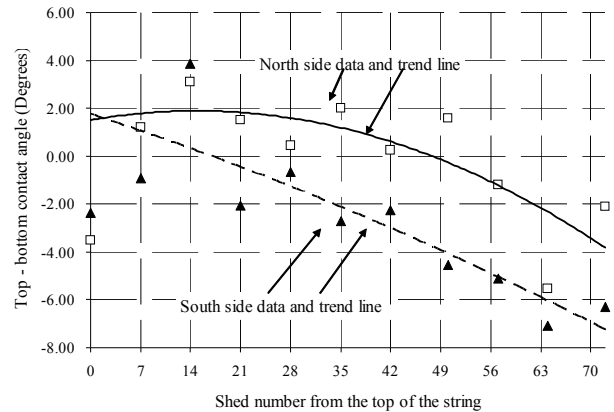
The difference between the top and bottom surfaces of the sheds is illustrated in Figure 11. Here the difference between the contact angle on the top surface and the average of the two bottom surface locations is produced for the north and south sides. It can be seen that on the north-facing surface, the average contact angle is greater on the top face and so the hydrophobicity is greatest on the top side. Towards the HV end, however, the trend is reversed and the sheds' undersides tend to be less aged than the tops. On the south side it is generally the case that the top surface is more aged than the bottom side. Second-order polynomial lines of best fit are shown on the Figure. The data points at the very top of the insulator have been disregarded in generating these curves. The line is almost a linear fit for the south side, and represents a good fit at the HV end.

Figure 11. The difference between the contact angle on the top face and the average of the two lower-surface measurements.
