An Investigation of the Therac-25 Accidents

Nancy G. Leveson, University of Washington

Clark S. Turner, University of California, Irvine

A thorough account of the Therac-25 medical electron accelerator accidents reveals previously unknown details and suggests ways to reduce risk in the future.

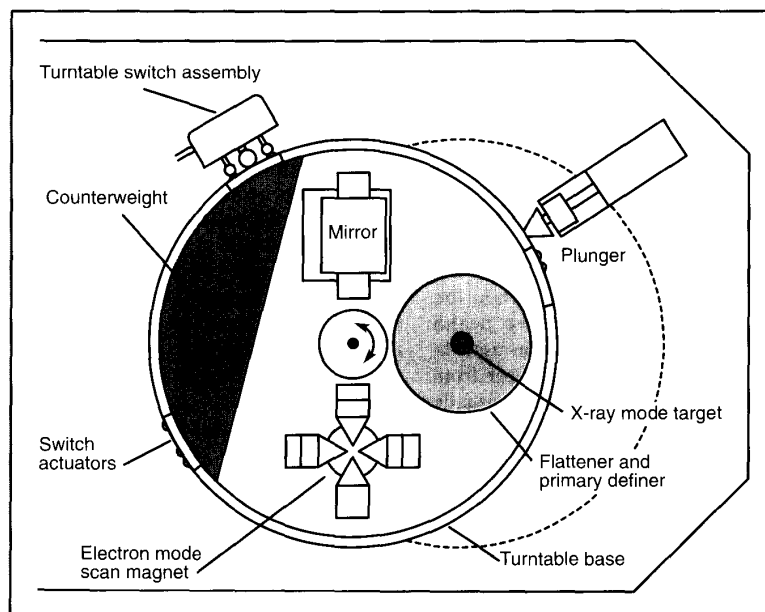
Figure B. Upper turntable assembly.

hazard of dual-mode machines: If the turntable is in the wrong position, the beam flattener will not be in place.

No accelerator beam is expected in the field-light position. A stainless steel mirror is placed in the beam path and a light simulates the beam. This lets the operator see precisely where the beam will strike the patient and make necessary adjustments before treatment starts. There is no ion chamber in place at this turntable position, since no beam is expected.

cate turntable position that tolerated a 1-bit error: The code would still unambiguously reveal correct position with any one microswitch failure.

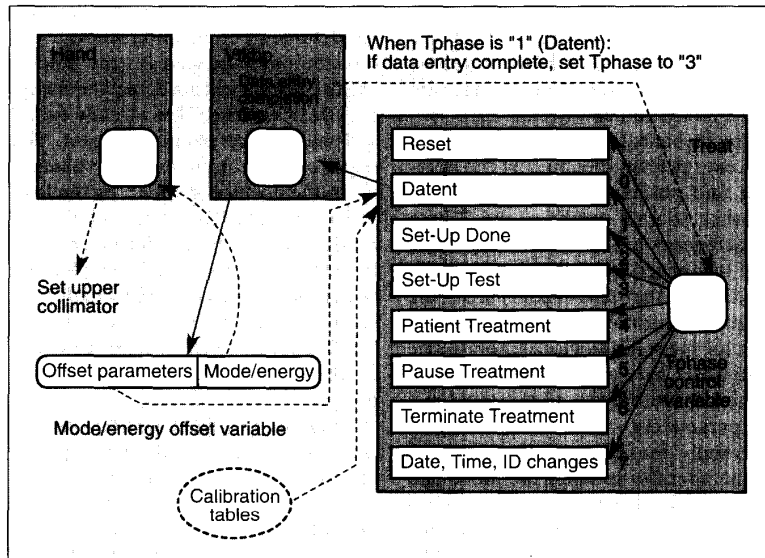
Figure 2. Tasks and subroutines in the code blamed for the Tyler accidents.

As described in the sidebar on Therac-25 software development and design, the treatment monitor task (Treat) controls the various phases of treatment by executing its eight subroutines (see Figure 2). The treatment phase indicator variable (Tphase) is used to determine which subroutine should be executed. Following the execution of a particular subroutine, Treat reschedules itself.

shared variable (Data-entry completion flag) to determine whether the prescription data has been entered. The keyboard handler recognizes the completion of data entry and changes the Data-entry completion variable to denote this. Once the Data-entry completion variable is set, the Datent subroutine detects the variable's change in status and changes the value of Tphase from 1 (Data Entry) to 3 (Set-Up Test). In this case, the Datent subroutine exits back to the Treat subroutine, which will reschedule itself and begin execution of the Set-Up Test subroutine. If the Data-entry completion variable has not been set, Datent leaves the value of Tphase unchanged and exits back to Treat's main line. Treat will then reschedule itself, essentially rescheduling the Datent subroutine.

Upon exit from the Magnet subroutine, the data-entry subroutine (Datent) checks the data-entry completion variable. If it indicates that data entry is complete, Datent sets Tphase to 3 and Datent is not entered again. If it is not set, Datent leaves Tphase unchanged, which means it will eventually be re-scheduled. But the data-entry completion variable only indicates that the cursor has been down to the command line, not that it is still there. A potential race condition is set up. To fix this, AECL introduced another shared variable controlled by the keyboard handler task that indicates the cursor is not positioned on the command line. If this variable is set, then prescription entry is still in progress and the value of Tphase is left unchanged.

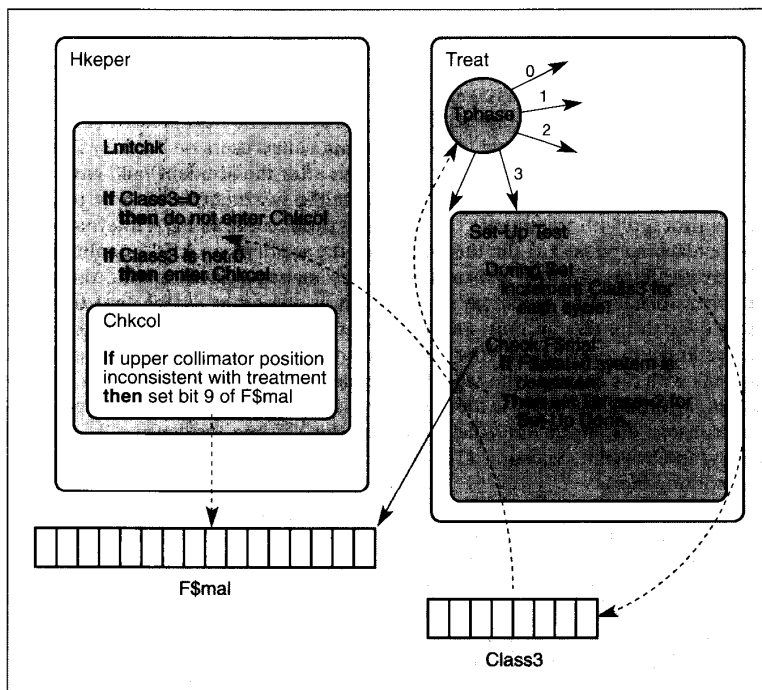
Figure 4. Yakima software flaw.

The second Yakima accident was again attributed to a type of race condition in the software — this one allowed the device to be activated in an error setting (a "failure" of a software interlock). The Tyler accidents were related to prob-

lems in the data-entry routines that allowed the code to proceed to Set-Up Test before the full prescription had been entered and acted upon. The Yakima accident involves problems encountered later in the logic after the treatment monitor Treat reaches Set-Up Test.
