Analysis of the causes of failure in 5Cr-1Mo pipes mounted in a preheating furnace

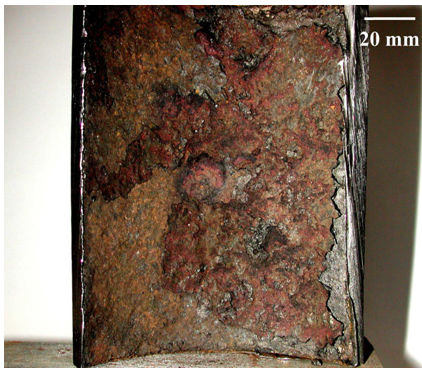
The macrographic analysis shows two types of damage inside the pipe: pitting corrosion and areas with thickly oxidized scale presence (Fig. 4).

Figure 4: Macrographic analysis. View of the internal surface of a pipe taken from a pre-heating furnace.

According to the technical literature, the condition of pipes, when examined, after a long period in high temperatures and with the aggressive charge in the last two operating years, shows a clear pitting corrosion (see Fig. 4, 5, 6) with a strongly discontinuous and porous scale. Due to conspicuous infiltrations, this scale involves the formation of a pit under the deposit itself and even attacks grain boundaries (Fig. 8).

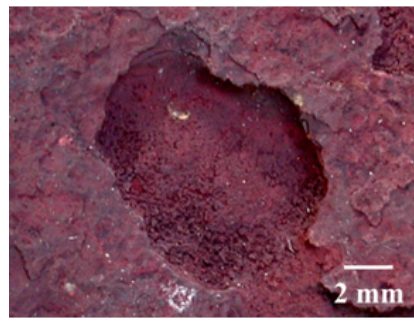
Fig. 5 is a magnification of a part of figure 4 and shows the presence of a large surface pit.

Figure 5: Macrographic analysis. Magnification of a detail from Fig. 4. Pitting corrosion.

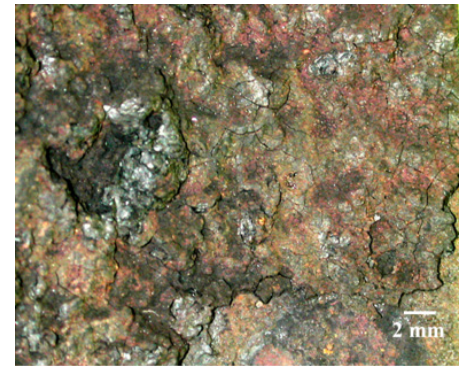
Fig. 6 is also a magnification of a part of figure 4: it highlights the deposits of the products of macroscopic corrosion, which are very coherent and thick. Areas with different colours are recognizable on the internal surface of the pipes, seemingly due to the presence of corrosion products such as α -Fe₂O₃ (hematite) and γ -Fe₂O₃ (maghemite) respectively reddish brown and dark yellowish brown [8-9], besides Fe₃O₄ and Cr₂O₃ oxides. Each Fe oxide shows a colour that is a function of several factors including the electron transitions, the particle size and shape, crystal defects, adsorbed impurities, and the degree of particle packing [9]. Particularly, a reduction in particle size of Fe oxides results in paler colours, one exception is goethite [9-10].

Figure 6: Macrographic analysis. Magnification of a detail from Fig. 4. Corrosion scale.

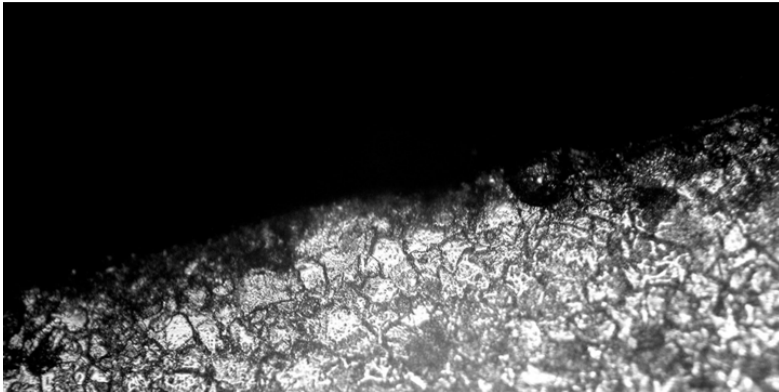
The top section of sample 1 (Fig. 7) was examined to investigate the region under the pit (Fig. 8). This region shows the presence of infiltrations that provoke new pits.

Figure 8: Micrographic analysis. Under site of large pit surface. Presence of infiltration that give birth to new pits. – 200 X.

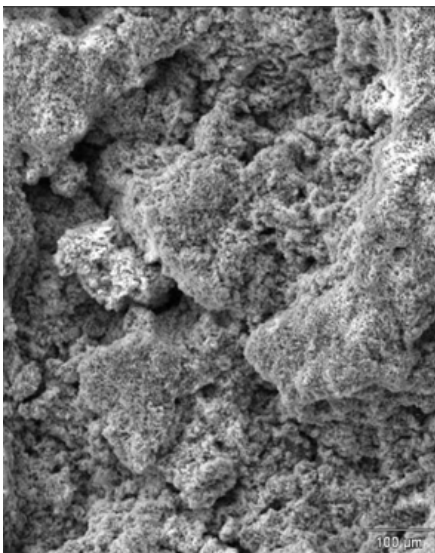
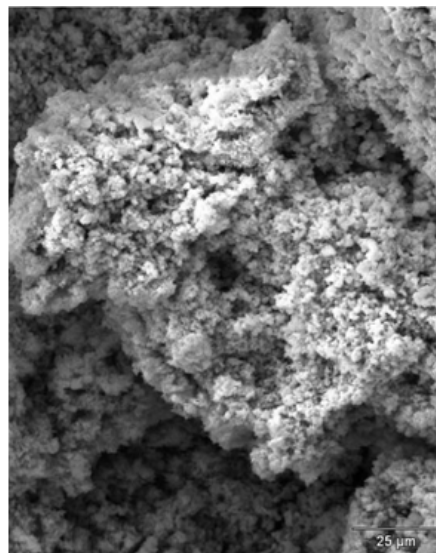
The surface of the pit valley was examined (Fig. 7 – sample 1 surface). Fig. 10 and its magnification, Fig. 11, show the surface of the pit valley, badly damaged and the porous and sponge-like scale, no longer protective. EDS analysis was carried out on this surface, and it showed the presence of chromium and sulphur, all elements related to corrosive products such as iron and chromium oxides (Fig. 12, Tab. 1).

Figure 10: SEM analysis. Surface of the pit valley – 200 X.

Figure 11: SEM analysis. Magnification of a detail from fig. 10. – 1000 X.

The Scanning Electron Microscope (SEM) and Energy Dispersive Spectrometer (EDS) analysis, executed on the craters of pits (see Fig. 10-11), clearly highlight the oxidized layer characterized by a porous and sponge-like structure. Moreover, the presence of chromium, oxygen and sulphur, shown by data, confirms oxides of iron and chromium as corrosion products.

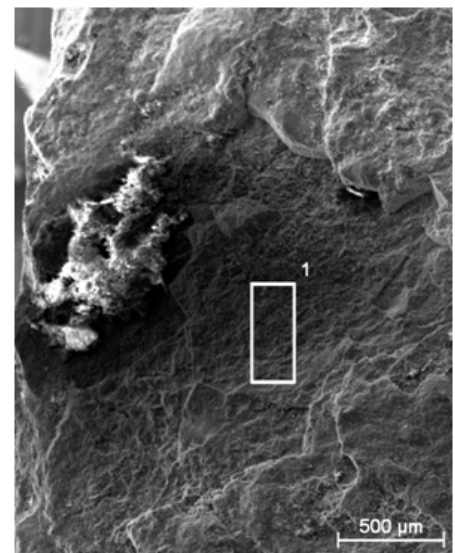
Figure 12: SEM analysis. Pit surface. – 60 X.

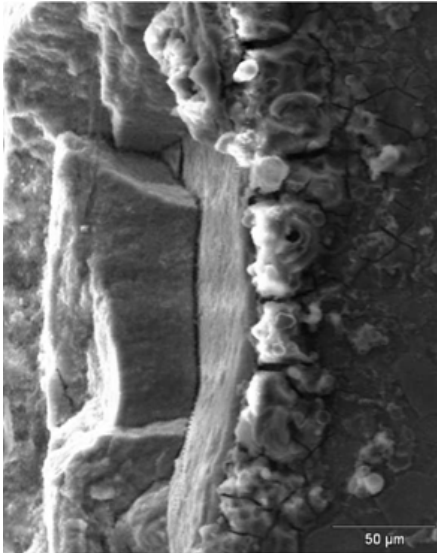
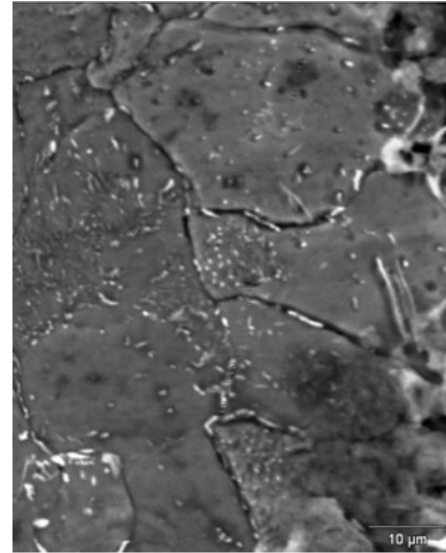
A section of the pit was made (Fig. 7 – sample 1 section). The progress of the corrosive process under the macroscopic pit (Fig. 13) and the inter-granular damage (Fig. 14) were monitored.

Figure 13: SEM analysis. Section view of the pit. Corrosive process. – 600 X.

Figure 14: SEM analysis. Section view of the pit. Intergranular damage. – 2200 X.

On the other hand, the Scanning Electron Microscope (SEM) analysis performed on the section of the pit (see Fig. 13-14) highlights the corrosion products present in the inner part of the cavity.

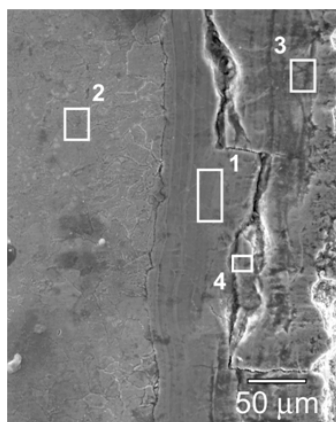
internal pipe section: Fig. 15 shows an internal area of the pipe where the protective scale layer is still present, even if very thin; the scale appears damaged and penetrated, so that a significant fracture is present. EDS analysis (Tab. 2) shows in point 1, where the scale is compacted, a greater chromium concentration (probably Cr₂O₃) than in points 3, 4, where the oxidation is principally due to Fe₂O₃ and Fe₃O₄ oxides.

Figure 15: SEM analysis. Internal area of pipe where protective scale layer is still present, even if very thin; the scale appears damaged and penetrated, so that a relevant fracture is present. – 400 X.

The EDS analysis executed on areas where the scale is still compact (Fig. 15, Tab. 2 - Pt 1) highlights greater chromium's concentration (maybe Cr₂O₃) than that on areas less compact that is to say where the scale is strongly attacked and penetrated where oxidation is generated by Fe₂O₃ and Fe₃O₄ (Fig. 15, Tab. 2 - Pt 3-4).

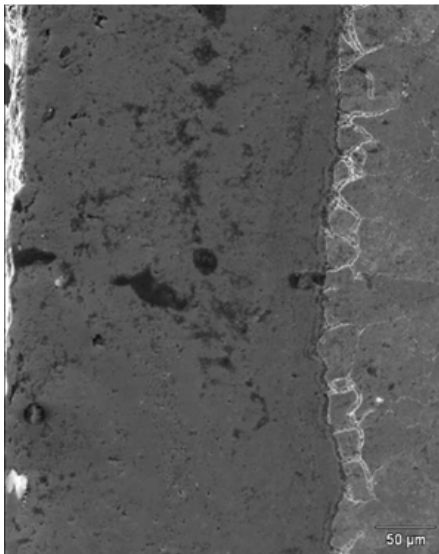
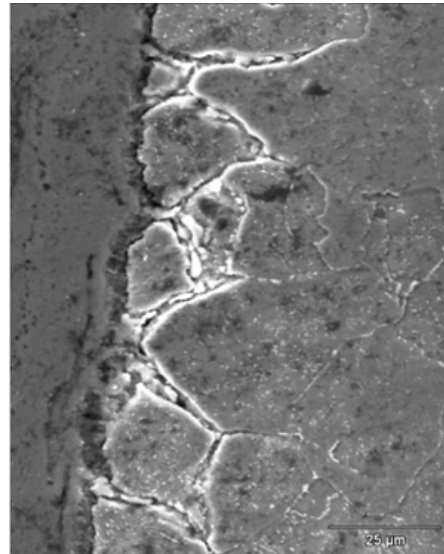
Considering the external pipe section scale: Fig. 16 shows a very porous and infiltrated surface, with relevant penetration of grain boundaries (Fig. 17).

Figure 16: SEM analysis. External pipe section scale – 350 X.

Figure 17: SEM analysis. Magnification of a detail from Fig. 16. – 1300 X.

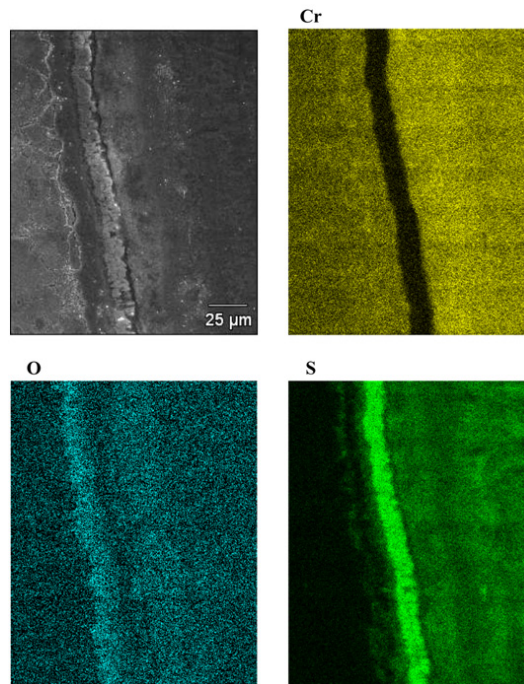
A map has been executed on a section of the scale (fig. 18). The map shows sulphur presence (sulphur compounds) at the interface between compressed and porous scale with a build-up immediately behind the compacted scale. A major Cr concentration appears in the penetrated area, while the oxygen is diffused.

Figure 18: SEM analysis. Map of corrosion crust – 800 X.

It shows sulphur presence (sulphur compounds) in all non homogeneous scale, and a build-up immediately beyond the compacted one.

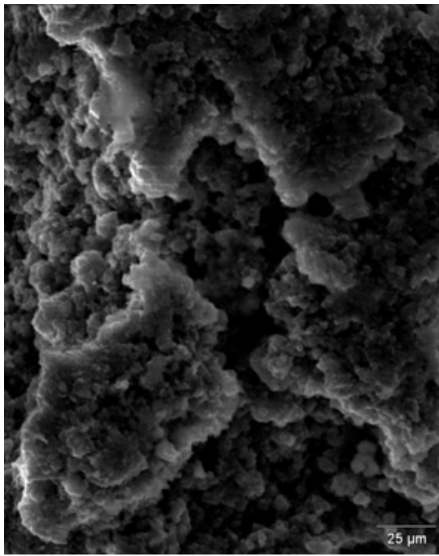
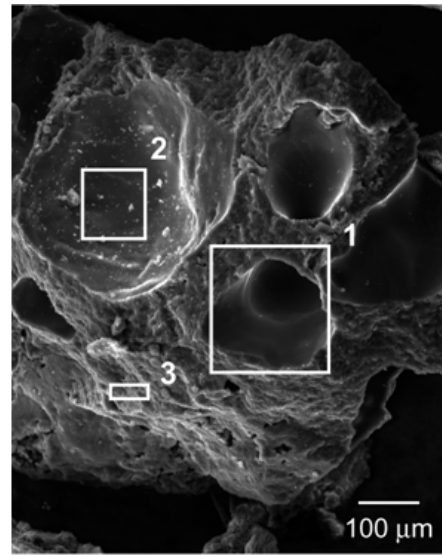
The pipe surface scale was examined (Fig. 7 – sample 2 section): micrographic analyses have been performed on particles removed from the surface scale. The following figures show two different crust types. The first one (Fig. 19) appears to be non homogeneous and porous. Channels rich in chlorine and sulphur formed by pressured gas are visible (Fig. 20), EDS analysis (Tab. 3).

Figure 19: SEM analysis. Porous particles from the surface crust – 700 X.

Figure 20: SEM analysis. Channels in the surface crust – 170 X.

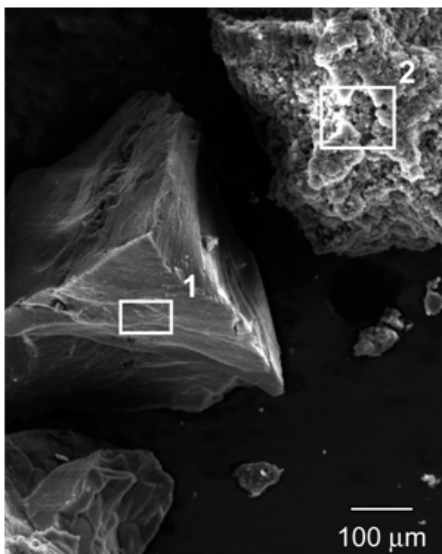
The second crust type (Fig. 21) seems to be compacted, with sulphuric and chloride compounds present, as the EDS analysis detected (Tab. 4).

Figure 21: SEM analysis. Compacted particles from the surface crust – 170 X.
