# Application of FRP composites for underwater piles repair

Rajan Sen \*, Gray Mullins

*Department of Civil and Environmental Engineering, University of South Florida Tampa, FL 33620, USA*

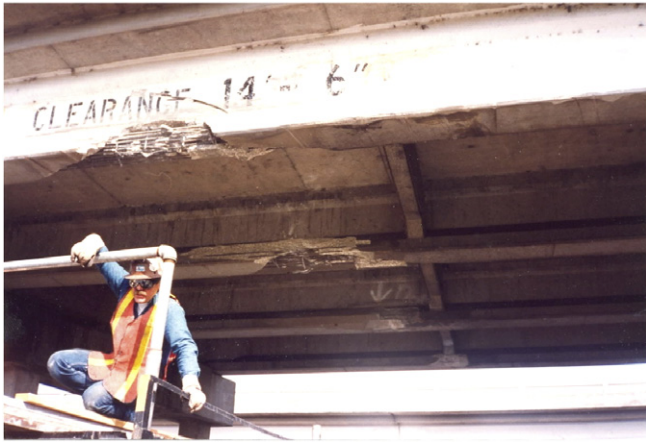
Fig. 1. Damage to prestressed girder due to vehicular collision (Courtesy A. Alvi).

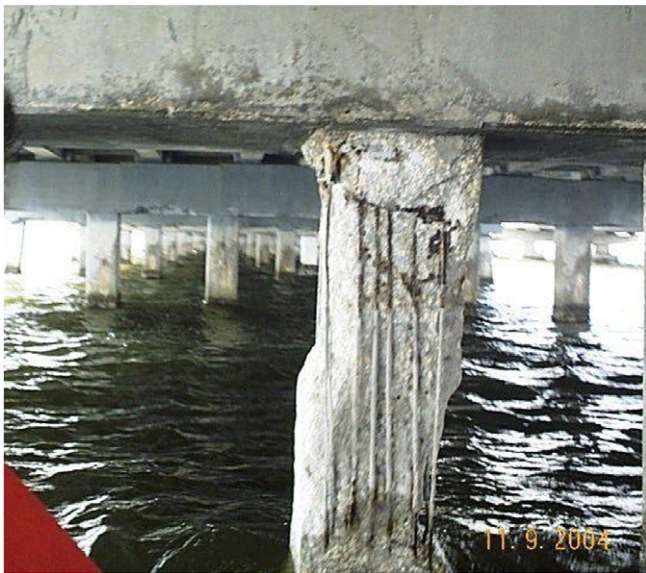
The emergence of new adhesives [1] that allow FRP to be bonded to wet concrete surfaces makes it possible to economically conduct emergency repairs on sub-structure elements. Fig. 2 shows impact damage that led to both cross-section loss and breakage of the spiral ties. Conventional repairs will require the cross-section to be enlarged to accommodate new ties. If instead, FRP were used it

Fig. 2. Damage to pile requiring emergency repair (Courtesy FDOT).

would only be necessary to re-form the cross-section and apply bi-directional layers that could restore lost tensile capacity while providing equivalent lateral support to the longitudinal steel. Moreover, the application of a protective UV (ultra-violet) coating on the wrap of the right color will render the repaired pile indistinguishable from other undamaged piles. The aesthetics of FRP repair is one of its unheralded benefits.

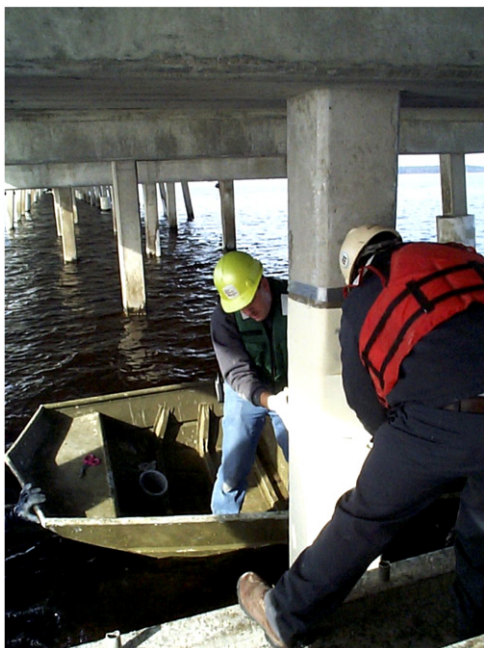
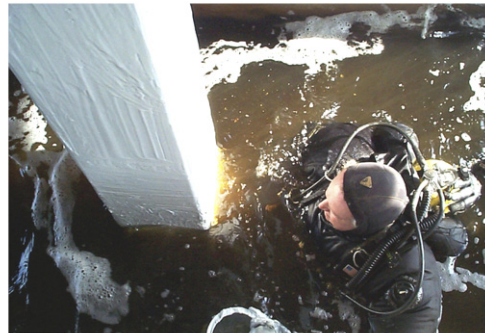
Fig. 4. Underwater repair using a boat and divers (Courtesy: Air Logistics).

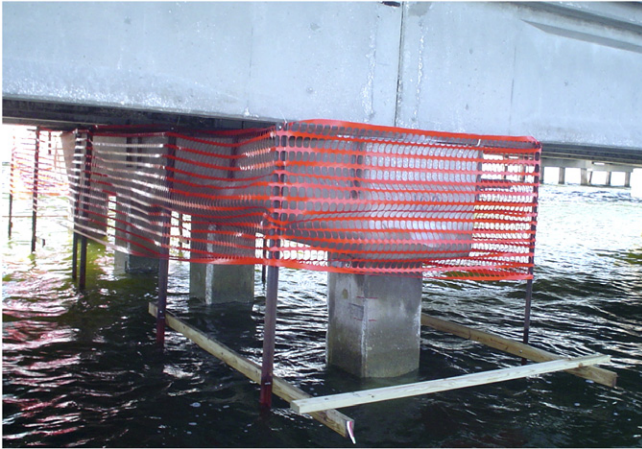
Fig. 5. Scaffolding system suspended from pile cap.

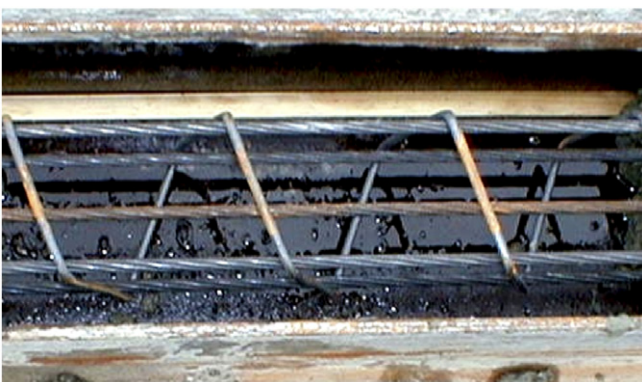
Fig. 6. Curved wood trim inserts at corners.

The damage to the section needs to be repaired using low shrinkage materials compatible with concrete. Should the section be reformed, appropriate inserts should be used at the corners (Fig. 6). This will greatly reduce the surface preparation work needed to round the edges since sharp corners introduce stress concentrations that cannot be taken by thin FRP material.

4. If the section is to be re-formed, styrofoam or wood inserts with a curved profile should be placed in the corners so that surface preparation work is minimized and overall costs reduced.

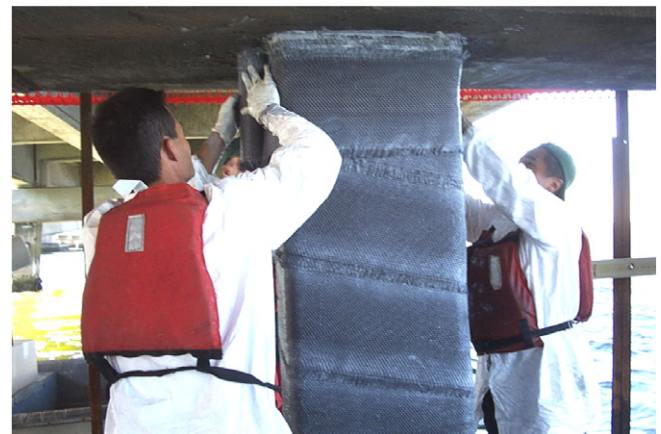
Fig. 7. Applying second transverse CFRP layer.

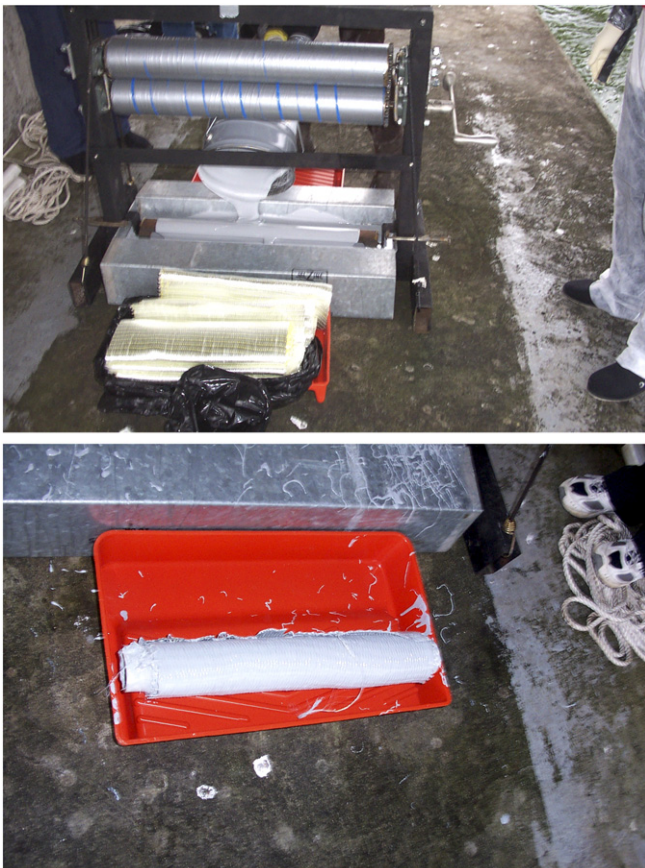
The FRP fabric for pile 101S was impregnated by hand. For pile 101N re-wrapped three months later, a resin impregnator was used (Fig. 8). Following the saturation of the FRP, the wrapping procedure was identical to that for System A. Complete details may be found in the final report [5].

Fig. 8. On-site saturation of fiberglass fabric.

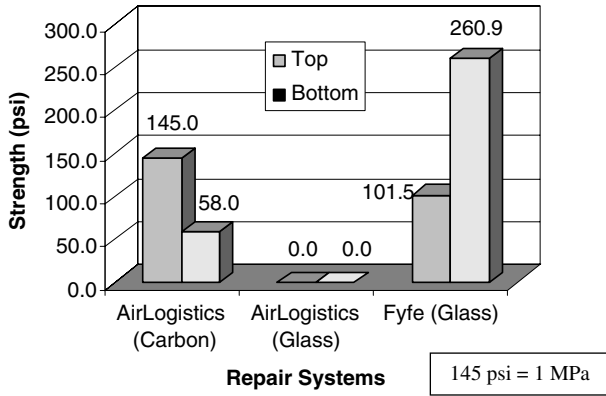
Table 4 and Fig. 9 summarize the results of the pullout tests. The bond of FRP to the concrete substrate was found to be poor. Most of the wet layup wrapped piles showed epoxy failures where the dolly separated from the concrete at its interface (Fig. 10). All tests conducted on the pre-preg system were inter-layer failures (Fig. 11) indicating that the bond between the FRP layers was poorer than its bond to concrete.

Inspection of Table 4 shows that the bond from System B performed better in the wet region while System A was better for the dry region. Similar differences were not observed on laboratory specimens tested [6]. Therefore, the problem with bond can be attributed to the field techniques used for wrapping. On-going research is developing a new protocol to prevent such inconsistency.

Fig. 9. Maximum residual bond strength after 2 years.

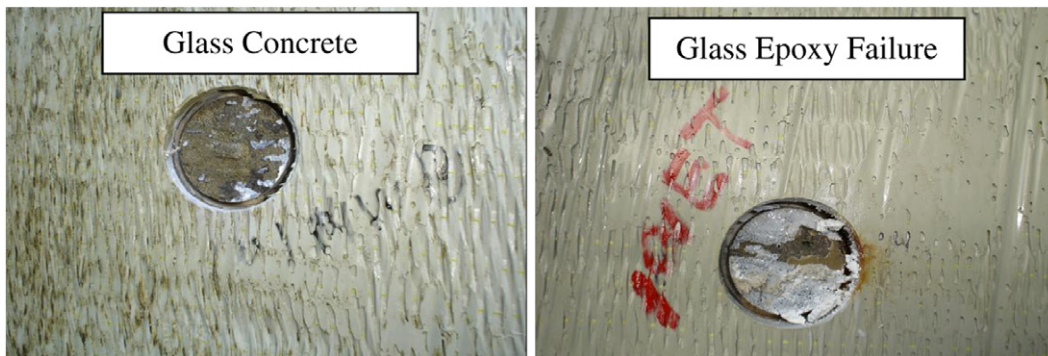
Fig. 10. Failure mode in wet lay up wrap system.

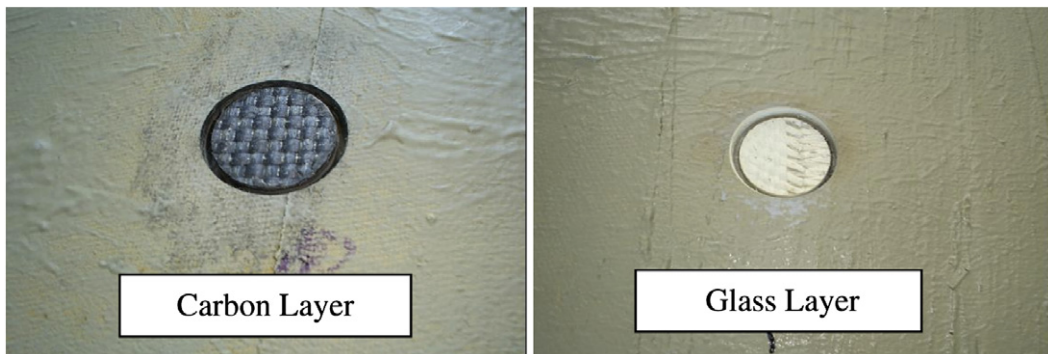
Fig. 11. Failure mode in pre-preg wrap system.
