Application of infrared thermography to failure detection in industrial induction motors: case stories

D. Lopez-Perez and J. Antonino-Daviu

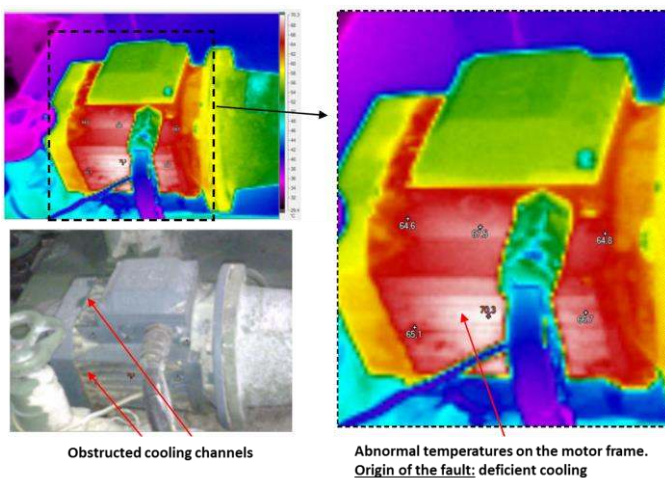
This motor was a L.V. machine that was driving a pump for bearing lubrication. The infrared inspection revealed a motor overheating, since the frame temperatures were reaching values above 70°C in some points (Fig. 3). After a more detailed analysis of the motor, it was observed that the cooling air flow was insufficient; the cause was an obstruction of the cooling channels that was produced by product wastes. The cooling channels and fins were properly cleaned and the subsequent infrared inspection revealed an abrupt decrease in motor frame temperatures up to values around 30-40°C with the motor operating under similar conditions as in the first inspection (see Fig. 4). Hence, in this case, infrared thermography enabled to detect the source of the problem.

Fig. 3. Infrared inspection of Motor 1: deficient cooling.

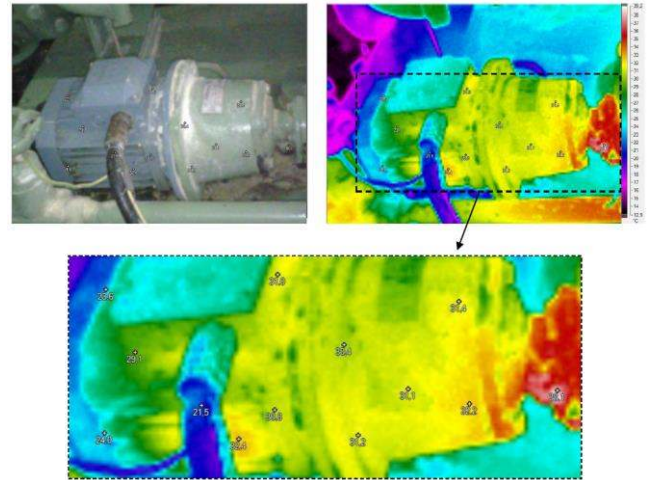
Fig. 4. Infrared inspection of Motor 1 after cleaning.

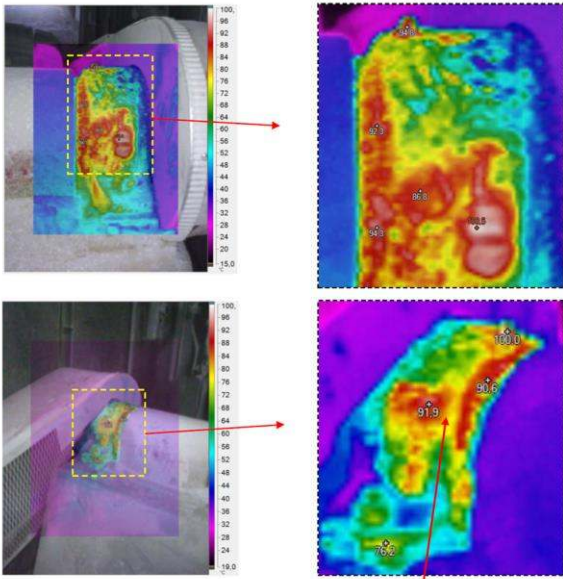
In this case, the inspected element was a bearing of a motor that was driving a blower. An initial infrared inspection revealed an excessive heating of the bearing. This can be noted in Fig. 5 which shows superficial temperatures above 90°C (and even 100°C) in the bearing region. We can also observe the deposit of product waste over the bearing cage. The bearing was properly cleaned and a new inspection was carried out. However, no significant temperature drop was detected. Therefore, it was finally decided to re-lubricate the bearing. This measure was much more effective, as a new infrared inspection revealed: the temperatures were not higher than 60°C in the bearing region for the motor operating under similar conditions (Fig. 6).

Abnormal temperatures on the bearing region.
Origin of the fault: deficient bearing lubrication.

Fig. 5. Infrared inspection of bearing of Motor 2: deficient bearing lubrication.

In order to prevent the occurrence of this type of bearing lubrication problems, the plant engineers proposed not only the use of the infrared technique to detect such anomalies in advance, but they also suggested the lubrication of the bearings by means of ultrasounds; this lubrication method may bring interesting benefits, such as the reduction of the possibility of an inexact lubrication, amongst others. Moreover, the accurate study of this failure enabled to plot a P-F curve associated with bearing faults; this curve shows, for the corresponding fault, the minimum detectable alarm level for each considered technique. This curve is plotted in Fig. 8 and shows how primary bearing defects (wear, indentations, smearing, corrosion...) are best detected via infrared thermography and ultrasounds while vibrations and oil analysis are best suited for the detection of secondary defects.

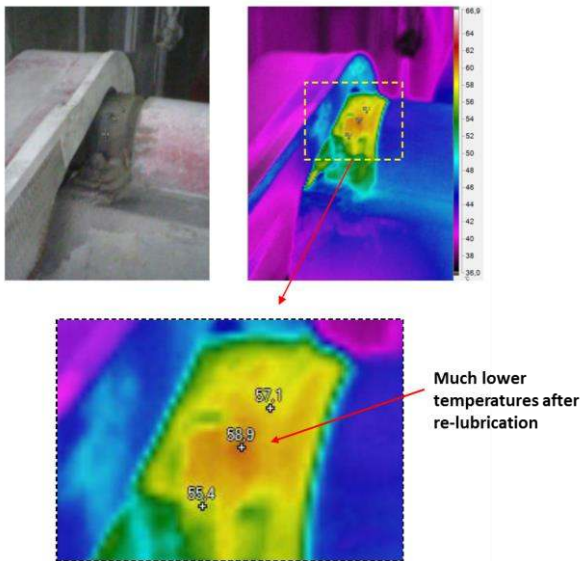
Fig. 6. Infrared inspection of bearing of Motor 2 after re-lubrication.

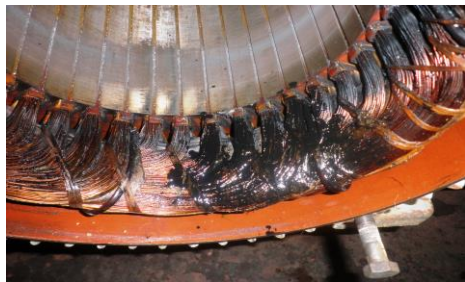
It is important to emphasize that, in the past, this motor had an episode of catastrophic failure caused by problems in the bearings: in 2010, the lack of proper bearing lubrication was not properly detected via vibration analysis; finally, this fact led to the collapse of the bearings and to the damage of the stator insulation (see Fig 7). This is an illustrative case that shows how the infrared thermography may provide very interesting information for the diagnosis in situations where other techniques may fail.

Fig. 7. Insulation damage occurred in 2010 in the same motor due to catastrophic failure of the bearings.

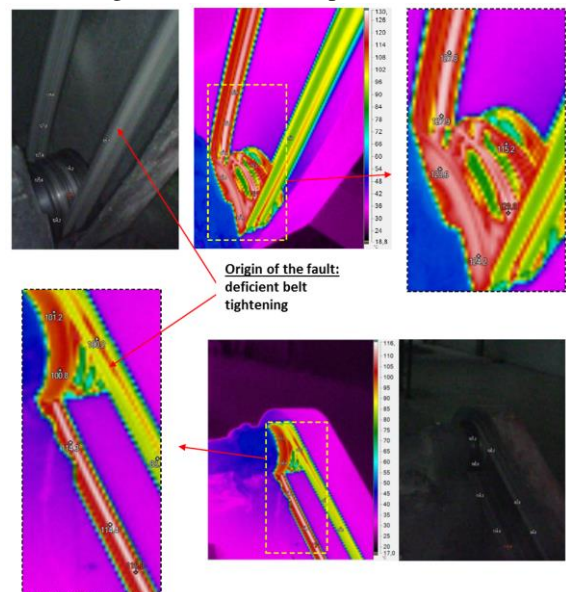
The inspected motor in this case was an L.V. machine driving a fan for deodorization purposes. Oddly enough, the infrared inspection revealed a very high heat dissipation in the belt transmission system (see Fig. 9), with a maximum temperature of 129.8 °C that was read on the pulley. The deficient tension leads to belt slip on the pulley and increases the heat dissipation due to the friction, which results in decreased efficiency and a reduction of the belt service life.

Fig. 9. Infrared inspection of Motor 3: deficient belt tightening.

To solve the problem, the belts were properly tightened and, afterwards, a new inspection was carried out. Fig. 10 shows the new thermal map after the belt tightening that reveals much lower temperatures in the transmission system (30°C in average lower than in the previous case).

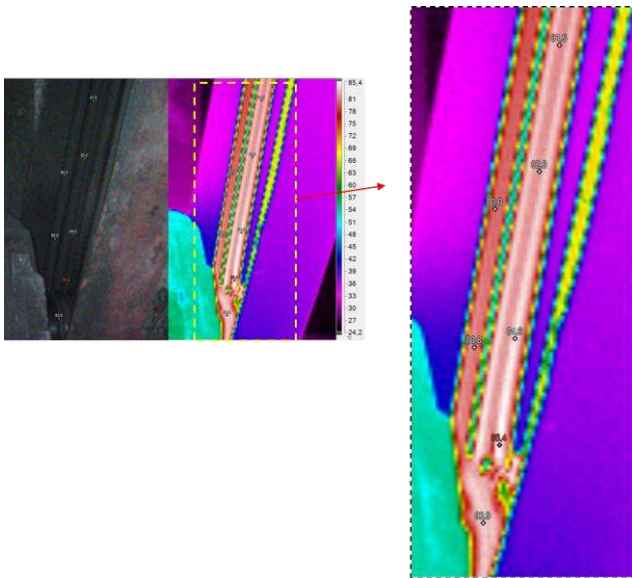
Fig. 10. Infrared inspection of Motor 3 after belt tightening.

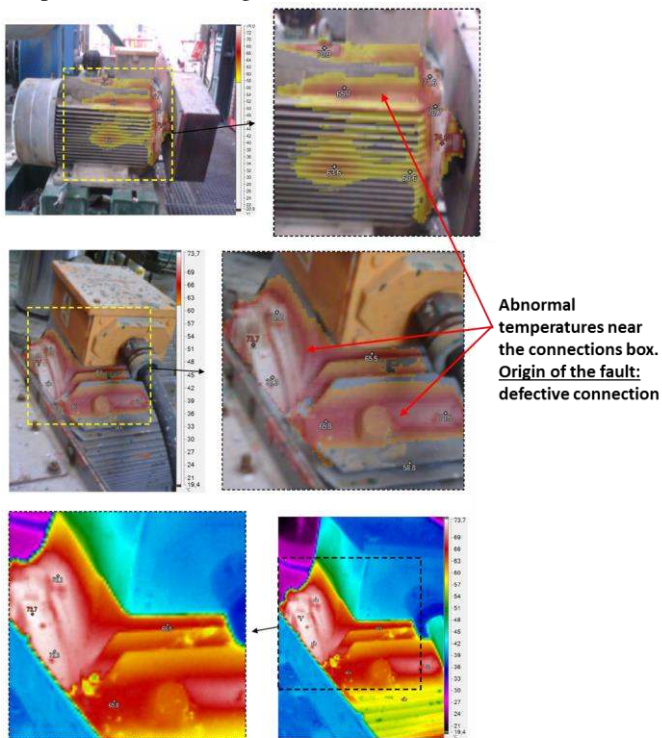
The inspected motor was an L.V. machine driving a blower. The infrared inspection revealed an excessive heat dissipation that was localized in the upper part of the frame, close to the motor terminal connection box, as shown in Fig. 11. The temperatures there reached high values (76.8 °C).

Fig. 11. Infrared inspection of Motor 4: defective connection.

While the motor was switched-off, the winding resistances were measured, obtaining very similar values. The connections were checked and a weak connection was found as well as a partial damage in one of the terminals (Fig. 10, top). After replacement of the terminal and after fixing the connections, the new infrared inspection showed lower temperature values (Fig. 12, bottom).

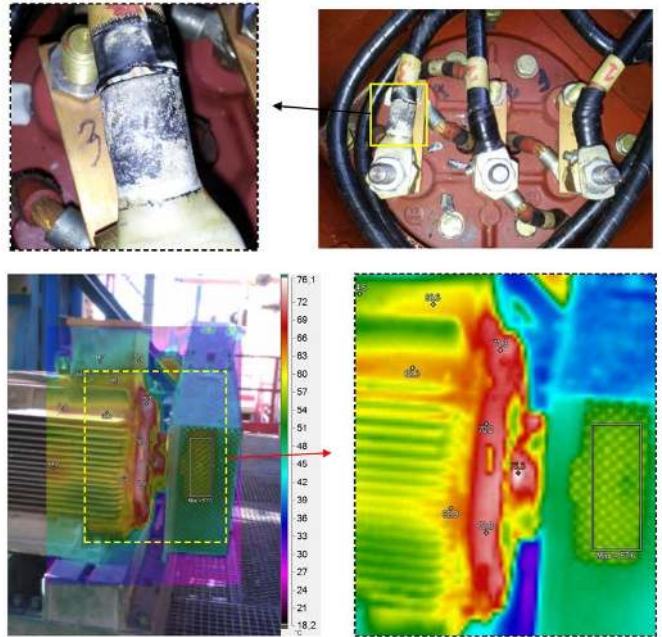
Fig. 12. Defective connection and terminal in motor connection box (top) and Infrared inspection of Motor 4 after repair (bottom).

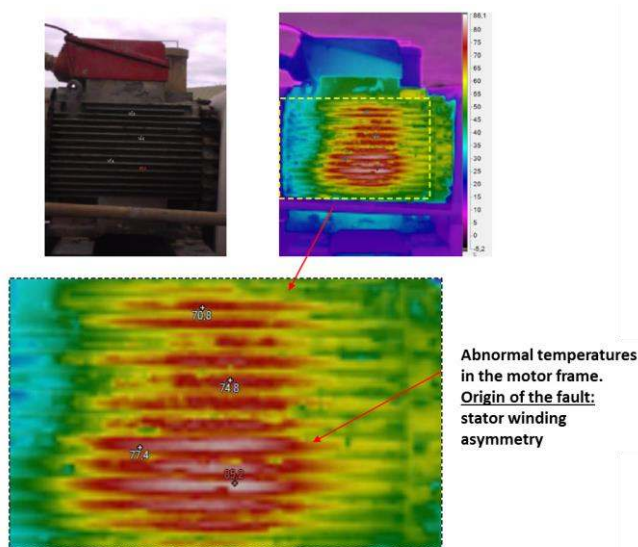
In this case, the considered motor was driving a fan of a cooling tower. The infrared inspection of that motor (Fig. 13) showed a significant heating in the motor frame (85.2 °C in the surface and, probably, above 100 °C inside the motor). No cooling anomalies were found during the inspection. As a first measure, the bearings were re-lubricated and repaired in a workshop but no temperature drop was observed.

Then, the motor terminal box was inspected and only a little temperature difference between connections was found. The winding resistance of each phase was measured with an ohmmeter and the results were very interesting (see Table IV, which compiles the results of the measurements): a significant winding asymmetry was detected between phases, leading to a Max Delta R value of near 9%. This could indicate internal high resistance connections, broken turns or internal shorts. This may be the potential cause of the abnormal heat dissipation. A motor re-winding was finally suggested.

Fig. 13. Infrared inspection of Motor 5: winding asymmetry.
