Trong Vinh Duong, Yu-Jun Cui, Anh Minh Tang, Nicolas Calon, Alain Robinet. Assessment of conventional French railway sub-structure: a case study. *Bulletin of Engineering Geology and the Environment*, Springer Verlag, 2015, 74 (1), pp.259-270. 10.1007/s10064-014-0575-y . hal-01271093

# Assessment of conventional French railway sub-structure: a case study

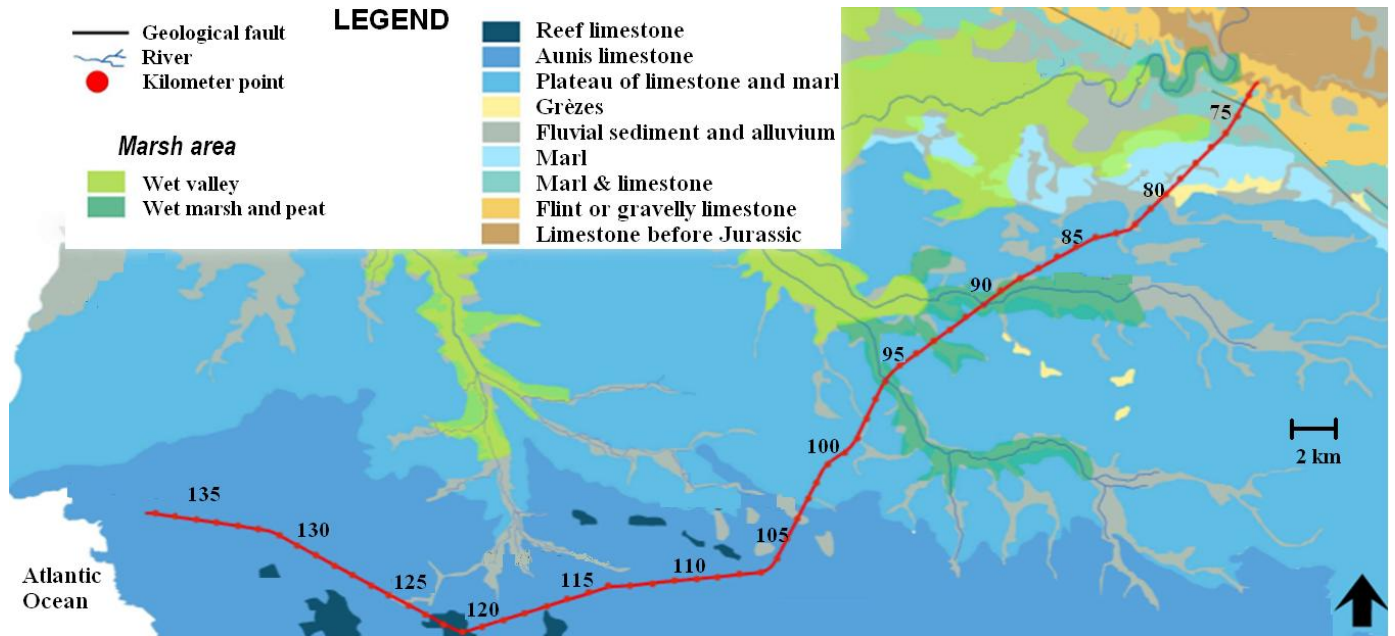
164 Fig. 7 presents the geological map of the studied line with the kilometer point (PK) and the geological  
165 information. The sub-grade includes five soil types. The first one at the very first kilometer of the line  
166 (from PK 74 to 75) consists of the soil of Middle Jurassic, mainly including hard limestone and marl.  
167 The thickness of each layer can vary from 10 mm to 1 m and the total thickness can reach 20 m. At PK  
168 75, the line passes through a zone varying from river alluvial silty clay to clay-limestone. The second  
169 (from 75 to 76) involves argillaceous limestone, marl, and to a lesser extent fine alluvial deposit and  
170 peat. The thickness of these layers varies from some centimeters to 1 m. The third consists mainly of

171 marl (from 76 to 79). The total thickness reaches 40 m. This marl layer can sometime be overlaid by a  
172 thin layer of more or less clayey limestone. The fourth group (from 80 to 102) is the alternation of white  
173 argillaceous limestone and marl. In several zones, the soil is very clayey with a very thin clay layer of  
174 intercalation in marl or limestone. From PK 80 to PK 87, the limestone layers become very hard and  
175 resistant. Around PK 87 and PK 89, the line passes through the zones of river alluvial silty clay and  
176 sometimes with peat. These zones of peat are very compressible, representing low-quality sub-soils. The  
177 fifth type involves marl, white chalky limestone and limestone sub-lithographic (Upper Jurassic). The  
178 total thickness is about 30 m. From PK 125 to PK 138, the soil consists of limestone with sandwiched  
179 marl. This complex geological situation must be correlated to the large number of problems recorded.

451 Fig. 7: Geological map of the studied line

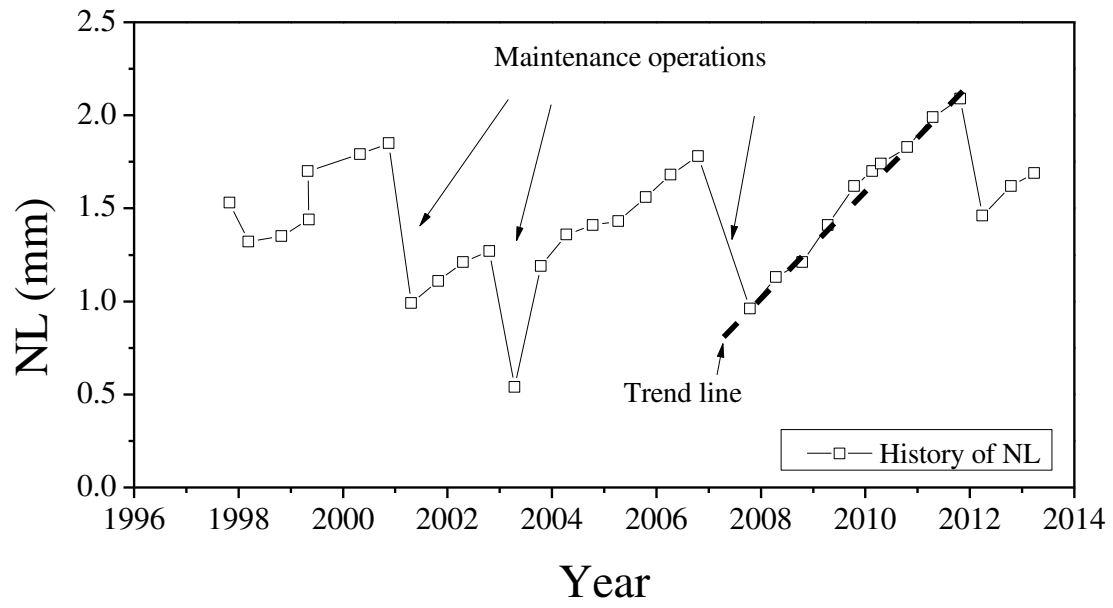
199 Fig. 9 presents the variations of  $NL$  at kilometer 70.3 of Track 2 from 1997 to 2013. It can be observed  
 200 that the value of  $NL$  decreased sharply after each maintenance (in the year of 2001, 2003, 2007 and  
 201 2012). However, after the maintenance, the value of  $NL$  continued to increase at almost the same rate: a  
 202 linear increase trend of  $NL$  over time can be identified. It is worth noting that the slope represents the  
 203 increase rate of  $NL$  or the degradation rate of tracks. The increase trend of  $NL$  persisted after a  
 204 maintenance, suggesting that ballast replacement did not resolve the problem, and the track degradation  
 205 was rather related to the sub-structure.

455 **Fig. 9: History of *NL* variations for a given kilometer, with maintenance operation**

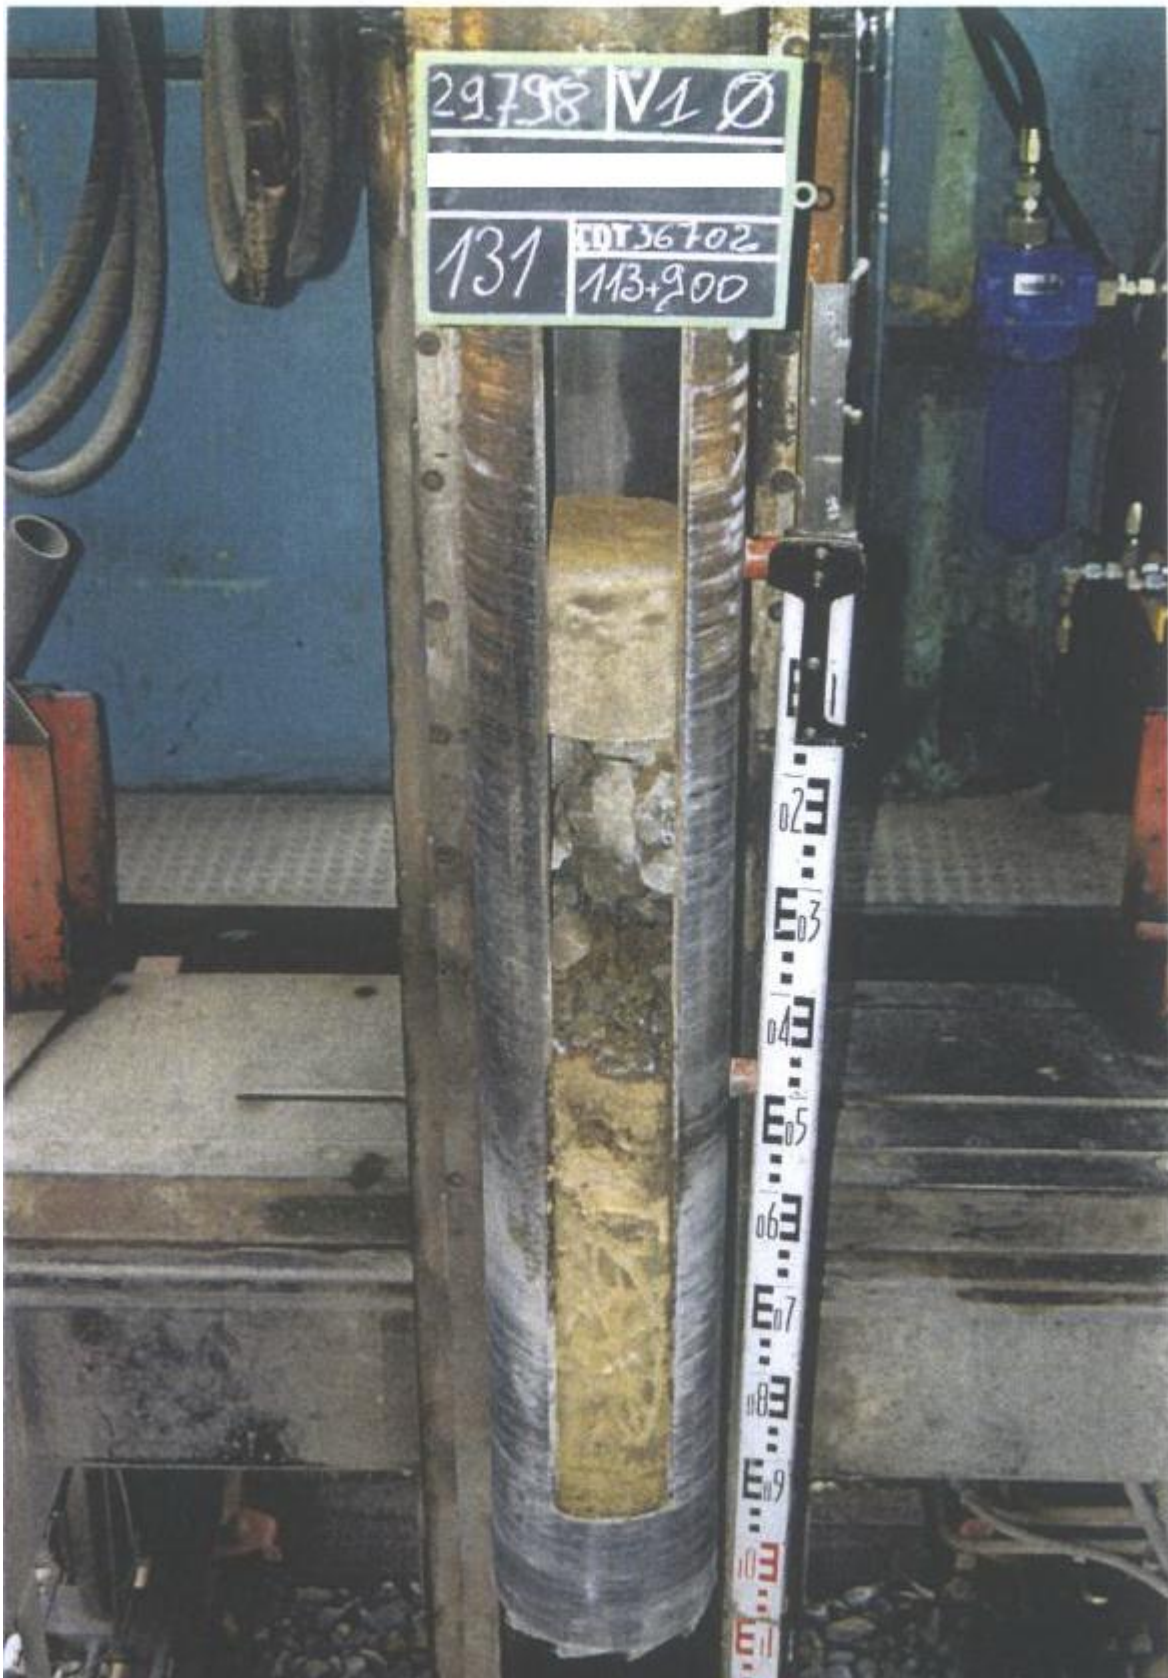
207 The core sampler train is a special train which has the function as indicated by its name (SNCF 2011).  
 208 The train was equipped with drilling equipment. Sample tubes are driven dynamically into track-bed to  
 209 obtain a continuous core sample composed of ballast and underlying formations (Fig. 10). A digital  
 210 camera is used taking photographs of the sample. From the photograph (see Fig. 10), the thickness of

211 each layer is analyzed and recorded. It can be seen that a typical track-bed consists of a clean ballast  
212 layer underlying fouled ballast layer and/or interlayer and sub-grade soil. The sample tube allows core  
213 sample to be taken till a depth of about 1.50 m. This depth is enough for identifying the different layers  
214 in the conventional railway track-beds. This investigation method was also reported in Brough et al.  
215 (2003; 2006).

**Fig. 10: Core sample from typical conventional railway sub-structure**

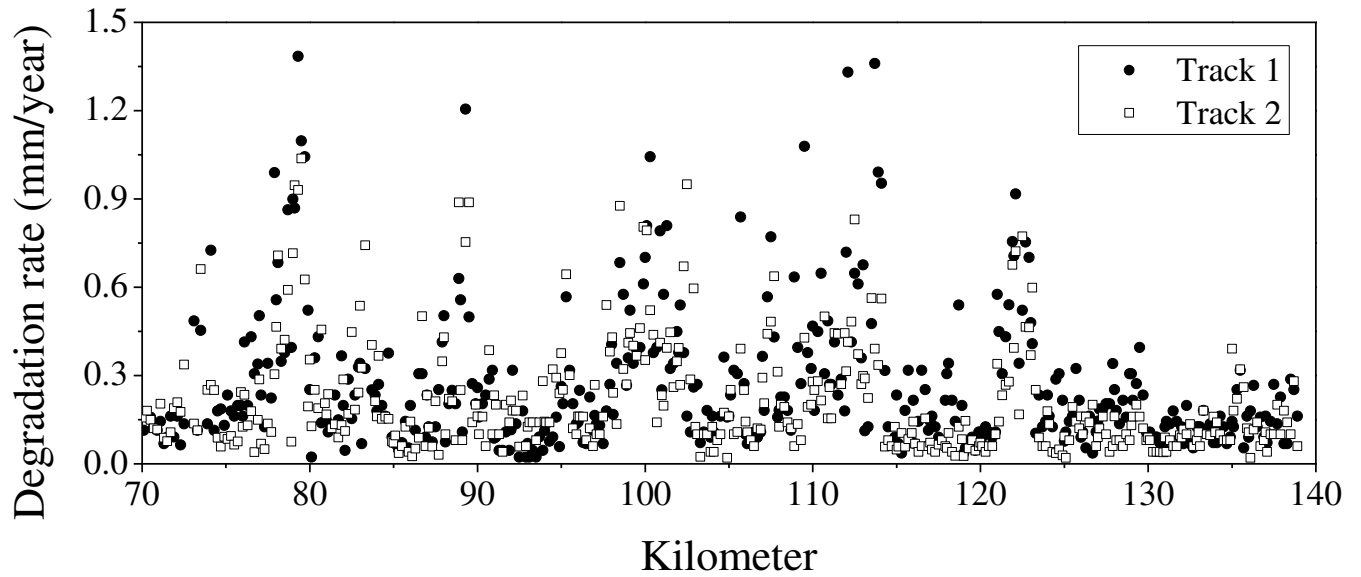
235 Fig. 12 depicts the degradation rate (the increase of  $NL$  per year which was calculated from the  
236 slope as presented in Fig. 9) versus the kilometer point for Track 1 and Track 2. On the whole, there is  
237 an agreement between the data of two tracks; the peaks of Track 1 appeared almost at the same  
238 kilometer points as the peaks of Track 2.

252 From Fig. 12, the zones with high degradation rates can be identified. They are around PK 73,  
253 79, 88, from 99 to 103, from 106 to 114 and 122. Referring to the geological information, it can be  
254 concluded that these kilometer points correspond to the zones where sub-grades contains large fraction  
255 of fine particles. Around PK 73, the sub-grade is rather argillaceous limestone and marl. Around PK 79,  
256 the sub-grade is fine alluvial deposits and peat. From PK 88 to 89, it is the alluvial deposits overlying the

464  
465 **Fig. 12: Degradation rate along the studied line**

266 From the analysis above, it can be seen that the sub-grade has a significant influence on the  
267 performance of railway structure. From a practical point of view, the zones with a sub-grade of low  
268 mechanical properties are not apt to become the foundation of railway sub-structure. If it is inevitable,  
269 improvement must be conducted in order to meet the requirements, such as a good drainage system or  
270 some soil improvements.

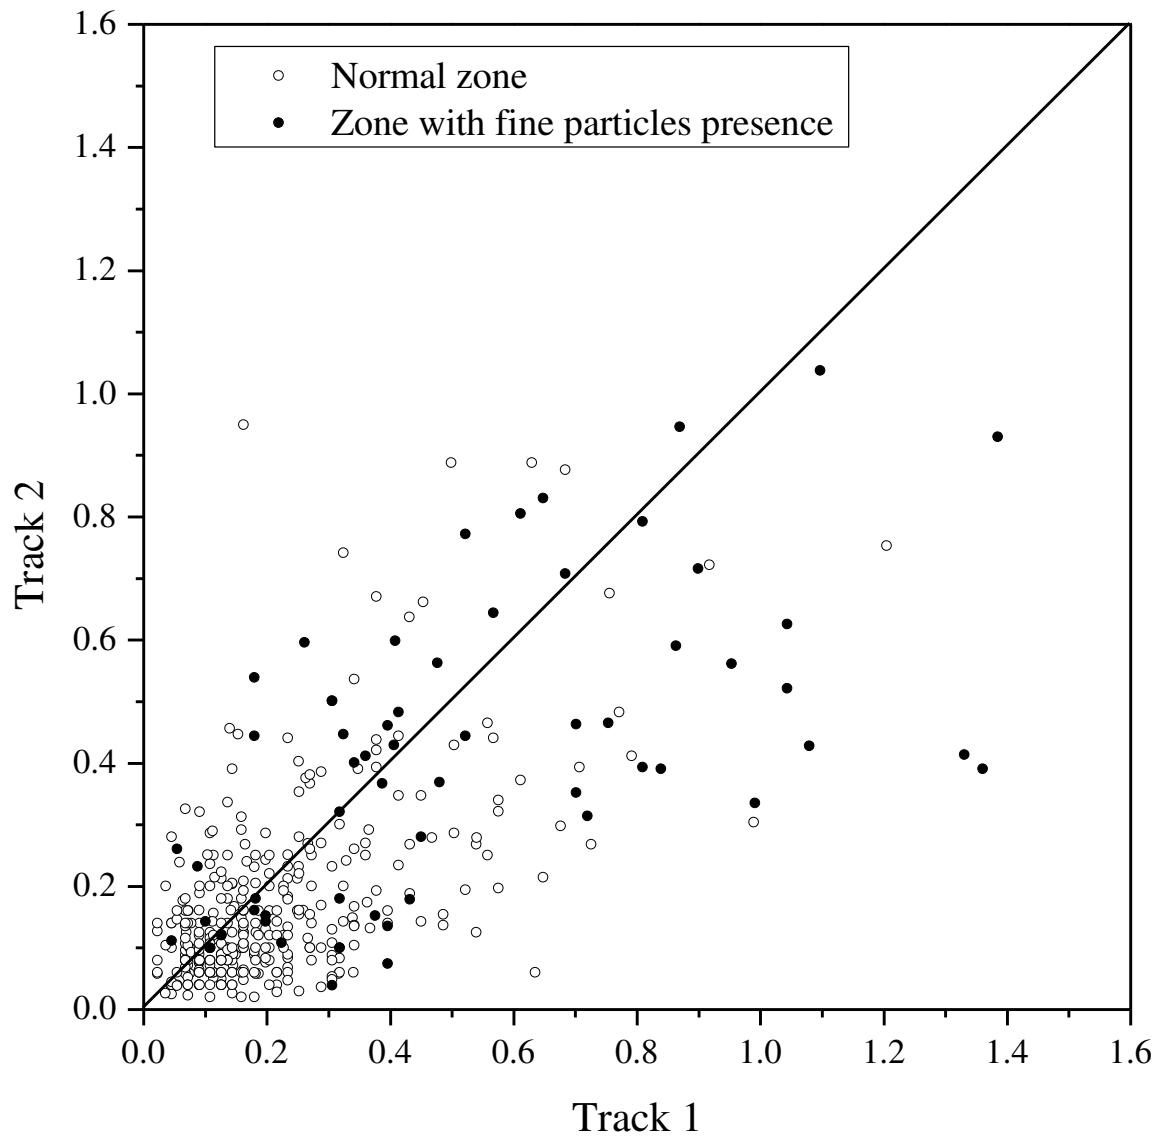
271 Fig. 15 presents the correlation between the degradation rates of Track 1 and Track 2. It is  
272 observed that the *NL* of Track 1 increased more quickly than that of Track 2, because more data fall  
273 below the equality line. This is in agreement with the finding in the first part of work where the number  
274 of sub-structure related problems were recorded (Fig. 4). It is normally admitted that the train heading to  
275 the center (up line) carrying more freights and passengers than the train leaving the center (down line).  
276 More studies are needed to clarify this observation.

277 During the assessment of the whole line, the zones where fine particles were found on the ballast  
278 layer surface were identified. The degradation rates of these zones are presented in Fig. 15 with the black  
279 symbols. It can be seen that most of the zones with the presence of fine particles correspond to the zones

280 with high increase rate of  $NL$ . These fine particles came probably from the sub-grade when mud  
281 pumping occurred. This implies that the sub-grade containing large fraction of fine particles is  
282 detrimental to the performance of sub-structure. Indeed, for this kind of sub-grade soils, a decrease of  
283 mechanical performance can be expected when the moisture content rises. It appears thereby important  
284 to further investigate the effect of water content of sub-soil having large fine particles fraction and also  
285 the mud-pumping phenomenon.

476 **Fig. 15: Correlation between degradation rate of Track 1 and Track 2**
