1 **Assessment of heritage rammed-earth buildings. The Alcázar of King Don**
2 **Pedro I (Spain).**

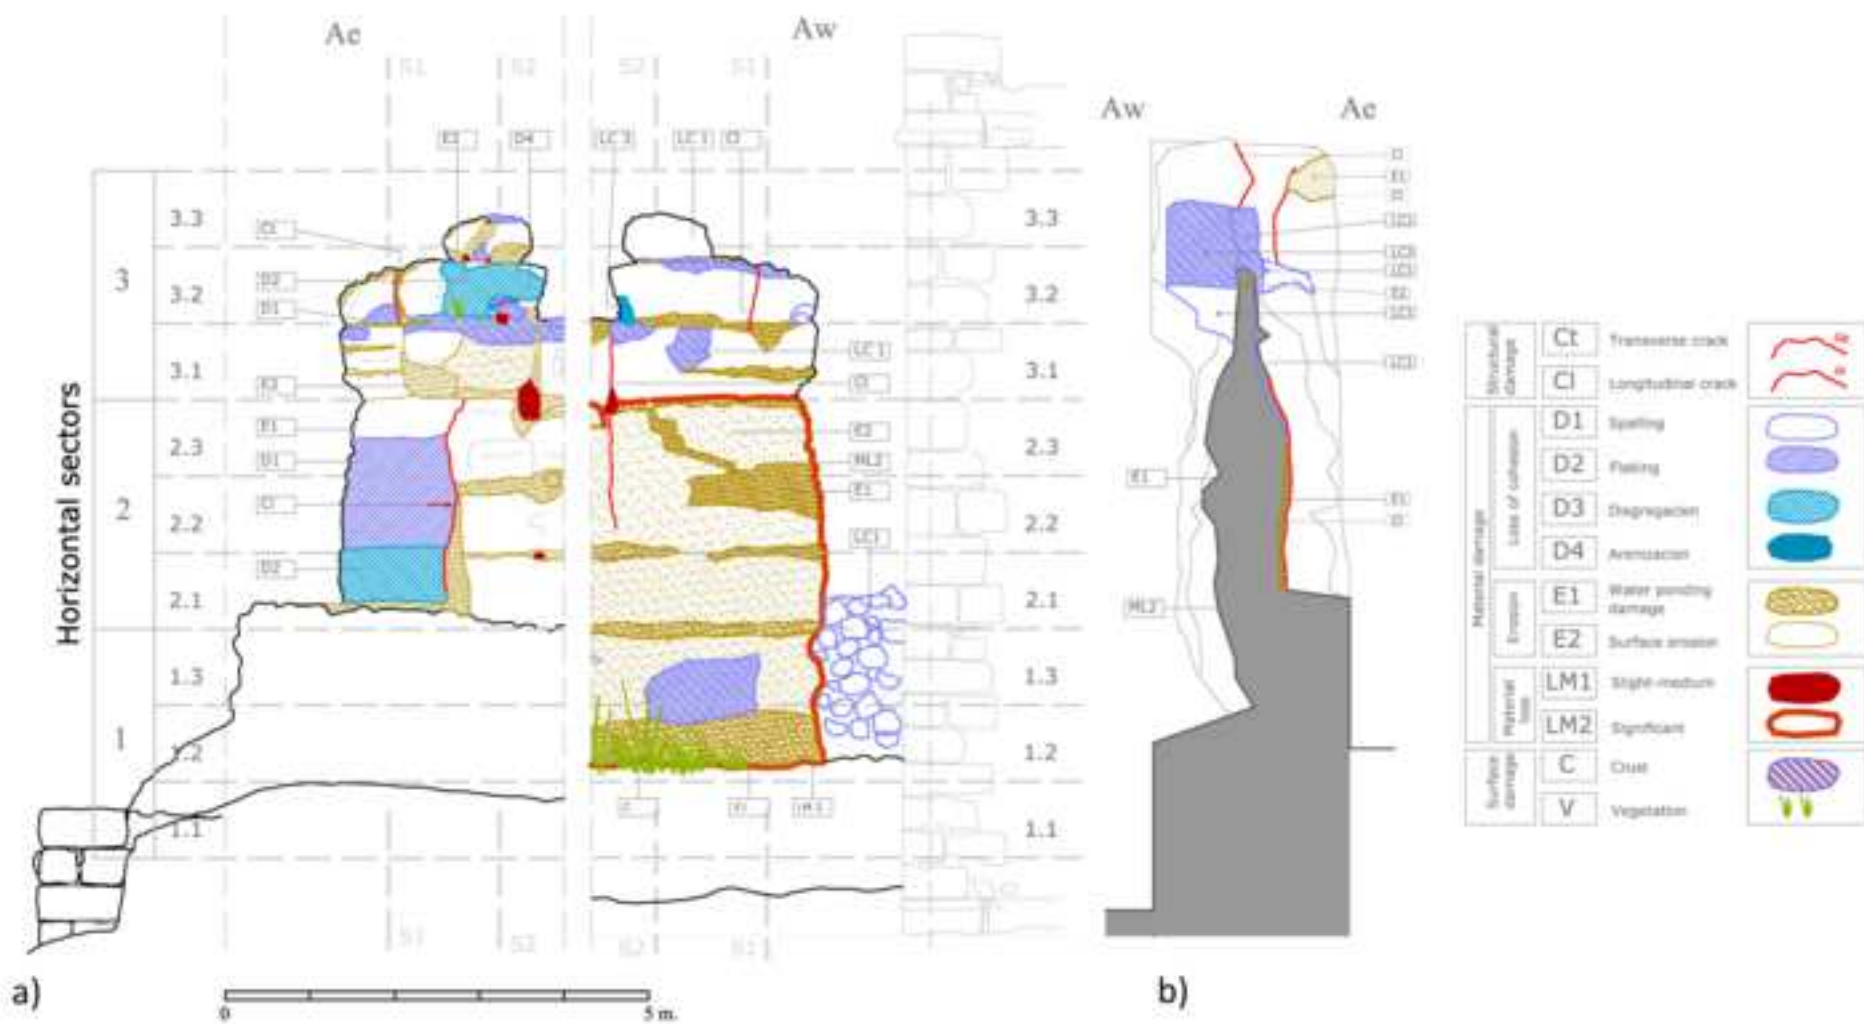
202 damage is rated in one of two categories (low and high) depending on the development and
203 intensity of the surveyed failure. For instance, Figure 4 represents two sectors, where sector Aw
204 is considered as high-damage, and Ae as low-damage, since the former sector presents failures
205 that are more critical and more widely spread (loss of mass, LM2). In Section 3, Table 3 shows
206 the results of the damage survey and the category of each sector depending on the rate of
207 damage.

582 Fig. 4. Failures represented in two elevations (a), and cross-section S1 of vertical sector A (b).

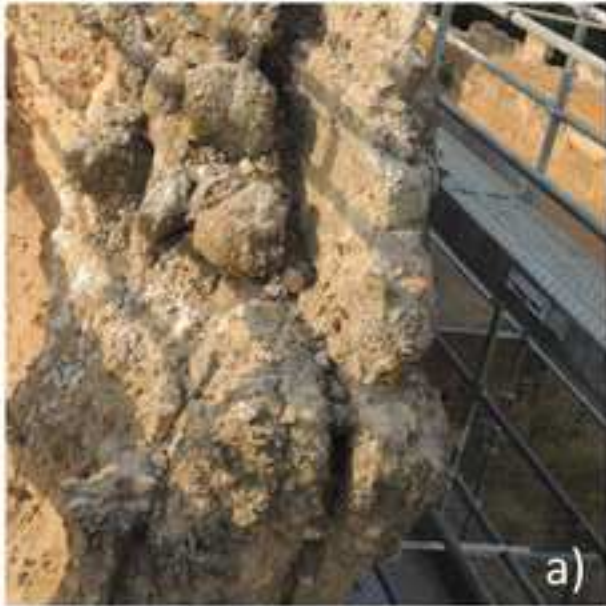
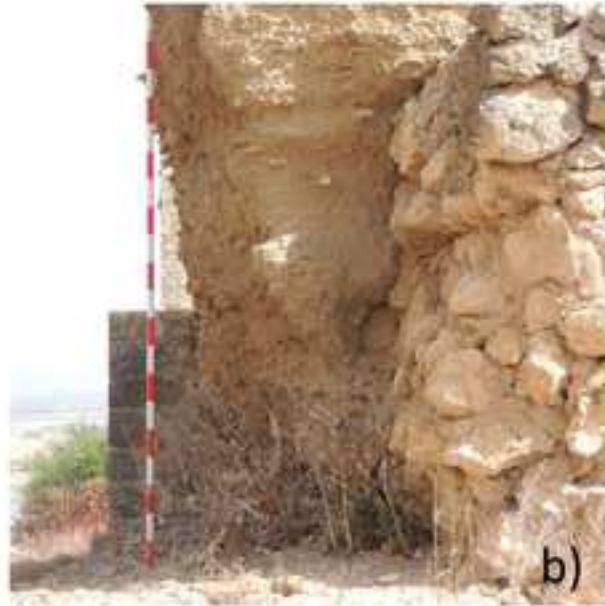
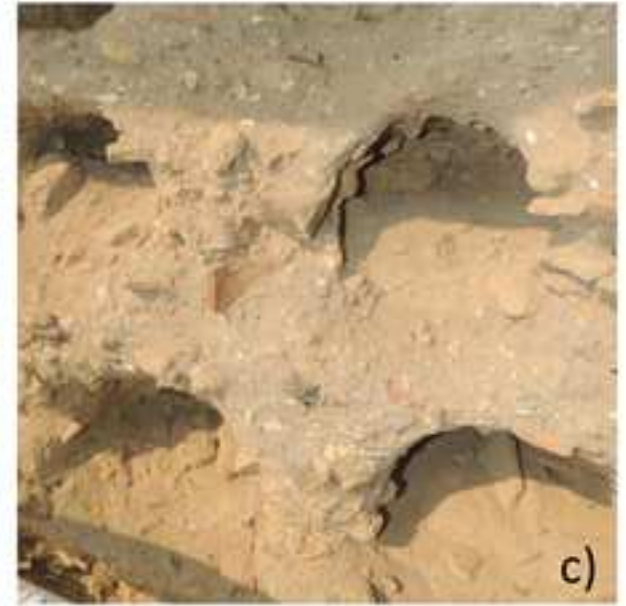
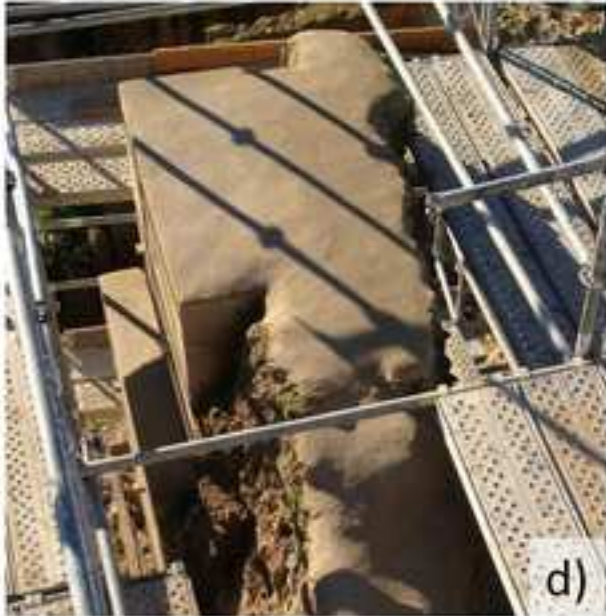
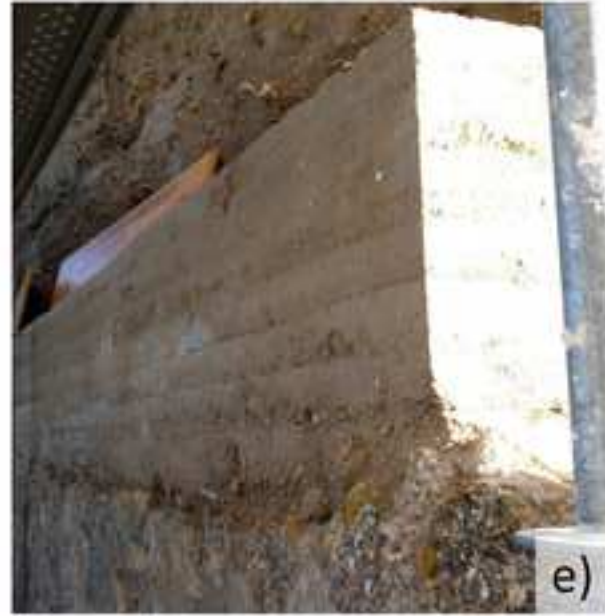
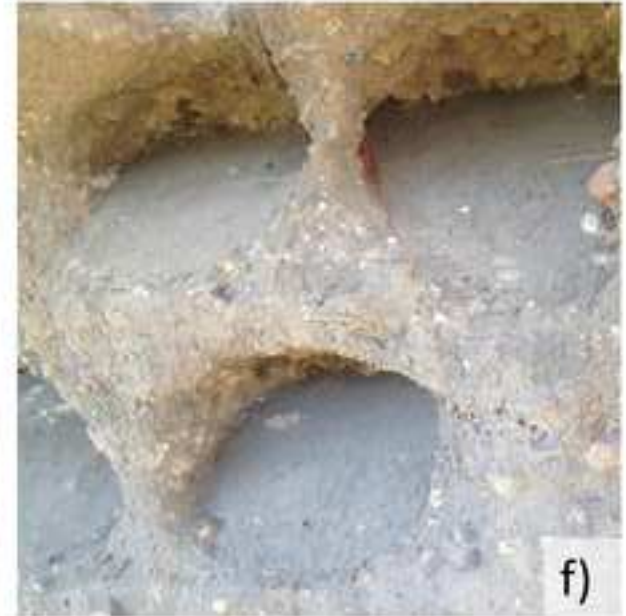
584 Fig. 6. Several prevailing failures (a, b, and c), and their corresponding repairs (d, e, and f).

430 Figure 6 shows several parts of the wall before and after the restoration work. Sector
431 Aw illustrated in Figure 6, which requires measures to prevent erosion and improve structural
432 stability, has been restored by means of a sloped lime mortar bed and a one-side replacement
433 of mass (Fig. 6, parts (a) and (d)). The high LR-St in sector Fw has been addressed with the
434 aforementioned solution for mass loss, but focused on lower horizontal sectors where the
435 undermining was critical (Fig. 6, parts (b) and (e)). Finally, the mass loss (failure ML1) due to
436 the presence of a dovetail was repaired through mortar filling executed in several layers (Fig.
437 6, parts (c) and (f)).
