# Assessment of Inservice Conditions of Safety-Related Nuclear Plant Structures

**U.S. Nuclear Regulatory Commission**

**Office of Nuclear Reactor Regulation**

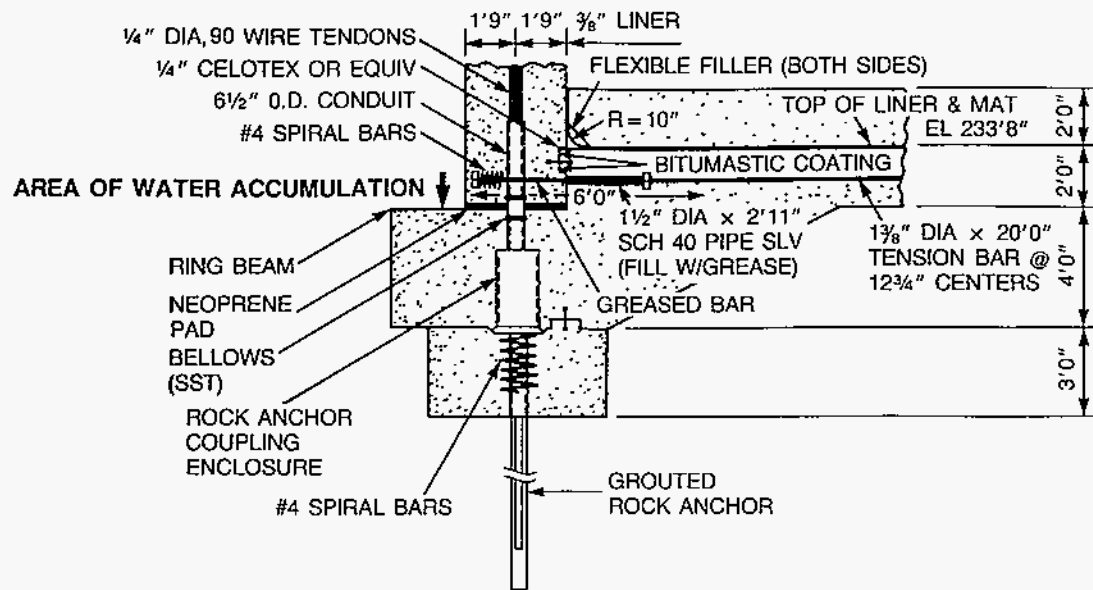
FIGURE 1 - CONTAINMENT BASE DETAILS AT GINNA

- The base of the cylindrical wall of the containment at R. E. Ginna Nuclear Power Plant is unique in that it is supported on a series of neoprene pads, each consisting of two layers of neoprene separated and covered with three carbon steel shim plates, installed on the thickened basemat (*ring beam*) along the circumference of the cylinder (Figure 1). Thus, the cylinder can move in and out under the loads (temperature, internal pressure, earthquakes) by deforming the neoprene pads. The vertical posttensioning tendons are enclosed in stainless steel bellows when passing through the gap between the cylinder and the ring beam. The vertical tendons are coupled to the rock anchors at the bottom of the ring beam. An NRC staff member visiting the site noticed puddles of water near the base of the cylinder along the outside circumference of the cylinder. He noticed degradation of the asphalt coating on the wall and the insulation material placed between the pads. The licensee dewatered the area and placed effective berms to alleviate water accumulation and future degradation of the pads, tendons, and concrete. The licensee also reanalyzed the structure and confirmed through deformation measurements during leak rate testing that the containment behavior at the base (under the postulated loadings) will be within the established criteria.

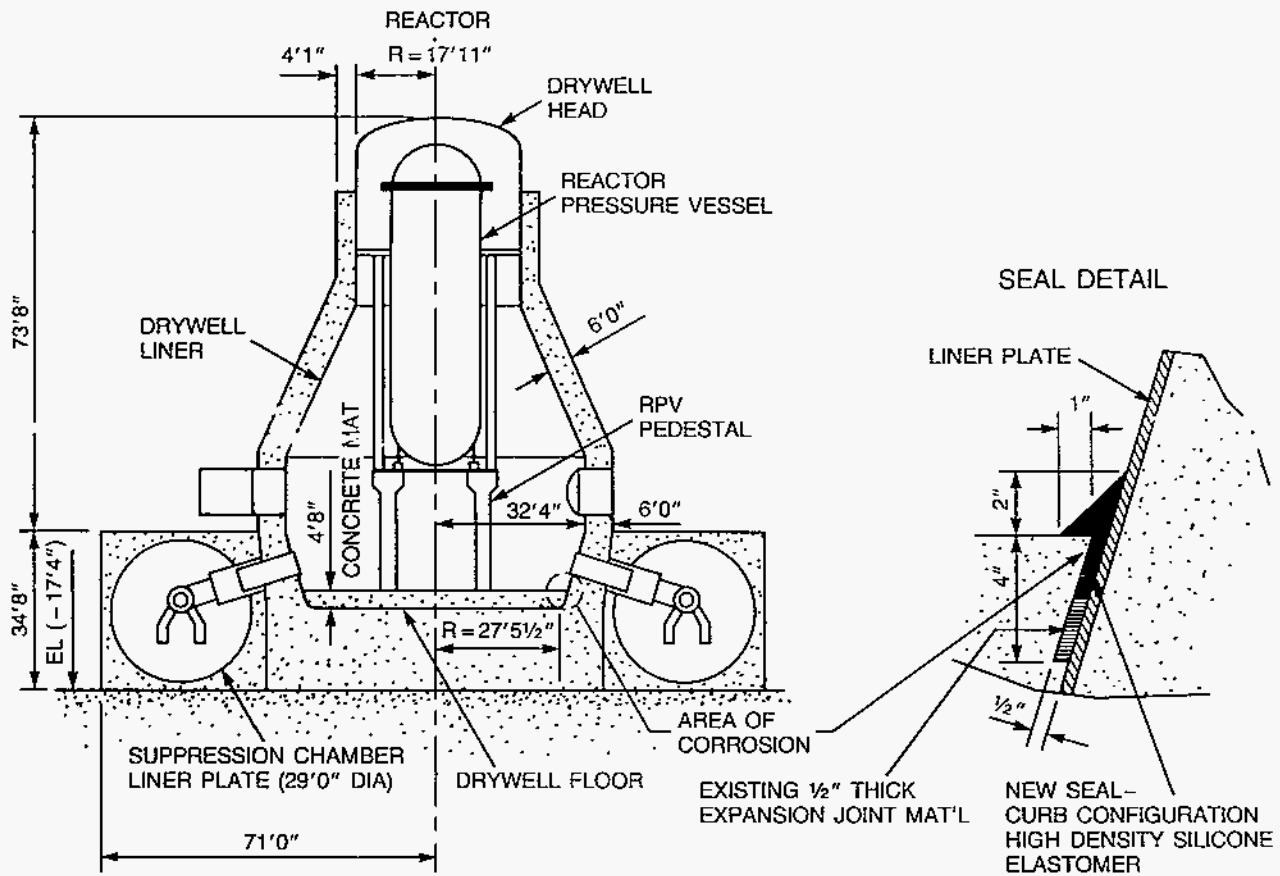
FIGURE 2 - DRYWELL LINER CORROSION AT BRUNSWICK

- Mark I containment structures at Brunswick Steam Electric Plant (drywells and tori of the two units) are constructed of reinforced concrete with steel liner plates on the inside surfaces serving as leaktight membranes. During a routine inspection by in January 1993, the inspector found the liner plate of Unit 2 drywell to be corroded at various spots at the junction of the base floor and the liner (Figure 2). The licensee

later found additional corrosion areas in both the units. The sealing material along the circumference had degraded and allowed water to accumulate at the junction. Some corrosion of the liner plates in the tori had been found in earlier inspections. In the drywells, the licensee cleaned the gaps, repaired the corroded plate areas as necessary, and resealed the gaps with dense silicon elastomer. For the corroded areas in the tori, the licensee confirmed that the noncorroded thickness of the plates is adequate for leaktightness under the postulated loading conditions, and is periodically monitoring the tori.

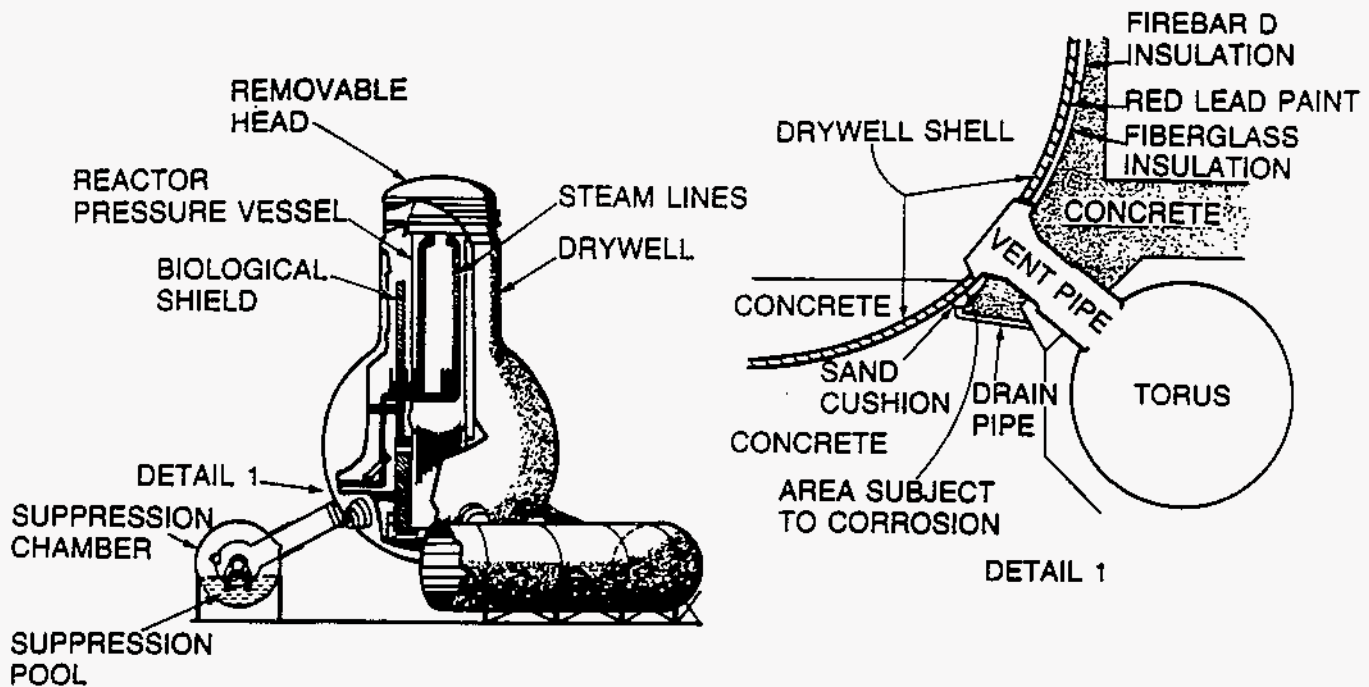
FIGURE 3 – DRYWELL CORROSION AT OYSTER CREEK

- After observing and monitoring the water leakage around various containment penetrations and floors for more than 5 years at Oyster Creek, the owner of the plant took extensive ultrasonic thickness measurements of the drywell shell to find out if the shell was being degraded. (See IN 86-99, "Degradation of Steel Containments," Dec. 1986). The measurements were taken at various locations near the sand cushion and at a higher elevation. They showed approximately 7.6 mm (0.3 in.) of the metal had been lost from the nominal metal thickness of 29.2 mm (1.15 in.) of the drywell shell in the sand-cushion areas. Measurements just above these areas in the shell indicated no reduction in the metal thickness. Figure 3 shows the area of corrosion. The licensee removed the sand from the areas affected by accumulated water and coated the drywell areas to minimize the possibility of future corrosion.

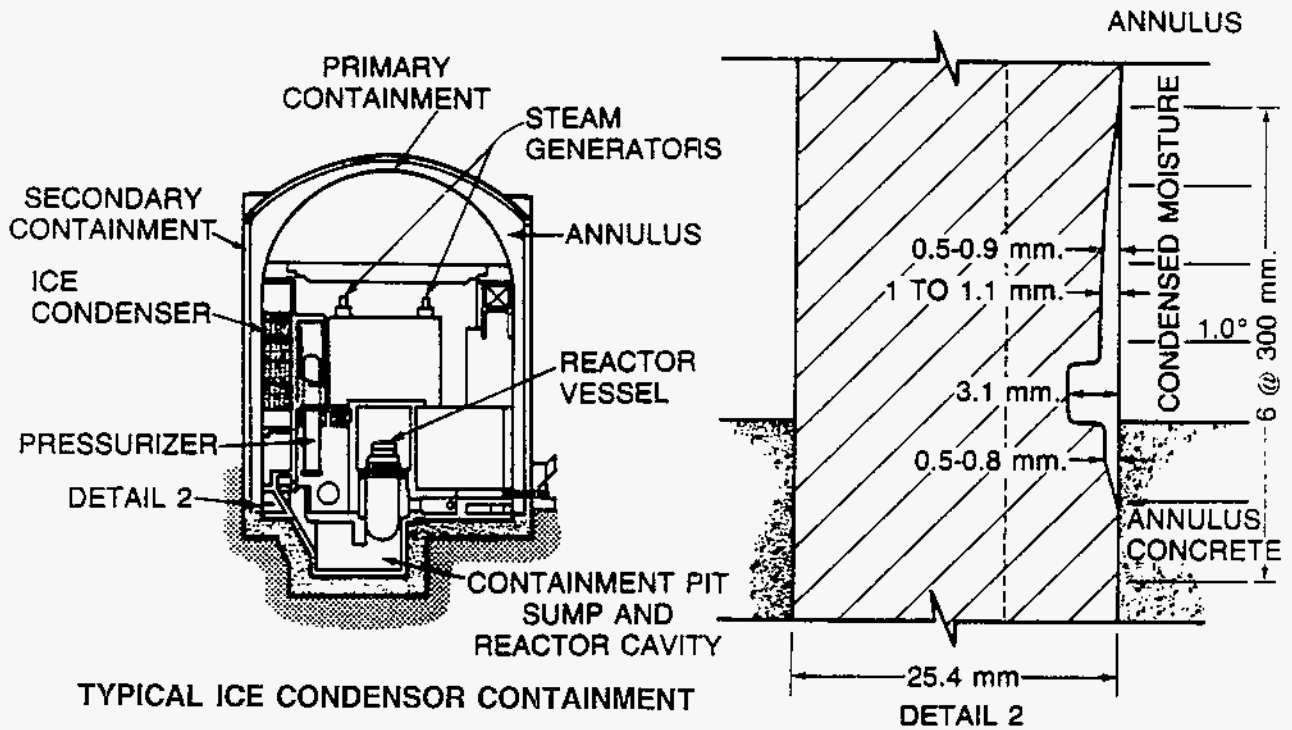
FIGURE 4 - CORROSION AT McGUIRE

- In 1989, the owner of the William B. McGuire and Catawba nuclear power plants reported significant coating damage and base metal corrosion on the outer surfaces of the steel shells of the PWR ice-condenser containments near the annulus floor levels. (See IN 89-79, "Degraded Coatings and Corrosion of Steel Containment Vessel," Dec. 1989.) The steel shells of the containments have nominal thicknesses of 25.4 mm (1 in.) near the annulus floors. The degraded areas varied in length from 5 to 10 m (16.5 to 33 ft) along the circumferences. The average depth of corrosion was measured as 2.2 mm ( $8.7 \times 10^{-2}$  in.), with pits up to 3.1 mm (0.12 in.) deep. Figure 4 shows the area of corrosion. The licensee took corrective actions to alleviate moisture accumulation and repaired the shell to ensure it was of adequate thickness.

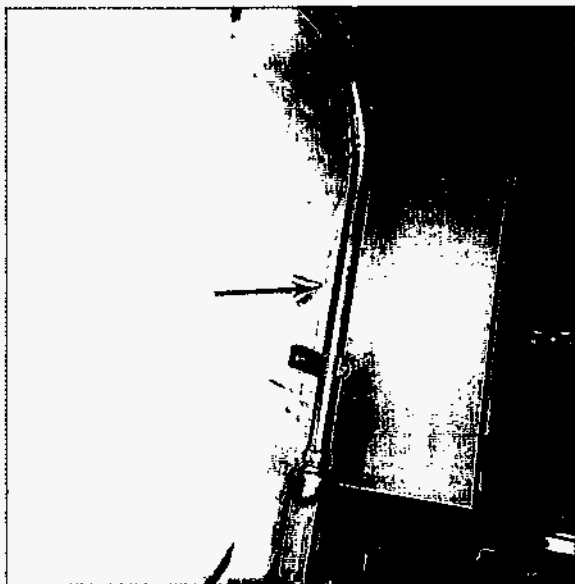
Cracks in Masonry Walls

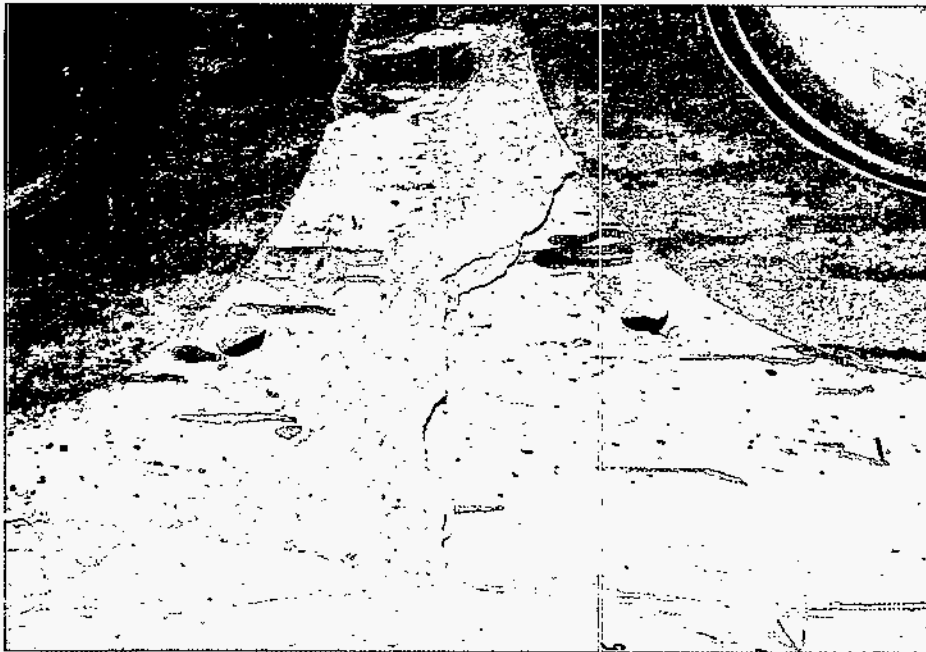
Closeup of Crack/Missing Concrete

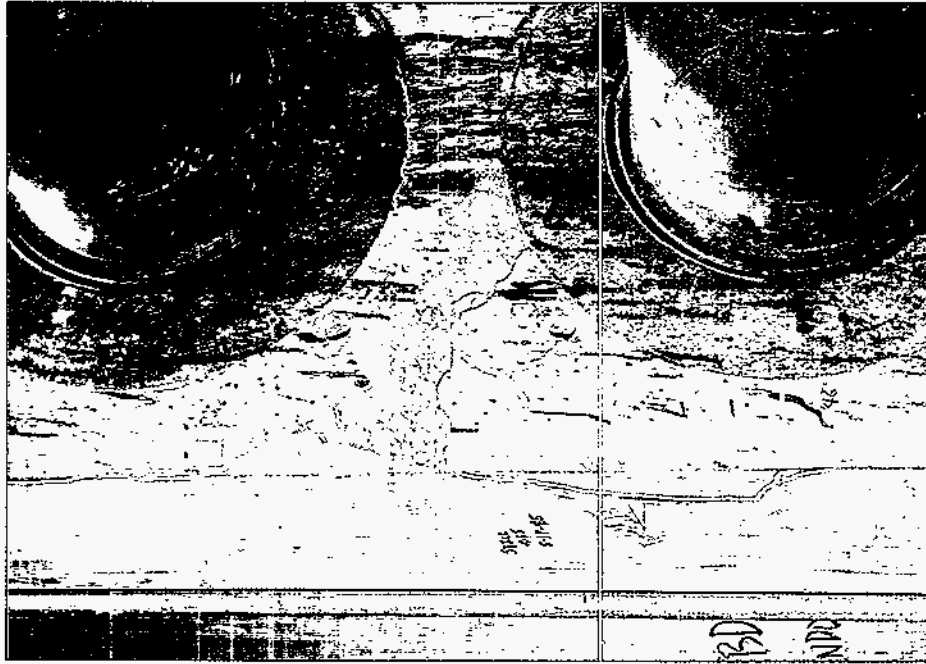
Concrete Damage/Grease Leakage

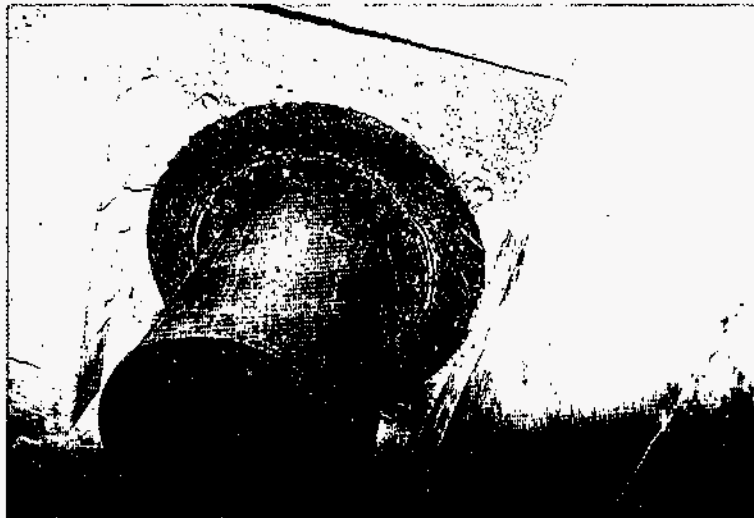
Worst Case of Anchor Corrosion  
Observed in the Vertical Tendon Gallery

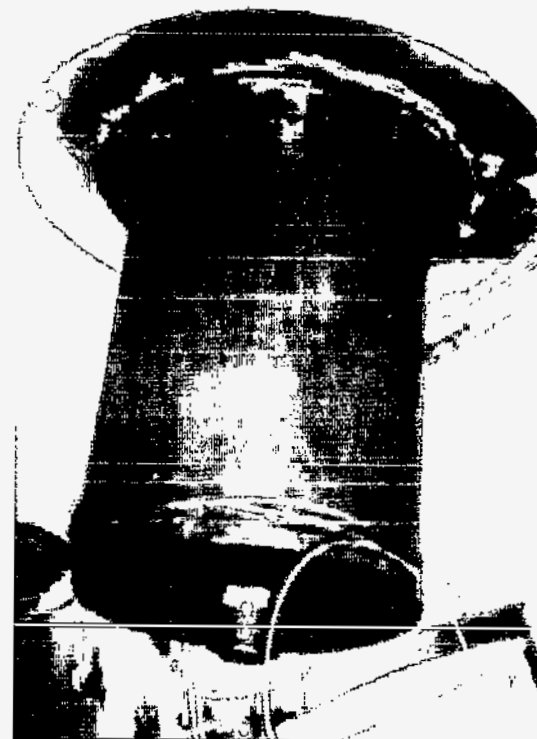
Grease Leakage at Tendon 212

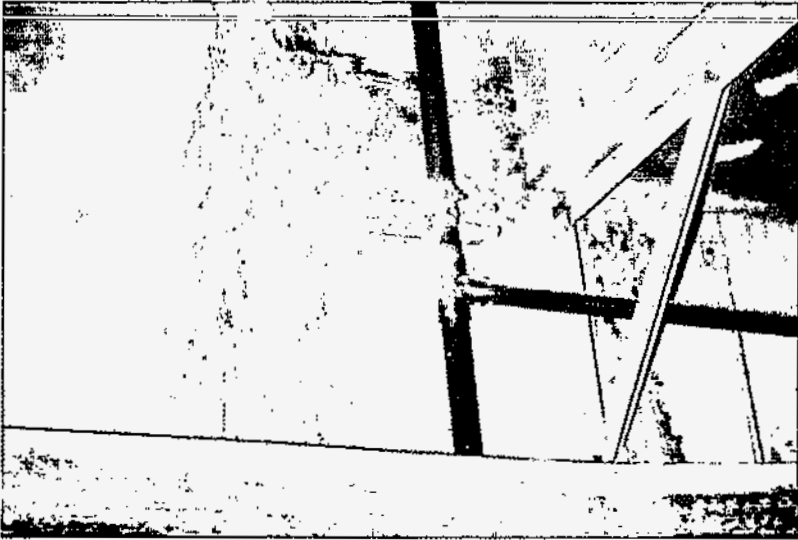
West Wall, El. 5' - Water Source Unknown

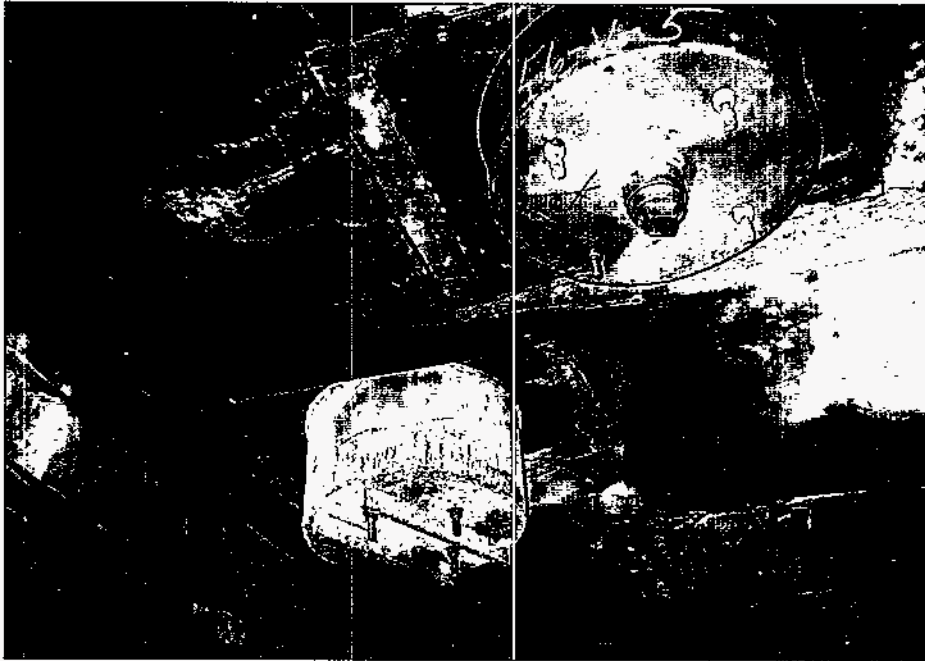
Grease Leakage at Tendon 56-V-5 (Typical)

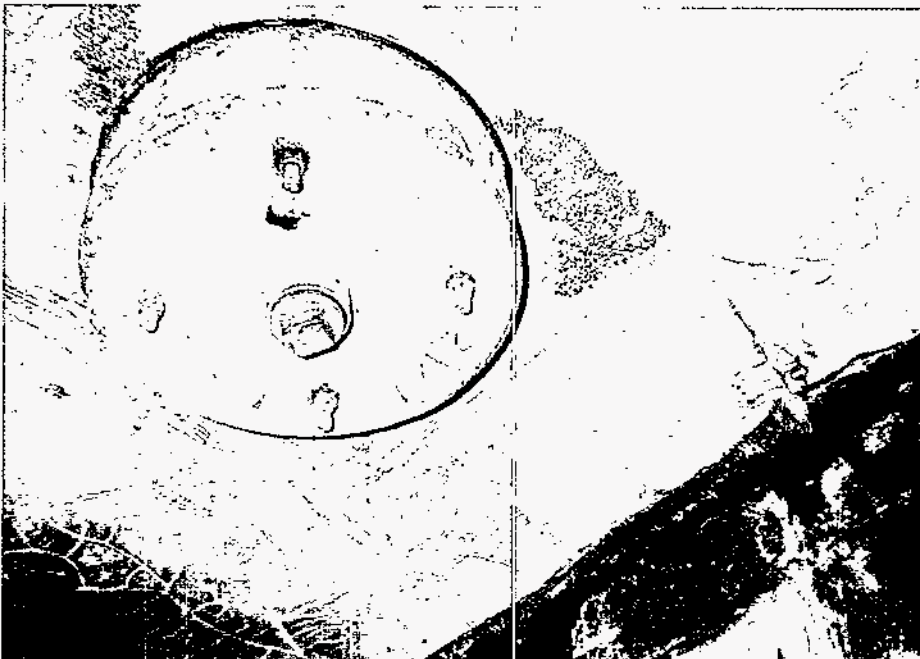
Metal Corrosion and Concrete Cracking  
at Tendon 12-V-1 (Typical)

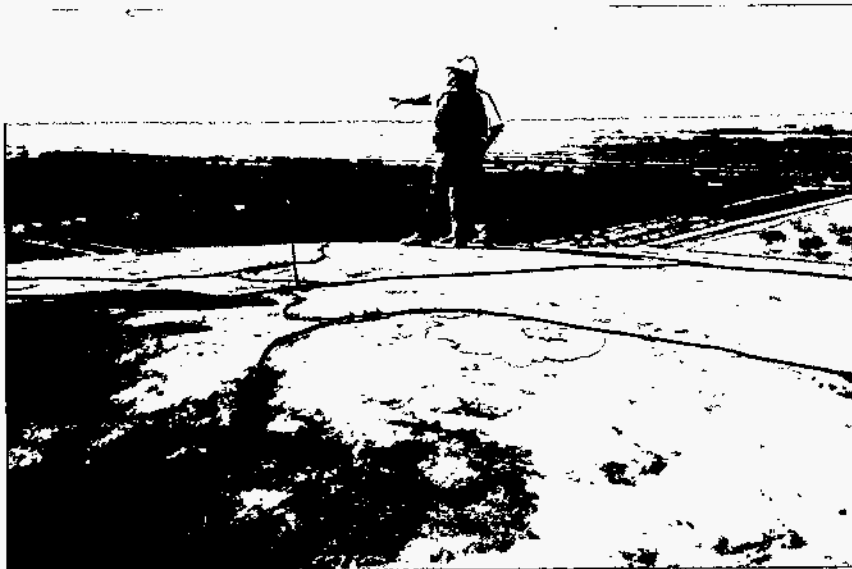
Peeling of Dome Coating Material (White Areas);  
Possible Cause of Water Drain Blockage

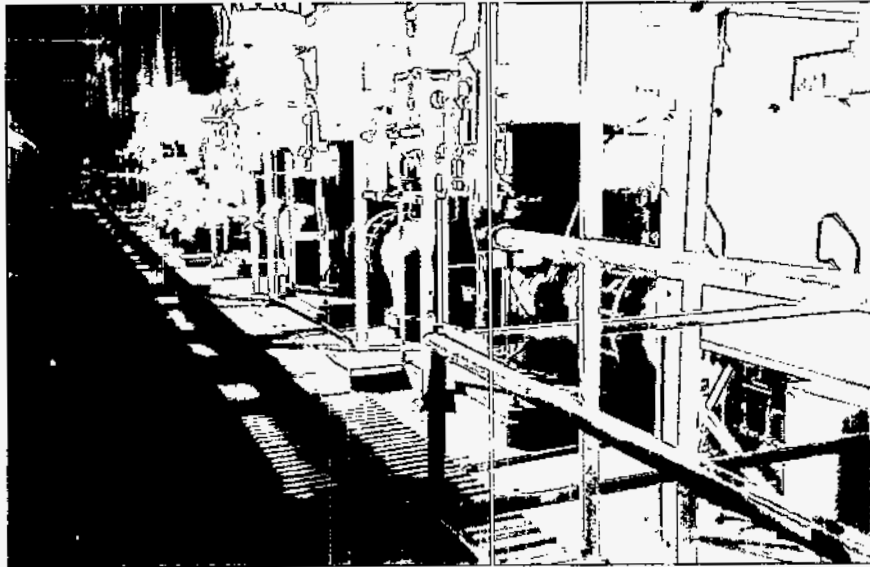
Circulating Water Pump Mounted on Top of Intake Structure;  
Supporting Concrete Beams Have Deteriorated and Are  
Currently Being Strengthened

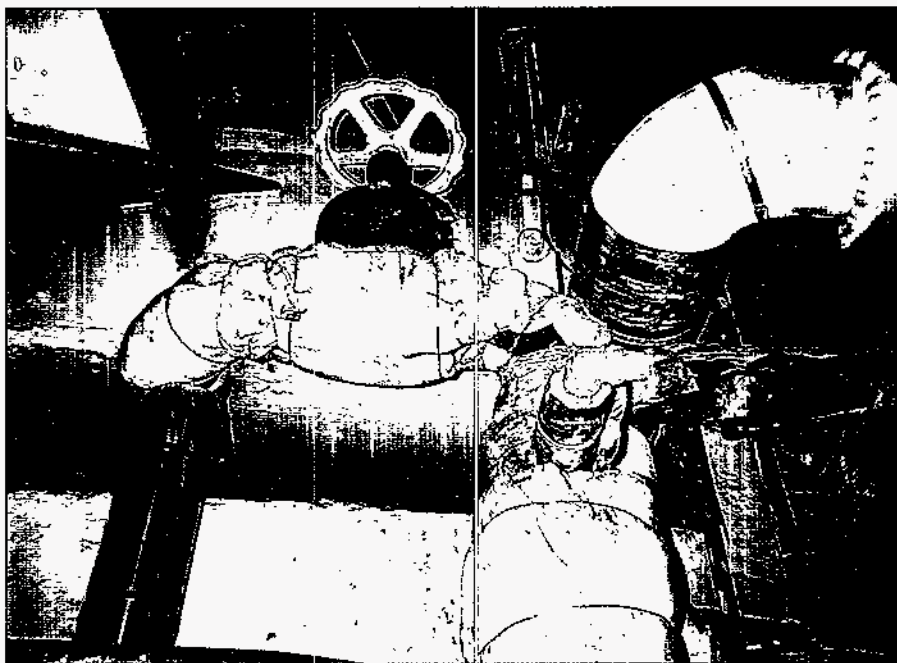
Plate 16 - H.B. Robinson Nuclear Plant, Unit 2  
Inside Containment - Corrosion

Component Cooling Water Valve and Piping

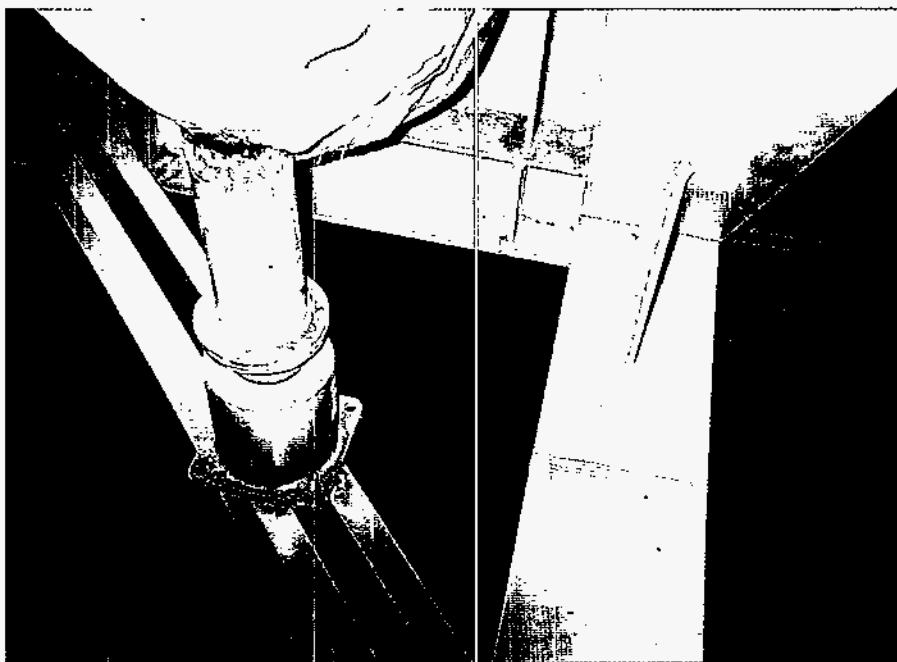
Top of Support to the Main Feed Line A

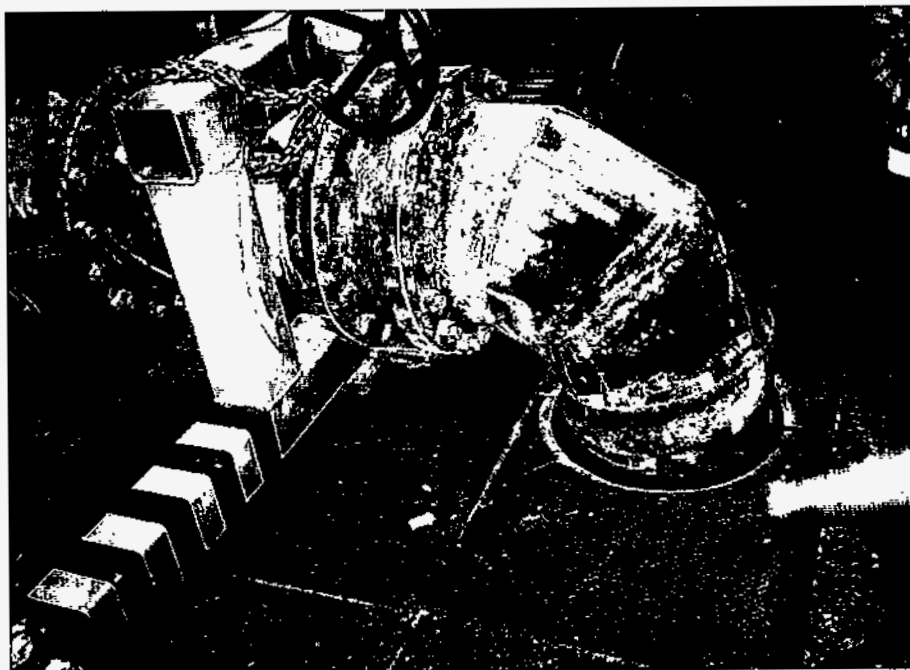
Corrosion and Degradation of Service Water Line - Above Grade

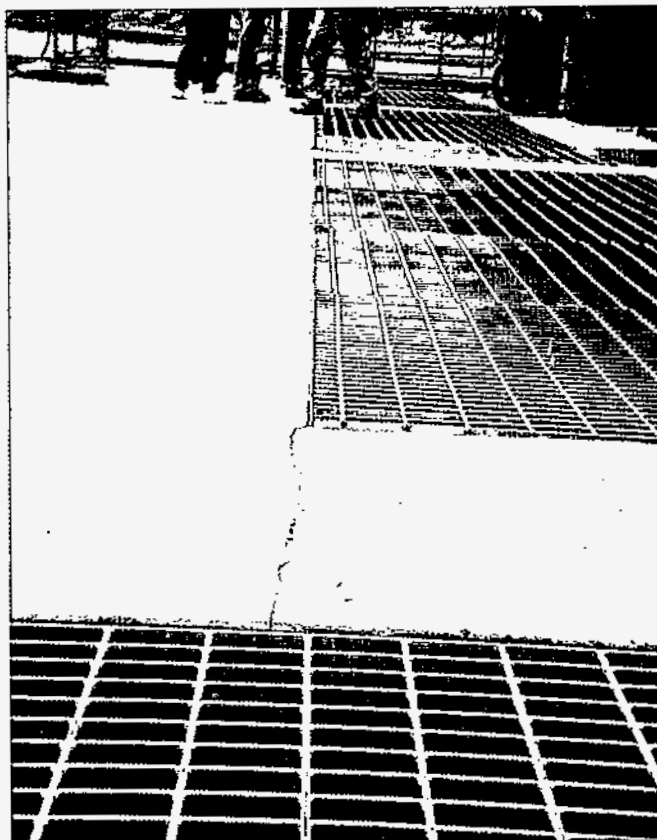
Cracks at Intersection of Concrete Walls

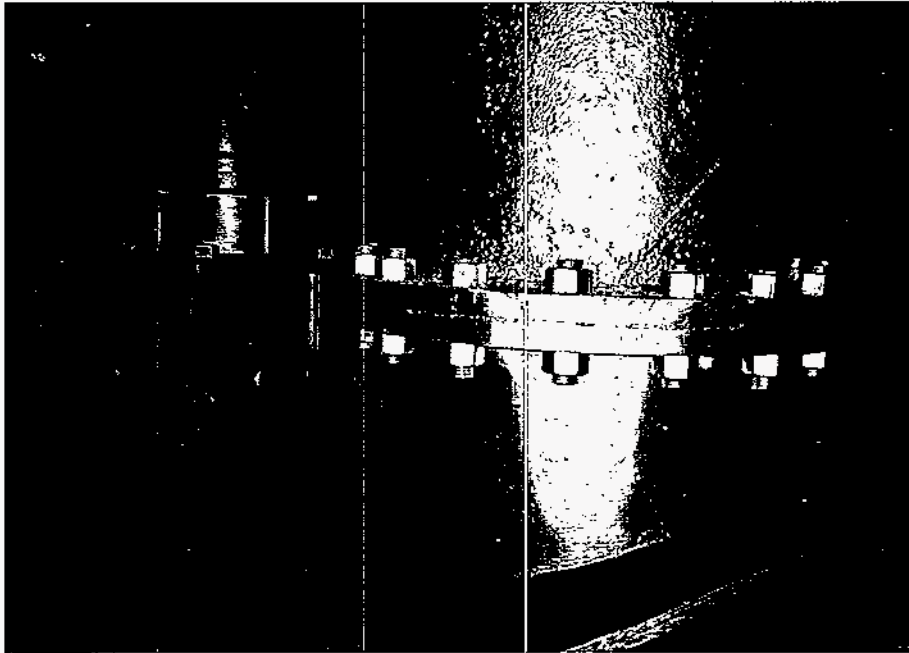
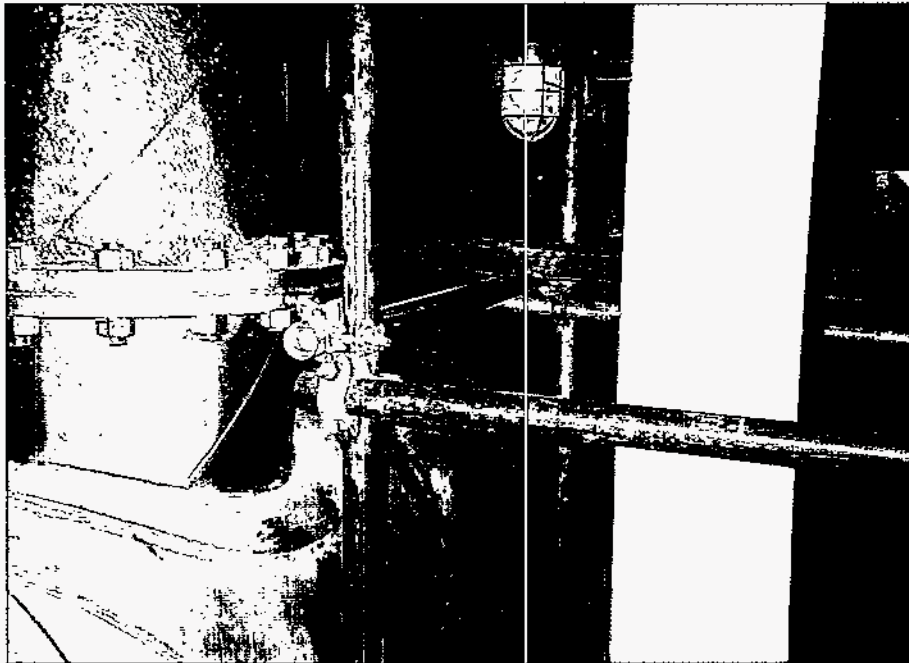
Plate 20 - H.B. Robinson Nuclear Plant, Unit 2  
Intake Structure - Severe Pitting of  
Service Water Line, Below Grade

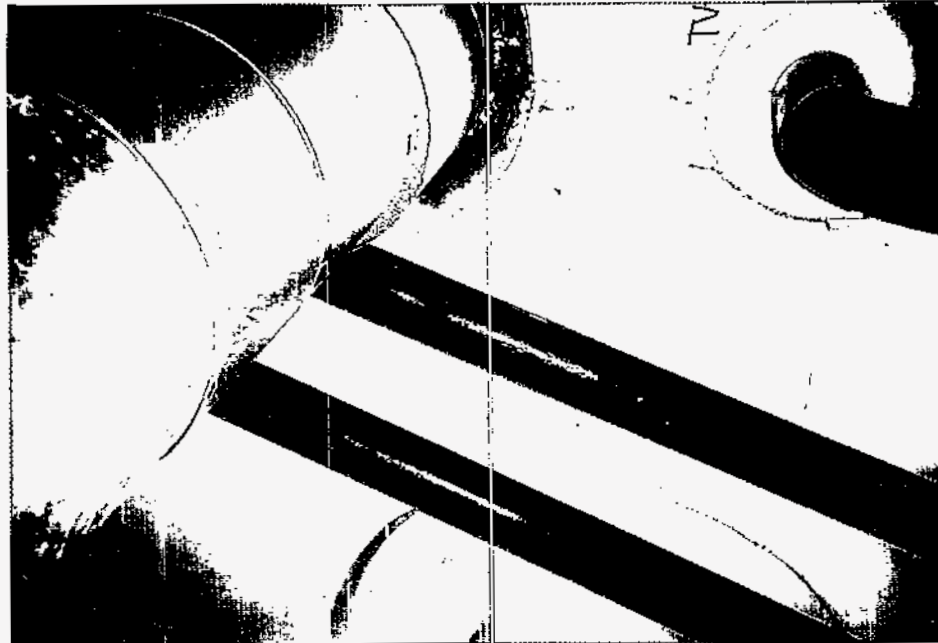
A - Corrosion of Containment Penetration  
for Component Cooling Line

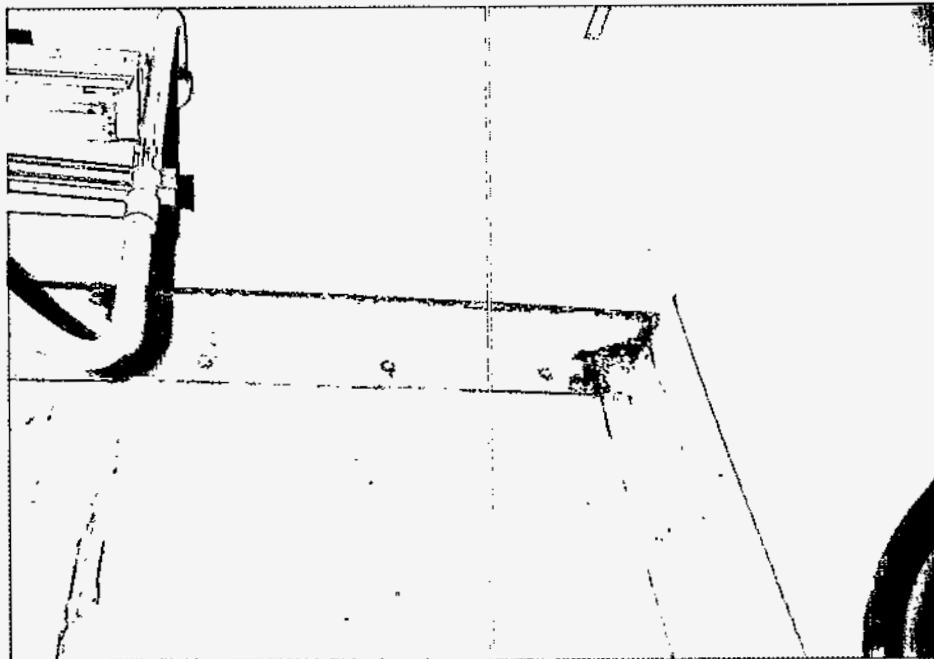
B - Water Infiltration and Corrosion of Steel Angles

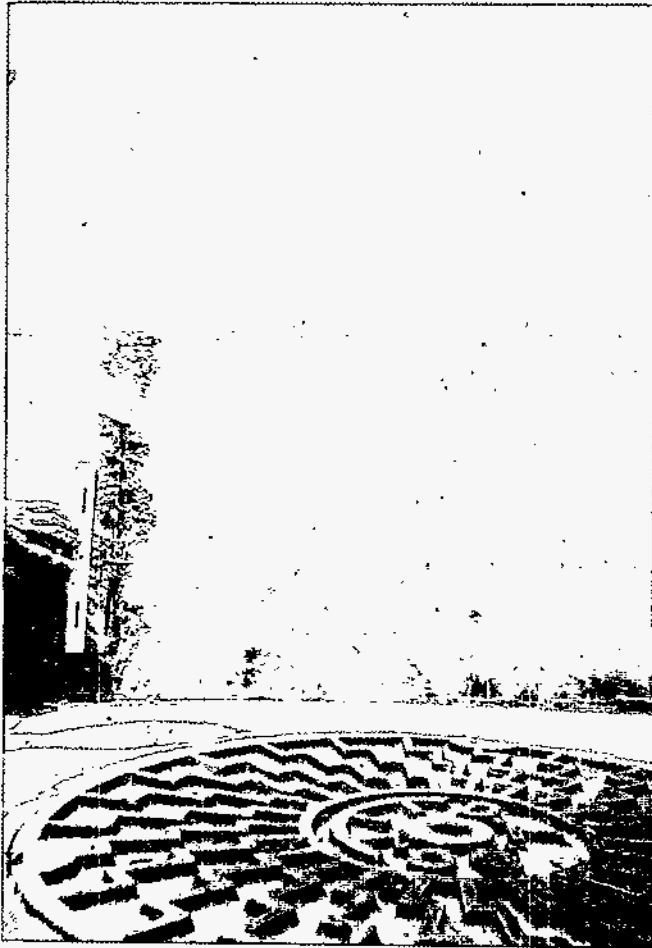
A - Concrete Spall and  
Corrosion of Reinforcement

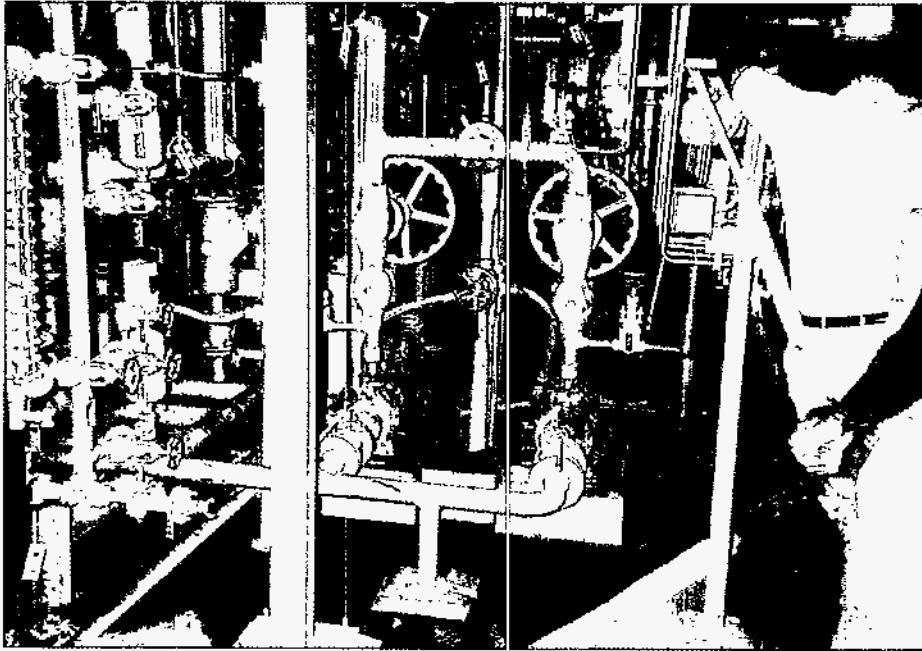
Plate 32 - Cooper Nuclear Station  
Control Building, Service Water Gland Water System -  
Corrosion/Degradation

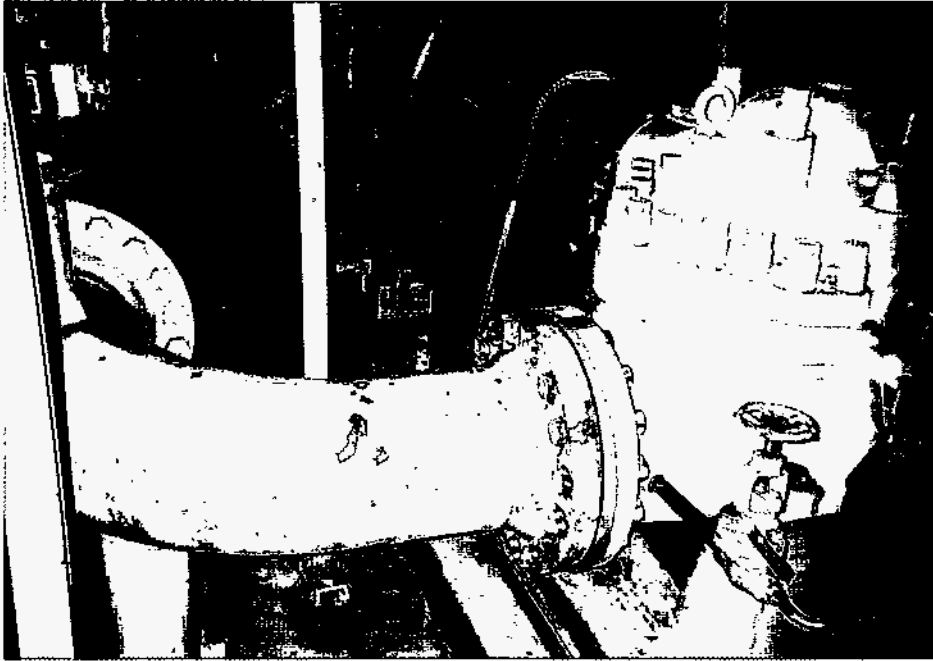
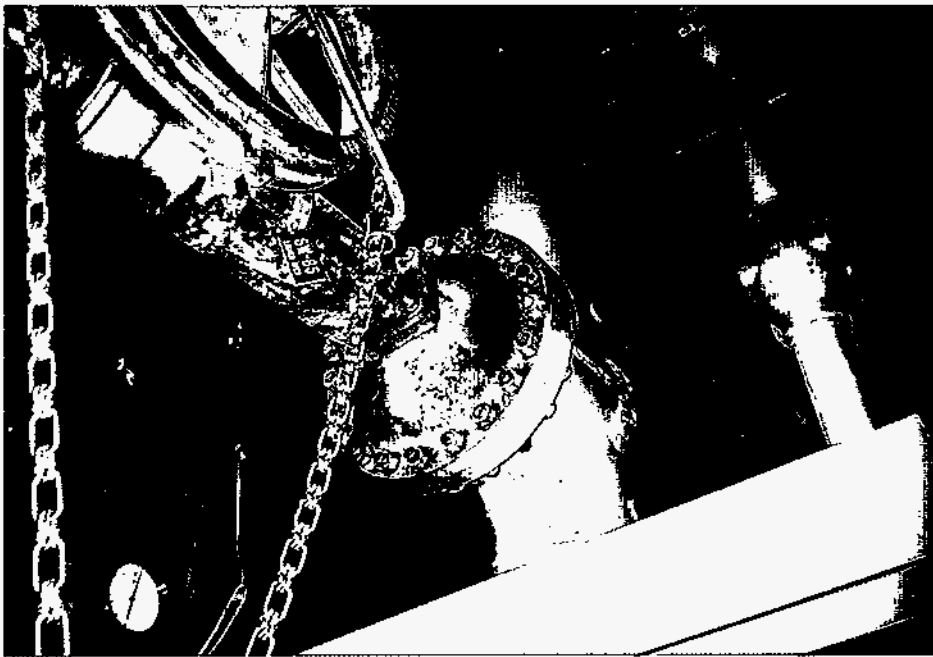
Valve Corrosion
