**BEHAVIOR OF COMPRESSION-LOADED COMPOSITE PANELS
WITH STRINGER TERMINATIONS AND IMPACT DAMAGE**

Dawn C. Jegley
NASA Langley Research Center
Hampton, VA

AIAA Paper No. 98-1785-CP
Long Beach, California

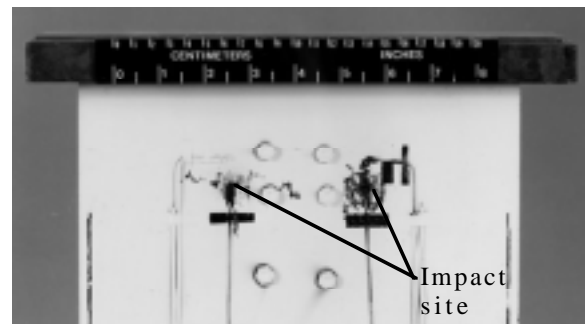
(a) Panel U-2

Figure 5. Typical impact damage.

Panel U-2 was initially loaded to 83,000 lb. The panel was not damaged during the initial loading. The panel was unloaded and subjected to a dropped-weight impact and a static indentation which resulted in two damage sites, each with dent depths of approximately 0.15 inches. The resulting damage was clearly visible. Descriptions of the damage are presented in Table 1 and a photograph of the damage is shown in figure 5.

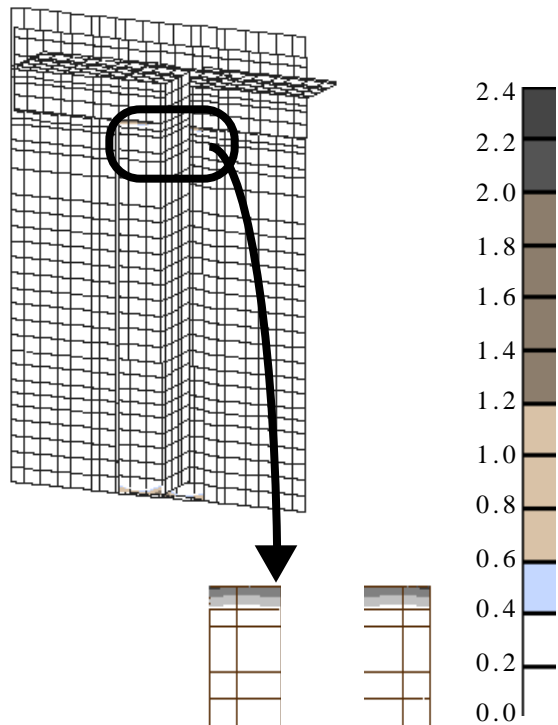
The maximum interlaminar stress in the stringer flange occurs at the end of the flange where it terminates at the intercostal flange. At this location the interlaminar failure parameter is approximately equal to 2.0 for a load of 100,000 lb. The maximum axial strain, shear strain and interlaminar shear strain occur in close proximity, and failure could result from a combination of strains.

Figure 10. Normalized interlaminar stresses at skin-to-stringer flange interface for a load of 100,000 lb for panel U-1.

Test results indicate that failure initiates at the interface between the skin and stringer flange. The separation of the stringer flange from the skin occurs immediately beneath the blade of the stringer. The analytical prediction of the location of failure agrees with the experimental results. The panel failed at 98,200 lb of load.
