**BEHAVIOR OF COMPRESSION-LOADED COMPOSITE PANELS
WITH STRINGER TERMINATIONS AND IMPACT DAMAGE**

Dawn C. Jegley
NASA Langley Research Center
Hampton, VA

AIAA Paper No. 98-1785-CP
Long Beach, California

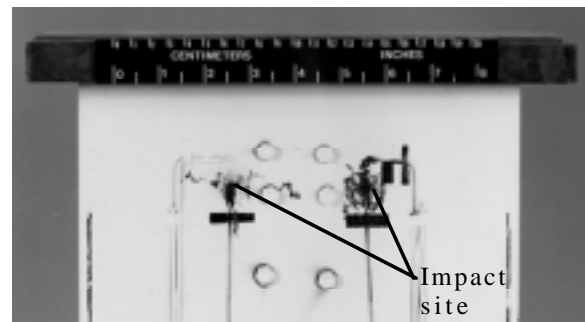
(a) Panel U-2

Figure 5. Typical impact damage.

Panel U-2 was initially loaded to 83,000 lb. The panel was not damaged during the initial loading. The panel was unloaded and subjected to a dropped-weight impact and a static indentation which resulted in two damage sites, each with dent depths of approximately 0.15 inches. The resulting damage was clearly visible. Descriptions of the damage are presented in Table 1 and a photograph of the damage is shown in figure 5.

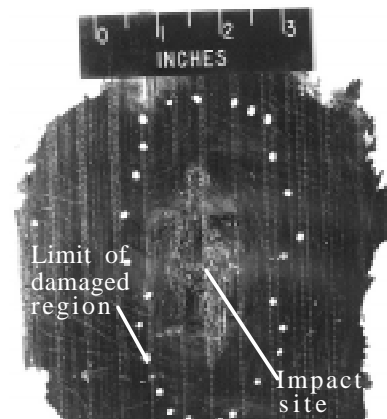
(b) Panel L-1

Panel L-1 was subjected to severe impact damage resulting in an indentation with a depth of 0.16 inches. The criterion of allowable strain at the reference surface of .0053 in/in. and the criterion described in reference 4

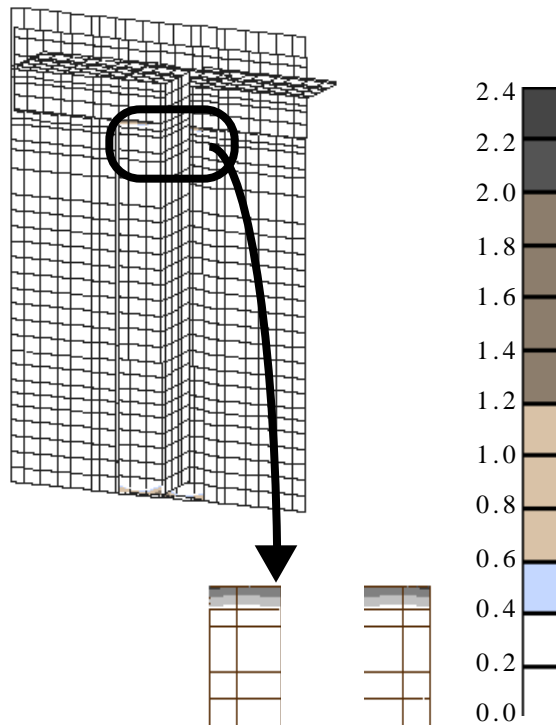
The maximum interlaminar stress in the stringer flange occurs at the end of the flange where it terminates at the intercostal flange. At this location the interlaminar failure parameter is approximately equal to 2.0 for a load of 100,000 lb. The maximum axial strain, shear strain and interlaminar shear strain occur in close proximity, and failure could result from a combination of strains.

Figure 10. Normalized interlaminar stresses at skin-to-stringer flange interface for a load of 100,000 lb for panel U-1.

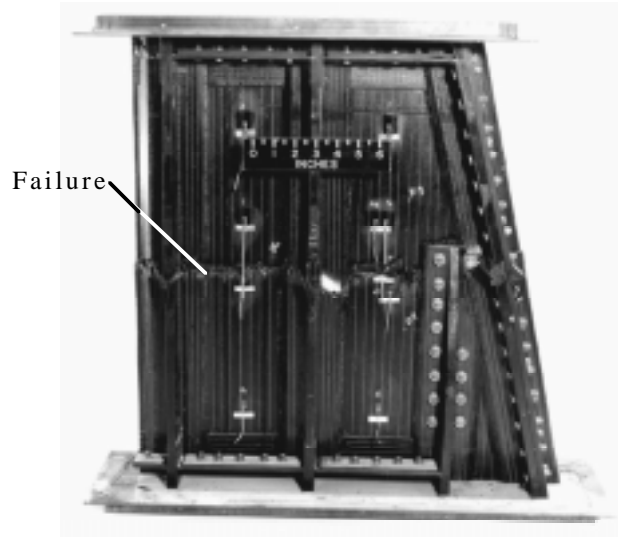
Panel L-1 failed through the impact site and the point of maximum strain in an undamaged skin with a load of 435,000 lb, and with damage 1.6 times as severe as required by the criterion. The panel failed with a stress at the impact site of 35.2 ksi, which is approximately 89 percent of the design stress. An undamaged panel would have had a strain of approximately .0037 in/in. at the impact site for the load at which the damaged panel failed. The maximum midplane strain (based on the measured surface strains) near the impact site was equal to .0052 in/in. The predicted maximum strain in the panel away from the impact site is equal to .0043 in/in., which is significantly less than the allowable strain in undamaged structure. These results indicate that failure was caused by the strain in the region of the impact site. A photograph of panel L-1 after failure is shown in figure 15.

Figure 15. Failed panel L-1.
