BUILDING DAMAGE FROM EXPANSIVE STEEL SLAG BACKFILL

BUILDING DAMAGE FROM EXPANSIVE STEEL SLAG BACKFILL^a

By Carl B. Crawford,¹ M. ASCE, and Kenneth N. Burn²

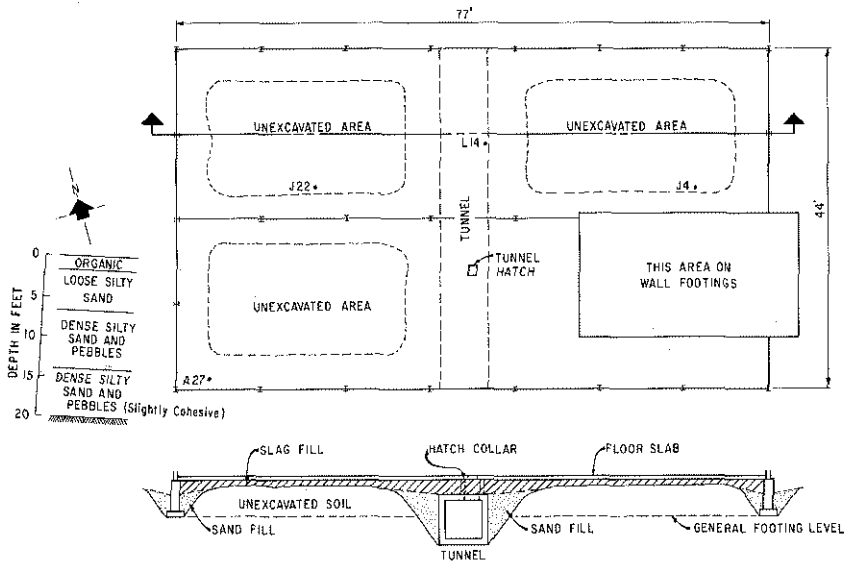
The building is located at the Canadian end of the international bridge between Michigan and Ontario at Sault Ste. Marie. A building plan is shown in Fig. 1, together with a cross section of the foundations. It is essentially a basementless, one-story structure with a partial second story. The exterior walls and interior columns are carried on spread footings at a depth of 5 ft. Footings on either side of a small service tunnel extend to depths of 9 ft and 10 ft. The excavated areas were backfilled after the foundations were in place,

FIG. 1.—PLAN OF BUILDING AND SECTION THROUGH FOUNDATIONS SHOWING UNEXCAVATED AREAS AND DISTRIBUTION OF SLAG FILL BENEATH FLOOR SLAB

separate iron slag from steel slag. The exact thickness of slag is not known, but it probably varies from a few inches in unexcavated areas to more than two feet adjacent to the tunnel and footings. Construction of the building was completed during the summer of 1962.

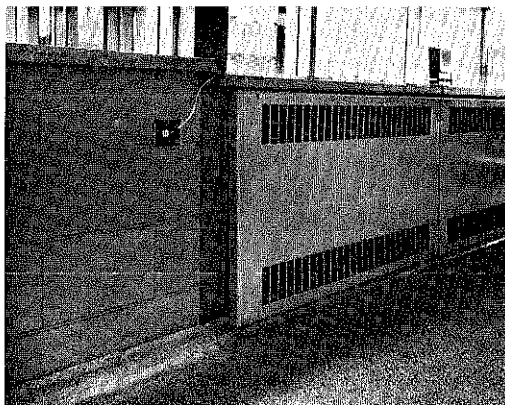
FIG. 2.—DIFFERENTIAL MOVEMENT ACROSS WINDOW SILL

window frames and interior metal and glass partitions began to buckle. Fig. 2 shows a section of window sill that was relevelled after it had become tilted upward on the inside. At this location the edge of the floor slab rests on a recessed shelf cast in the foundation wall and the interior cinder-block facing rests on the floor slab. The window frame is carried directly on the exterior precast slab wall, which rests on the foundation wall. Differential movement between the inner facing and the outer wall caused the tipping of the window sill and some buckling of the window frame. An excavated section through the floor slab in 1965 revealed that the floor was resting on fill and that it had been raised 1/2 in. above the shelf on the foundation wall. By the end of 1967 the differential movement had exceeded 1 in. The cover for the heating unit in the background of Fig. 2 also is attached to the outer wall, and it was necessary, therefore, to detach it at the bottom to prevent buckling as the floor slab heaved.

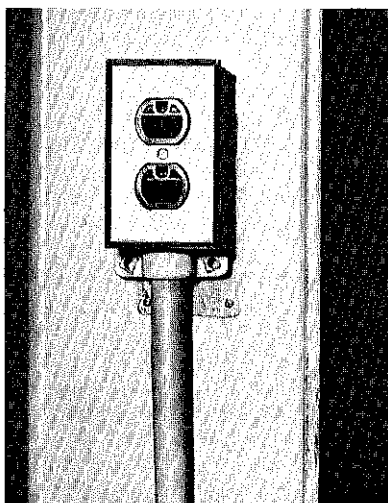
FIG. 3.—EVIDENCE OF MOVEMENT BETWEEN COLUMN AND FLOOR SLAB (MATERNA STUDIOS)

Fig. 3 shows further evidence of differential movement between an interior column and the floor slab. The electrical conduit shown is cast in the floor slab and turns up at the base of the column. Movement and slippage between the floor and column have caused relative movement between the column and the conduit and sheared off the bolts fixing the outlet box to the column.

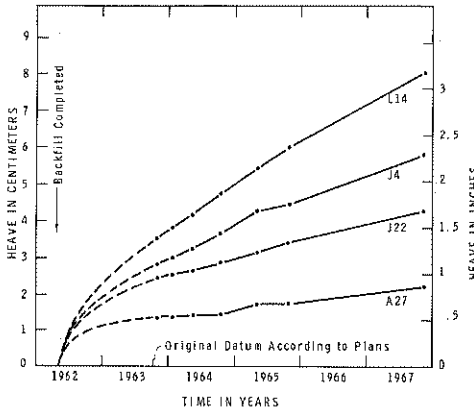
In 1965 the Division of Building Research of the National Research Council of Canada was asked to investigate the problem. During an inspection of the site in May, 1965 it became clear that swelling of the slag backfill was the most probable explanation for the movements, based on the following observations: Near the center of the building a vertical hatch extends from the roof of the tunnel through the floor slab; the space between (about 18 in.) is occupied by slag. A horizontal crack about 1-1/2 in. wide all around the hatch collar indicated a relative upward movement of the floor slab from the tunnel. Unless the slag had expanded vertically a void should have existed between the under side of the slab and the top of the fill, but removal of a small portion of the floor slab revealed that no void exists. The observed vertical movement represented about 7% of the original thickness of slag above the tunnel. By the

end of 1967 the crack had increased to 2 in. in width, indicating a vertical expansion of more than 9%.

FIG. 4.—MEASURED HEAVE WITH TIME

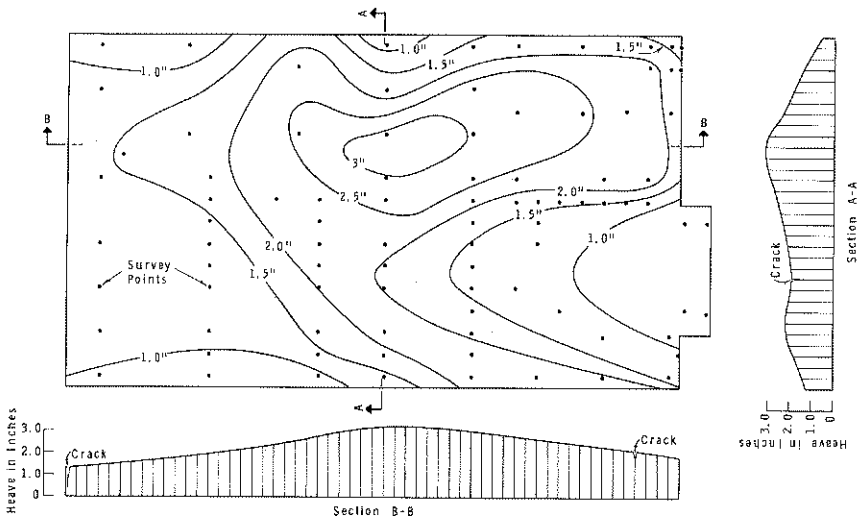
FIG. 5.—CONTOURS OF HEAVE OF GROUND FLOOR (NOVEMBER, 1967)

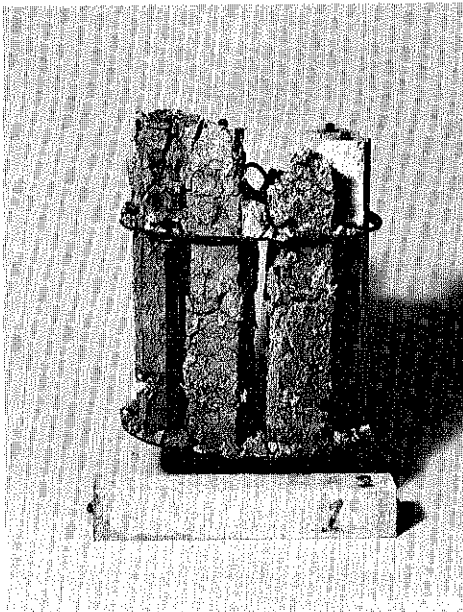
FIG. 7.—AUTOCLAVE TEST SPECIMENS

When removed from the autoclave the specimens were in the conditions shown in Fig. 7. The intact bars on the right were made from BF slag; those in the foreground and to the left that have disintegrated were made from OHF slag. One of the reference specimens is shown lying in the foreground. Linear expansion of the OHF bars was about 10%.

Until evidence to the contrary is forthcoming, it should be considered hazardous to use any slag except blast furnace slag for fill in confined spaces or where long-term volume changes cannot be tolerated.

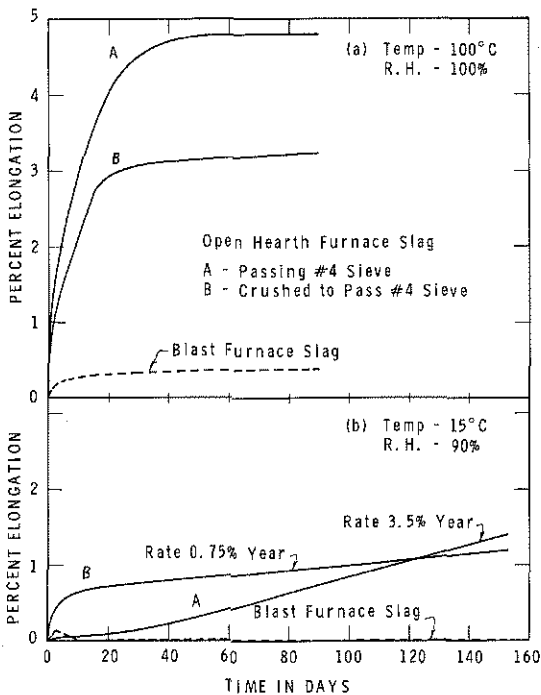
FIG. 8.—TIME-EXPANSION TESTS, BLAST AND OPEN HEARTH FURNACE SLAGS

Low Temperature Tests.—Three additional specimens were tested as for the moderate temperature tests, except that the surrounding atmosphere was maintained at 15° C and approximately 90% relative humidity. Under these conditions the open hearth slag expanded less, but was still expanding at significant rates after 5 months [Fig. 8(b)]. The blast furnace slag exhibited a small movement during the initial stages, but the specimen cap became loose and may have accounted for the slight movements shown in Fig. 8(b). No movement was observed after 10 days.
