Cause Analysis of Pier Inclination of An Expressway Interchange Bridge: Case Study

Longxi interchange ramp bridge of Guangzhou–Zhongshan–Jiangmen Expressway, which connects the North Jiangzhu Extension Expressway and Zhongjiang Expressway, with a total length of 1452.236 m, as shown in Figure 1.

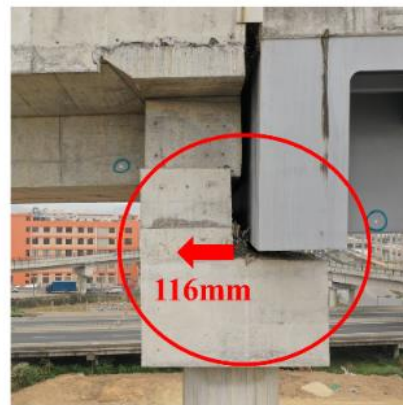
Inclination of Pier P30

1. Pier inclination: Piers P27, P28, P29, P30, P33, P34, and P35 were obviously inclined, and the maximum inclination of the top pier was up to 12 cm. However, there were no cracks, concrete defects, or other damage found on the pier columns.
2. Support slipping: Supports on Piers P30 and P33 had slipped excessively, which exceeded the design maximum limit value of ±10 cm.
3. Expansion joint damage: The expansion joint on Pier P33 was large; the other expansion joints worked properly.

Based on the above, the treatment measures recommended and used on-site were: (1) the rectification of the deviation of Piers P30 and P33 after superstructure lift, and the adjustment of the eccentric distance of supports and replacement of the supports; (2) unloading the asymmetric filling soil at the bottom of Pier P30; (3) replacing the supports on Pier P35.

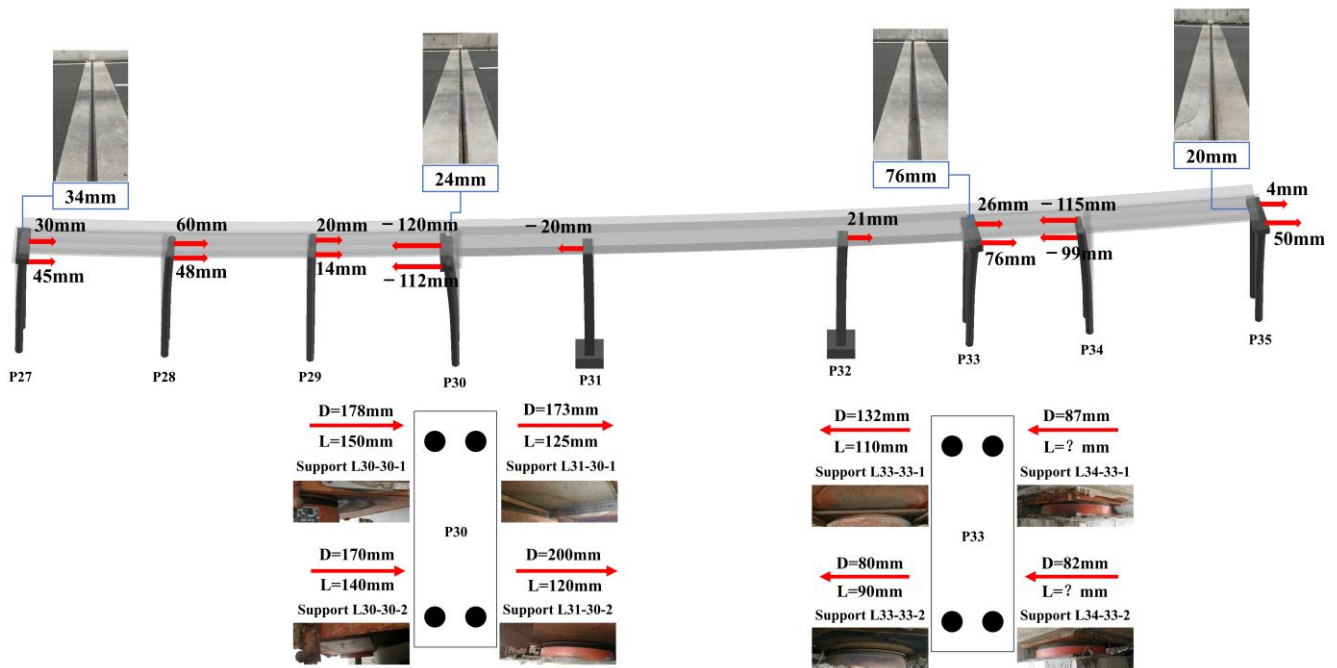
Figure 8. Disease investigation data of the ramp bridge.

Detailed forensic disease investigation data are shown in Figure 8. (The symbols and notations in Figure 8 are summarized as follows: ① arrows at the top of the pier column in the figure represent the inclination direction, and a positive value shows that the inclination direction as the pier number is increasing; ② within the support region, the arrow to the right highlights the top plate moves as the pier number is increasing. D refers to the relative slip between the top and bottom plates, and L refers to the length of the slip mark on the top plate; ③ the expansion joint width was measured at 19 °C.)

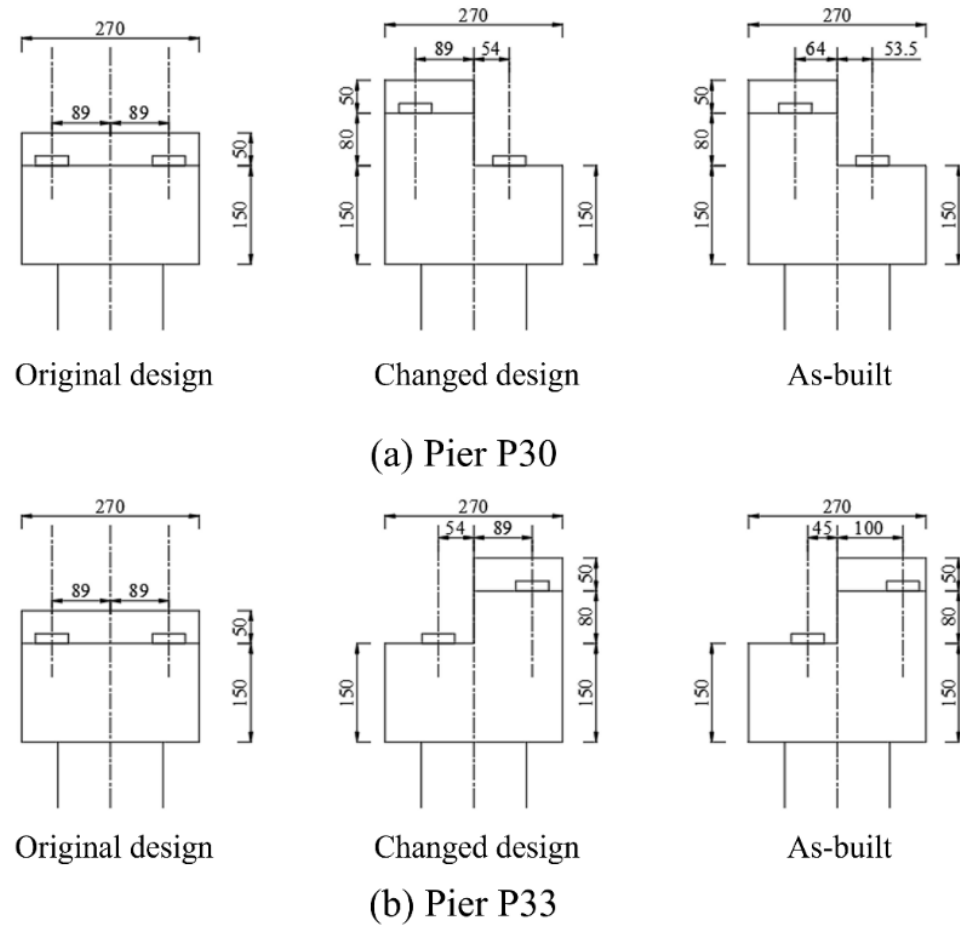
Figure 9. Eccentricities of supports on Piers P30 and P33.

As shown in Figure 9, the design eccentricities of the supports on Piers P30 and P33 are 89 cm for each concrete side. Since the original design was changed, i.e., a steel box girder was adopted between Piers P31 and P32, the design eccentricities of the supports on Piers P30 and P33 were adjusted to 89 cm for the concrete side and 54 cm for the steel side. However, the engineering field investigation showed the great difference between the measured and design values of the support. The field data are 64 cm for the concrete side and 53.5 cm for the steel side on Pier P30, and 100 cm for the concrete side and 45 cm for the steel side on Pier P33. The measured support eccentricities should be considered in numerical analysis.

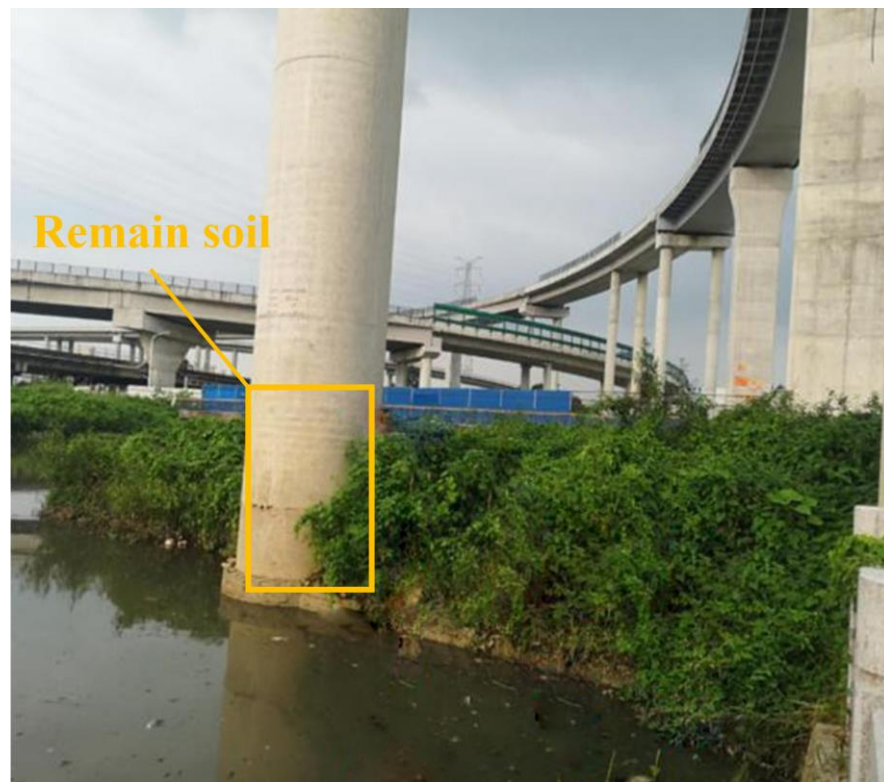
Figure 10. Surrounding conditions of Pier P30.

The foundation of the ramp bridge site is mainly soft soil. In the forensic engineering investigation, as shown in Figure 10, the remaining soil under Pier P30 reveals that the silt around the pier was excavated to a depth of 2 m at the river side and dumped at the other side during operation, which resulted in an asymmetric filling soil load at the bottom of Pier P30.

During the operation of the bridge, the silt around Pier P30 was excavated at a depth of 2 m at the river side and dumped at the other side. When the filling depth difference is 4 m in the numerical model, the longitudinal inclination of Pier P30 is $-(94.97 - 66.11) = -28.9$ mm, which is one of the main factors resulting in the inclination of Pier P30.

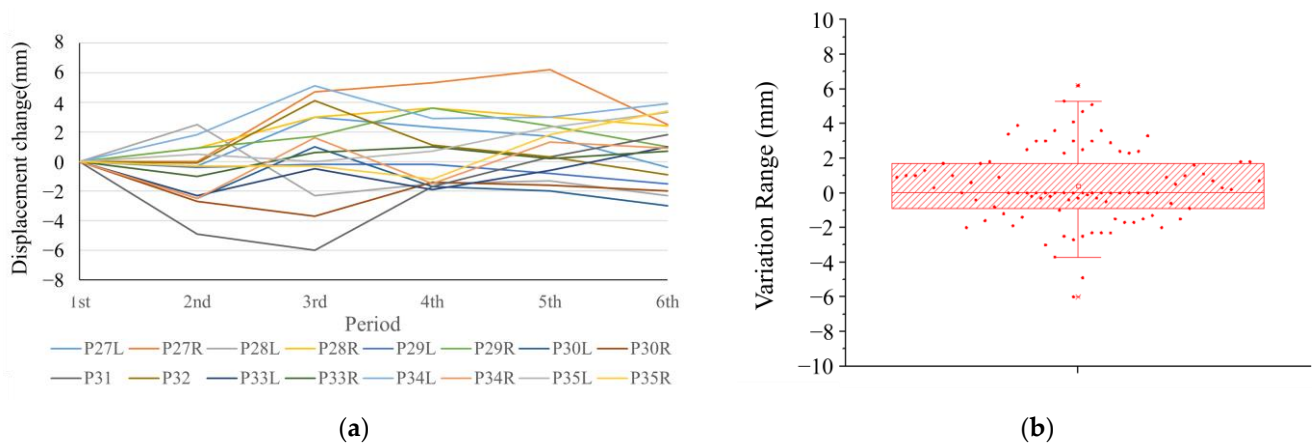
Figure 11. (a) Longitudinal inclination changes of piers during the monitoring period; (b) variation distribution of longitudinal inclination changes of piers during the monitoring period.

To identify the development of disease in the bridge, six monitoring sessions on the pier inclination, foundation settlement, and girder displacement of the ramp were conducted from July 2019 to March 2020. Figure 11 shows the change in the longitudinal inclination of the top of the pier during the monitoring period. It can be seen from the data that the changes were within ± 6 mm during the monitoring period, mainly induced by vehicle load or environmental influences. In conclusion, there was no obvious change in pier inclination, foundation settlement, and girder displacement during the monitoring period. The monitoring results indicate that piers did not continuously incline, and the disease of the ramp bridge occurred before the bridge was open to traffic.
