PNNL-20365

# Characterization of Fish Passage Conditions through a Francis Turbine, Spillway, and Regulating Outlet at Detroit Dam, Oregon, Using Sensor Fish, 2009

## Final Report

JP Duncan  
TJ Carlson

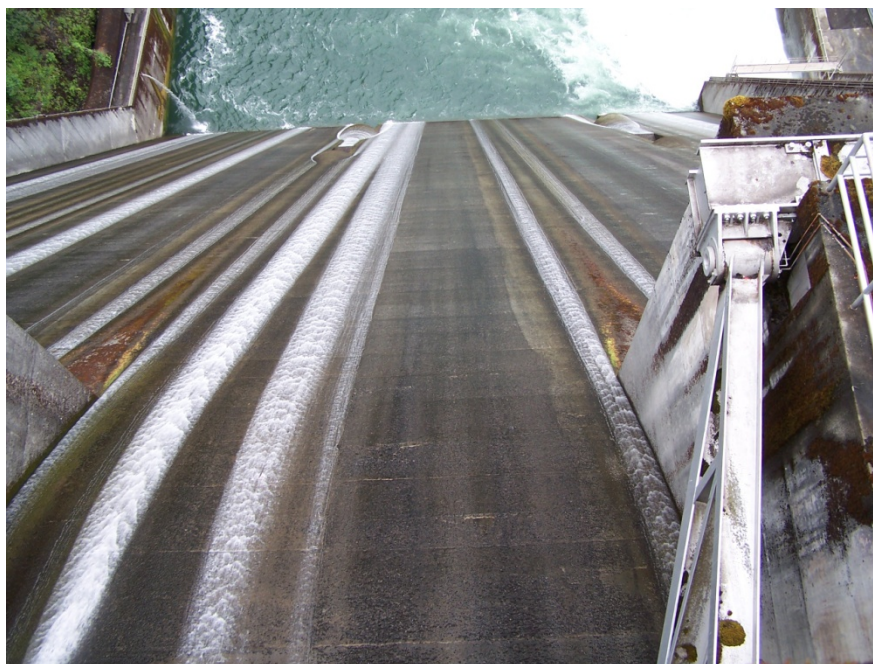
**Figure 4.1.** Spillbay 3 at Detroit Dam showing the rough, irregular concrete surface.

Spillbay 3 and Spillbay 6 were evaluated at two spillgate openings. The height and slope of the spillway chute contribute to deleterious exposure conditions observed during the study. Detroit Dam, completed in 1953, is slowly deteriorating due to age. The concrete surface of the spillway is rough from weathering (Figure 4.1), and the descending flow is irregular (Figure 4.2)—conditions that probably incrementally worsened spillway passage conditions.

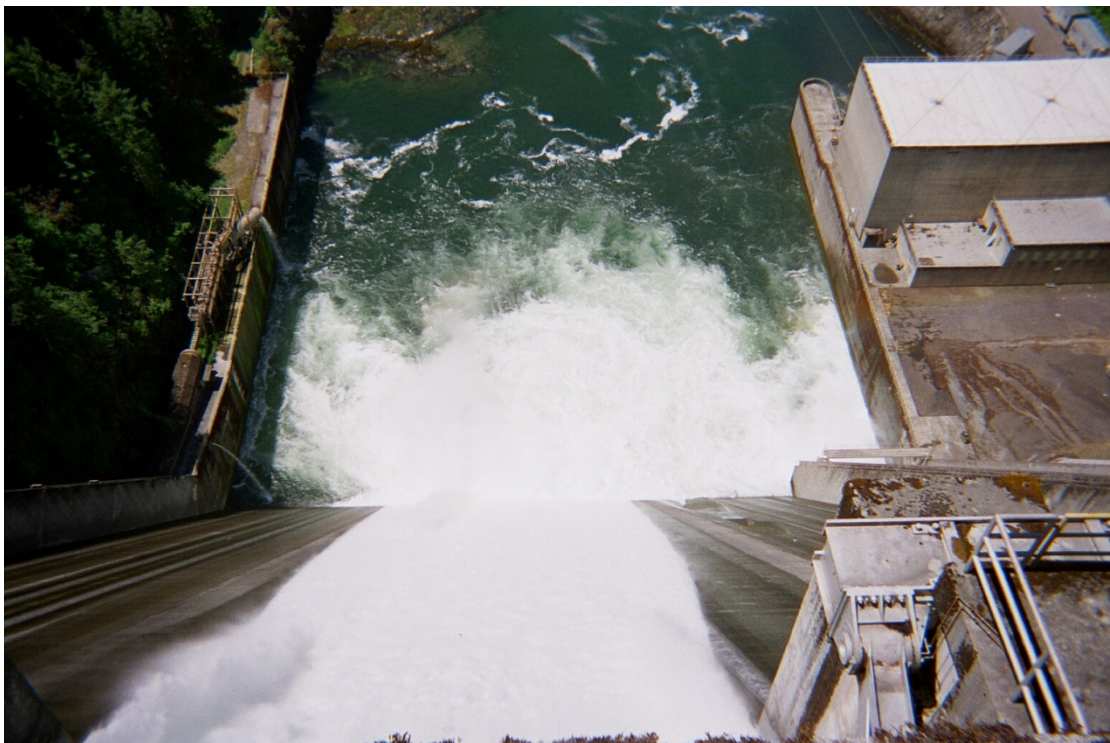
**Figure 4.3.** Flow through Spillbay 3, 1.5-ft gate opening (1560 cfs discharge) spreads to adjoining spillbays.

In Spillbay 3, the unconfined spillway discharge spread rapidly once past the structure supporting the tainter gate hinge assemblies (Figure 4.3). In contrast, Spillbay 6 was confined from the tainter gate through stilling basin entry (Figure 4.2). Spillway flow velocities were estimated to exceed 150 fps before plunging into the stilling basin. Sensor Fish were often carried to depths of over 30 ft with spillway discharge, at times striking rocks or other unidentified objects as they were carried in turbulent flow through the stilling basin.

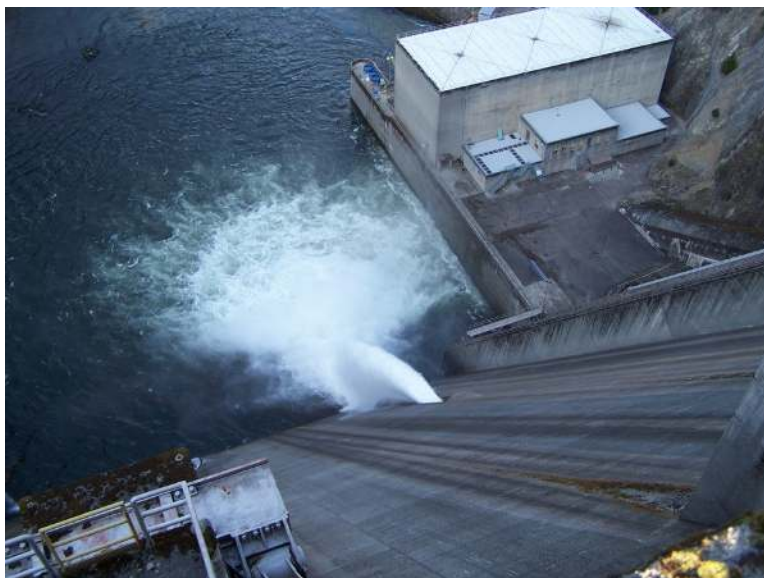
**Figure 4.8.** Regulating outlet discharge at Detroit Dam when the control gate was open 1 ft.

Regulating outlet passage conditions for the 1-ft gate opening were found to be detrimental to live fish. The rapid acceleration in flow during passage under the flow control gate created conditions that were responsible for decapitation of 9.3 % of test fish. In contrast, none of the live fish passing through the 5-ft gate opening were decapitated. Flow acceleration magnitudes during the 1-ft gate open test condition were nearly 4 times greater than those observed during the 5-ft gate opening test condition. Rapid changes in pressure were also observed as flow passed under the control gate, with pressure rates of change 3.5 times greater for the 1-ft gate opening than for the 5-ft gate opening.

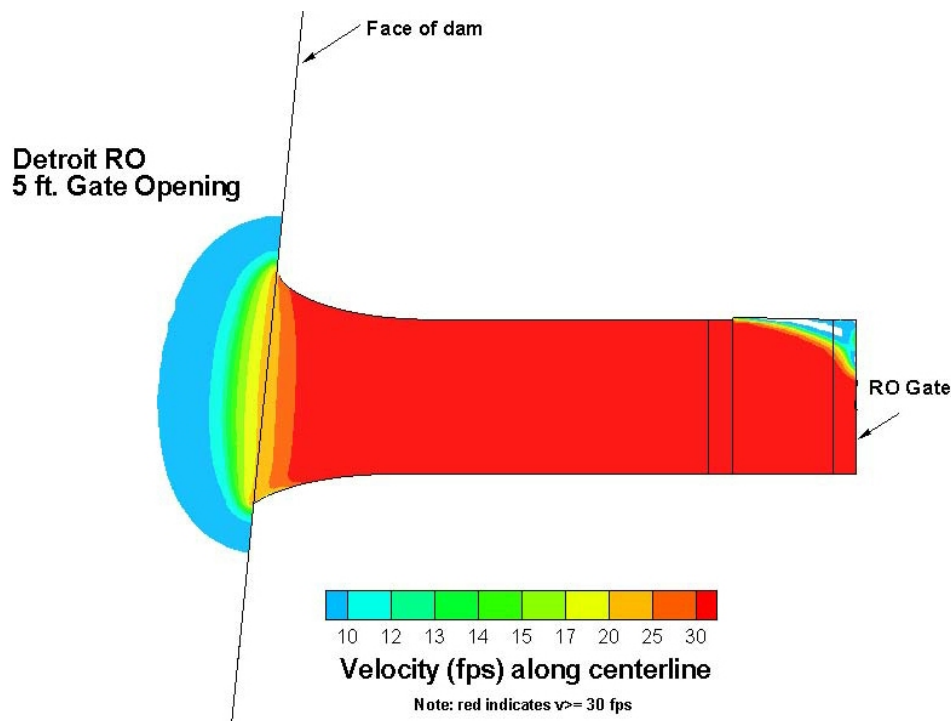
**Figure 4.10.** Computational fluid dynamics estimate of water velocity through the RO when the control gate was open 5 ft (Phillips 2010<sup>1</sup>).

Computational fluid dynamics modeling of flow through the RO conduit when the control gate was open 5 ft is shown in Figure 4.10. At this gate setting, RO discharge was approximately 1900 cfs when the forebay elevation was 1450 ft MSL. The mean forebay elevation for the study was approximately 1441 ft MSL, which corresponds to a discharge of approximately 1800 cfs at a 5-ft control gate opening. The CFD model estimates flow velocity at 18 fps at the entrance to the RO for the 5-ft gate opening. The flow rapidly accelerates to more than 30 fps a short distance into the RO conduit.

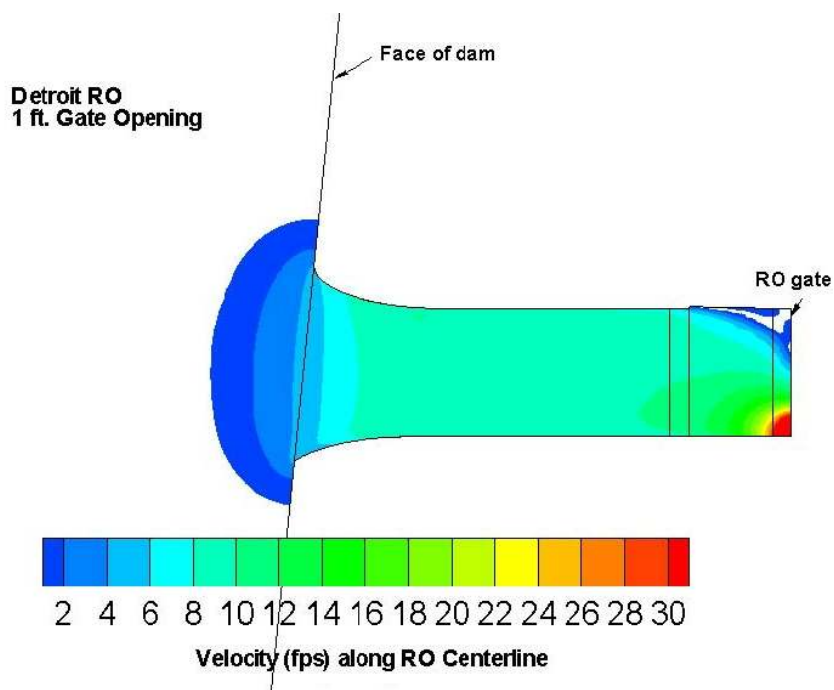
**Figure 4.12.** Computational fluid dynamics estimate of water velocity through the RO when the control gate was open 1 ft (Phillips 2010<sup>1</sup>).

Computational fluid dynamics estimates of water velocity through the RO conduit when the control gate was open 1 ft are shown in Figure 4.12. In contrast with that for the 5-ft gate opening, there is a significant increase in water velocity from 10 to 30 fps immediately upstream of the control gate. The average acceleration magnitude of the Sensor Fish during passage under the control gate at an opening of 1 ft was nearly 4 times that observed during passage when the gate was open 5 ft. During passage under the 1-ft open gate, flow becomes supercritical; depth of flow decreases as water velocity increases. There is a rapid decrease in pressure from that in the conduit to atmospheric in the partially filled conduit downstream of the control gate. Immediately after gate passage, there is a hydraulic jump in the flow, followed by a reduction in water velocity, as the flow becomes subcritical and exits the RO conduit into

the spillway stilling basin. The turbulent flow combined with the shallow depth of flow immediately downstream of the control gate were probably the main factors that contributed to the high rate of Sensor Fish collisions observed in this region. Approximately 71% of the Sensor Fish that passed through the RO when the control gate was open 1 ft experienced a collision event immediately following gate passage. No similar collision events were observed for any of the Sensor Fish that passed through the RO when the control gate was open 5 ft.
