Collapse of 2000 Commonwealth Avenue: Punching Shear Case Study

Suzanne King, S.M.ASCE,¹ and Norbert J. Delatte, M.ASCE²

Abstract: On January 25, 1971, two thirds of a 16-story apartment building collapsed while under construction at 2000 Commonwealth Avenue, Boston, Massachusetts. Four workers died after a failure on the roof instigated a progressive collapse all the way to the basement, where the men were found. Fortunately, the collapse occurred slowly enough for most of the other workers to run to safety. An investigation, conducted by a commission assembled by the Mayor of Boston, painted a picture of a troubled project, with considerable confusion about responsibility for structural safety. The surviving workers' descriptions of the failure provide a textbook definition of punching shear. Low concrete strength due to inadequate protection against cold weather contributed to low punching shear strength of the flat slab. Inspection, quality control, planning, and supervision were for all practical purposes absent from the project. This paper investigates the numerous causes and lessons learned of this structural failure. Two similar cases are also reviewed.

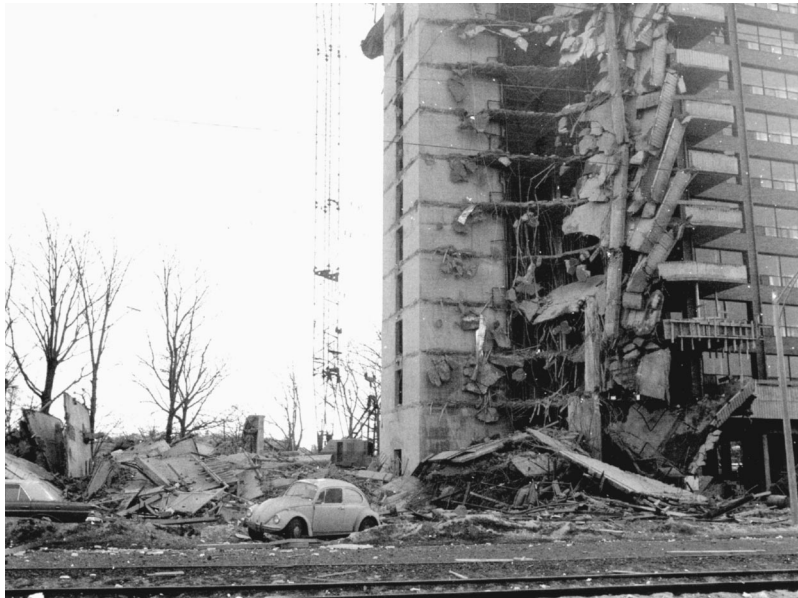
Fig. 1. Chunks of concrete and wood were strewn across MBTA track (in foreground) by building collapse [from *Boston Globe*, January 26, 1971; republished with permission]

At the time of failure, the structural subcontractor was placing reinforcing steel for the stairs on the fourteenth and fifteenth floors on the east side of the building. When the workers were making their way from the roof and floors above, most of them crossed over to the west side of the building when they reached the fifteenth floor (Granger et al. 1971). Thus, the portion of the building that remained standing, shown on the right side of Fig. 1, provided an escape for many of the workers that survived.

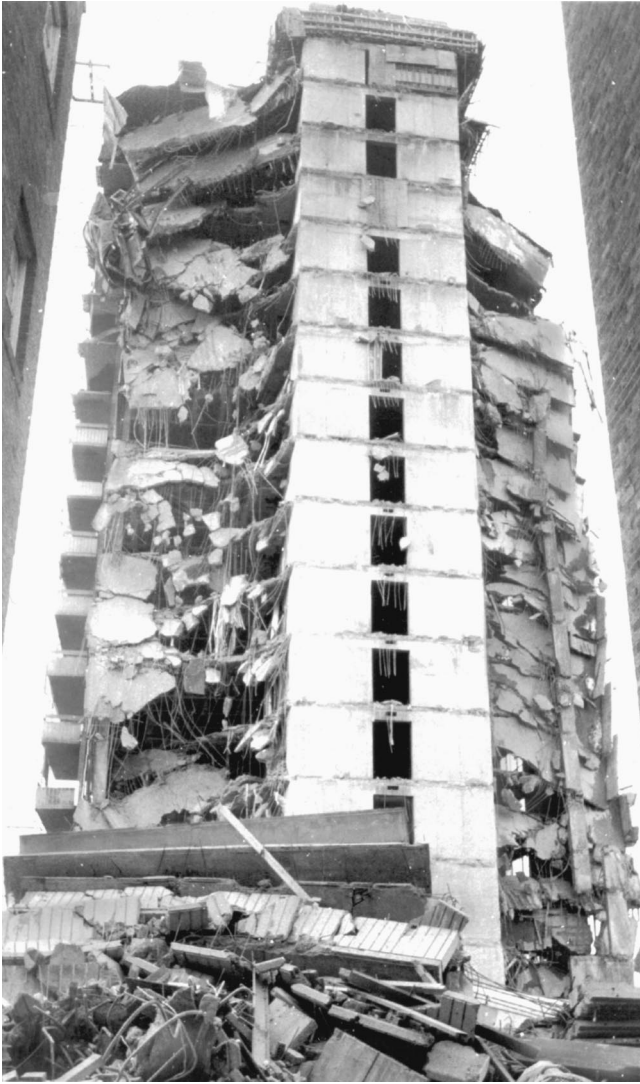
Fig. 2. Building collapse; four men missing and three injured when apartment under construction collapsed in Brighton [from *Boston Globe*, January 26, 1971; republished with permission]

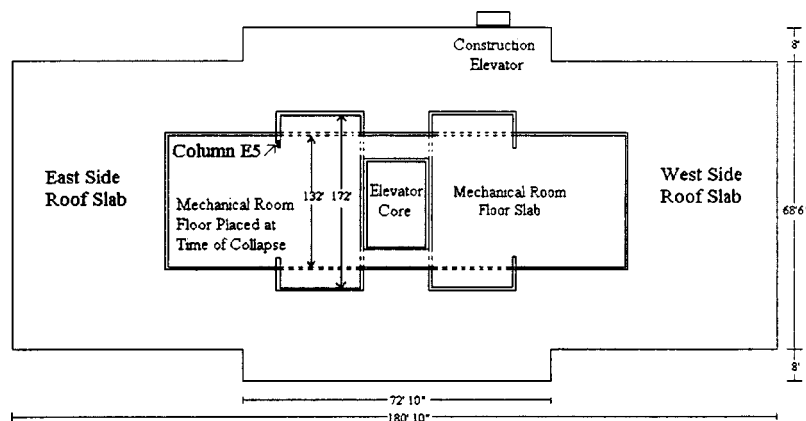
The carpenter foreman, Mr. A. F., was also in the area and immediately yelled a warning to the men working on the sixteenth floor and roof of a possible roof collapse. The slab had dropped 125–150 mm (5 or 6 in.) around the column, and there was a crack in the bottom of the slab extending from column E5 toward column D8. Column E5 is located directly below where the concrete was being placed for the mechanical room floor slab on the east side of the building, as shown in Fig. 3 (Granger et al. 1971).

**Fig. 3.** Floor plan and location of column E5 [after Granger et al. (1971)] (1 ft=0.3 m)

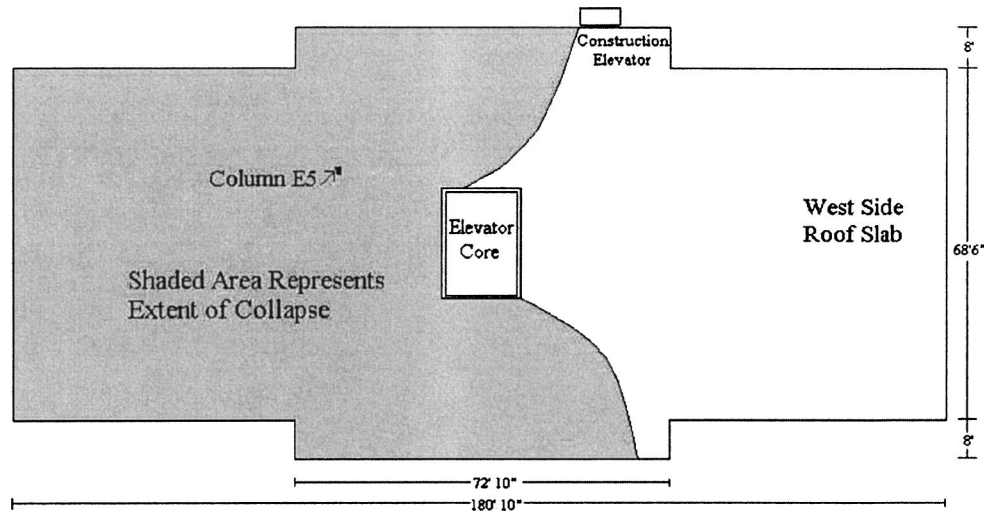
At first the different floors were distinguishable, but later dust and debris made it difficult to tell them apart. When the dust finally settled, two-thirds of the building had collapsed. The east side and areas on either side of the elevator shaft were gone. Four workers were killed during the collapse, and 30 workers suffered injuries (Granger et al. 1971). The extent of damage is shown in Fig. 4. The elevator core probably prevented the collapse from propagating to the other half of the structure.

Fig. 4. Extent of collapse [after Granger et al. (1971)] (1 ft=0.3 m)

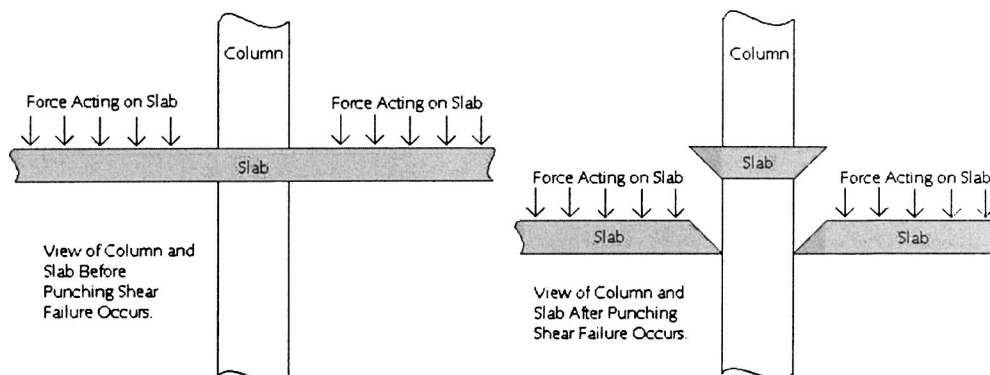
Punching shear is usually the critical failure mechanism for flat slab reinforced concrete structures. This mechanism is illustrated in Fig. 5. With this type of failure, the column and part of the slab punch through the slab as it moves downward.

The force acting on the slab around a column overcomes the resistance and the slab falls down around the column. A portion of the slab is left around the column, but the remainder of the slab falls to the next floor. If the lower slab is unable to hold up both floors, then a progressive collapse will begin.

Fig. 5. Punching shear mechanism
