# Common structural and construction deficiencies of Nepalese buildings

**Abstract** This paper outlines the common observed failure patterns in the buildings of Nepal after  $M_W$  7.8 Gorkha (Nepal) earthquake. Several types of damage patterns were observed for reinforced concrete buildings, as well as for unreinforced masonry and adobe houses during the reconnaissance survey performed immediately after the earthquake of 25 April 2015. Several field visits in the affected districts were conducted and associated failure/damage patterns have been identified and analyzed. This paper also covers damage patterns in non-engineered buildings, middle and high-rise buildings, commercial complexes, administrative buildings, schools and other critical facilities from Kathmandu valley as

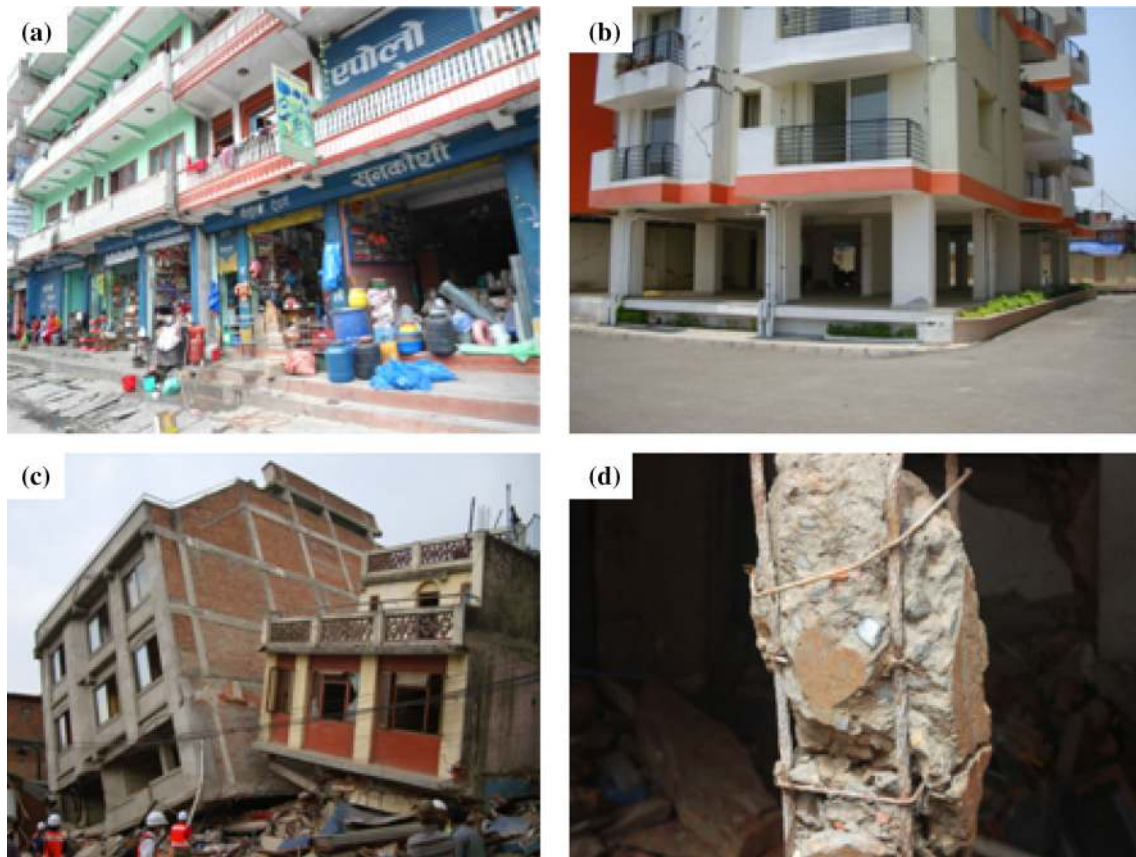
**Fig. 1** a Ground floor of residential buildings without infill walls. b Ground floor of an apartment building without infill wall. c Soft storey and structural pounding failure. d 16 mm diameter rebar but only four in number (corroded as well) from a collapsed building in Kathmandu

walls (Fig. 1b). Such practices have led the soft storey failure during 2015 earthquake in most of the damaged RC buildings (Fig. 1c). In addition to this, it was observed that most of the buildings in residential level were found to be practicing “weak column-strong beam” as depicted by the massive beams and smaller columns during field reconnaissance. Due to lack of infill wall on ground floor, the increased flexibility has significantly triggered the increased displacement in ground floor thus majority of the cracks or minor to severe damages were found to be concentrated therein during reconnaissance.

The longitudinal rebar’s are mostly limited to 12–16 mm diameter and usually in four to eight in numbers. In most of the collapsed buildings, the longitudinal rebar’s were usually four, however majority of the building columns were found to be constructed with six rebar in vertical direction. The intense damage was significantly governed by the horizontal re-bars (stirrups). The stirrups were found to be 6 mm diameter bars usually gaped in regular interval of 0.15 m or more and in some cases (Fig. 1d), such gap was measured up to 0.40 m.

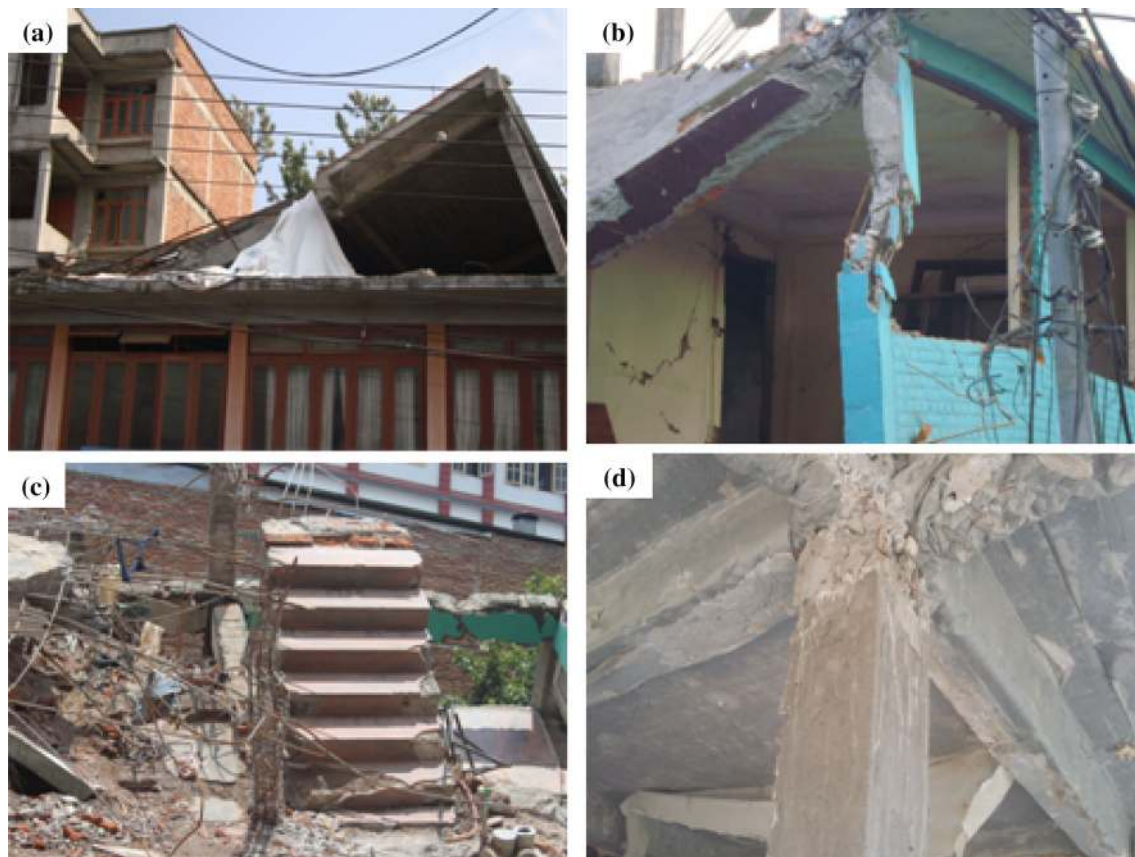
**Fig. 2** a Collapsed column due to welded vertical re-bars. b Column failure due to large gap of stirrups. c Outwardly placed 6 mm diameter re-bars exposed on collapsed structures. d Poor beam column connection with exposed re-bars

Reinforcement in infill walls were not found to be provided in residential constructions with exception to some apartments. Due to lack of reinforced walls in most of the brick kiln chimneys, almost all chimneys suffered from partial to complete collapse in Kathmandu valley [12]. More significantly, the connection between the structural components was also found to be poor. In some cases, it was observed that people preferred welding for connection of vertical reinforcements rather than anchoring thus failures were observed in those columns (Fig. 2a). The larger gap of stirrups was noticed to be significantly contributing in the failure of columns (Fig. 2b). Moreover, the structural damage and building collapse was found to be more governed by too less, smaller diameter and tying the vertical re-bars outwardly (Fig. 2c). Similarly, the beam column connection and layout of the reinforcement was found to be random leading to minor to serious damages. The workmanship defect along with the connection deficiencies were widely observed (Fig. 2d).

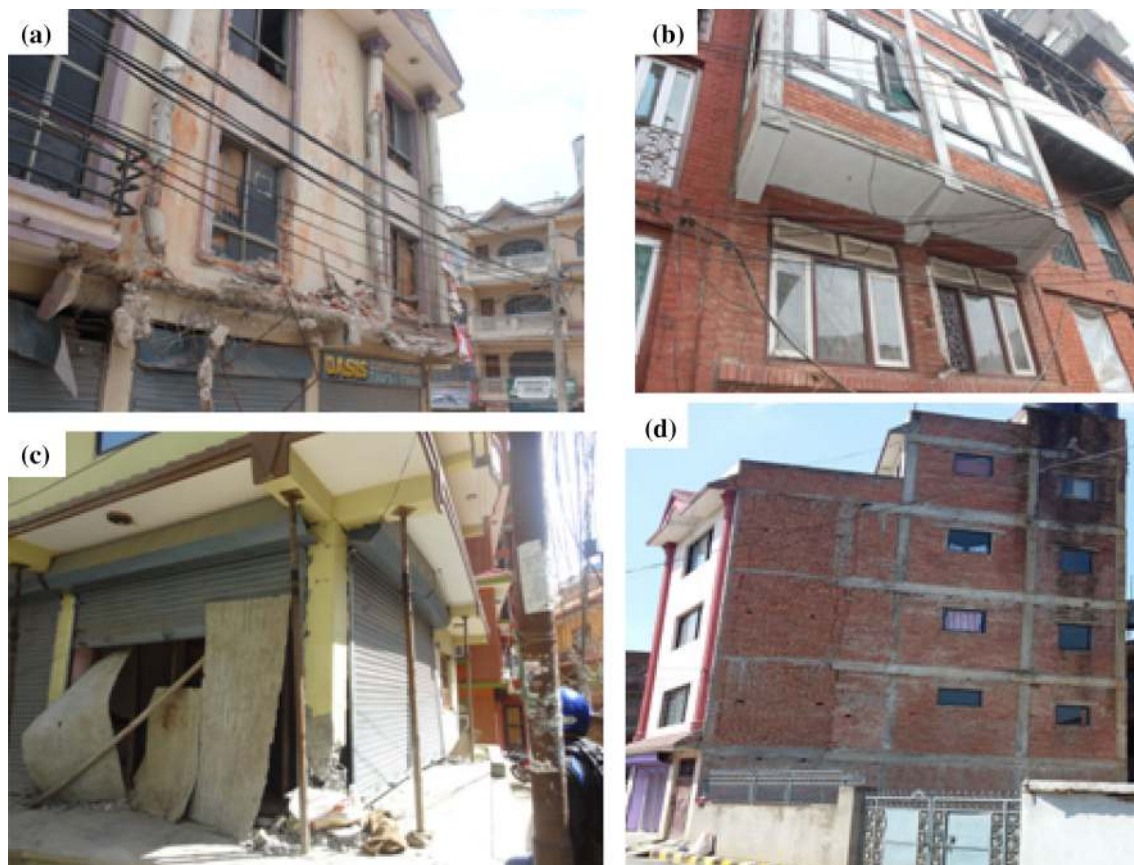
from first storey were commonly observed in residential construction within as well as outside Kathmandu valley (Fig. 3a). The floating columns are frequently used for increasing the built up area from upper stories (Fig. 3b). Due to lack of continuous load path during earthquakes, the lateral forces are not effectively transferred to the foundation. The overturning forces developed lead to buckle the columns of ground floor and subsequent damage was noticed in some buildings (Fig. 3c). Due to poor mechanism of construction monitoring, many of the urban constructions were noticed to be haphazardly increasing the housing size beyond structural system (Fig. 3d). Figure 3d is a residential construction in Lalitpur sub-metropolitan city which is taken as the successful example of building code implementation framework in Nepal, however the enforcement of building code was not found to be effectively monitored.

**Fig. 3** a Floating column with projected construction in upper stories. b Floating columns and continued construction in upper stories. c Column buckling in a building with cantilevered construction and floating column. d Large cantilevered construction projected from structural system

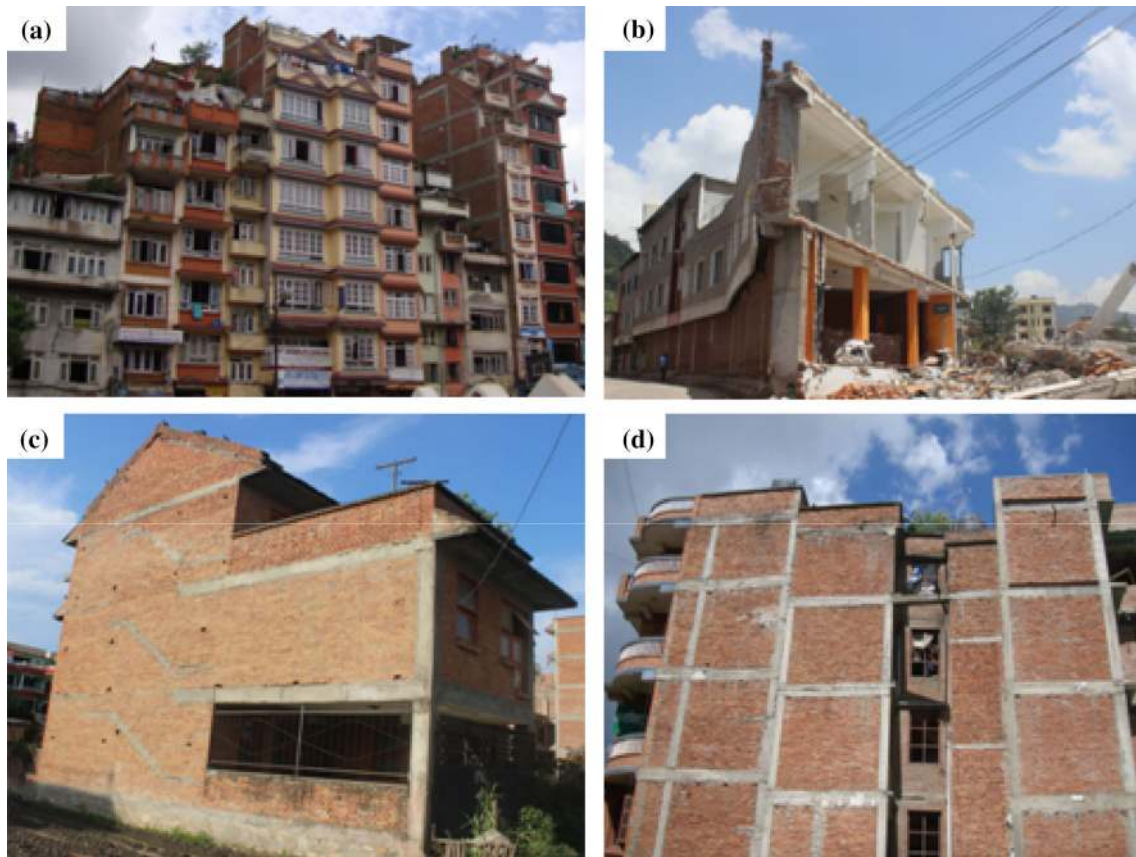
**Fig. 5** **a** A neighborhood in Kathmandu metropolitan city with dominance of slender structures. **b** Asymmetric building with severe damage in Kathmandu. **c** Columns too less and not even in grid.

**d** Two RC buildings connected with a beam and one masonry building in between at Bhaktapur

Nepal. Later, with the commercialization of areas, houses with the same column size were made up to seven stories. This was the significant cause for damage in most of buildings in Nepal during 2015 Gorkha earthquake. In addition to this, several houses were found to be constructed with combination of load bearing walls and columns (Fig. 5c), in doing so, it was observed that columns were too less and heavy RC slabs were provided for load bearing wall system. In some sites of Kathmandu valley, some of the construction flaws like joining masonry as well as RC buildings were observed (Fig. 5d).

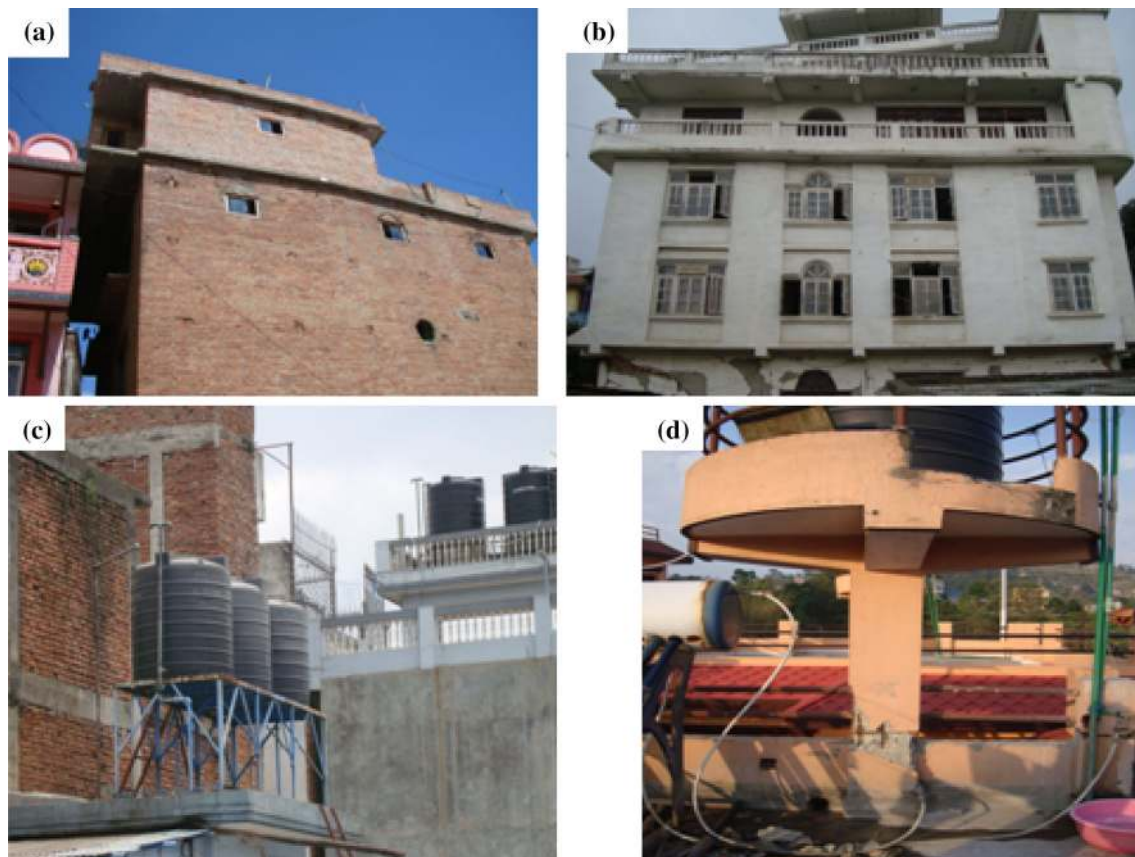
In some locations of Kathmandu valley, traditional masonry houses were found to be added with reinforced concrete construction in third or four storey (Fig. 6a). Many of the buildings in Kathmandu are constructed with higher load concentration in upper stories and reducing the column size while constructing upper stories (Fig. 6b). Water tanks were found to be installed in every RC building in Nepal for gravity distribution in taps, though the weight of water tank was found to be nevertheless

accounted during structural analysis and design before construction even if it was obvious to install. At least one to five water tanks of varying capacity were found to be installed during field reconnaissance (Fig. 6c). Due to continuation of single column for water tank and construction of short column, some of the buildings sustained damages in those structures (Fig. 6d). Also in some houses, the load of telecommunication tower was found to be established without any structural analysis and design.

**Fig. 6** **a** Plain cement concrete construction with RC slab above traditional masonry building. **b** Massive construction in upper stories and subsequent damage in ground floor. **c** Water tanks in Kathmandu

valley buildings. **d** Continued column from structural system damaged after Gorkha earthquake in a colony building

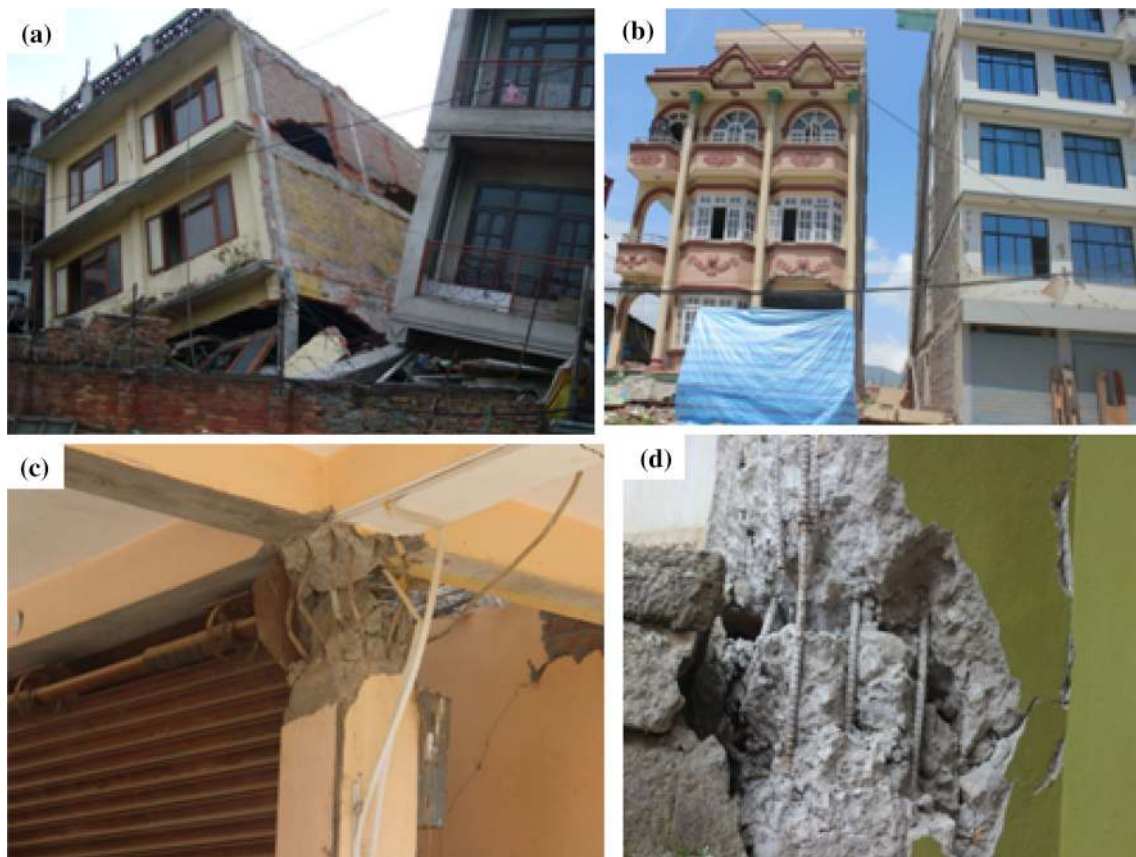
so almost all portion of land is covered by the structural system. Due to such close proximity led pounding, some structures were found to be separated some 3 m (Fig. 7b).

In columns, due to large spacing between the stirrups, weak column strong beam, insufficient development length of rebar, among others were found to be governing the damage concentration in columns. Plastic hinge formation (Fig. 7c) was also observed in some of the structures along with concrete spill caused due to buckled re-bars on ground floor (Fig. 7d).

**Fig. 7** a Collapsed buildings due to structural pounding in Gongabu (Kathmandu). b Structural pounding led displacement of building (3 m) in Sitapaila (Kathmandu). c Plastic hinge formation. d Base of first storey column with buckled rebar and concrete spall

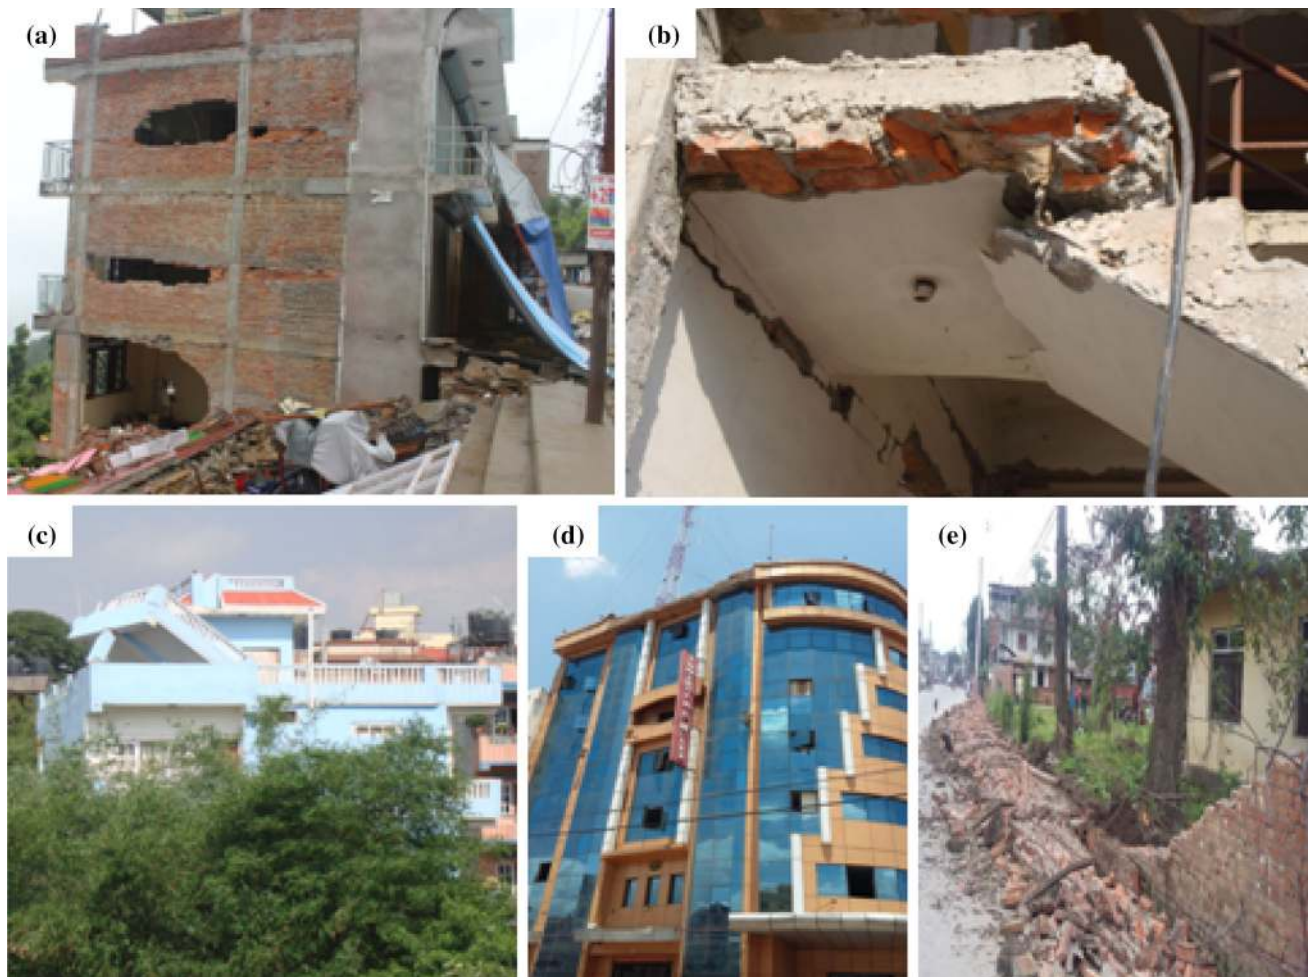
Damages in staircase without proper anchoring with structural members was also noticed (Fig. 8b). Staircases could effectively perform as diagonal bracing members but due to lack of sliding joints in design most of the damage concentration was found to be in staircase. Also staircases are never isolated from structural elements as well, so the performance of buildings during earthquakes is also affected by the heavy staircases.

Failure of water storage tanks was noticed during the reconnaissance (Fig. 8c). Water tanks are not accounted during building design and also it is found that owners themselves hire masons to construct water tanks. Moreover, there is no proper regulation to monitor how many water tanks a single building can install is not governed by any by-law or design code. Due to this fact, many houses in Kathmandu were found to be installing water tanks, heavy purification system and water heating systems.

Damage in parapet walls was observed in some RC buildings which were not reinforced and excessively high (Fig. 8d). The anchorage with roof diaphragm was found to be often lacking in case of damaged parapet walls.

The boundary walls were among the severely collapsed non-structural members during 2015 Gorkha earthquake (Fig. 8e). In order to separate property line or for security purpose, boundary walls were found to be constructed in almost every house within Kathmandu valley in newer settlements. However, in case of older settlements and outside Kathmandu valley boundary walls were not frequent. Due to poor workmanship and inferior quality of plain cement concrete construction proper binding was not assured so around

**Fig. 8** **a** Out of plane collapse of brick infill wall in Chautara (Sindhupalchowk). **b** Damaged staircase. **c** Damaged water tank. **d** Damaged parapet wall in a high rise building. **e** Damaged boundary wall

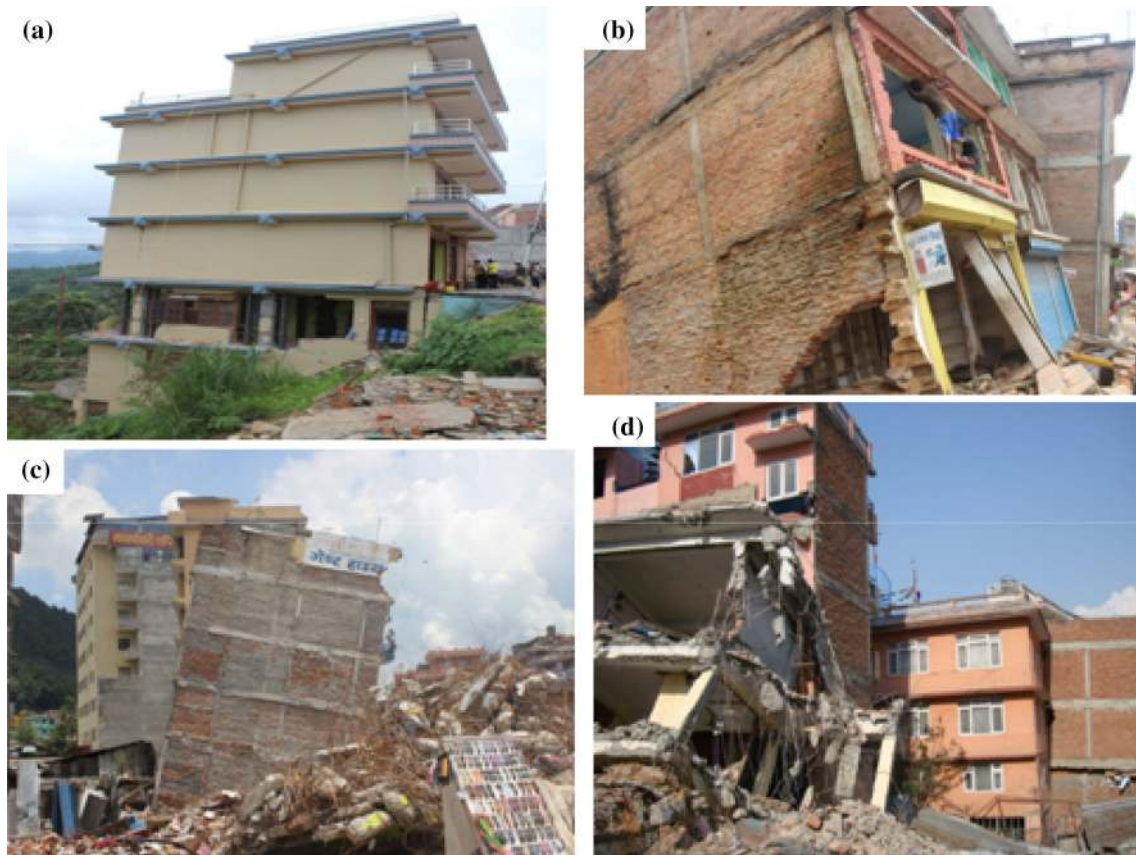
was observed that the buildings constructed in river banks were facing rocking and sliding of foundation problem (Fig. 9c) even if the structural system was undamaged. Moreover, both foundations as well as structural deficiencies led building collapse were also noticed in some locations within Kathmandu valley (Fig. 9d).

**Fig. 9** **a** RC building in stepped foundation with partial damage. **b** Building tilted with column failure due to stepped foundation. **c** Large displacement in foundation led tilting of building constructed

in river bank in Gongabu (Kathmandu). **d** Collapsed RC building in Kathmandu due to combination of foundation as well as structural deficiencies

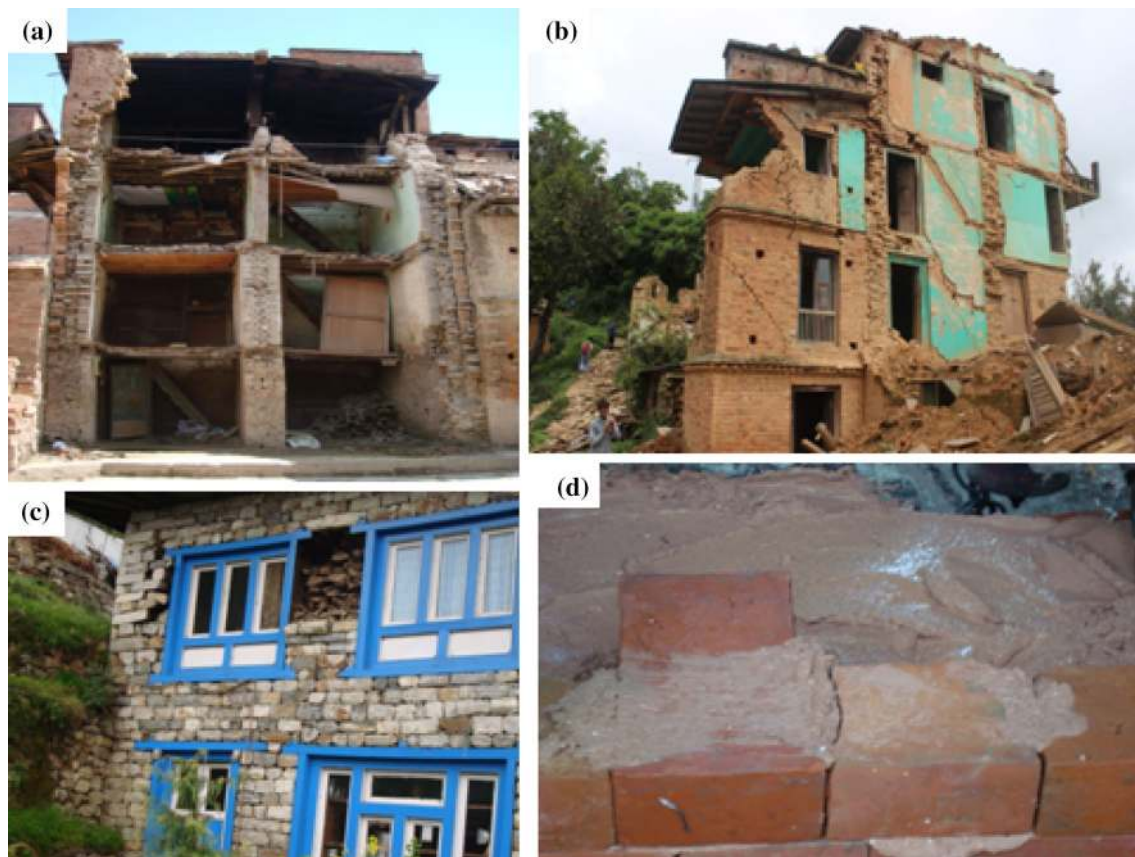
Almost all, except some URM buildings were found to be not consisting any bands at various levels like; sill, lintel or gable. Due to lack of proper bonding in masonry load bearing wall, out of plane collapse was more commonly observed in Kathmandu valley and other settlements with abundance of URM buildings (Fig. 10a). In most of the URM building, the orthogonal walls were found to be behaving differently due to lack of proper connection between such walls showing poor integrity. Also due to lack of integration of several members within the structural components, out of plane failures were more intense than any other type of failure (Fig. 10b). In case of masonry structures, due to poor quality of binding materials, delamination of wythes was also common in stone masonry houses outside Kathmandu valley (Fig. 10c), however such

**Fig. 10** **a** Out of plane collapse of load bearing masonry wall in Bhaktapur. **b** Heavily damaged masonry structure in Chautara due to out of plane collapse of majority of walls. **c** Delamination of wythes

observed in stone masonry wall in Solukhumbu (Everest base camp area). **d** Common practice of mortar placement for masonry construction

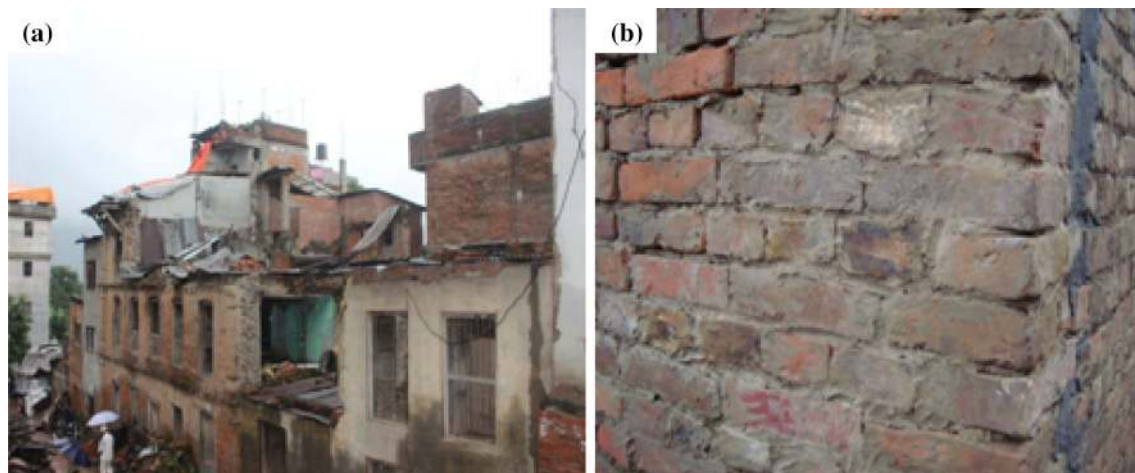
The structural integrity depends also on monolithic and homogenous behavior of masonry structures; however the mud mortar used for binding the brick/stone units were found to detached already and brick/stone units were found to be behaving separately (Fig. 11a). This binding problem led the severe devastation during 2015 Gorkha earthquake in the historic settlements of Kathmandu, Lalitpur, Bhaktapur, Sankhu, Harisiddi, Barpak, among others. Even after the earthquake damage people were found to be using the same binding material for reconstruction (Fig. 11b). This could be detrimental in future events.

**Fig. 11** **a** Failure of masonry units due to lack of proper binding. **b** Mud mortar used for reconstruction of URM building destroyed during 2015 Gorkha earthquake at Bhaktapur

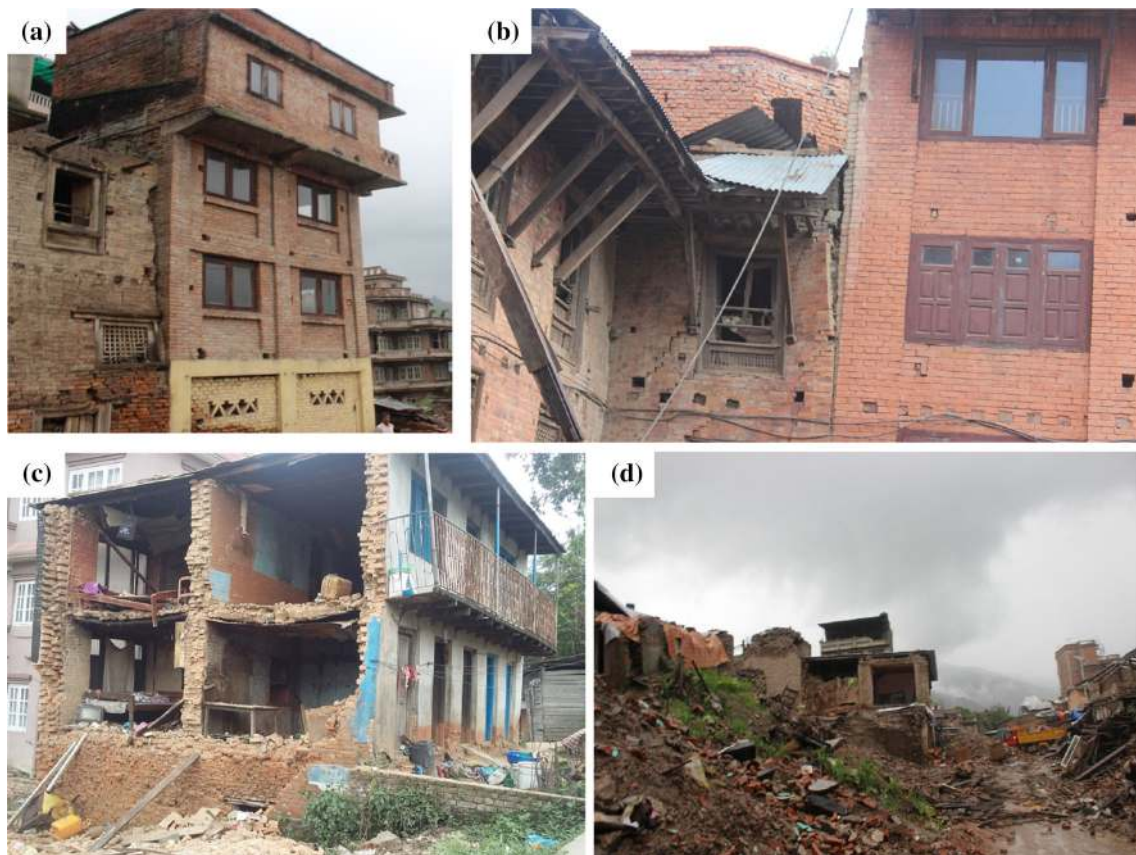
cantilevered constructions, many of the buildings in Kathmandu valley were observed with load path discontinuity (Fig. 12a). The reentrant corners and diaphragm discontinuities were also noticed in masonry construction practices

**Fig. 12** a Heavy load concentration in the fourth storey of a masonry building. b Re-entrant corner and associated damage in masonry building in Bhaktapur. c Lack of connection led collapse of wall. d Heavy damage in old masonry houses in Sankhu

in Nepal (Fig. 12b). Masonry buildings up to six stories were found inside Kathmandu valley and in case of outside Kathmandu valley the number of stories for masonry buildings is limited to four. Struts in some masonry buildings performed the function of transferring the cantilevered load into structural wall [13], but majority of masonry structures were found to be without having struts even if the roofing was too heavy constructed with roof tiles.

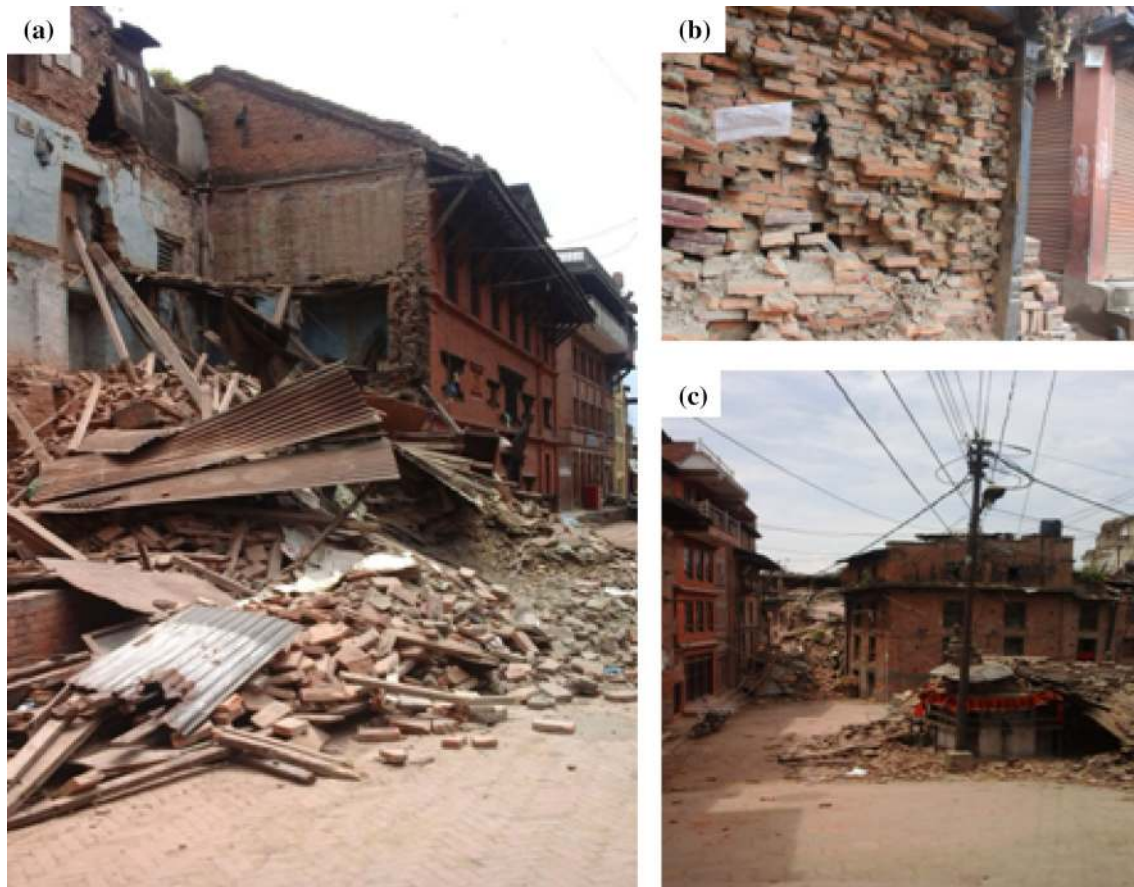
**Fig. 13** **a** Damage in shared wall. **b** Segregated mud mortar and associated delamination of wythes. **c** Damaged building with inclined foundation and intact buildings having leveled foundation

settlement where single house is divided into two and phased construction or repair was done in either unit. The thickness of brick masonry wall was found up to 0.60 m but poorly connected with mud mortar. Such mud mortar binding was found to be detached from brick units many years back and delamination of wythes was commonly observed in those buildings with segregated mud mortar (Fig. 13b).

Shallow and spread foundation is commonly adopted in masonry constructions in Nepal. Beside this, natural terrain was found to be adopted directly for foundations so that inclined foundations were commonly observed in majority of masonry buildings constructed across and outside Kathmandu valley. It is observed that the buildings resting on inclined foundations were more damaged than those buildings resting on leveled foundation (Fig. 13c).

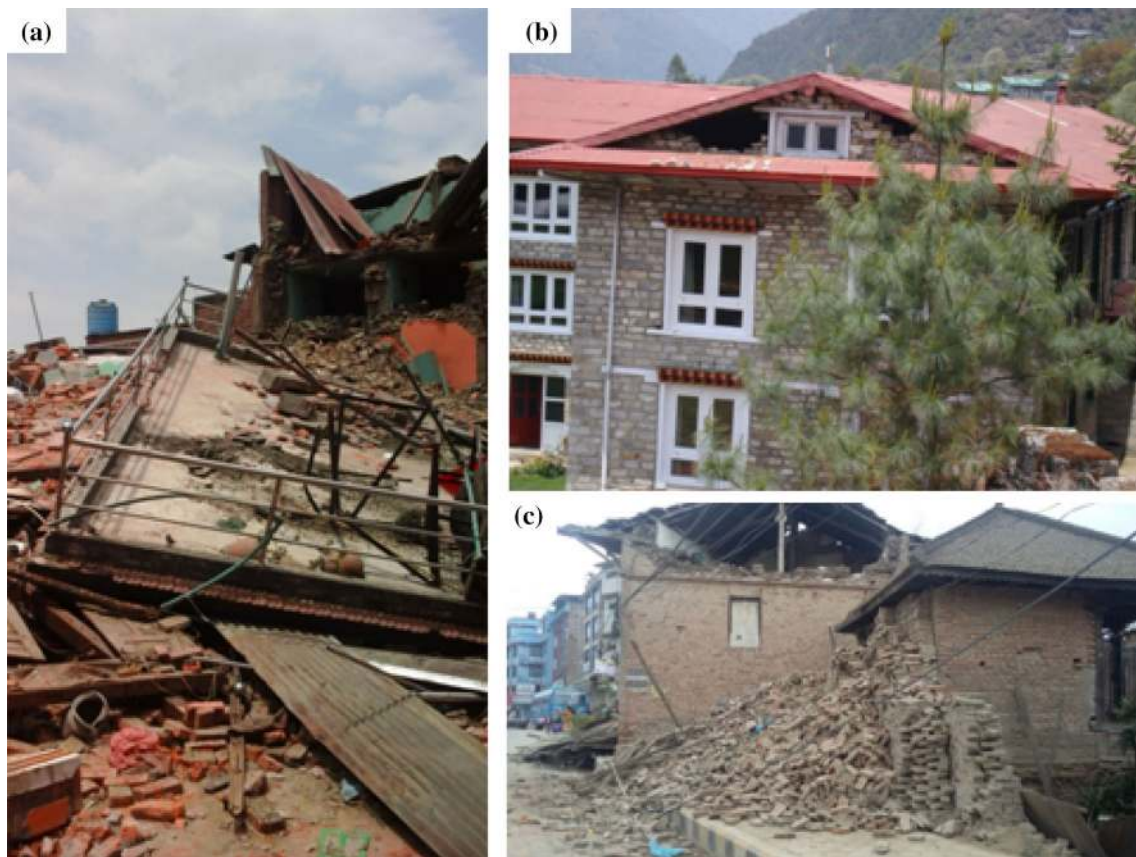
The gable portion of most of the masonry buildings was found to be constructed with thick brick wall; this ultimately led to most of the gable portion failure (Fig. 14b). The performance of thick gable wall was weak throughout Nepal in stone masonry and brick masonry structures (Fig. 14b, c). Although, some areas used to have small to big gable openings, due to heavy concentration of stacked and unsupported masonry units, failure was commonly observed in central Nepal, eastern Nepal as well as inside Kathmandu valley.

**Fig. 14** a Complete collapse of RC slab used as roofing in a masonry building. b Out of plane failure of gable portion of a stone masonry building. c Heavy gable portion out of plane failure in brick masonry

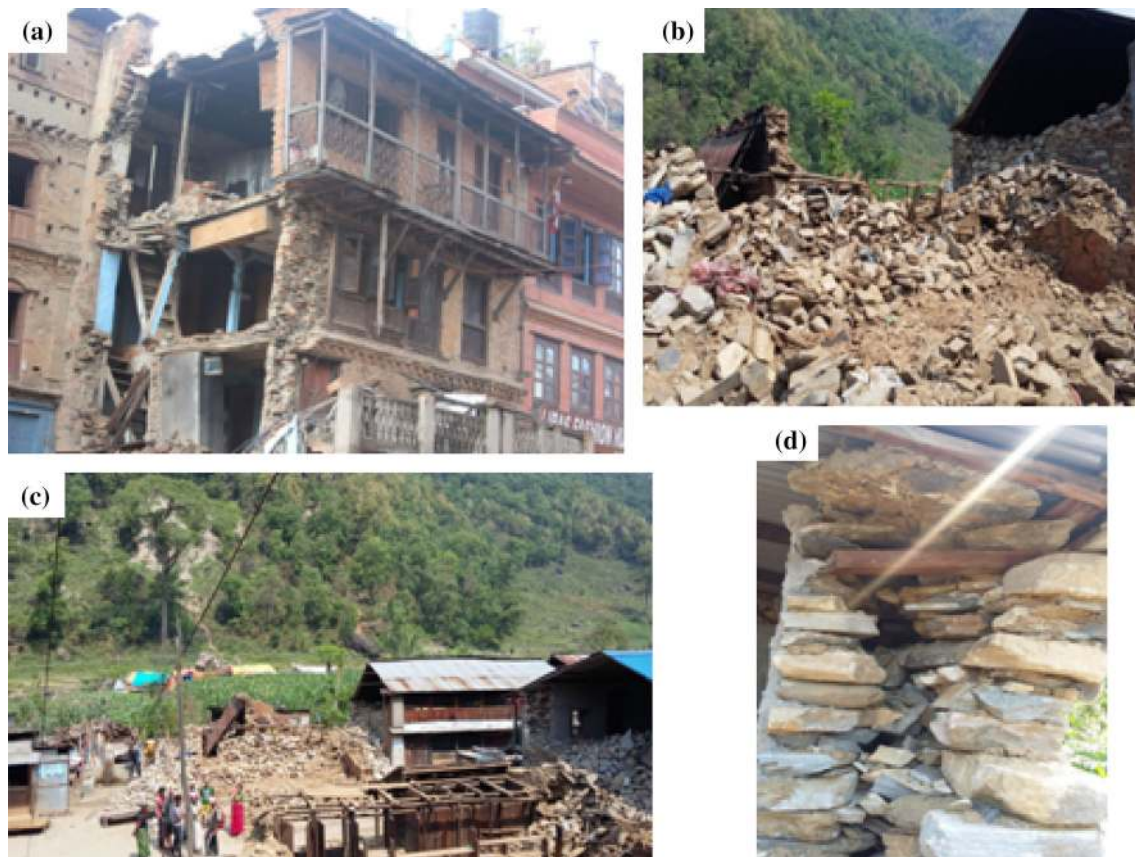
**Fig. 15** **a** Pounding and progressive failure on the building situated on edge. **b** Complete collapse of row houses in Baluwa (near epicenter). **c** Progressive failure on row houses and good performance of timber frames. **d** Separated wall due to structural pounding

thick was observed (Fig. 15d). The stone masonry houses constructed with piling of stones were severely affected like in the epicentral village of Barpak (Fig. 16a). Beside this, very heavy roofs constructed from stone slices (Fig. 16b) were found to be dominant than any other roofing system in Barpak leading to severe collapse of houses.

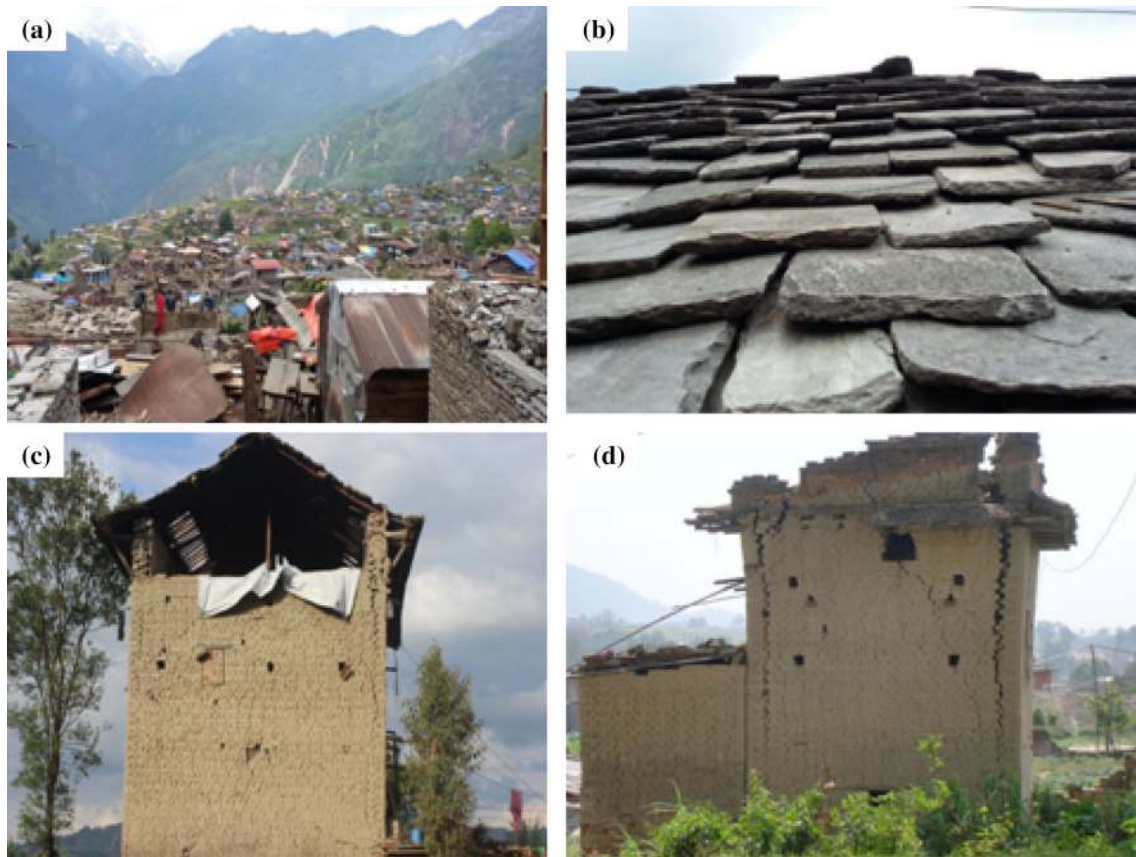
**Fig. 16** **a** Heavily damaged neighborhood of Barpak village where 1250 houses out of 1450 total were collapsed. **b** Heavy stone roofing in Barpak. **c** Gable collapse in adobe house in Bhaktapur. **d** Separation of diagonal walls in an adobe house
