Conservation Status Diagnosis of Mural Painting in Geungnakjeon Hall of Daewonsa Temple, Boseong: Avalokitesvara Bodhisattva Mural and Buddhist Monk Bodhidharma Mural

Journal of Conservation Science
2022;38(4):314-326
<https://doi.org/10.12654/JCS.2022.38.4.06>

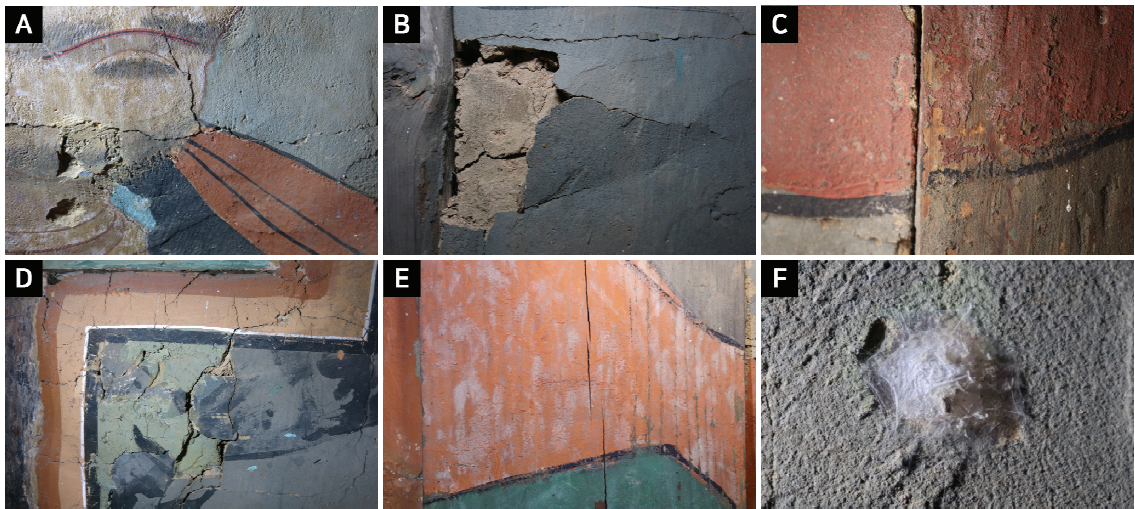
The main damage to the wall is cracks. In the case of the Avalokitesvara Bodhisattva mural, cracks are found throughout the mural, and it is concentrated in the center and the right part (Figure 2A). In the case of the Buddhist Monk Bodhidharma mural, cracks were observed in Buddha's face (Figure 3A), and the cracks were worsened in the lower left part of the mural.

For damage to the finishing layer, exfoliation and delamination damage are mainly observed in the Avalokitesvara Bodhisattva mural at the point where the edge and the Junggit meet (Figure 2B). Buddhist Monk Bodhidharma mural, like Avalokitesvara Bodhisattva mural, was also mainly found to have damage to the finishing layer in the area in contact with the edge and Junggit of the mural (Figure 3B).

part of the Yeonhwamun (louts pattern) (Figure 2C). In the Buddhist Monk Bodhidharma mural, delamination and exfoliation are observed mainly in the orange painting layer painted over the Junggit (Figure 3C).

Damage to the area restoration material during the past repair is confirmed in both murals. In the Avalokitesvara Bodhisattva mural, the restoration material area is roughly treated, therefore it feels different from the surrounding mural surface, and cracks or separation from the surrounding mural are observed (Figure 2D). The restoration material areas of the Buddhist Monk Bodhidharma mural also show damage similar to those of the Avalokitesvara Bodhisattva mural (Figure 3D).

In case of the surface stains and contamination of murals, the Avalokitesvara Bodhisattva mural shows them mainly on the parts painted in skin colors such as Buddha's face and Samdo (the three lines of Buddha's neck) and mudra. In addition, the substance presumed to be the fixative from the past treatment forms spots around the cracks, and white contamination are observed in the painting layer of the Junggit (Figure 2E). In the Buddhist Monk Bodhidharma mural, white contamination is observed on the orange painting layer of the Buddha's face, skin-colored parts, and Junggit (Figure 3E).

Figure 3. Type of damages of the Buddhist Monk Bodhidharma mural (A: Crack of finishing layer, B: Exfoliation of finishing layer, C: Exfoliation of painting layer, D: Restoration material, E: Contamination, F: Biological damage).

Bodhidharma mural. In particular, webs of spiders inhabiting the surface of the murals are observed, and the concentration tends to be high in the lower part of the murals (Figure 2F, Figure 3F).

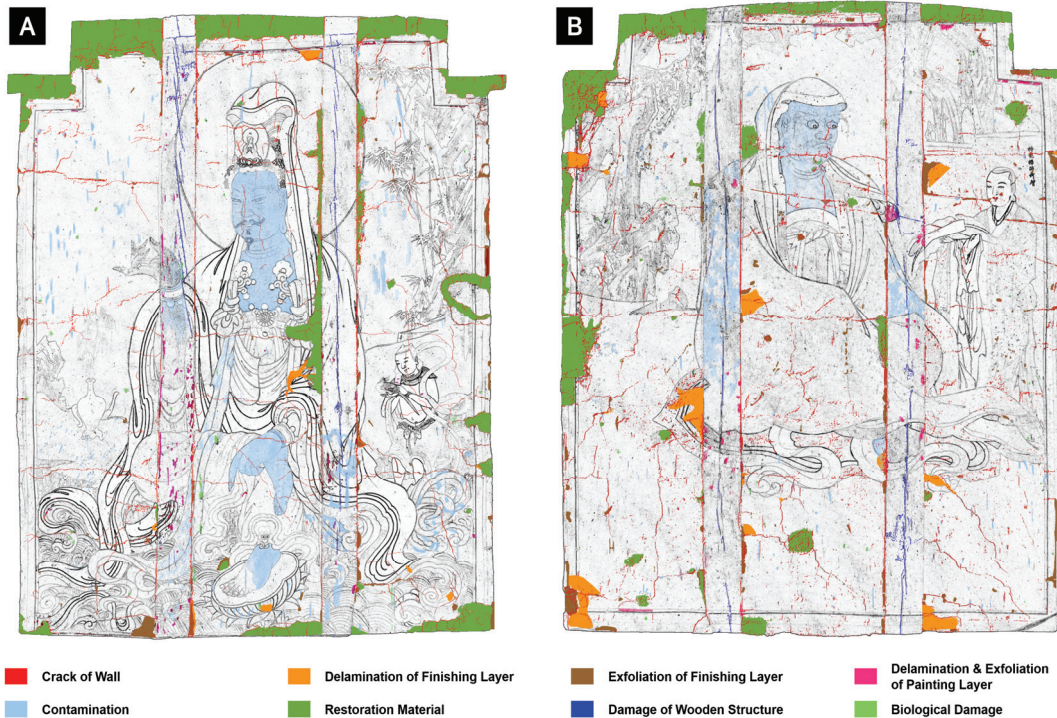
Bodhisattva Mural, it was confirmed in the order of contamination (7.30%)> restoration material (6.26%)> crack (1.65%)> exfoliation of finishing layer (1.01%)> delamination & exfoliation of painting layer (0.58%)> delamination of finishing layer (0.27%). In addition, damage of wooden

Figure 4. Damage mapping image (A: Avalokitesvara Bodhisattva mural, B: Buddhist Monk Bodhidharma mural).

structure was 0.34%, and biological damage was 0.24% (Figure 5). In the case of the Buddhist Monk Bodhidharma Mural, it was confirmed in the order of restoration material (4.33%)> contamination (4.14%)> crack (2.01%)> exfoliation of finishing layer (1.42%)> delamination of finishing layer (1.33%)> delamination & exfoliation of painting layer (0.45%). In addition, damage of wooden structure was 0.22%, and biological damage was 0.11% (Figure 4, Figure 6).

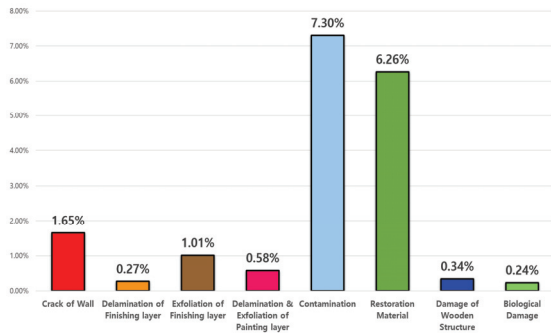
Figure 5. Graph of area by damage type of Avalokitesvara Bodhisattva mural.

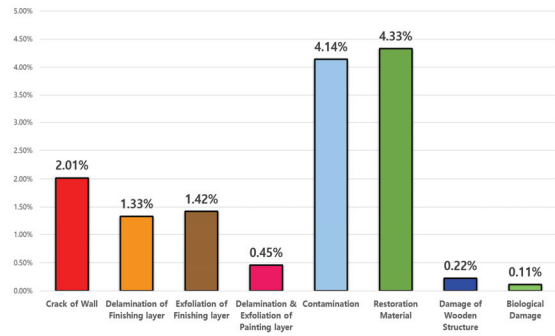
Figure 6. Graph of area by damage type of Buddhist Monk Bodhidharma mural.

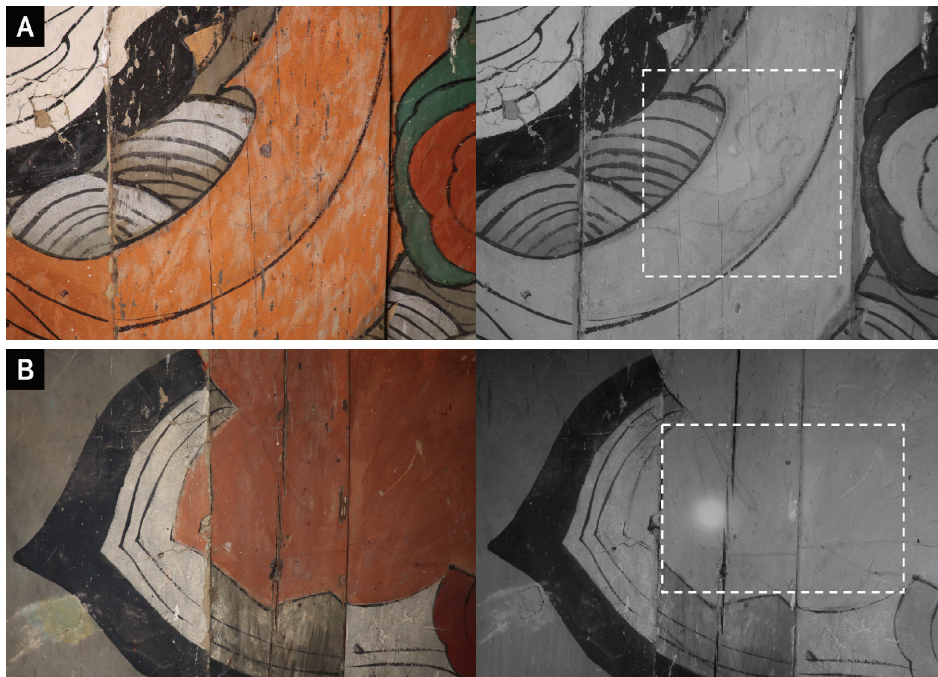
As a result of infrared photography, drawing under the painting layer, which is difficult to visually identify (Figure 7A, 7B), was confirmed, and damage such as exfoliation or contamination of the painting layer was identified. As a result of UV photography, restoration material and contaminated parts were detected in both murals.

Figure 7. Result of the infrared survey (A: Detection of drawings under the painting layer in Avalokitesvara Bodhisattva mural, B: Detection of drawings under the painting layer in Buddhist Monk Bodhidharma mural).

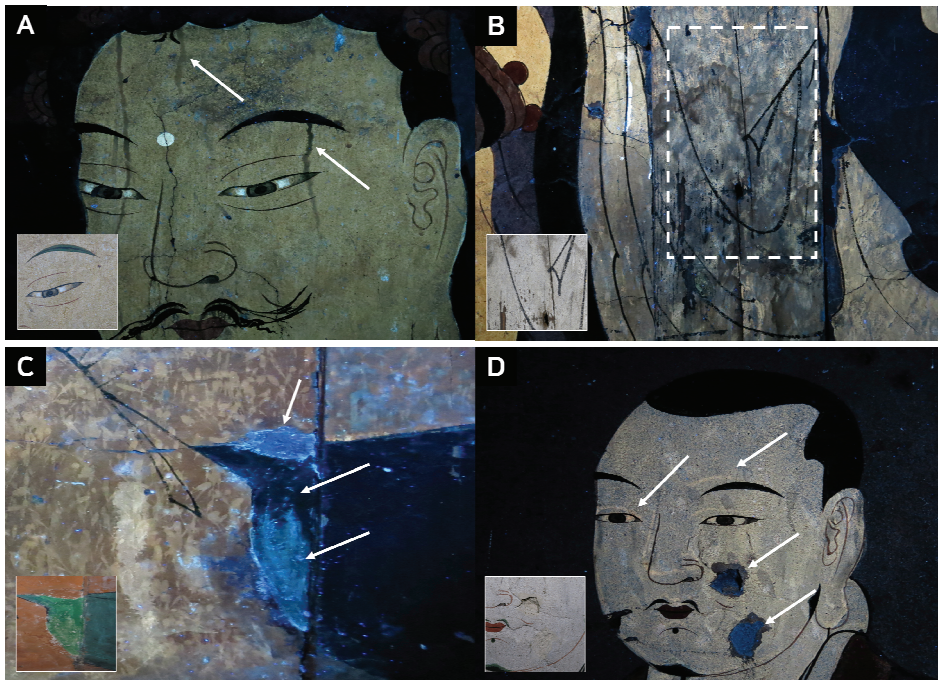
Figure 8. Result of uv survey (A: Detection of presumed to be a fixative, B: Detection of stains, C: Damage detection through uv light, D: Detection of repainted site and drawing in Huike Duanbei).

form of a material that was presumed to be a fixative from past treatment in the Buddha's face was identified by UV fluorescence reaction (Figure 8A). In the part of the white

clothes above the Junggit (Figure 8B), stains that are not identified in the visible light area cause a fluorescence reaction to UV light, and a similar reaction was observed in

various parts such as the skin color of the Sudhana Kumāra.

In the Buddhist Monk Bodhidharma mural, it was investigated that the part of the Buddha's beard, the right shoulder, and the green repainted wall adjacent to the Junggit showed UV fluorescence reaction (Figure 8C). In addition, ultraviolet fluorescence reactions were detected in areas repainted on Huike Dianbei, and drawing such as eyebrows, eyes, and nose was identified (Figure 8D).

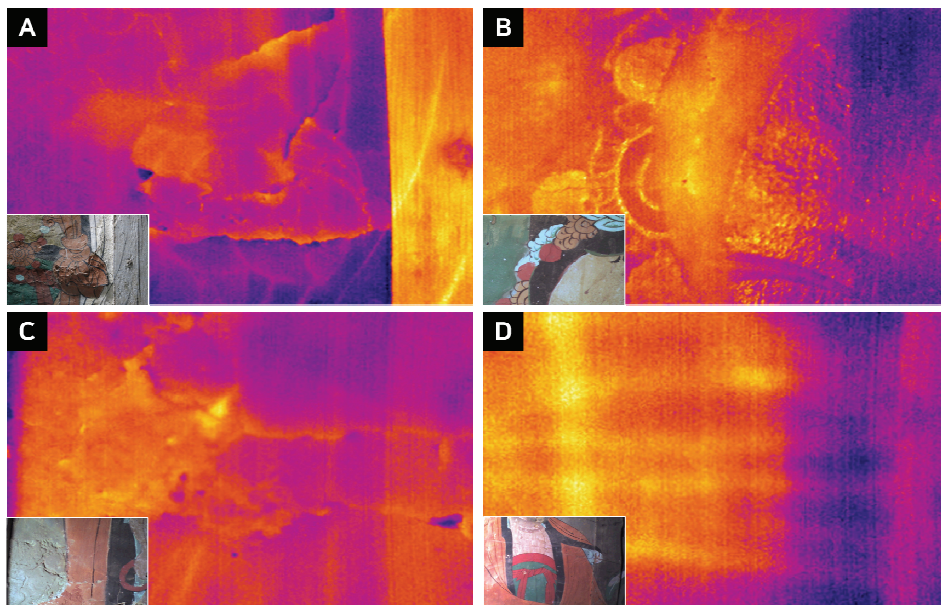
Figure 9. Result of the infrared thermography (A: Delamination of finishing layer, B: Contamination of mural's surface, C: Restoration material, D: Detection of wooden lath in wall).

Infrared thermography was used to identify the range of physical damage to the murals. In the case of the Avalokitesvara Bodhisattva mural, there was a difference in the temperature distribution due to the delamination of the

finishing layer that occurred around some wall cracks (Figure 9A). The temperature distribution on the face and chest was shown in a grid shape, and the location and shape of the wooden lath inside the wall were identified. Also, on the Buddha's face, there was a difference in the temperature distribution of the part presumed to be the fixative used in the past conservation treatment (Figure 9B). In the Buddhist Monk Bodhidharma mural, the range of the restoration material around the edge and the Junggit was identified (Figure 9C), and the shape of the wooden lath of the inner wall was confirmed from the chest (Figure 9D).

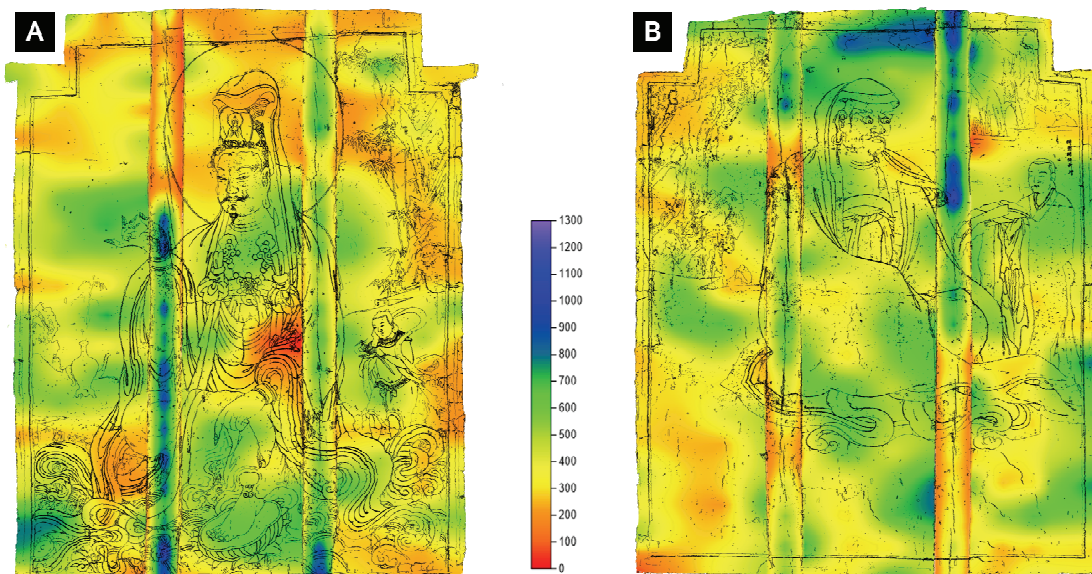
Figure 10. Ultrasonic examination mapping image (A: Avalokitesvara Bodhisattva mural, B: Buddhist Monk Bodhidharma mural).

mural was about 382.0 m/s, the minimum was 79.5 m/s and the maximum was 802.0 m/s. In the case of the Junggit, the average ultrasonic speed was measured to be approx. 699.5 m/s, the minimum of 204.0 m/s, and the maximum of 1277.0 m/s. The average ultrasonic speed of the wall of the Buddhist Monk Bodhidharma mural was approx. 415.6 m/s, the minimum 166.0 m/s, and the maximum 872.5 m/s, and the ultrasonic speed of the Junggit was measured to be approx. 581.7 m/s, the minimum 244.0 m/s, and the maximum 1178.0 m/s (Table 2, Figure 10).

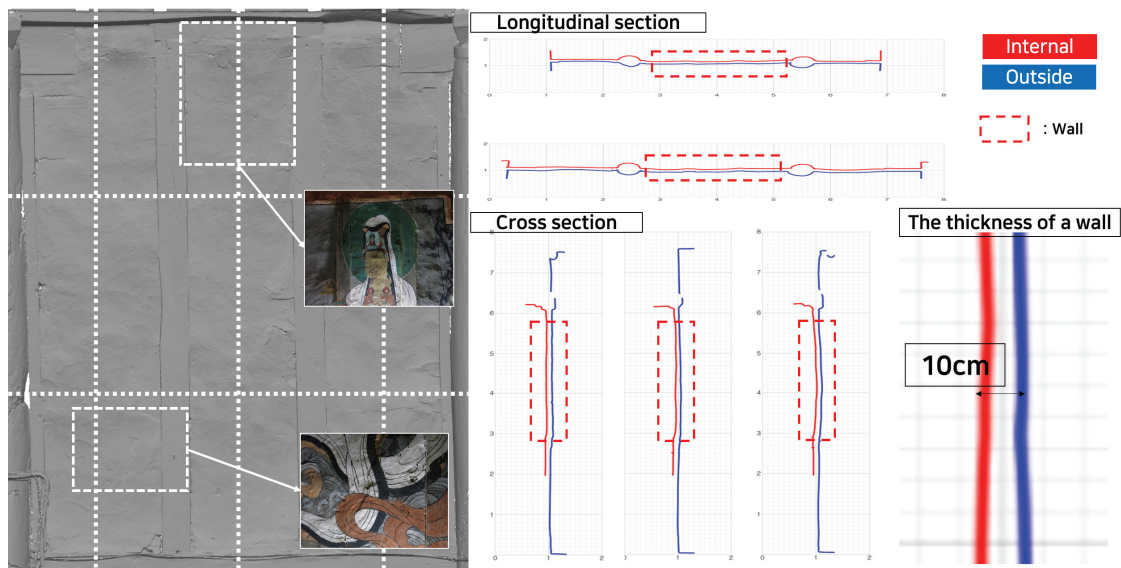
Figure 11. The result of displacement in wall.

the degree of wall deformation of the murals (Figure 11). It was confirmed that the average thickness of the walls was about 100 mm from the results of the cross-sectional and longitudinal scan images of the walls. In the case of the Avalokitesvara Bodhisattva mural, it seems that the left center of the wall protrudes about 35 mm, and some restoration materials are separated from the wall (Figure 12A). The Buddhist Monk Bodhidharma mural also showed that the left center of the wall protruded about 32 mm, and some restoration materials were separated (Figure 12B).

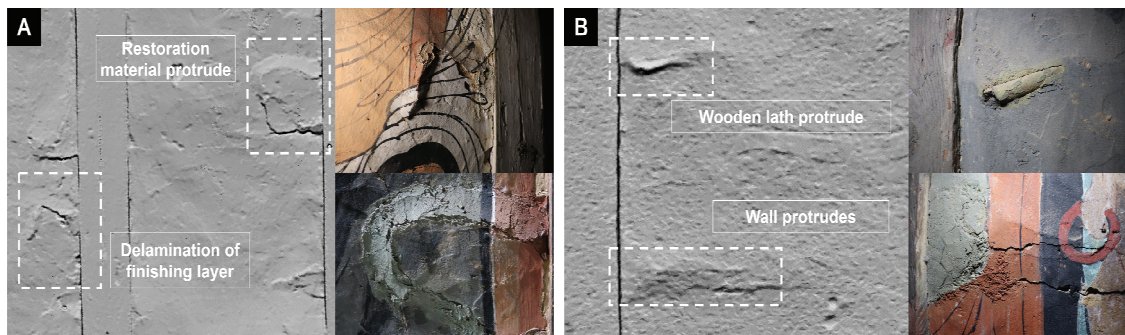
Figure 12. Detection of wall protruded to 3D scanning (A: Avalokitesvara Bodhisattva mural, B: Buddhist Monk Bodhidharma mural).

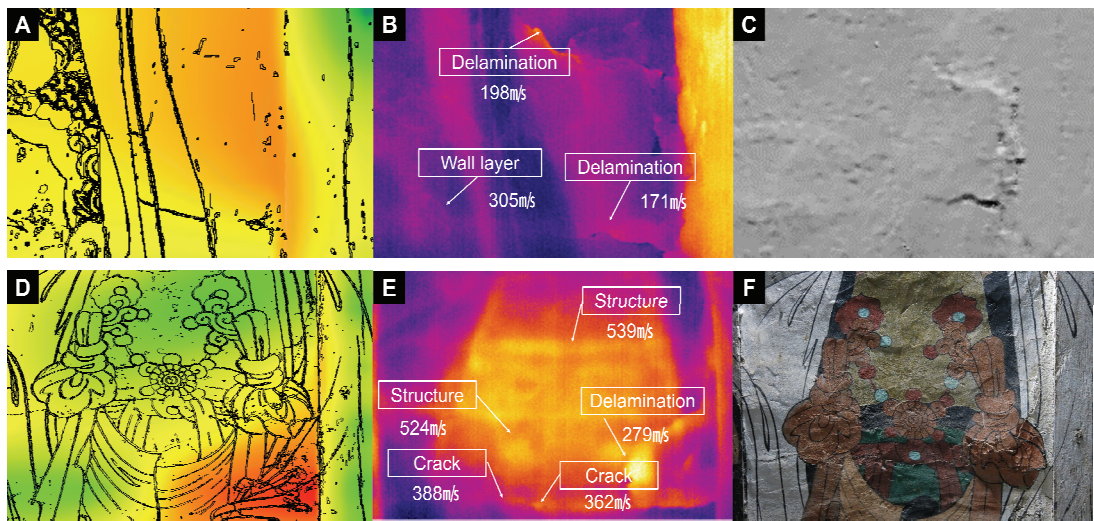
This is due to the influence of the wooden lath, which has a higher ultrasonic speed than the wall and it is assumed that the wooden lath is close to the wall surface therefore the average speed is measured high. Ultrasonic speed values

were also high in some wall cracks or delamination sites, and it was confirmed by the infrared thermal imaging results that the wooden lath inside the wall was located in those parts (Figure 13D, 13E, 13F).

Figure 13. The result of non-destructive diagnosis in the Avalokitesvara Bodhisattva mural (A: Detection the ultrasonic speed difference between the wall and the restoration material, B: Delamination of wall detection by an infrared thermograph, C: 3D scanning image of deviation site, D: High values of ultrasonic speed in some wall cracks or delamination sites, E: Wall interior wooden lath detection by an infrared thermograph, F: A real image of E).

If structural deformation of the murals occurs under the condition that the wooden lath is adjacent to the surface of the mural, cracks in the wall or exfoliation of the finishing layer may be developed faster, and additional damage may occur in the current conservation status. Therefore, it is necessary to observe the physical change in the murals through periodic monitoring and to respond promptly when a change occurs.

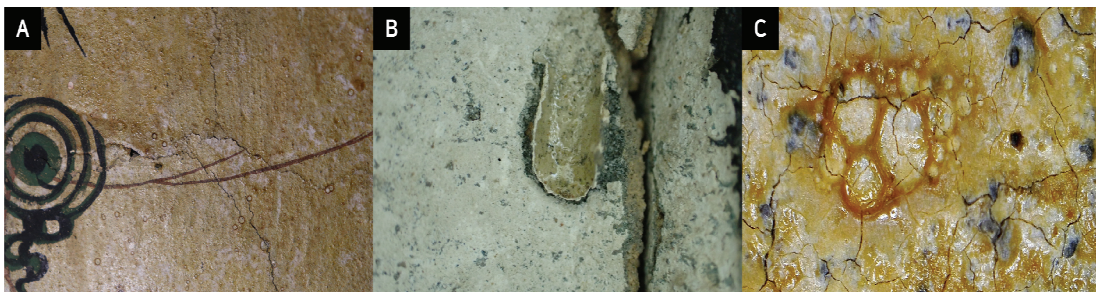
In some cases, the conservation status is good where a stain caused by a presumed fixative is found, but there are parts where the painting layer has deteriorated (Figure 14B).

Figure 14. Damage caused by presumed to be the fixative (A: Crack, B: Delamination, C: Gloss).

It seems that measures such as fixation treatment are necessary for areas where the painting layer is cracked or exfoliation or delamination off due to the change in the presumed fixative. Also, areas showing luster and stains while the presumed fixative forms a film of paint on the surface of the painting layer may show damage due to deformation or discoloration in the future, therefore a methodology for periodic inspection and stabilization should be prepared (Figure 14A, 14C).

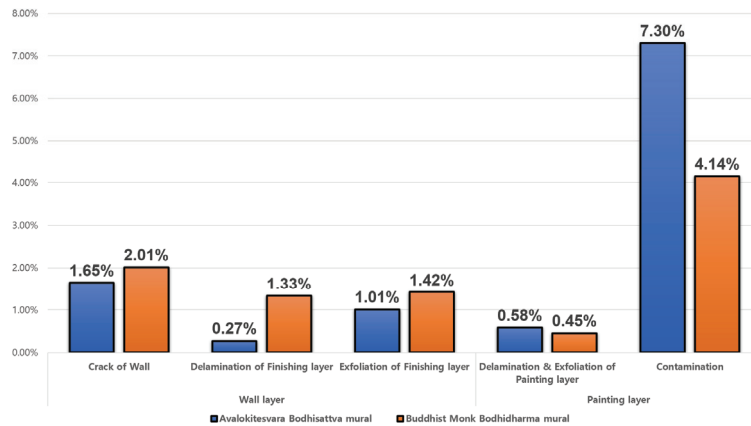
Figure 15. Comparison of damage to murals.

As a result of comparing the area values of the two murals by type of damage, the Buddhist Monk Bodhidharma mural showed 1.84% higher damage to the wall and finishing layer than the Avalokitesvara Bodhisattva mural, and in particular, the damage to the delamination of finishing layer showed a greater difference. The damage to the painting layer is 3.29%, indicating that the Avalokitesvara Bodhisattva mural is more damaged than the Buddhist Monk Bodhidharma mural (Figure 15).

through periodic inspection of the relevant elements is necessary, and a countermeasure for damage that may occur in the future should be prepared along with intensive monitoring of the major damage identified in this diagnosis result.
