CONTINUOUS ASSESSMENT OF A DRINKING WATER PVC PIPE

A. M. Arsénio^{1,2}, J. H. G. Vreeburg^{1,2}, M. P. C. Wielinga³, J. C. van Dijk²

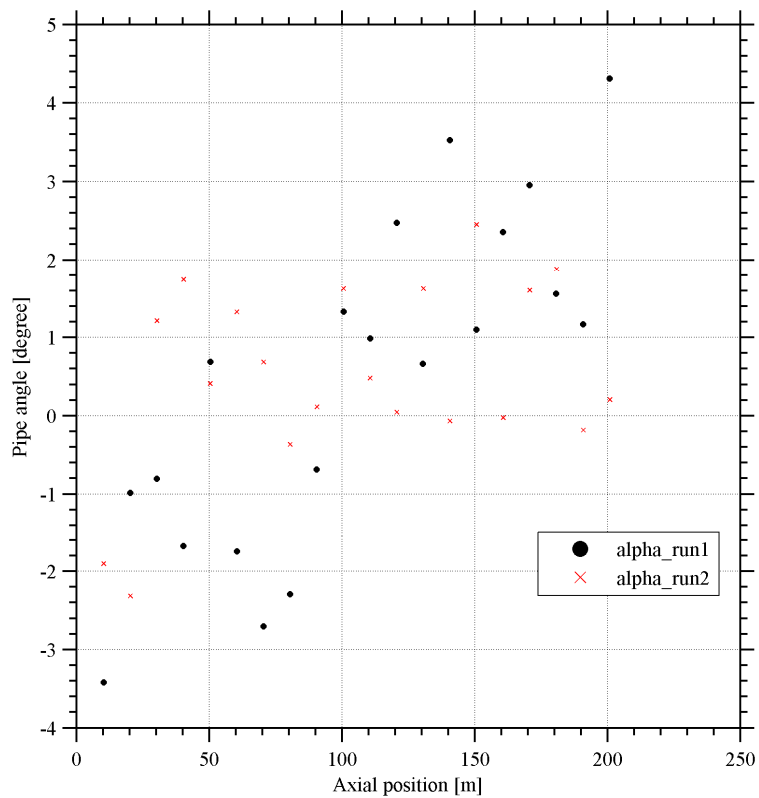
- The results from the CCTV inspection are given on Figure 4. On the x-axis is given axial location inside the pipe. On the y-axis is given the angle between the two pipes determined inside the joint. This angle was determined using the gap widths at the top (12 h) and bottom (6 h) of the pipe obtained from CCTV and the following formula:

- These results show that the installation procedure was correctly performed as far as pipe alignment is concerned. In fact, no extreme joint angle was detected.
- The reproducibility of CCTV inspection's can be discussed considering that, for some of the inspected joints, the results of both inspections differ significantly.

Figure 4 – Results of the CCTV inspections. On the x-axis is given axial location inside the pipe (m). On the y-axis is given pipe angle inside the joints (degree). Only angles calculated from the measured gaps for the pipe's invert and crown are presented (alpha). The inspection was duplicated (run 1 and run 2). A negative angle indicates that the gap at the pipe's invert is wider than the gap at the pipe's crown.

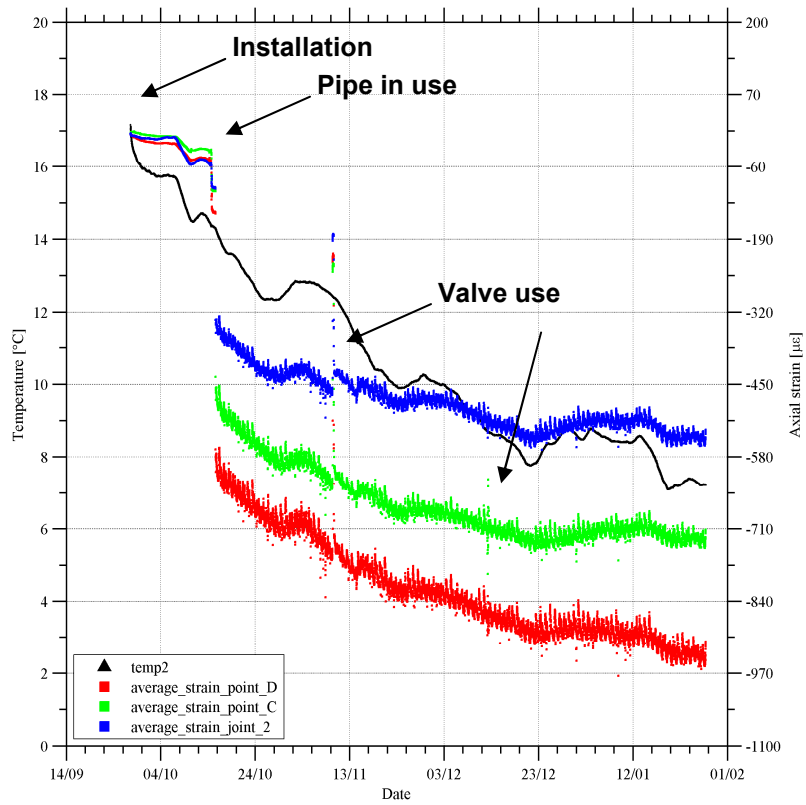
- Results for location II are given in Figure 5. Point C is located 7 cm before the joint and point D is located 7 cm after the joint. Joint 2 is the monitoring point on the joint's outer wall. The setup is similar to the one presented in Figure 3. On the X-axis is given the date, on the left Y-axis is given soil temperature and on the right Y-axis is given average axial strain (microstrain) recorded on the outer joint and pipe walls. The date of the equipment's installation, the date when the pipe started to be used and a day when a valve on the pipe was used are highlighted on the plot.

- The analysed data shows that the strain gauges, can detect daily variations in strain related to water demand patterns, water pressure fluctuations and environmental variations.

- In fact, for example, with an increase of the temperature the pipe will expand (increase of strain), and the opposite occurs with a decrease of the temperature (decrease of strain), that can be easily detected from the presented data.

Figure 5 – Data from location II: average axial strain at points D, C and joint 2 together with temperature from thermistor installed next to joint 2.
