CORROSION OF ORTHOPAEDIC IMPLANTS

SMITH-PETERSEN TYPE HIP NAILS

This report is concerned with the incidence of corrosion of 65 Smith-Petersen type hip nails, with four of which a Pidcock pin was also employed.

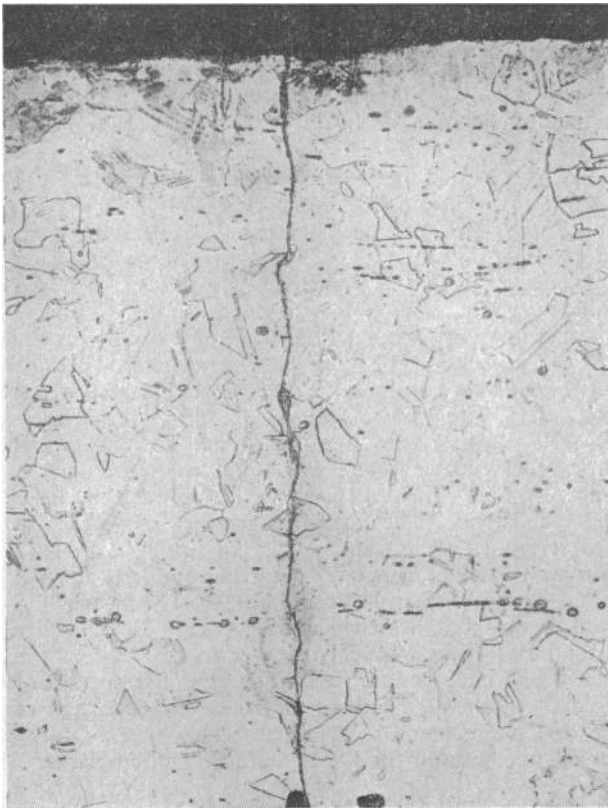
Six of the 21 nails were corroded. One nail—A.49—was fractured in two places, the appearance of the fractures being consistent with failure by fatigue, though one fracture had been so severely damaged by rubbing that it was not possible to be certain as to the cause. Microscopical examination of the longitudinal section of the nail up to this fracture showed several small transcrystalline cracks parallel to the fracture. An example is shown in Fig. A. The presence of

FIG. A.—Nail A.49. Transcrystalline crack parallel to fracture. ($\times 200$.)

several cracks such as this would suggest that corrosion fatigue was responsible. There was no obvious sign of corrosion on the outer surface of the nail. The cannula contained a considerable amount of oxide or corrosion products, and from an examination of the etched section it appeared that some intercrystalline corrosion had taken place (Fig. B). There was a quantity of carbide out of solution in the inner surface of the wall of the cannula, which suggested that local carburization had occurred during manufacture (Scales *et al.*, 1959). Carburization is an increase in the carbon content of the steel. In this case it arose from diffusion of carbon from a high-carbon-steel mandrel used in the production of the tube from which the triflanged nail had been machined. Steps have now been taken which should overcome this effect. The other five nails showed slight corrosion in various places on the surface of the stem and the head, at the head-stem junction, and in the cannula. Radiographs showed a zone of rarefaction around five of the 21 nails. Neither the radiological appearances nor the "reason for removal" could be correlated with corrosion of the implant. Five of the nails were accompanied by tissue, but in three cases the tissue could not be definitely related to the implant. Histological sections of the other two specimens which were adjacent to corroded implants showed dense fibrous tissue with collections of particulate material which gave a positive staining reaction for iron.

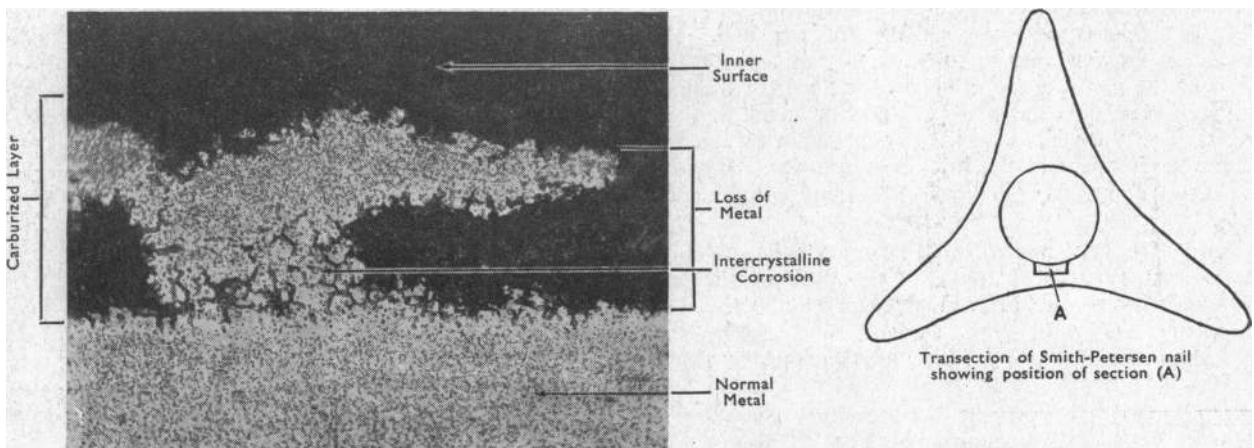
FIG. B.—Nail A.49. Section (A) through wall of cannula showing intercrystalline corrosion. ($\times 385$.)

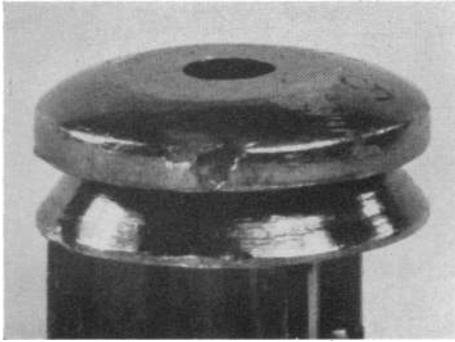
The nail used in 1958—A.419—was removed after six weeks because the position of the arthrodesis was not satisfactory. There was no extrusion of the nail. The entire surface of the nail was darkly stained and there was a deep corrosion pit in the head (Special Plate, Fig. 1). Nail A.683, inserted in May, 1959, was removed 14 weeks later because of pain associated with penetration of the nail into the acetabulum. There was no extrusion of the nail. The soft tissues over the distal end of the nail were discoloured; there was no evidence of infection, and the wound healed without drainage. Histological examination of tissue from over the head of the nail showed cellular granulation tissue with foreign-body giant cells. There were extensive intracellular and extracellular deposits of iron. The stem of the nail was brightly polished, but there were pits around the rim of the head. In making the nail the head had been fitted to an extension of the stem. The cannula had then been

FIG. 1.—Nail A.419. Corrosion pit in head of 13% Cr hip nail removed after six weeks.

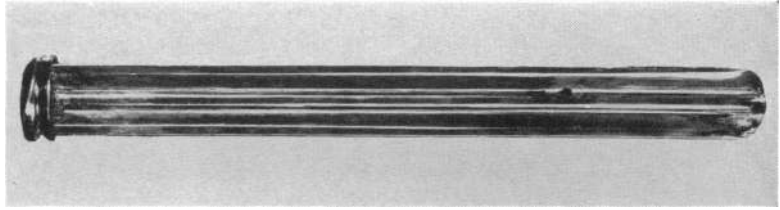
FIG. 2.—Nail A.46. Corroded 13% Cr hip nail removed after eight years

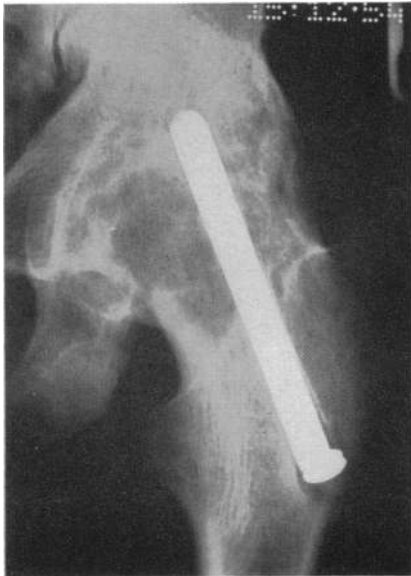
FIG. 3.—Nail A.46. 13% Cr hip nail eight years after operation.

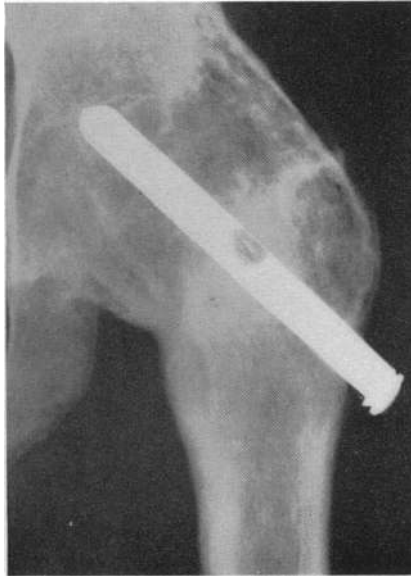
The most severely corroded nail was A.606. In 1942 a patient aged 47, with osteoarthritis of the left hip, had a Smith-Petersen pin arthrodesis supplemented with an ilio-femoral graft. The arthrodesis was successful, and the patient was free from pain for eight years. Then from 1950 to 1952 she complained of pain in her left hip, knee, and lumbar region. A radiograph taken in 1951 (Special Plate, Fig. 4) showed a corrosion pit midway along the nail with a zone of increased density in relation to the pin at this place. The patient was not seen again until 1959, when because of severe pain she attended hospital. A radiograph showed that the pin had corroded through (Special Plate, Fig. 5). There was no extrusion of the nail. At operation considerable soft-tissue reaction around the head of the nail was found. The distal half of the nail was removed, but the proximal portion could not be extracted. When last seen the patient had a recurrence of the severe pain in the hip. The remaining part of the pin will probably have to be removed at a later date.

FIG. 4.—Nail A.606 nine years after insertion.

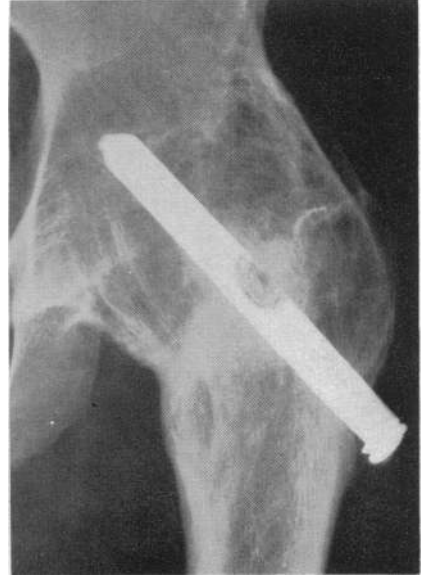
FIG. 5.—Nail A.606 17 years after insertion.

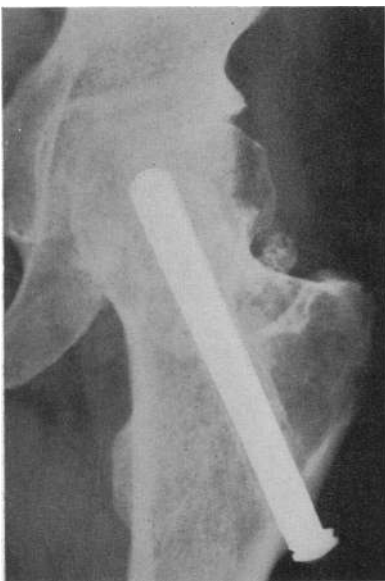
Another patient had a Smith-Petersen nail—A.460—inserted in 1940 for fracture of the neck of the left femur. The fracture united satisfactorily, and she was completely well until 1955. From then until 1958 she had gradually increasing pain and developed a slight limp, with limitation of abduction and of internal and external rotation. An antero-posterior radiograph (Special Plate, Fig. 6) showed a zone of rarefaction

FIG. 6.—Nail A.460. Antero-posterior radiograph of left hip showing zone of reaction around corroded nail. Note that deep corrosion pits are scarcely visible in this view.

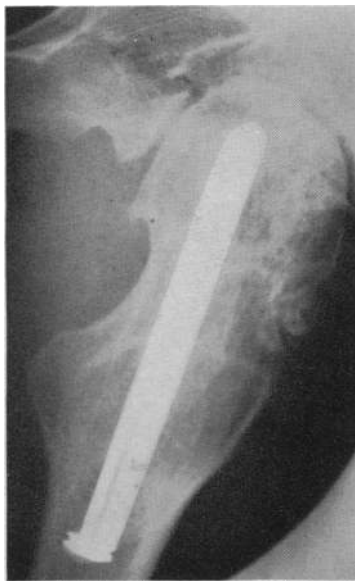
about the stem of the nail, while a lateral radiograph (Special Plate, Fig. 7) showed corrosion of the distal third of the stem. At operation there was no evidence of infection. A McMurray osteotomy was performed and a four-flanged nail and plate inserted, after which the pain was relieved. The nail, which was black in colour, had corrosion pits all over the outer surface and in the wall of the cannula which communicated in the distal third of the nail. The pain in this case may have been due to developing arthritis or to the corrosion. Nevertheless, it was apparent that the corroding nail was causing a tissue reaction.

FIG. 7.—Nail A.460. Lateral radiograph of left hip. Note corrosion pits in distal third of nail and zone of reaction in bone.

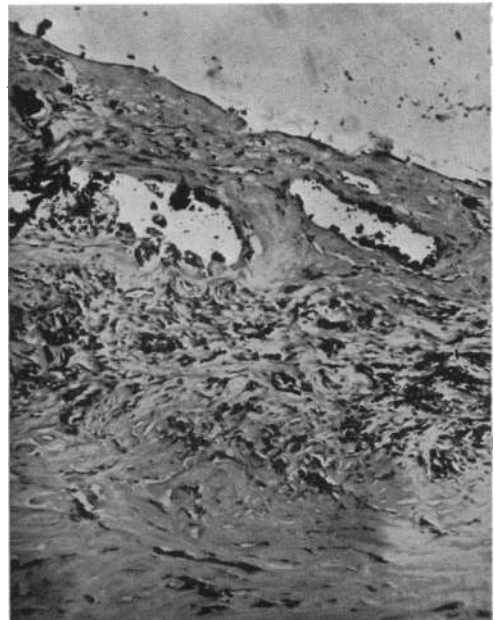
Rarefaction of bone adjacent to corroding 13% Cr alloy hip nails usually occurs, but sometimes the reaction is one of sclerosis, as occurred with nail A.606. The same radiographic appearances may be due to infection and movement. Infection was proved in one of these cases, but no swabs were taken from the others. In two cases tissue adjacent to the nail and corresponding to the rarefied areas in the radiographs was examined. It was highly collagenous fibrous tissue with iron-containing deposits (Special Plate, Fig. 8).

FIG. 8.—Nail A.46. Tissue from around 13% Cr nail after eight years.

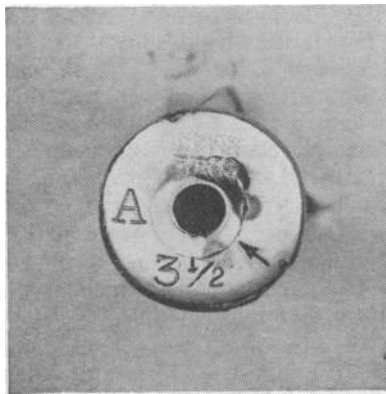
FIG. C.

A typical example of corrosion of a two-piece nail was shown by A.7, the head of which is illustrated in

Fig. C. Corrosion had taken place at the junction between the head and stem, as reproduced at higher magnification in Fig. D. A section through the junction is shown in Fig. E. Though in this particular example corrosion had occurred only at the outer surface, a gap, such as can be seen in Fig. F, between the threaded portion of the stem and head favours corrosion of the "shielded type." Nineteen of the nails were extruded, and it was usually found at operation that the implant was quite loose in the femoral neck. This extrusion was associated with infection in three cases and with avascular necrosis of the femoral head in five cases. By virtue of its weight, shape, and the position in which it is inserted, a hip nail is liable to extrude, and this tendency is accentuated by the inevitable vibration present in a living organism. As with the 18/8 implants, there was no correlation between visible corrosion and the radiographic appearances and clinical histories of the patients.

FIG. C.—Nail A.7. (Maker's name removed.) Corrosion at junction between head and stem of 18/8/Mo nail (arrowed). Marks at 3 and 5 o'clock are initial spark spectroscopy burn marks. After sectioning composition of head and stem was confirmed. (x2.) FIG. D.—Nail A.7. Showing corrosion (x100) at junction of head with stem at site indicated by arrow in Fig. C.

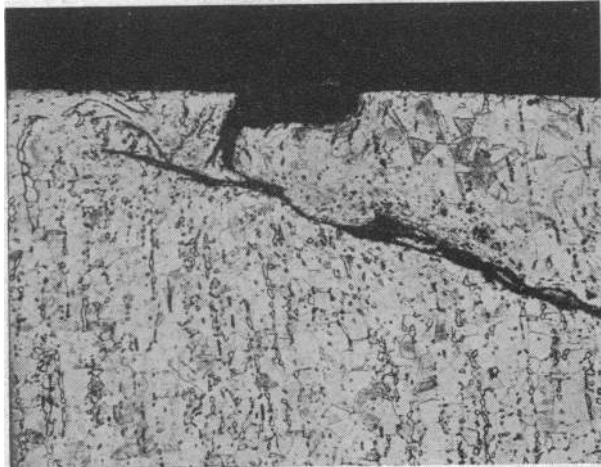
FIG. E.—Nail A.7. Section through junction of head with stem. ($\times 150$.)

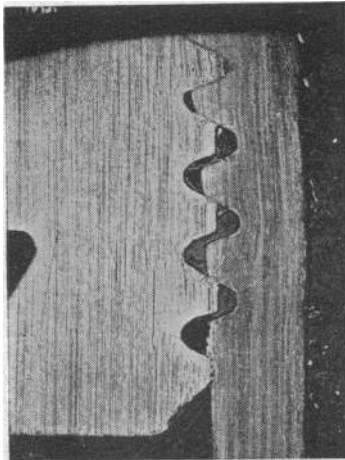
FIG. F.—Nail A.7. Gap between threads of head and nail. Contained blackish powder with metal particles.
