Damage patterns in the town of Amatrice after August 24th 2016 Central Italy earthquakes

Gabriele Fiorentino¹

Received: 26 June 2017 / Accepted: 26 October 2017 / Published online: 9 November 2017
© The Author(s) 2017. This article is an open access publication

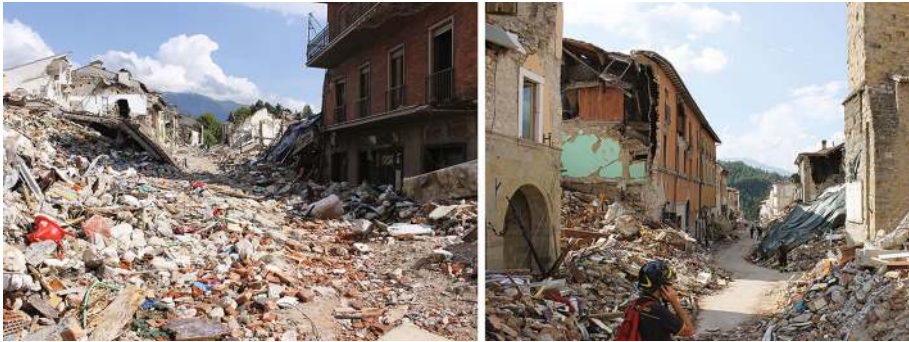
The observation of the map allows to make the following considerations: many of the buildings which suffered major damage or collapsed lied along Corso Umberto, where the majority of the historical buildings are located (32 collapses out of a total of 105); the majority of the collapses in Corso Umberto happened east of Via Roma, while in the west part of the town the damage seems to be more scattered (see Fig. 11).

Fig. 11 Overview of damage on Corso Umberto: east (left) and west (right) of Via Roma

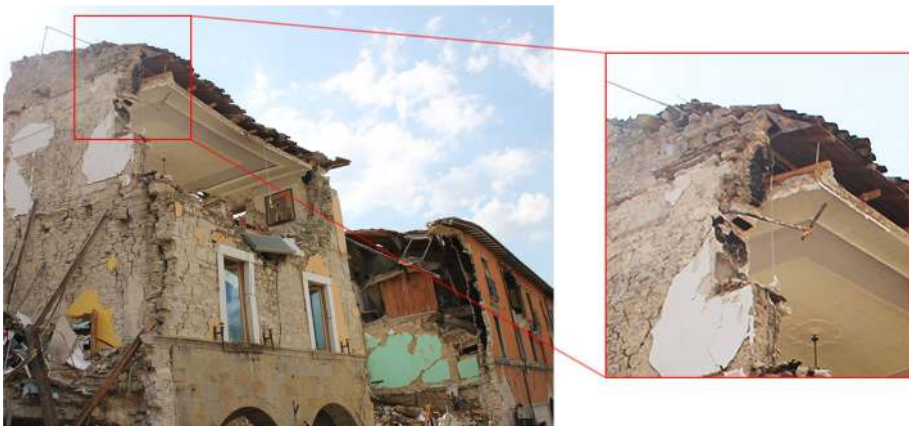
Fig. 14 Partial facade collapse (mechanism M3) of a building which had tie rods: general view (left) and detail (right)

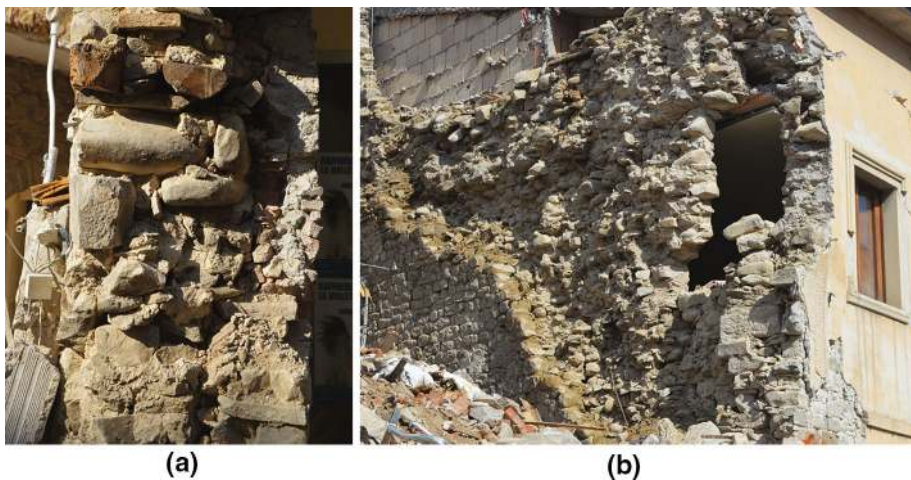
Fig. 18 Example of ev4 vulnerability factor (poor quality masonry): **a** absence of bondstones in the wall-section; **b** cobblestones with poor quality mortar

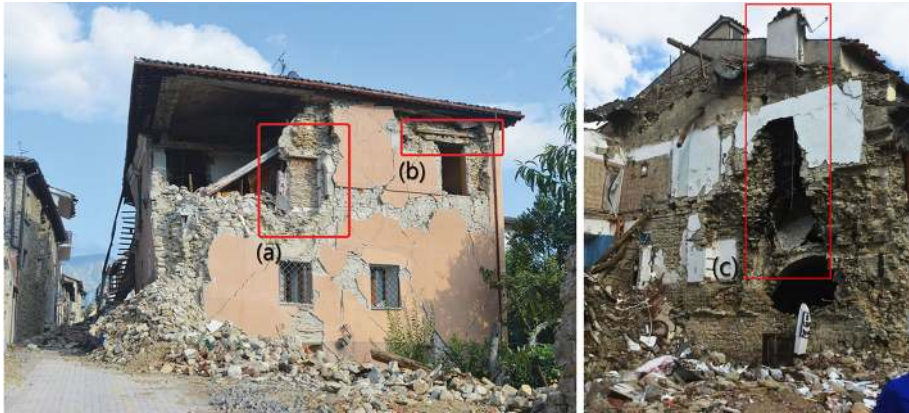
Fig. 19 Example of ev12 vulnerability factor (local discontinuities): closure of previous wall openings (a), presence of weak wooden elements (b), presence of chimney in the wall (c)

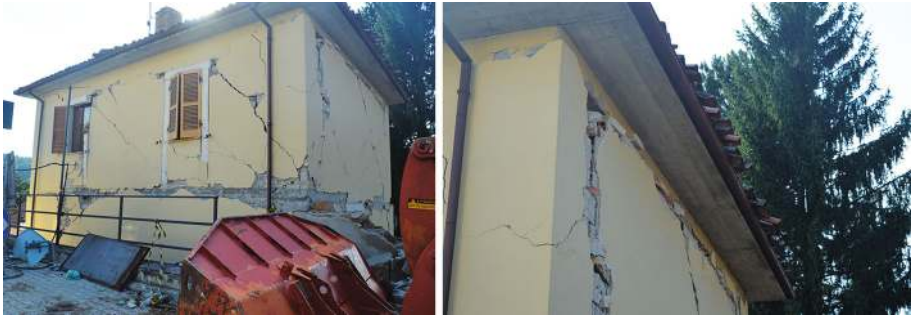
Figure 22 shows the picture of a 3-floors masonry residential building located at the entrance of the town along the provincial road. The assigned damage level was D3 due to the in-plane cracking and partial detachment of the external walls. The visual inspection revealed: poor masonry quality and different types of masonry at various floors (irregular pattern stone masonry at the first floor, regular pattern brick masonry at the second floor); local discontinuities under the windows (hollow bricks); presence of RC roof and RC stringcourses; incipient overturning of the wall corner.

Fig. 22 Residential masonry building: D3 damage level, in-plane cracking shear mechanism (M2), poor masonry vulnerability factor (ev4)

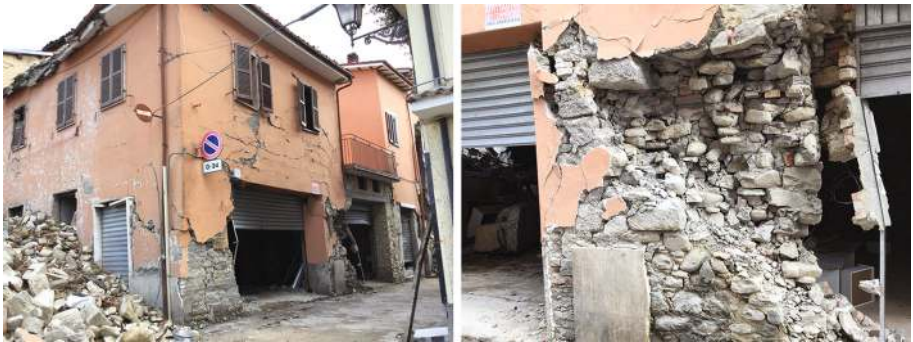
In Fig. 23 a 2-storeys masonry building, located in Via Madonna della Porta and which had a damage level D4 is depicted. The damage mechanism was an in-plane shear walls failure. The assigned vulnerability factors are: the poor quality of masonry, the presence of large openings realized in recent times, the presence of local discontinuities (recess and cracking in spandrel panels).

Fig. 23 Residential masonry building: D4 damage level, shear failure of external walls mechanism (M1), poor masonry vulnerability factor (ev4)

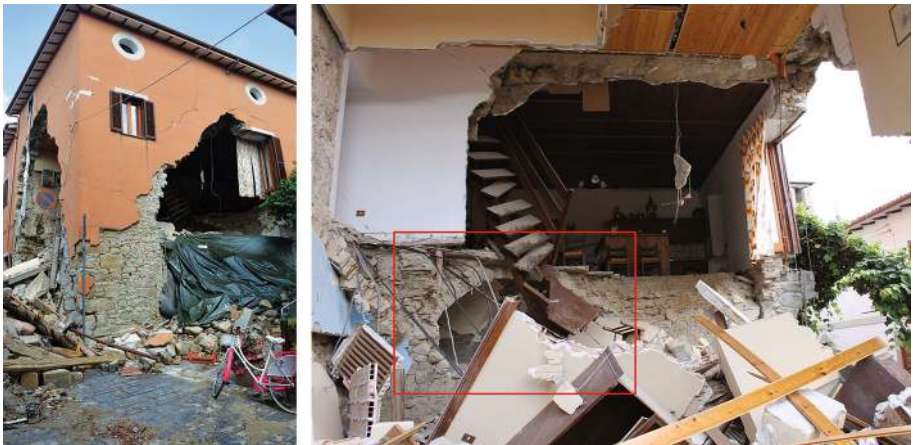
Fig. 24 Residential masonry building: D5 damage level

Figure 24 shows a 3-storeys building which represents an example of a building rated with a damage level D5 (total collapse of the floor) in which the roof did not collapse. In particular, it is possible to highlight the poor quality of masonry, the presence of discontinuities (chimney inserted in the spine wall), the presence of a collapsed arch at the basement, the overturning of external walls.

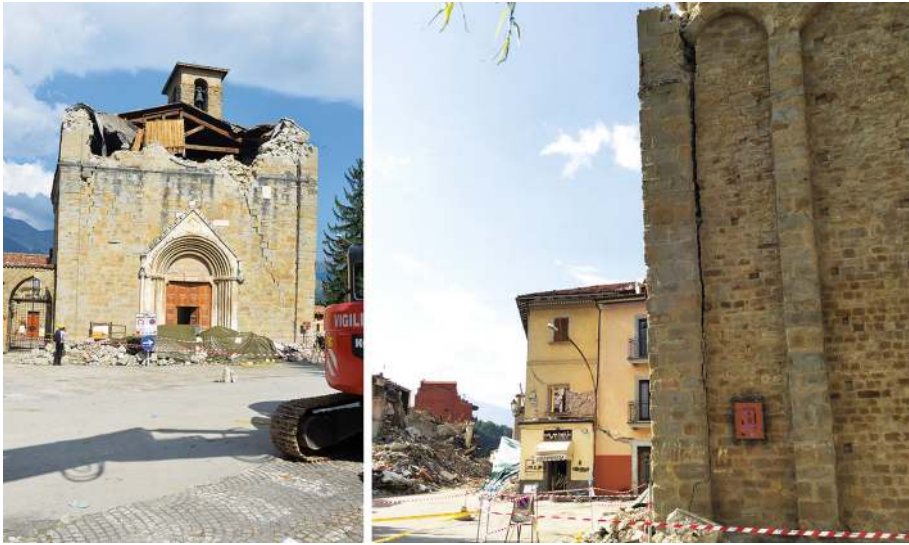
Fig. 25 Church of S. Agostino: damage level D4, collapse of tympanum (M6) and in-plane cracking of façade (left); overturning of façade (M3, right), ev1 vulnerability factor

Figure 25 shows the damage occurred to the fourteenth century church of S. Agostino, which was assigned to a D4 damage level. On the left, it is possible to notice the total collapse of the tympanum and the partial roof collapse. Moreover, on both sides of the façade it can be noted an in-plane cracking bringing to the detachment of the right corner of the façade. In the right part of the picture it is highlighted the overturning of the façade.

This collapse mechanism is probably due to the lack of connections between elements. As in other churches in the area, the ruptures revealed the masonry type, a multileaf masonry with an inner core made of poor quality rounded stones with an external panel made of regular stones.

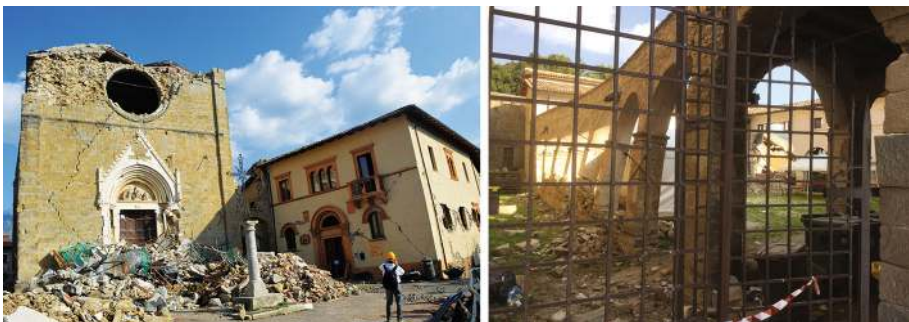
Fig. 26 Church of S. Francesco: damage level D4, collapse of tympanum (M6) and in-plane cracking of façade (left); collapse of columnnade (right), ev1 vulnerability factor

The church of S. Francesco, built at the end of the fifteenth century and depicted in Fig. 26 presents similar damages. It suffered the partial collapse of the tympanum and the partial collapse of the roof. There is a shear diagonal cracking on the façade and an overturning mechanism of the colonnade outside the church. It is worth noting that the collapse mechanism is the same of the church of S. Agostino.

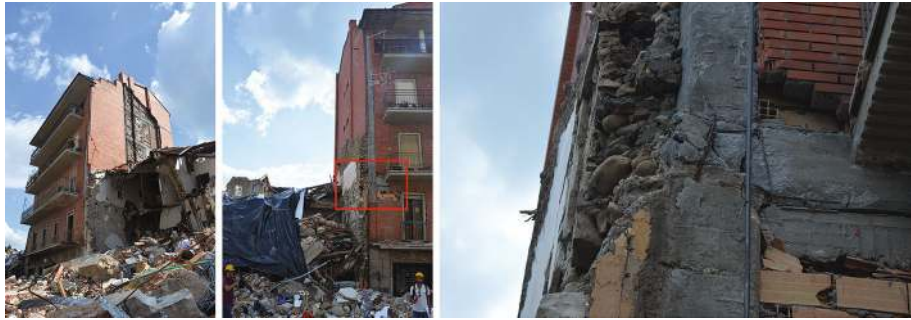
Fig. 27 Residential RC building (damage level D3): global damage (left), damage of beam-column node (center), particular of the node (right). Damage mechanism MC, vulnerability factor e_vD

In Fig. 27 a residential 5-storeys RC frame building is depicted. This building became a symbol of the city of Amatrice in the days after the earthquake because it was one of the few buildings that did not collapse in the eastern part of Corso Umberto. The picture shows in particular the failure of a beam-column node. A detail of the node shows also that the longitudinal rebars are external to the stirrups. The pictures show also the partial detachment of the infill brick panels, poorly connected to the RC frame.
