## Damage resistance and tolerance of carbon/epoxy composite coupons subjected to simulated lightning strike

Paolo Feraboli\*, Mark Miller

Department of Aeronautics and Astronautics, Box 352400, Guggenheim Hall, University of Washington, Seattle, WA 98195-2400, United States

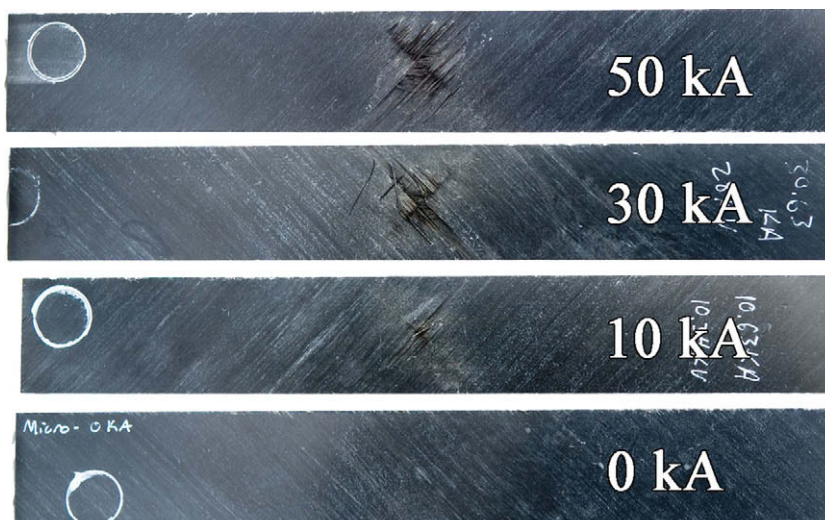
Both unnotched (or pristine) and filled-hole specimens are tested. Unnotched specimens exhibit increasing external damage for increasing current intensity, Fig. 8. Damage manifests as visible fiber fracture in the outer ply oriented at 45°, as well as

Fig. 8. Typical unnotched specimens, from pristine at the bottom to maximum current at the top.

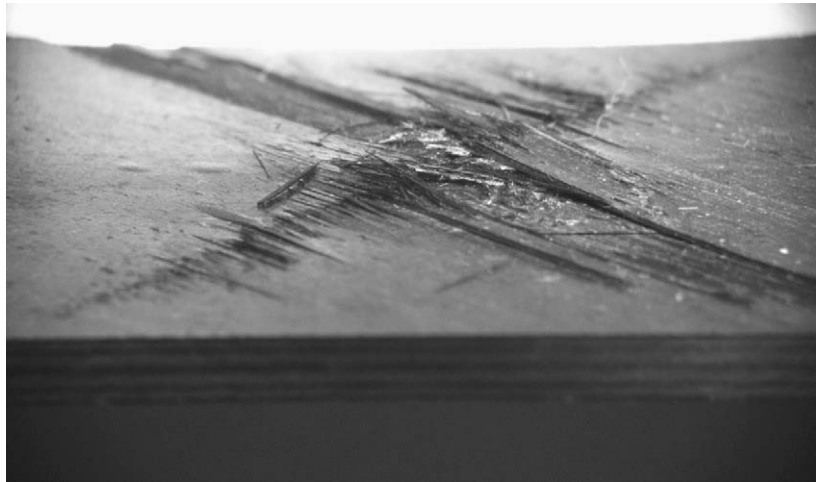
longitudinal splitting and bulging of the area around the strike, Fig. 9. In some cases the upper ply or plies even separate in small chips or fragments and leave an empty space on the surface. In general however, the damage appears to be confined to the surface of the specimen and in the region immediately surrounding the strike zone. For the given specimen, boundary conditions and loading configuration, damage does not reach the backface of the specimen. The visible damage area appears to be almost identical

Fig. 9. Close-up of surface damage for unnotched specimens at 50 kA.

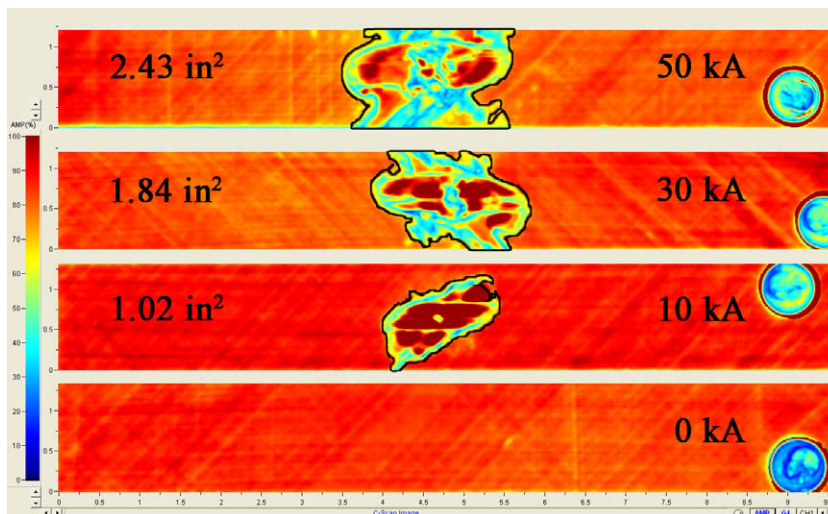
Ultrasonic images for a representative unnotched specimen for each of the strike levels are reported in Fig. 10. The circular object appearing on the side of each specimen is a dime (USD 0.10) that is used for reference during the ultrasonic scan. Fig. 10 shows the shape of the damage area, which tends to be elongated in the direction of the fibers in the outer ply, and reports a calculated damage area. Although there appear to be a clear trend of increasing projected damage area for increasing current intensity, the size of the damage areas for the 30 and 50 kA strikes are relatively similar. Beyond 10 kA, the damage area reaches the boundaries of the specimen and is then forced to grow longitudinally. However, with these finite-width limitations in mind, it is possible to perform quantitative comparisons between specimens, and obtain the plot in Fig. 11. For the unnotched specimen it appears that the projected damage area increases linearly up to 30 kA, and then levels off, for the reasons mentioned before. From the plot it can be seen

Fig. 10. Projected damage area obtained via C-scan for unnotched specimens.

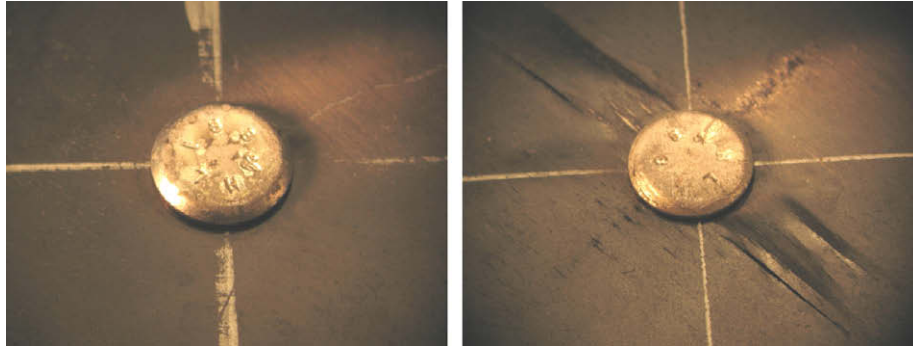
For filled-hole specimens the results are dramatically different. For 10 kA strikes, the only damage visible is surface pitting of the fasteners on the head side, where the strike takes place, Fig. 12. However, for the 30 and 50 kA strike the surface damage is much

Fig. 12. Close-up of top surface fastener and laminate damage for filled-hole specimen at 10 and 30 kA.

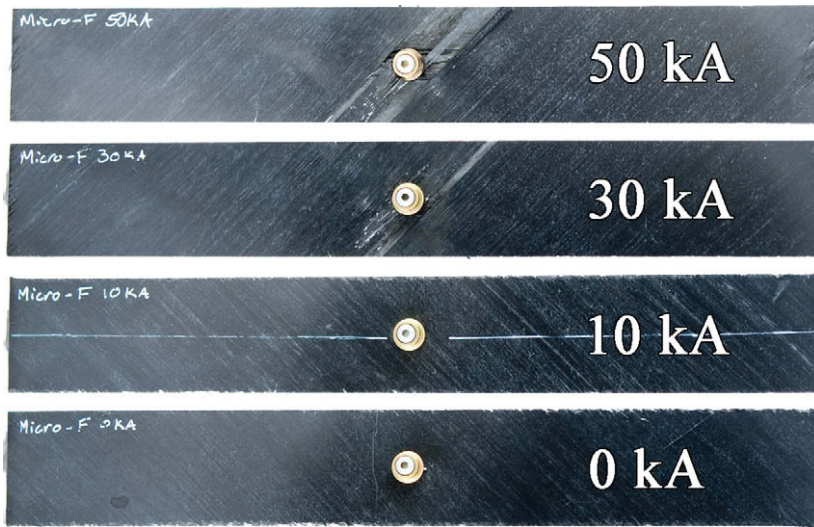
more extensive than in the unnotched specimens, Figs. 12–14. Besides pitting of the fastener, severe bulging of the plies toward the surface is visible in the proximity of the fastener, and extensive fiber breakage observable on both top and back faces. Entire laminate segments delaminate throughout the thickness of the specimen, and in some cases even split and detach from the bulk of the specimen itself. At 50 kA, the fastener appears to sink inside

Fig. 13. Typical filled-hole specimens, from pristine at the bottom to maximum current at the top.

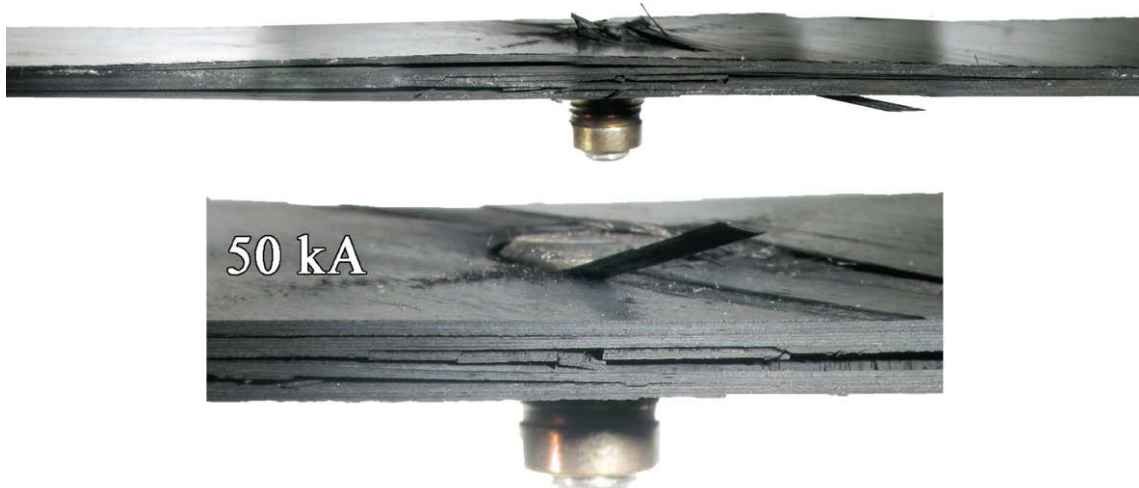
Fig. 14. Close-up of edge/top surface damage for filled-hole specimen at 50 kA (different sides shown).

the top plies of the laminate. In general, the damage on the surface of the filled-hole specimens appears to be due mostly due to acoustic shock, hence the large bulging of the upper plies, rather than burning of the matrix on the surface, as for the unnotched specimens.

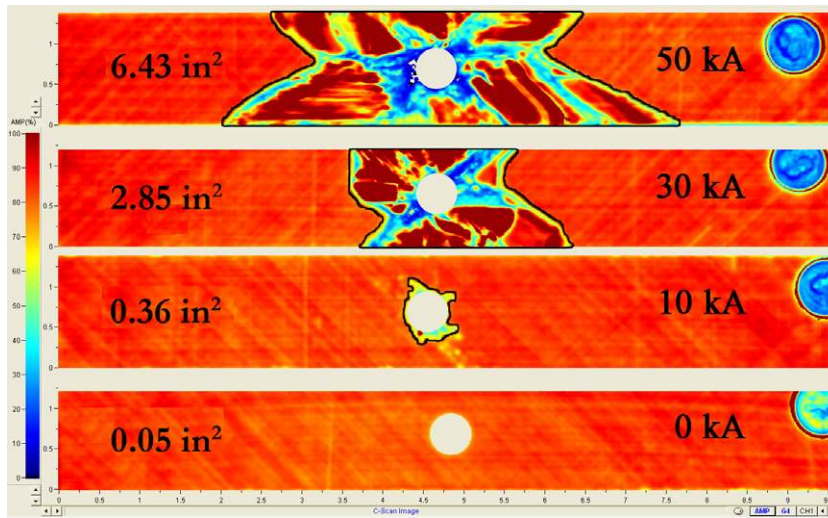
Fig. 15. Projected damage area obtained via C-scan for filled-hole specimens.

Ultrasonic images for a representative filled-hole specimen for each of the strike levels are reported in Fig. 15. In the pristine specimen the fastener appears as a white round, with an area of 0.05 in<sup>2</sup> (32.2 mm<sup>2</sup>) approximately. Fig. 15 confirms that for the 10 kA strike the damage area is contained in the fastener itself, or in the immediate proximity of the fastener hole. For 30 and 50 kA strikes, however, there appears to be a radical increase in damage area, and at 50 kA the vast majority of specimen appears to be damaged. From the ultrasonic image it is only possible to obtain information about a projected damage area; hence, to further identify the location and nature of the damage it is necessary to inspect the cross-section via micrography, as discussed later in the paper. Once again it is important to remember that the energy used to inflict damage exceeds the amount that the specimen can contain within its short width, and hence the damage is forced to grow longitudinally.

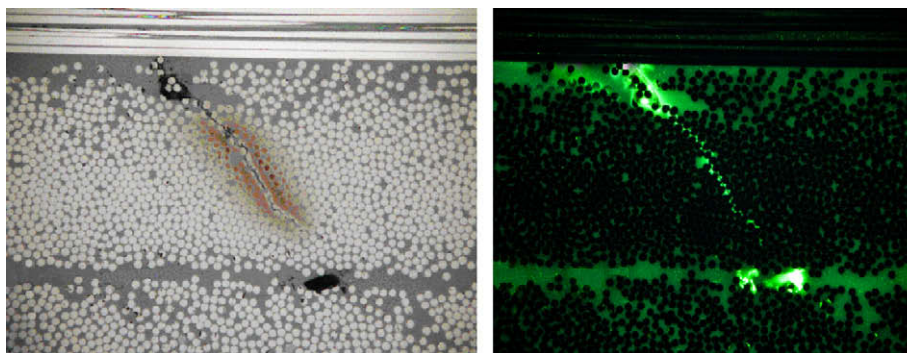
Fig. 22. High magnification micrograph of localized area of pyrolyzed fibers and vaporized matrix in specimen after 50 kA strike under brightfield (left) and UV light with dye penetrant (right).

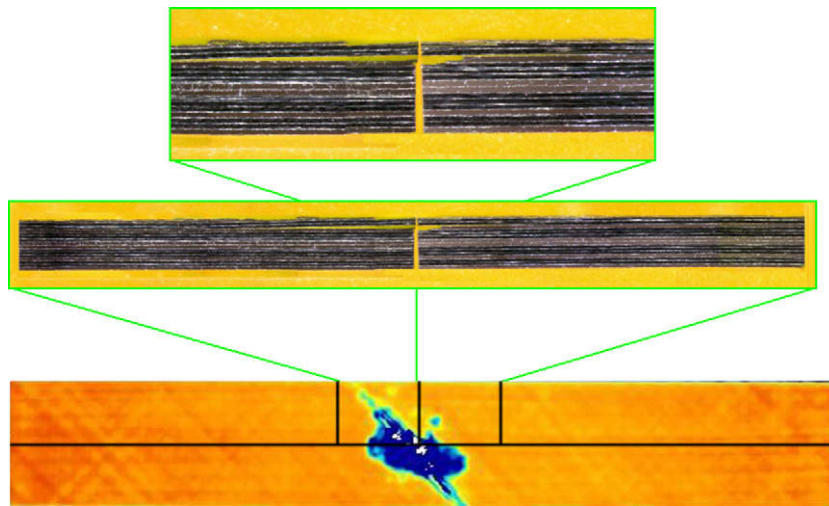
For 10 kA unnotched specimens, Fig. 23, the section shows partial obliteration of the +45° surface ply, and a major delamination running at the interface between 3rd and 4th ply. The two 0° plies appear to remain intact and separate from the adjacent –45° ply, suggesting that the mismatch in electrical resistance between the different orientation plies has a significant role in the distribution of the current, and hence damage, in the laminate.

Fig. 23. C-scan and relative micrograph of 10 kA strike unnotched specimen.

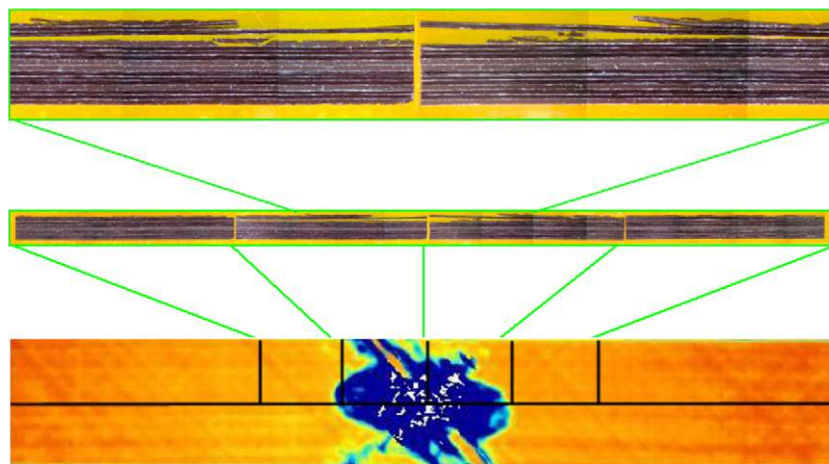
For 30 kA unnotched specimens, Fig. 24, the top +45° surface ply is completely obliterated and separated from the laminate, the adjacent 2nd and 3rd 0° plies remain intact but burst open toward the outside, and the 4th –45° ply appears to be also completely obliterated. A major delamination appears to run along the interface between the 4th and the 5th ply, which is the first of a three 0° stack. The remaining part of the specimen appears intact.

Fig. 24. C-scan and relative micrograph of 30 kA strike unnotched specimen.

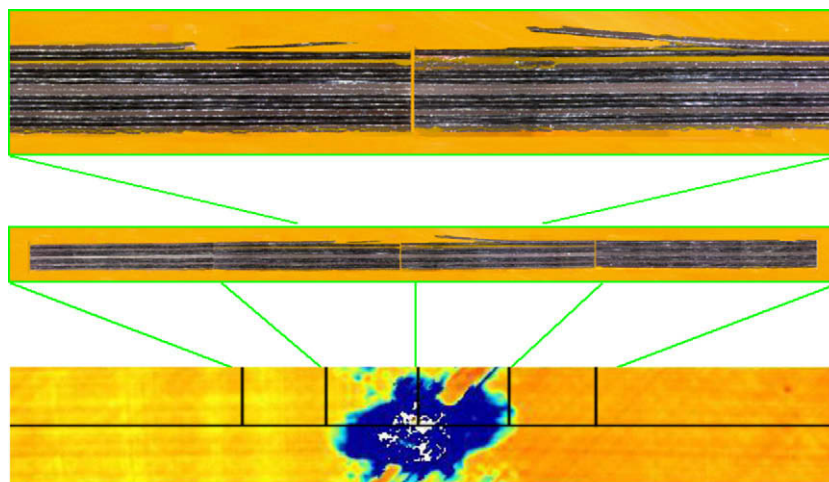
The situation for the 50 kA unnotched specimens, Fig. 25, is very similar and again shows that the interface between plies with low electrical resistance in the direction of the current flow (such as the 0° stacks) and higher resistance plies ( $\pm 45^\circ$ ) constitutes the preferred path for the formation of the large delaminations visible in the ultrasonic images.

Fig. 25. C-scan and relative micrograph of 50 kA strike unnotched specimen.

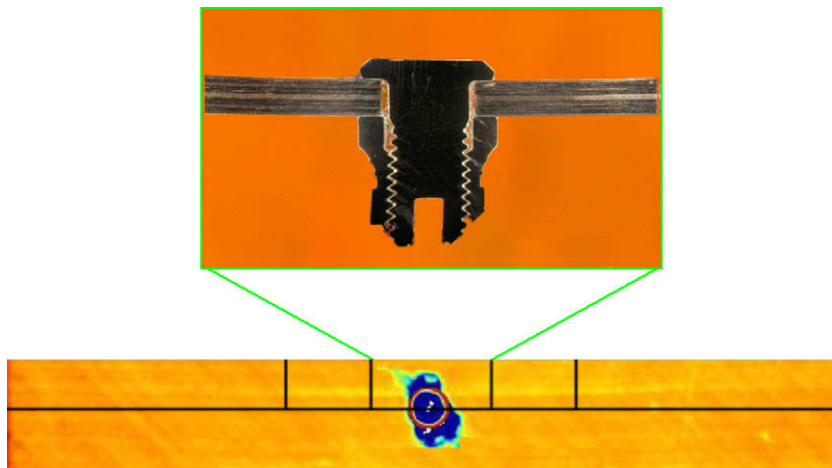
Ten kiloamperes filled-hole specimens, Fig. 26, appear to show no damage through the thickness, and the minimal damage area observed in the ultrasonic scan in some of the specimens is confined to a partial resin burn-off on the top ply around the fastener.

Fig. 26. C-scan and relative micrograph of 10 kA strike filled-hole specimen.

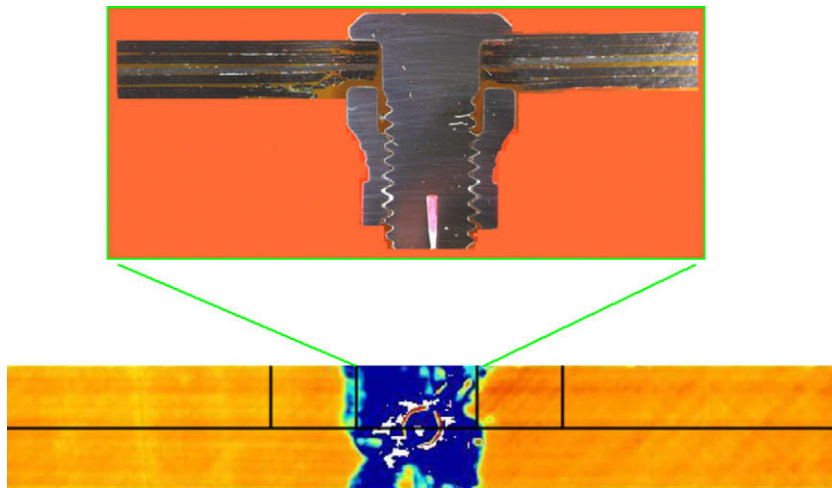
Thirty kiloamperes filled-hole specimens, Fig. 27, exhibit quite a different behavior than any previous ones, and show different

Fig. 27. C-scan and relative micrograph of 30 kA strike filled-hole specimen.

delamination paths through the thickness of the laminate. These are visible mostly at the interface between 0-ply stacks and either  $\pm 45^\circ$  or  $90^\circ$  plies. Complete obliteration of the resin and fibers is observable on the backface of the laminate, in proximity of the fastener collar. Partial fragmentation of  $0^\circ$  ply stacks is also observable, and suggests that the fastener has the effect of distributing the electrical load to all the plies in its contact or proximity.

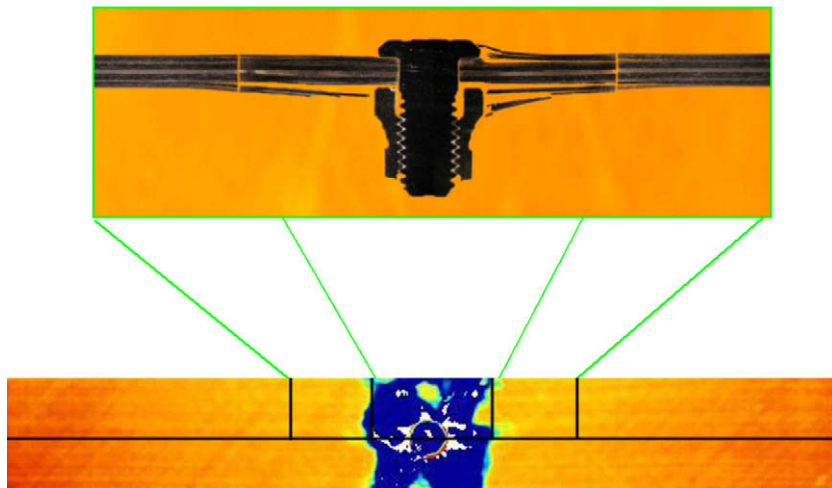
Fig. 28. C-scan and relative micrograph of 50 kA strike filled-hole specimen.

Fifty kiloamperes filled-hole specimens, Fig. 28, show even more extensive damage, with both top and bottom plies splaying outward, and extensive delamination fronts at all interfaces between high and low conductivity plies. Integrity of the specimen is completely compromised.
