Damage Study and Future Direction for Structural Design Following the Tuscaloosa Tornado of 2011

David O. Prevatt, Ph.D., P.E., University of Florida, Gainesville, FL
John W. van de Lindt, Ph.D., University of Alabama, Tuscaloosa, AL
Andrew Graettinger, Ph.D., University of Alabama, Tuscaloosa, AL
William Coulbourne, P.E., Applied Technology Council, Rehoboth Beach, DE
Rakesh Gupta, Ph.D., Oregon State University, Corvallis, OR
Shiling Pei, Ph.D., P.E., South Dakota State University, Brookings, SD
Samuel Hensen, P.E., Simpson Strong Tie, Pleasanton, CA
David Grau, Ph.D., University of Alabama, Tuscaloosa, AL

July 27, 2011

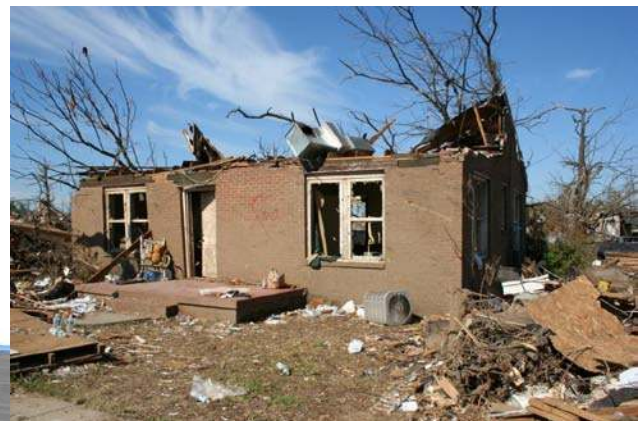
Roof uplift: This failure mode is defined as the roof framing being lifted off the walls leaving the ceiling exposed inside and the tops of the exterior walls with no roof rafters attached. Figure 4.1 illustrates this failure mode.

Figure 4.1: loss of roof assembly

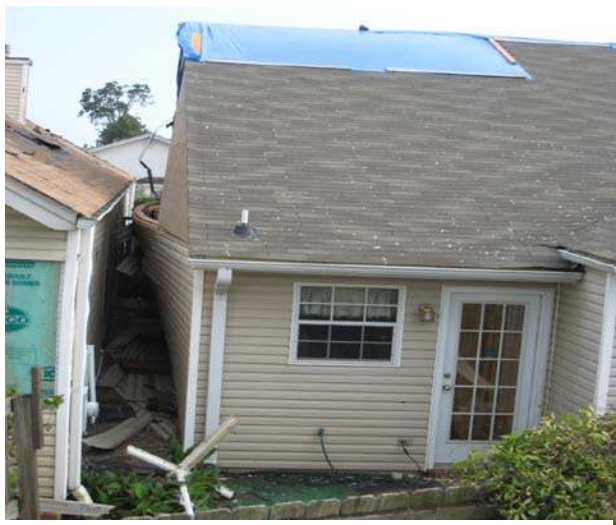
Figure 4.2: Exterior walls pushed out by high internal wind pressure

Exterior walls pushed out: This failure is indicative of excessive internal wind pressure pushing the exterior walls out of plumb. This could occur at any of the exterior walls including those with gable ends. The roof may or may not be attached when this occurs. Figure 4.2 illustrates this failure mode.

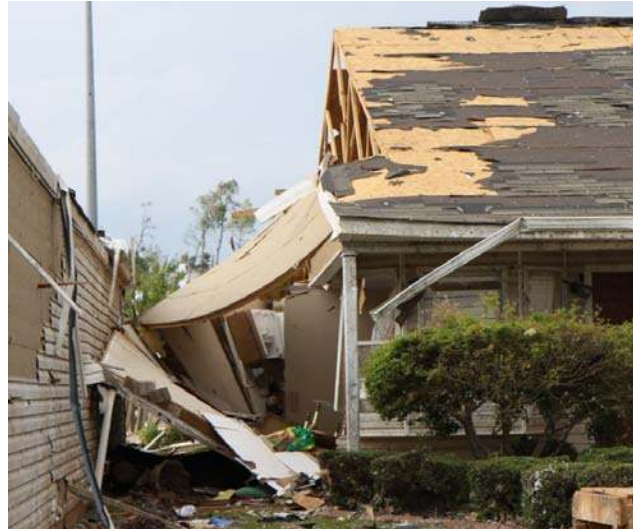
This failure mode could be indicative of excessive internal wind pressure, but it is also possibly indicative of excessive leeward pressure created by suction of the wind field as it passes by the building. Figure 4.3 illustrates this failure mode.

Figure 4.3: Exterior wall and gable roof end pulled out as a result of high leeward winds

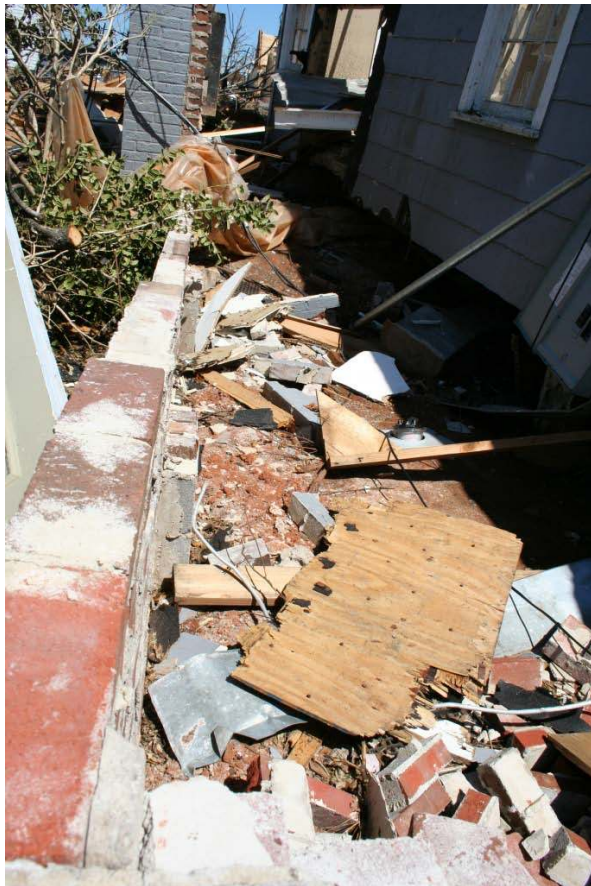
Figure 4.4 House lifted off its foundation. Chimney shown to the right approximately 5ft over.

This failure mode is indicative of high lateral windward pressure on a building that is inadequately attached to the foundation. Figure 4.4 illustrates this failure mode.

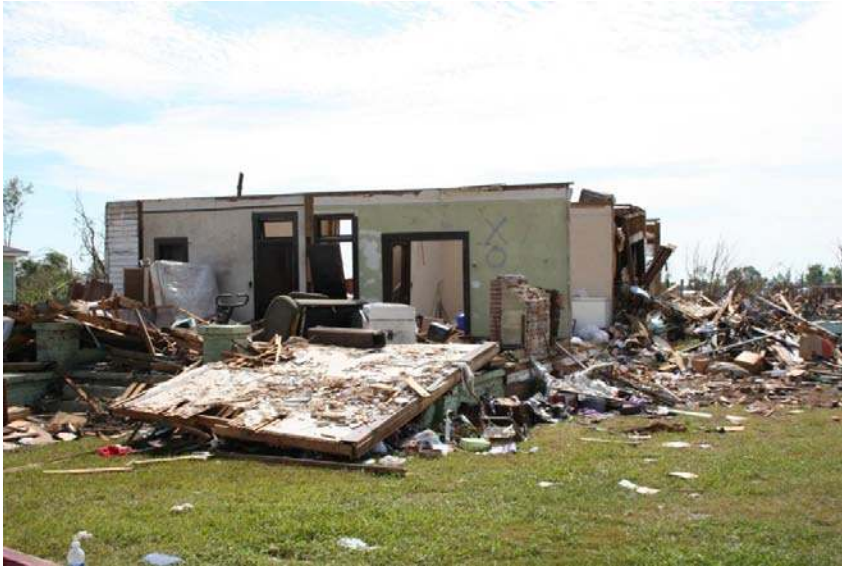
Figure 4.5 Interior walls collapsed

This failure mode occurs after the roof and exterior walls have failed. There is typically minimal connection between these interior walls and the roof system so losing the roof allows the interior walls to collapse. Figure 4.5 illustrates this failure mode.

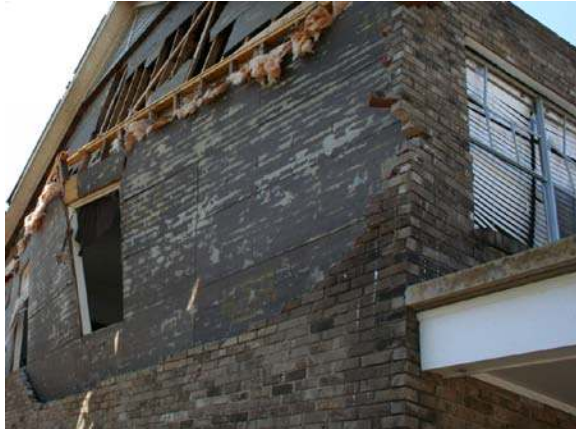
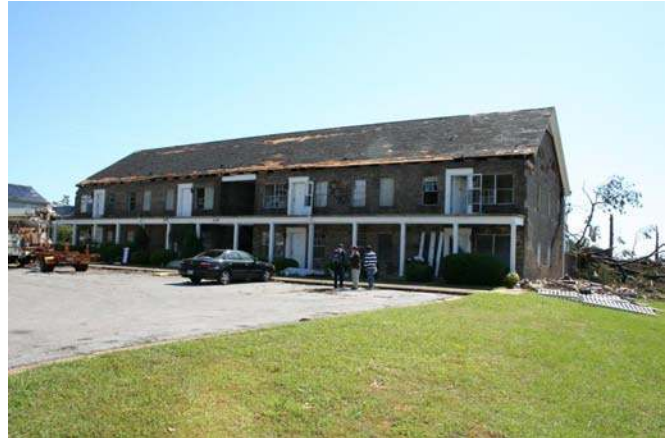
Figure 4.6 Two-story apartment building with gable end failure and brick veneer failure.

The wood-framed building appeared to be built in the 1960's. Winds broke the windows and then created sufficient interior pressure to fail the brick façade and push out one gable end wall. The damage sustained included:

- Less than 20% of the roof covering
- Broken windows and doors
- Brick façade failure
- Gable end wall ballooned outward
- Exterior fiberboard sheathing damaged by wind at gable ends

The Degree of Damage on the EF scale for multi-story apartment buildings is 2, which suggests wind speeds in the range of 82 – 121 mph with an expected speed of 99 mph.

1. The construction observed suggests brick ties at spacing that was larger than the current IBC requirements.
2. There is no wind-borne debris protection for the glazing.
3. There is little resistance from wind pushing up the interior 2nd floor ceilings into the attic space.
4. The gable end wall was pushed out by wind.

5. There was some evidence that the double top wall plates were connected into the gable end as the double top plates were cracked.
6. There was no evidence that the building experienced lateral movement of the 2nd floor in relation to the first floor; the building walls were not pushed out of the vertical plane.
7. There were gable end vents that probably helped relieve the wind pressure in the attic as there was no loss of roof sheathing.
8. Roof damage was limited to shingles and underlayment.

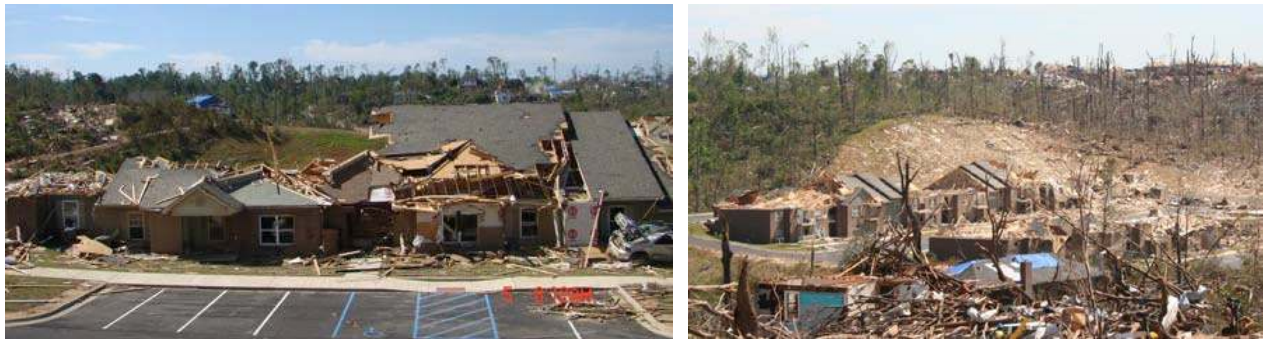
Figure 4.8: Badly damaged and partially destroyed apartment complex

These wood-frame buildings were built in 2010. It appears that the terrain at this location affected the wind speeds. This area is lower than adjoining land to the southwest; damage at the extreme southwest end of this complex was primarily roof and upper floor damage while damage levels increased as the storm moved toward the northeast. Damage at the extreme northeast included concrete slabs being swept clean by the winds. Undoubtedly, debris from the southwest end struck the other parts of the complex making total destruction of the northeast end more likely. The damage sustained included:

The Degree of Damage on the EF scale for multi-story apartment buildings is 6, which suggests wind speeds in the range of 155 - 205 mph with an expected speed of 180.

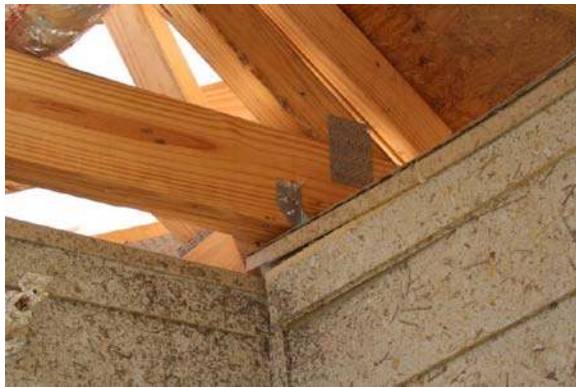
1. Roof trusses were connected to the top wall plates with hurricane clips (see Figure 4.9).
2. The date on the roof sheathing suggests a construction date of approximately 2010.
3. The exterior wall sheathing was OSB.
4. Windows and doors were broken with wind-borne debris.
5. Anchor bolts attaching the sill plate to the concrete were spaced approximately 6 feet on center in a few locations that were visible.
6. Some sill plates had been attached with only cut nails (see Figure 4.10).

Figure 4.9 Photograph of installed hurricane clip

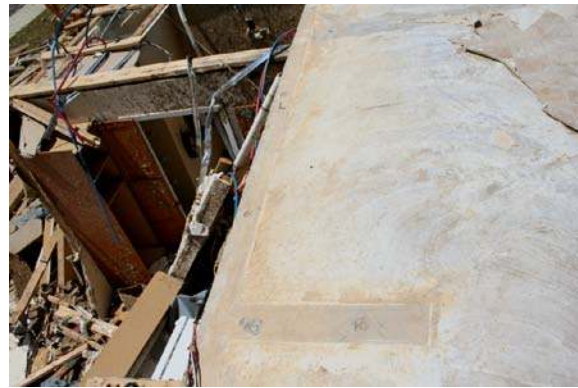
Figure 4.10 Slab swept clean with cut nails at edge

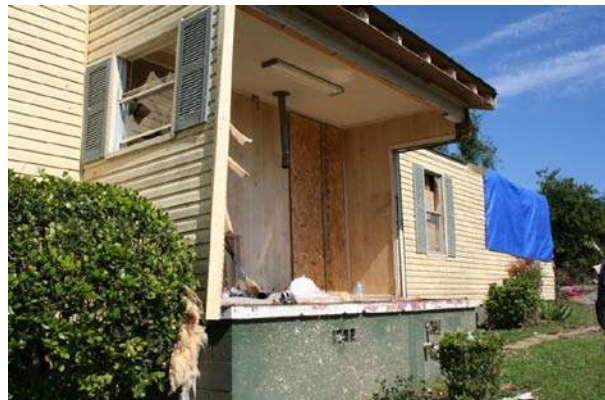
Figure 4.11: Single family dwelling with moderate EF/damage

The wind pressure and wind-borne missiles broke a few windows. The wind pressure tore off some vinyl siding that had been installed over the original fiberboard siding. While the windows were broken, there was not sufficient uplift pressure to create any damage to the roof sheathing or roof framing. There was a poorly attached wall on the east side of the house that was torn off by wind pressure or was hit by debris. The damage sustained was:

- More than 20% of the roof shingles were removed
- Siding on both the front and east side was torn off
- Windows are broken
- One wall of a small addition on the west side was removed (see Figure 4.12)
- Roof framing is completely intact
- All primary walls of the house are standing

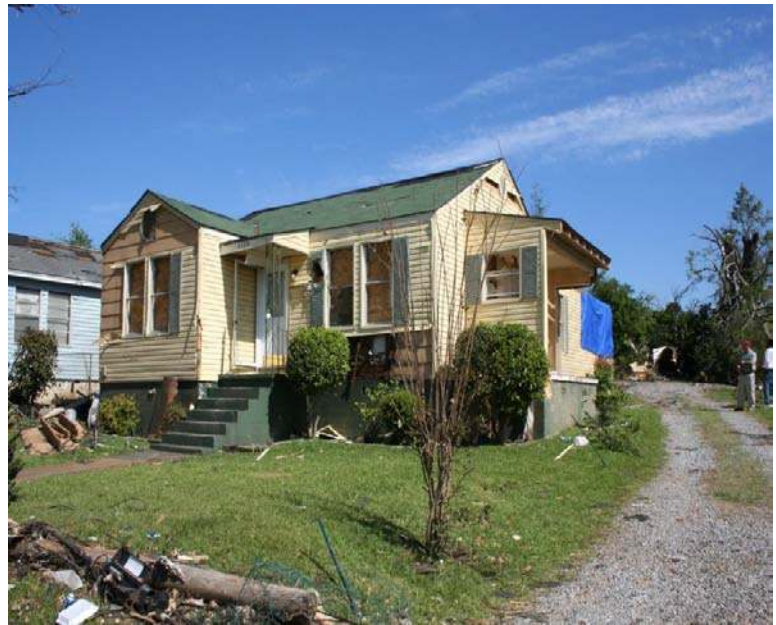
Figure 4.12 Loss of a wall

The Degree of Damage on the EF scale for single family buildings is between 2 and 4 with the loss of the porch walls, which suggests wind speeds in the range of 79 - 116 mph with an expected speed of 96-97 mph.

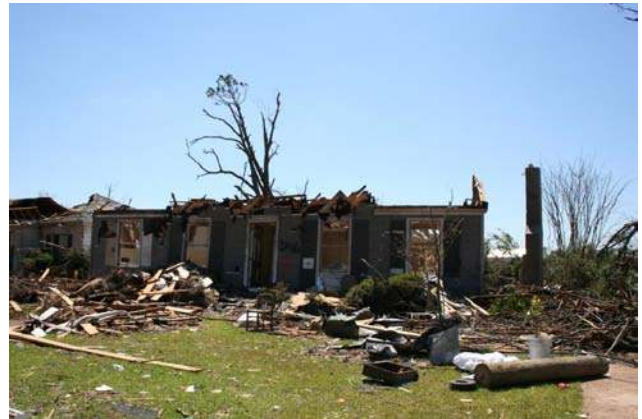
It was a one-story wood frame building built in 1949. It has approximately 1800 sq. ft. of living area. The wind pressure and wind-borne missiles broke the windows which helped lift off the roof. The lightweight building was pushed off the foundation.

Figure 4.13 Single family dwelling with DOD of 5 to 6.

- Large section of roof structure removed
- Most walls are standing
- House is shifted on its foundation
- Windows are broken

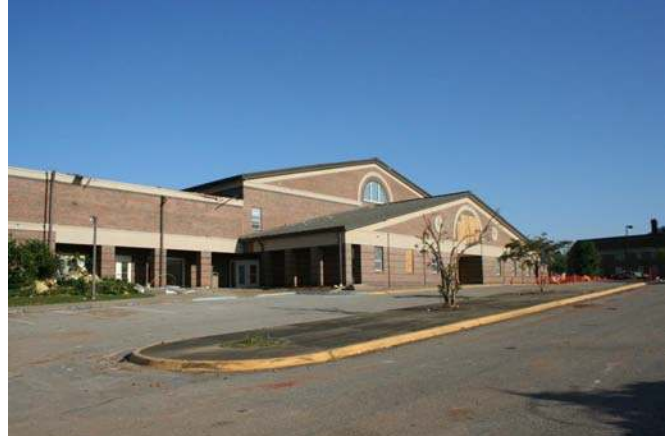
Figure 4.14 University Place Elementary School

- The roof and exterior walls of the gymnasium completely collapsed (see Figure 4.15)
- The second floors of two large wings of the school lost roofs and the upper walls collapsed
- Some chords of the steel roof trusses were buckled
- Base plates for the end bearing of the roof trusses on the exterior walls had holes for 2 bolts but no room for the bolts to go through the holes (see Figure 4.16)
- There was minimum steel reinforcing bars extending up from the concrete floor slab that should have been used for splicing with wall reinforcing steel

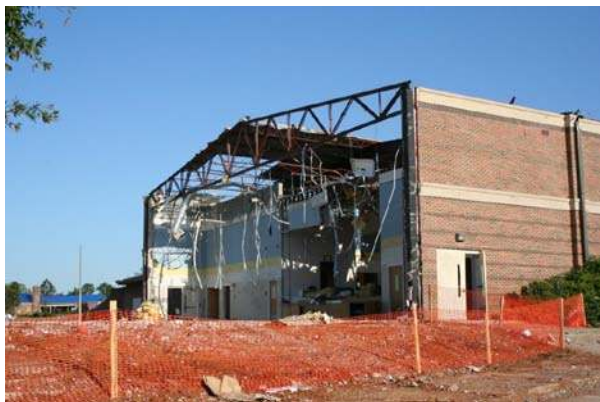
Figure 4.15 Damaged gymnasium

The Degree of Damage on the EF scale for junior or senior high schools where 2nd floor exterior walls are collapsed and the roof structure is damaged is 9, which suggests wind speeds in the range of 121 - 153 mph with an expected speed of 139 mph. If this building type was classified as an elementary school where the roof structure of the gymnasium was lost and the non-load bearing walls collapsed, the DOD is 7 or 8, which suggests wind speeds in the range of 108 – 162 mph with an expected speed of approximately 125 – 140 mph.

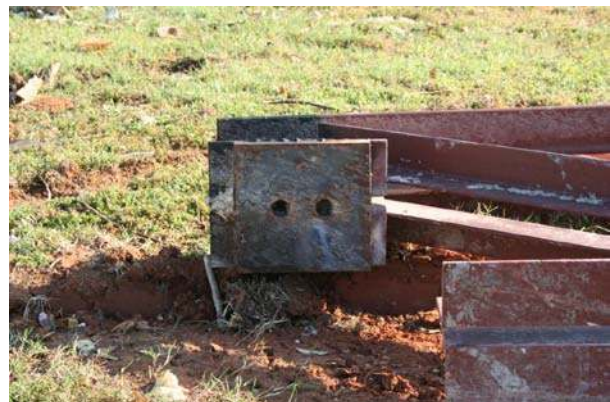
Figure 4.16: Roof truss that was lifted off during tornado; diagonal member buckled (not shown here).

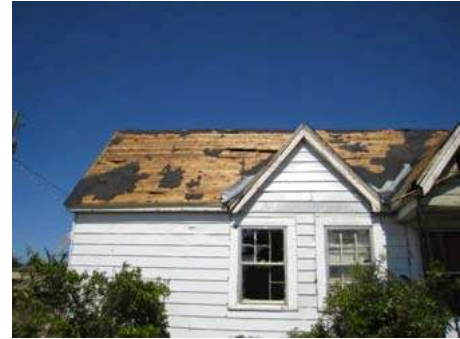
Figure 5.2: Loss of roof covering

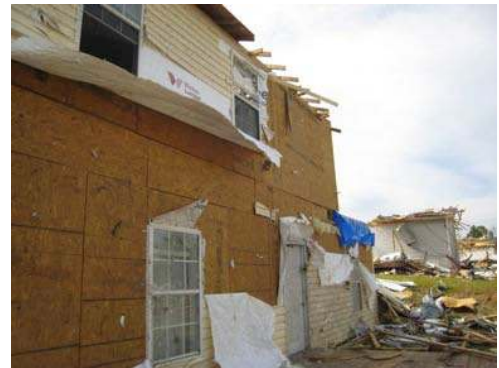
DOD2: Loss of vinyl/metal siding:

Figure 5.3 Loss of siding material

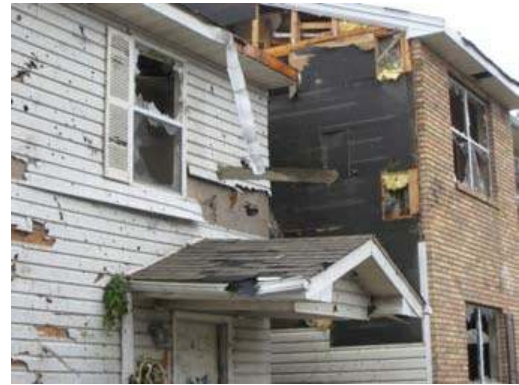
DOD3: Broken glass in doors and windows:

Figure 5.4 Broken windows and doors

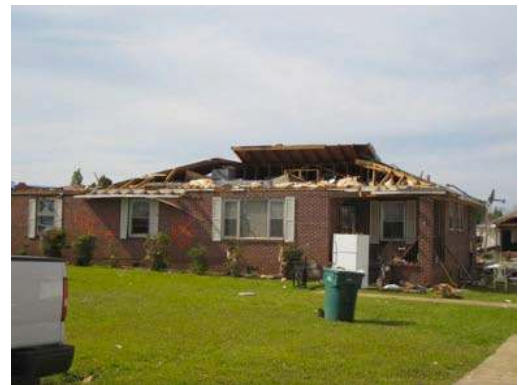
DOD4: Uplift of roof deck and loss of significant roof covering material:

Figure 5.5 Significant roof damage

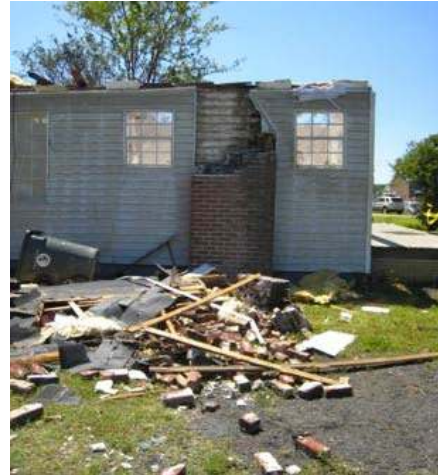
Figure 5.6 Collapse of chimney

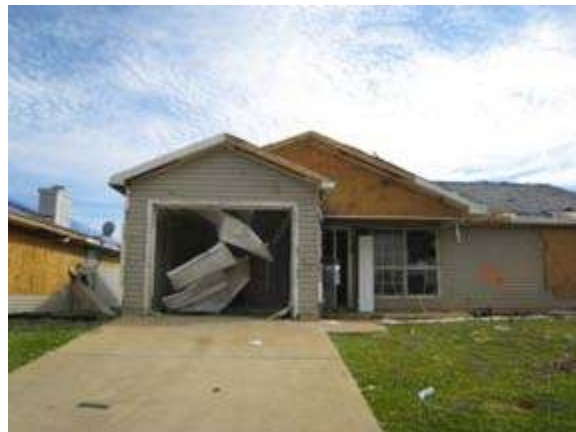
Figure 5.7 Garage wall blown-in

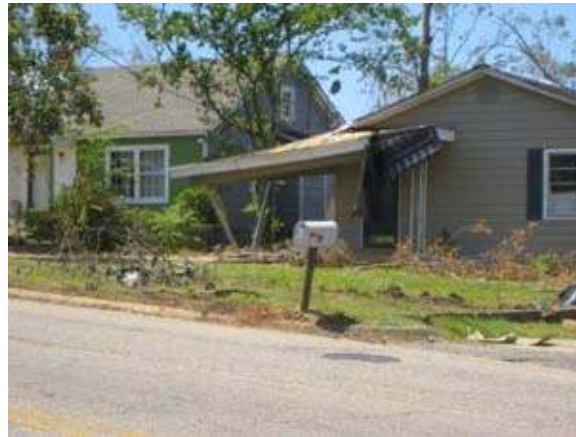
DOD4: Failure of porch or carport:

The porch or carport as an extension of the roof system often creates a weak link at its interface with the main structure, i.e. frames back into the roof system of the main portion of the structure. The columns supporting the porch are often inadequately connected to the foundation for winds of this speed. Once these weak interfaces are designed properly, porch or extended roof failure can be reduced for a range of wind speeds beyond 90 mph, perhaps even as high as 140 to 150 mph.

Figure 5.8 Porch or carport damage

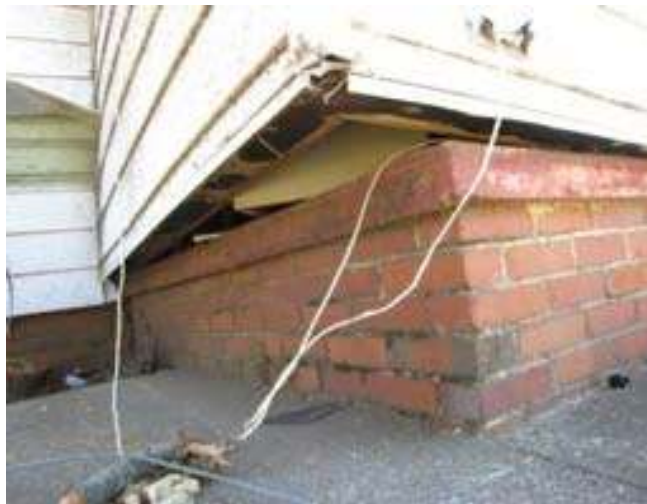
DOD5: House shifts off foundation:

It takes a significant wind speed to shift the entire building off the foundation, even if the foundation is poorly anchored. Although engineering design can address the foundation slippage relatively easily, the level of lateral force may just damage the other structural components if the foundation holds. The design of the foundation must be done in coordination with other lateral wind force resisting systems, but it can be mitigated with proper anchorage similar to earthquake anchoring systems.

Figure 5.9 House shifting off the foundation

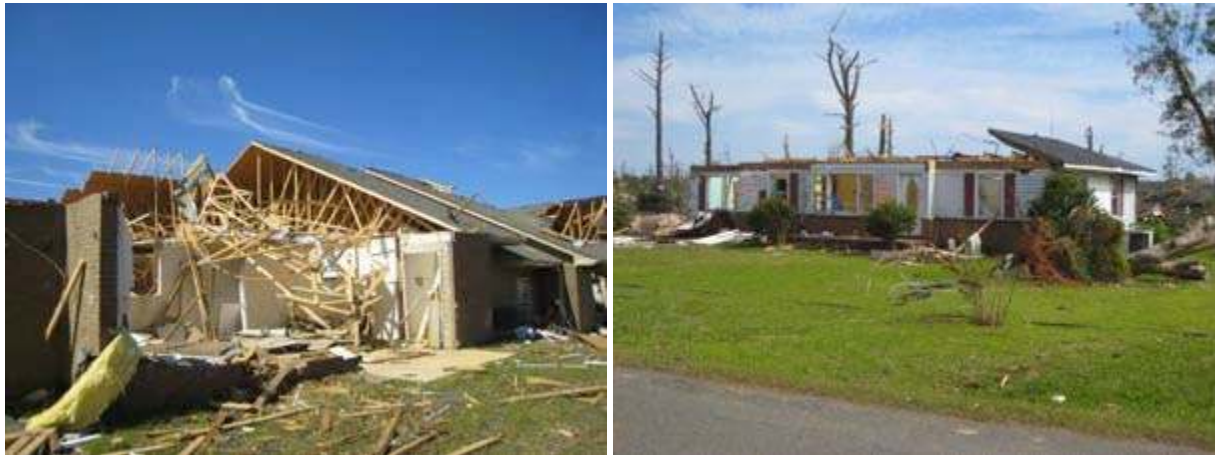
The failure of the majority of the roof structure may be mitigated through the use of connection hardware and non-conventional sizes for roof trusses. This may be a good practice for customized design or specific buildings. Due to the large uplift pressures on the roof, just improving the connection of the roof truss to the wall may not be sufficient. The roof ridge connections may also need to be strengthened so the roof does not come apart at the ridge.

Figure 5.10 Large sections of roof removed

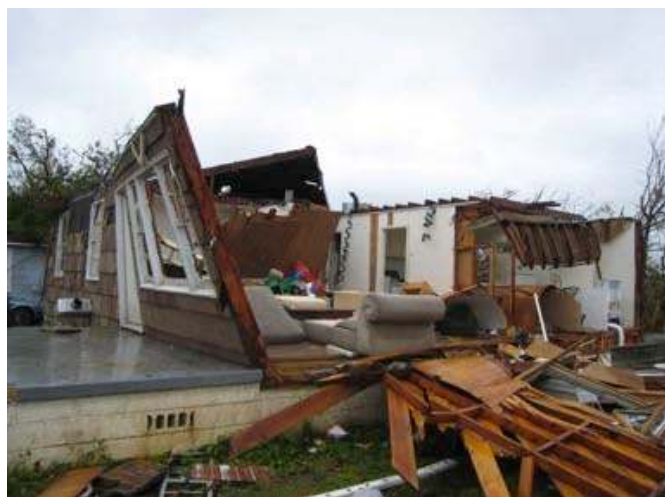
Figure 5.11 Exterior walls collapse

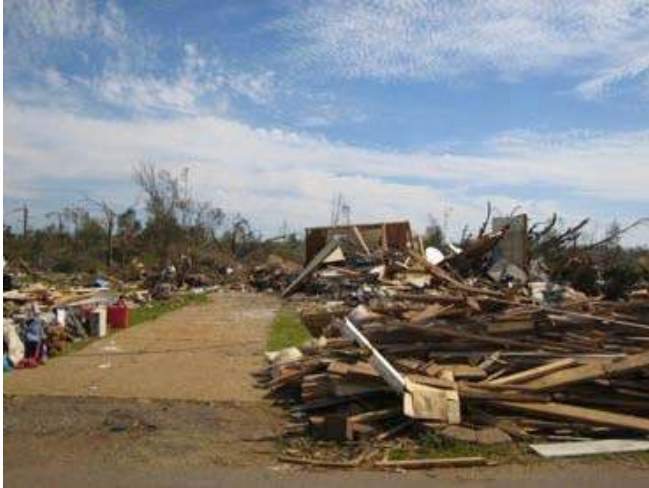
DOD8: Most walls collapsed:

Figure 5.12 Most walls collapsed

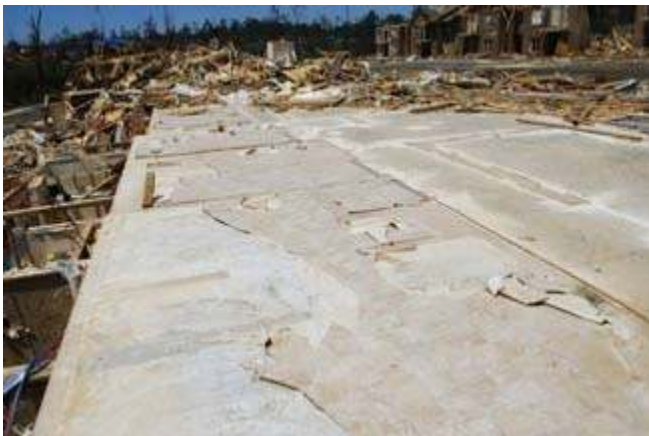
Figure 5.13 Slab swept clean in newer 2010 construction

A safe room or shelter is the best means of protecting the lives of the occupants in the event of wind speeds in excess of 160 mph.
