# Decay Detection in Red Oak Trees Using a Combination of Visual Inspection, Acoustic Testing, and Resistance Microdrilling

Xiping Wang and R. Bruce Allison

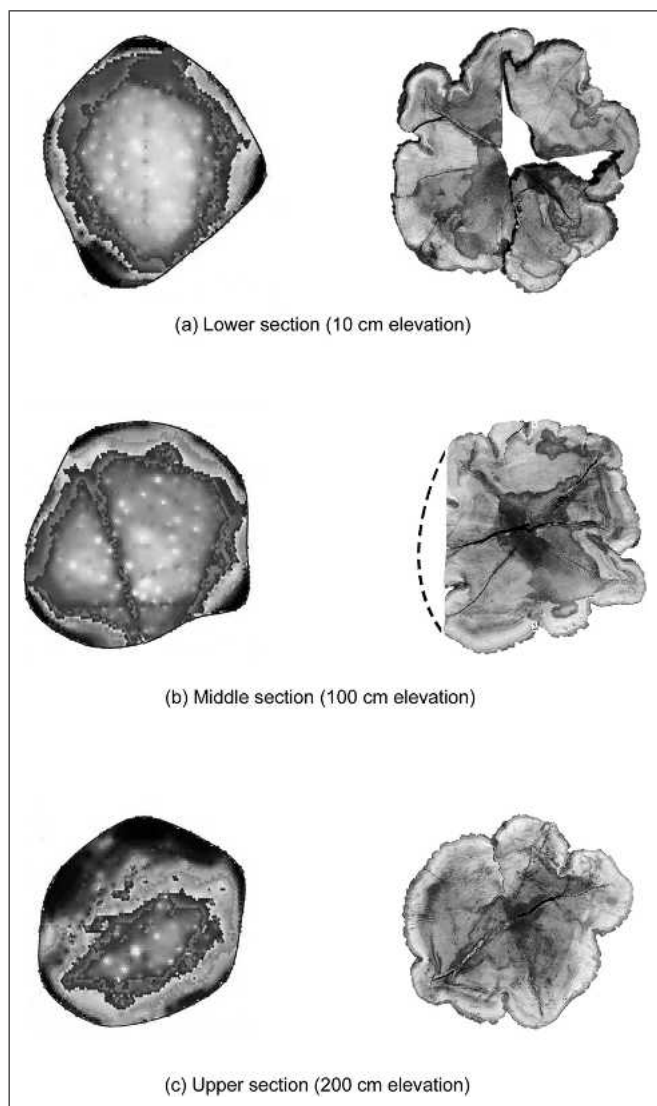
After being cut down, tree No. 307 was found to have heartwood decay at all three elevations. Laboratory examination confirmed the presence of white rot decaying fungus. The decay was less severe in the upper cross-section (200 cm [80 in] elevation), but it increased in size as the elevation dropped.

In addition to decay, major internal cracks were present in the cross-sections of tree No. 307. The combination of extensive decay and large lateral cracks caused the base disk to fall into several pieces during transportation. The photographs of the disks show that lower and middle cross-sections had multiple lateral cracks and the upper cross-section had one large lateral crack.

Figure 1 shows the comparisons of acoustic tomographs and photographs of the cross-sections at three elevations for red oak No. 307. The dark-colored zones (brown if it is in color print) in the tomograms represent solid wood, and the light-colored zones represent potentially decayed wood (if displayed in color, the tomograms use green, violet, and blue to represent increasing degradation by decay). It is clear that the tomographs show a strong correspondence to the images of the disks. Extensive decay and radiating lateral cracks in the lower and middle cross-sections were reflected by large light-color zones in the tomographs. The tomograph of the upper cross-section accurately located the position and orientation of the big lateral crack and heartwood decay.

**Figure 1.** Comparison of acoustic tomographs and photographs of corresponding cross-sections for red oak tree No. 307.

were larger than the true decay areas present in the cross-sections. Examination of the cross-sections revealed that internal cracks (“star” crack, “snake” crack, lateral crack, and so on) were also the dominating defects in these two red oak trees. These cracks, mostly present in the radial direction and extended up and down in vertical planes within the trunk, effectively cut off linear propagation of the acoustic waves diverting them to a much longer travel path. The direct result of this was that, even without decay present, the software produced a wide light-colored zone in the tomographs that resembled the influence of extensive heartwood decay. This observation was consistent with the warning provided in the operating manual (Argus Electronic GmbH 2006). Tomographs generated using the Picus software were the composite effects of both decay and cracks. Only through carefully directed resistance microdrilling can the tomography displays be interpreted as representing decay versus crack-induced acoustic shadows.

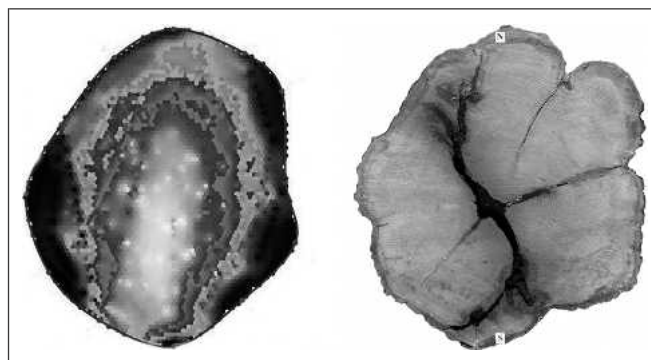
For red oak No. 123, the visual inspection revealed trunk seams and cracks with cankering on the south side with associated *Ustulina deusta* fungus. The single-path stress wave tests revealed a stress wave transmission time ranging from 1908 to 2320  $\mu\text{s}/\text{m}$  (581 to 707  $\mu\text{s}/\text{ft}$ ). The tomography revealed a large area of defect. The Resistograph drilling revealed a large snake-shaped crack. Figure 2 shows the comparison of the acoustic tomograph and photograph of the cross-section for red oak No. 123.

**Figure 2.** Comparison of acoustic tomograph and photograph of the cross-section for red oak tree No. 123.
