DEFECTIVENESS OF EXTERNAL AND INTERNAL SURFACES OF THE MAIN OIL AND GAS PIPELINES AFTER LONG-TERM OPERATION

Abstract. Damage by pitting corrosion of the surface areas of the local oil and gas pipelines was identified and numerically analysed in this paper. Having used the methods of optical and scanning electron microscopy, the basic laws of structural and mechanical degradation were established. Based on the data of fractographic control, the shape of defects and substantiated morphological characteristics were examined. It was established that certain informative signs of the defects correspond to certain stages of operation. Having used methods of fractodiagnostics, the main reasons for the performance defects of main oil and gas pipelines were established, and the mechanisms of degradation as well as fracture of the materials they are made from were described. According to the findings, the cause of the decrease in the reliability of the main oil and gas pipeline networks is general and localised corrosion as well as technological defects in the pipeline metal. These studies are essential for the establishment of the complex of mechanical and corrosion-mechanical properties, p

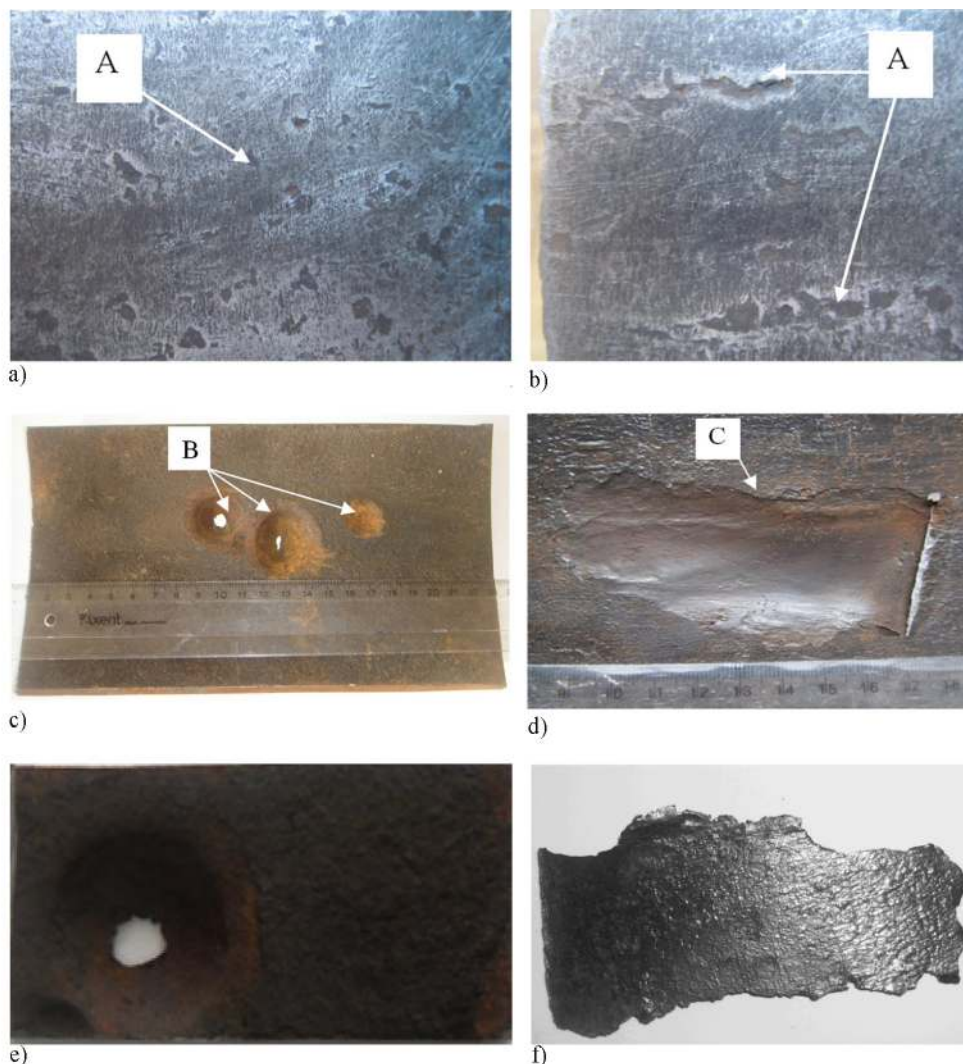
Black inclusions in the form of corrosion pits were found on the surface of the gas pipeline fragment (Fig. 2a, b). It should be noted that some characteristic sections, within which the corrosion damage of the metal occurred, could be seen on the metal surface.

Fig. 2. Investigated in-service defects of oil and gas pipelines: a, b – pitting; d, f – film peeling; c, e – megalospheric corrosion pits; A, B, C – defects are indicated by arrows

Using the methods of the optical or scanning electron microscopy, it was established that the fracture surface is covered with a dense network of deep, large-sized (200–500 μm) pits, which were the result of the corrosion effect during operation.

The shape of individual corrosion pits is uneven, which can be explained by the non-uniform fibrous structure and a high anisotropy of the pipe steel properties, which increases due to degradation, causing non-uniform localisation of the corrosion process (Maruschak *et al.* 2014a; Aleksandrov *et al.* 2011).

Defects in the form of through holes in the pipeline wall were investigated (Fig. 2c, e). Fragments with through holes were cut from the damaged section to determine the reason for their formation. The results of determining the chemical composition of the gas pipeline fragment are presented in Table 3.

According to the *optical macroanalysis* of the internal and external surfaces of the pipe in the initial state and after deseaming, holes have a semispherical shape. The semi-sphere diameter on the internal surface of the pipe is 22 mm. A hole with the diameter of 6 mm appeared on the external wall, the metal thickness in the vicinity of the hole is less than 0.5 mm (Fig. 4a). The internal surface of the defect is covered with a thick layer of oxides. The oxides have sections of local bulging, in which a layer of corrosion separated easily from the lower corrosion layer. This testifies to the fact that corrosion developed gradually, in a stepwise manner within this section. There are traces of the uniform corrosion and

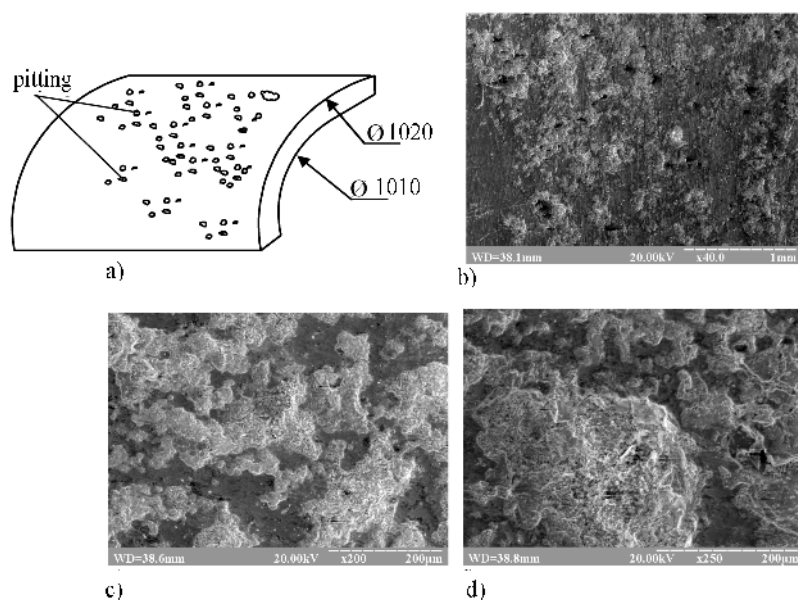
The presence of the pitting corrosion (Fig. 3a) intensifies degradation processes due to:

- the formation of the atomic hydrogen on the pipe surface in case of penetration of the ground water into the pipe surface (Nykyforchyn *et al.* 2009b);
- metal decarbonisation resulting from blockage of carbon atoms by the diffusion hydrogen atoms;
- metal hydrogenation and accumulation in dislocations, structural defects and micropores;
- metal embrittlement.

Thus, for the investigated sections of the main pipelines, the danger it is not in multiple pitting (Figs 3b–d) but the activation of the structural and mechanical degradation caused by them.

Fig. 3. Scheme of multiple pitting location on the pipe surface (a); local (b) and coalesced pitting (c, d)

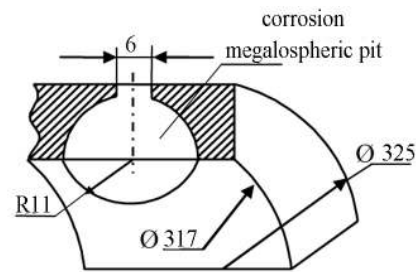
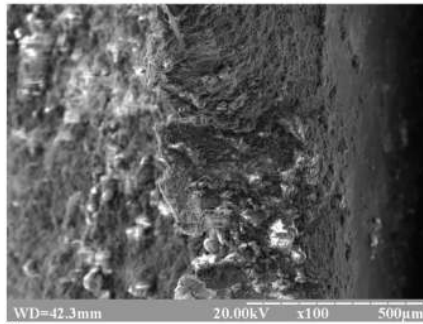
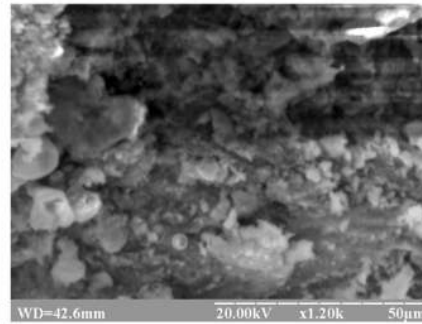
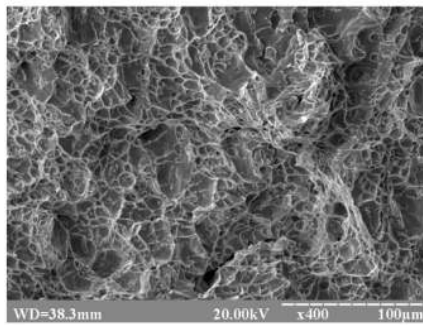
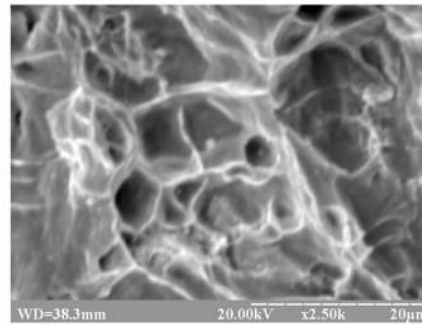
Fig. 4. Scheme (a) and the surface of the corrosion of a semispherical hole (b, c) and the surface of static failure of the pipe material (d, e)

The use of the *optical microanalysis* for the geometry analysis of the corrosion defect bottom testifies to the absence of crack-like defects. The view of the through hole and the general condition of templates testify to an insignificant intensity of corrosion processes on the gas pipeline wall. Based on the results of the damage analysis on the pipeline surface, a conclusion can be made that the through hole with the maximum diameter on the internal wall and the minimum diameter on the external wall is a corrosion pit, which propagated from the inside (Fig. 4a). The shape and locality of the defect allow presuming the presence of a technological defect of the pipe within this area (most probably a film or flanging).

The analysis of the hole surface morphology allowed establishing that the material has a surface fragmented with corrosion, on which flanges covered with the corrosion film are formed (Fig. 4b, c).

It should be noted that the mechanism of steel failure depends on many factors (strength, structural degradation, the presence of concentrators). Failure of the material near the hole occurred in a ductile manner. A dimple relief testifies to the presence of non-metallic inclusions. We can presume that the dimples with the diameter above 10 µm are caused by the presence of the non-metallic inclusions of oxides and sulfides, whereas the pits of smaller size are connected with the intrasubgranular mechanism of failure or the formation of pores on dispersed particles (Fig. 4d, e). The attainment of the critical volume of pores caused a beginning of microplastic deformation, coalescence of pores and fast failure.

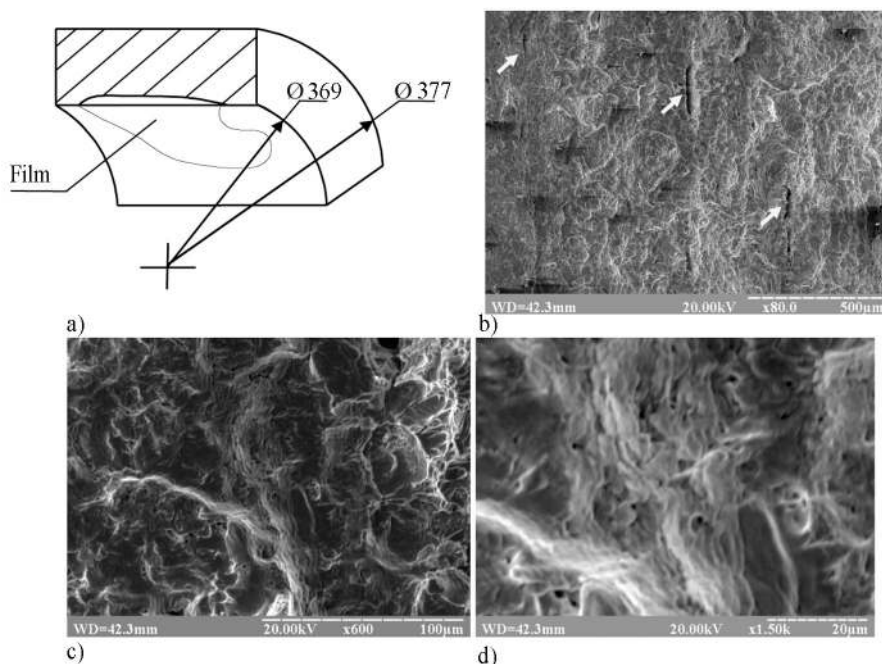
A tongue-like defect was found on the pipe surface, which is joined with the base metal of the pipe on one side. These are the so-called films – metallurgical defects caused by violations of the pipe production technology. Films of the steelmaking origin are located randomly along the surface of the metal sheet and have a significant thickness of local delamination (above 1.0 mm), and the size up to 35 mm, which is similar to the case under investigation.

The use of the complex technique for investigating the defects of "film" type (Fig. 5a) and the analysis of pipe production technology allows identifying the reasons for the formation of this type of damage on the walls of the main oil pipeline systems. The external view of the defect of "film"-type represents thin, tongue-like delamination of metal plates from the pipe surface of the oil pipeline (Fig. 5a). The delamination has a shiny dark colour.

The defect was found to have a structural gradient along the depth of fracture (Fig. 5b). In particular, longitudinal delamination of different sizes was noticeable very well. The defects were oriented along the direction of rolling and looked like delamination caused by the effect of hydrogen on the metal (Szkłarska-Śmiałowska,

The structure of the fracture is formed by the lateral shear mechanism (Fig. 5c, d). In general, the surface has a "smoothed-out" look, and a decreased roughness, which testifies to a low energy efficiency of the material fracture.

Fig. 5. Film fracture surface (a) and micromechanisms of its fracture (b, c) (hydrogen delamination is indicated by arrows)
