DEGRADATION OF THE MAIN GAS PIPELINE MATERIAL AND MECHANISMS OF ITS FRACTURE

Received 18 Mar 2014; accepted 04 Sep 2014

Keywords: fracture, failure, structural damage, strain localisation, hydrogenation, degradation, gas pipeline.

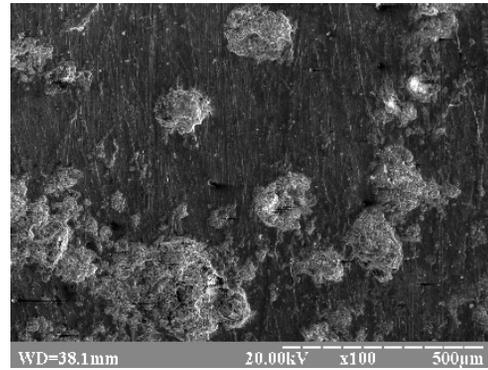
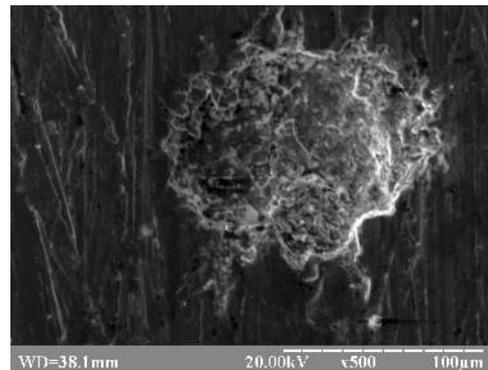
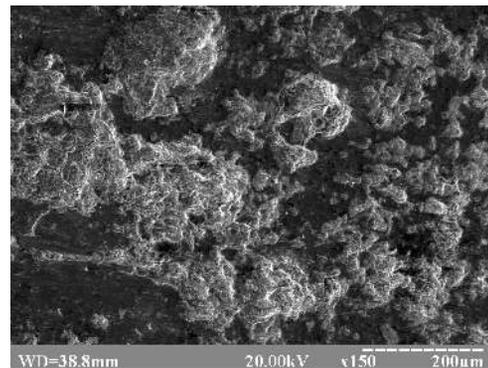
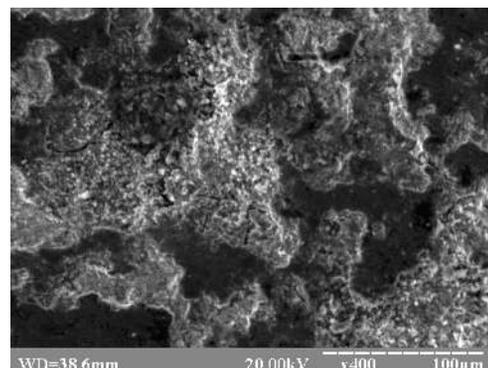
It is known that pipeline systems, which have been under ground for more than 5 years, usually contain corrosive and metallurgical microdefects or microcracks (Lublińska *et al.* 2007). The effect of technological loads and residual stresses combined with the medium (soil), which has a certain humidity and acidity, intensifies the accumulation of damage and hastens the propagation of these defects (Ghajar *et al.* 2013). Figure 2 shows the distribution of pitting and corrosive pits on the surface of the main gas pipeline.

Fig. 2. Pitting (a, b) and corrosive pits (c, d) found on the external surface of the gas pipeline after 40 years of operation

In places of contact between the pipe metal and the corrosive medium, the acidification of the medium takes place under the insulation, which facilitates a reduction in the surface energy and hastens failure of the passivating film. The most active elements of the soil electrolytes are the halide chloride ion Cl^- and the adsorbed hydrogen (Ghajar *et al.* 2013; Kotrechko *et al.* 2004).

As a result of microplastic deformation, the destabilization of the internal energetic state takes place on local sections of the pipe material, and the sensitivity to stress concentrators increases under the effect of hydrogen. Moreover, cyclic loading lowers the plasticity of the deformed metal, thus increasing its liability to the corrosive cracking under the effect of the hydrogenous medium (Nykyforchyn *et al.* 2010).

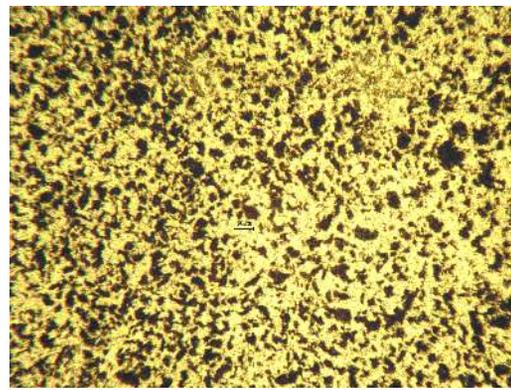
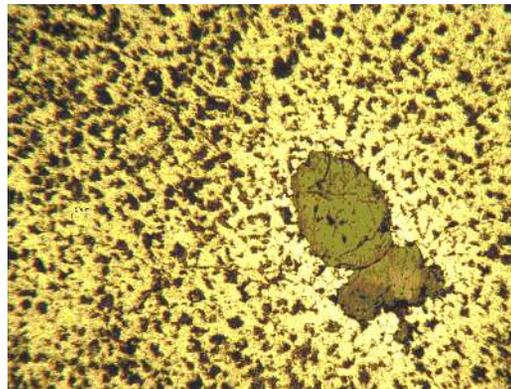
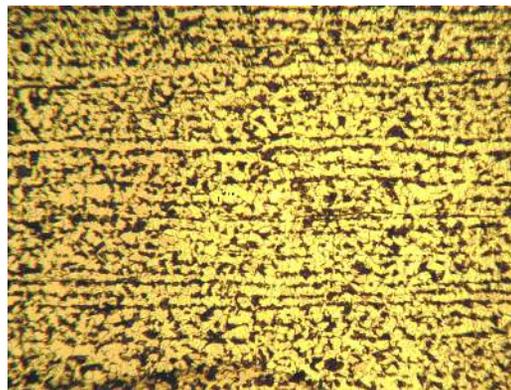
The templates cut in the axial direction are characterized by the clear-cut damage of the ferritic-pearlitic structure (Fig. 3a, b). A partial decarbonation of the pearlitic grains is detected on polished sections. Numerous defects in the form of laminations are found, which are oriented along the rolling direction and formed due to the hydrogenation of metal. These defects are called hydrogen lamination and hydrogen cracking (Nykyforchyn *et al.* 2010). Obviously, cracks nucleated on grain boundaries and propagated under the action of stresses by the “stress–corrosion” scheme (Lublińska *et al.* 2007). As is known, it is the localisation of the degradation processes between rolling fibers (Fig. 3c) that causes a significant reduction in the impact toughness of the service-exposed pipelines (Baron 2012).

In our opinion, the said defects testify to the overstrained condition of the analysed section (possibly, due to a local subsidence of soil), moreover, an increase in the internal stress caused the localisation of structural damage and its coalescence in the direction perpendicular to the maximum tensile stresses. A change in the density of metal damage is accompanied by a change in its geometry, size and spatial orientation, which preconditions a change in microhardness of the surface layers (Teirlinck *et al.* 1988). One of the main reasons for the appearance of the said defects is damage and loss of adhesive properties of the pipe coating, which caused the penetration of ground water into the pipe surface. Atomic hydrogen penetrated into the metal and accumulated in micropores and structural defects (Fig. 3b). In parallel, the decarbonation of metal developed due to blocking of carbon atoms by hydrogen atoms, thus decreasing the material plasticity (Kadkhodapour *et al.* 2011).

Fig. 3. Microstructure of gas pipeline after 40 years of operation ($\times 200$): a – in the transverse direction, where a – external surface; b – internal surface; c – along the pipe axis

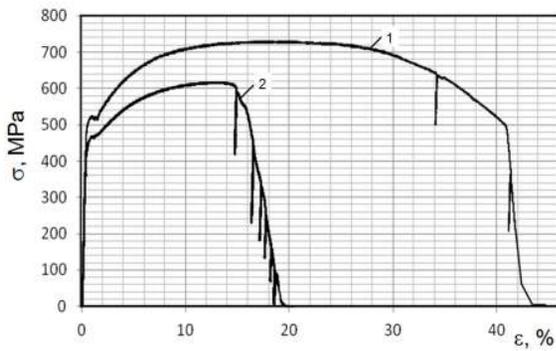
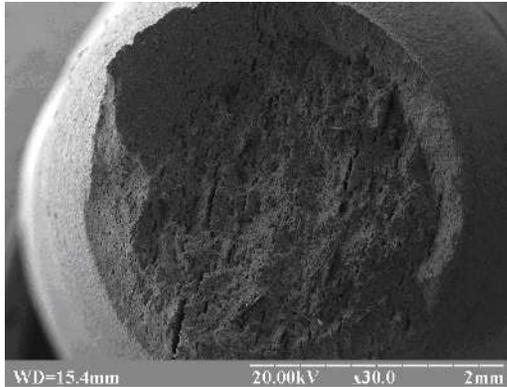
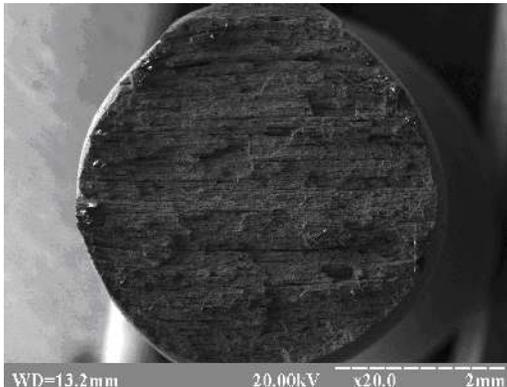
It is known that long-term operation causes changes in the kinetics of deformation defects accumulation in the structural material (Yasnii *et al.* 2012), and the level of the structural and mechanical damage of the material has an immediate effect on the regularities in the material failure (Fig. 4b, c).

Fig. 4. Complete static tension curves for the service-exposed 17G1S steel: a – cut in the longitudinal (1) and transverse (2) directions after 40 years of operation under ground; b – microfracture of specimens cut in the longitudinal direction; c – microfracture of specimens cut in the transverse direction

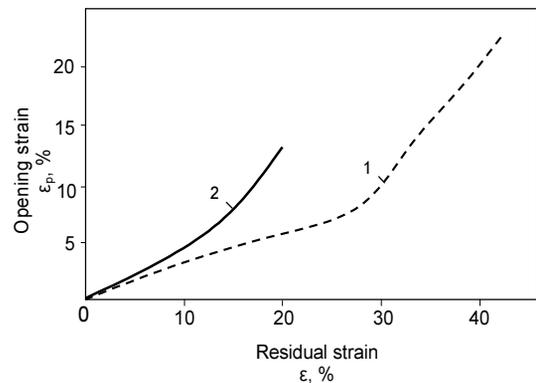
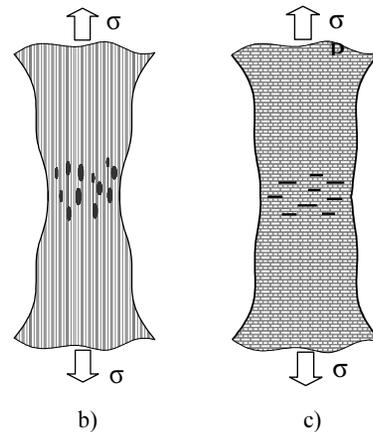
The presented data testifies to the fact that degradation, first of all hydrogenation, raises the degree of the material opening, due to which some essential differences between the deformation properties are observed (Fig. 5a). As is seen, in qualitative terms, the kinetics of the damage accumulation process in specimens with different degrees of deformation is similar to the insignificant strains, when deformation processes are localized in the vicinity of structural formations (macrolevel), in particular, a difference between the loosening strains of specimens at low strains ($\epsilon = 8\%$) was 2%. However, at strains equal to 20%, the difference between the loosening strains was 16%.

For the specimens cut in the longitudinal direction with $\epsilon = 42\%$, the loosening strain was $\epsilon_p = 27\%$. For the specimens cut in the transverse direction the maximum relative strain was $\epsilon = 20\%$, and the loosening strain was $\epsilon_p = 13\%$.

So, the specimens cut in the longitudinal direction have better deformation properties (Fig. 5b). Lower strength and plasticity of the specimens cut in the transverse direction are connected with the processes of the preliminary hydrogenation and multiple lamination of the structure of the internal material layers (Fig. 5c). The said defects impede the involvement of the material mesovolumes in the plastic deformation process, which is confirmed by low values of the residual strain (Makarov 2000). Significant differences were also observed in the slopes of the descending branches of the stress-strain curves, which testify to a big difference between the mechanisms of macrofailure.

Fig. 5. Visualization: a – dependence of loosening strains on the residual strain for the specimens of the longitudinal direction of cutting (1) and transverse direction of cutting (2); b – scheme of the deformation behavior of specimens cut in the longitudinal direction from the service-exposed pipe; c – scheme of the deformation behavior of specimens cut in the transverse direction from the service-exposed pipe

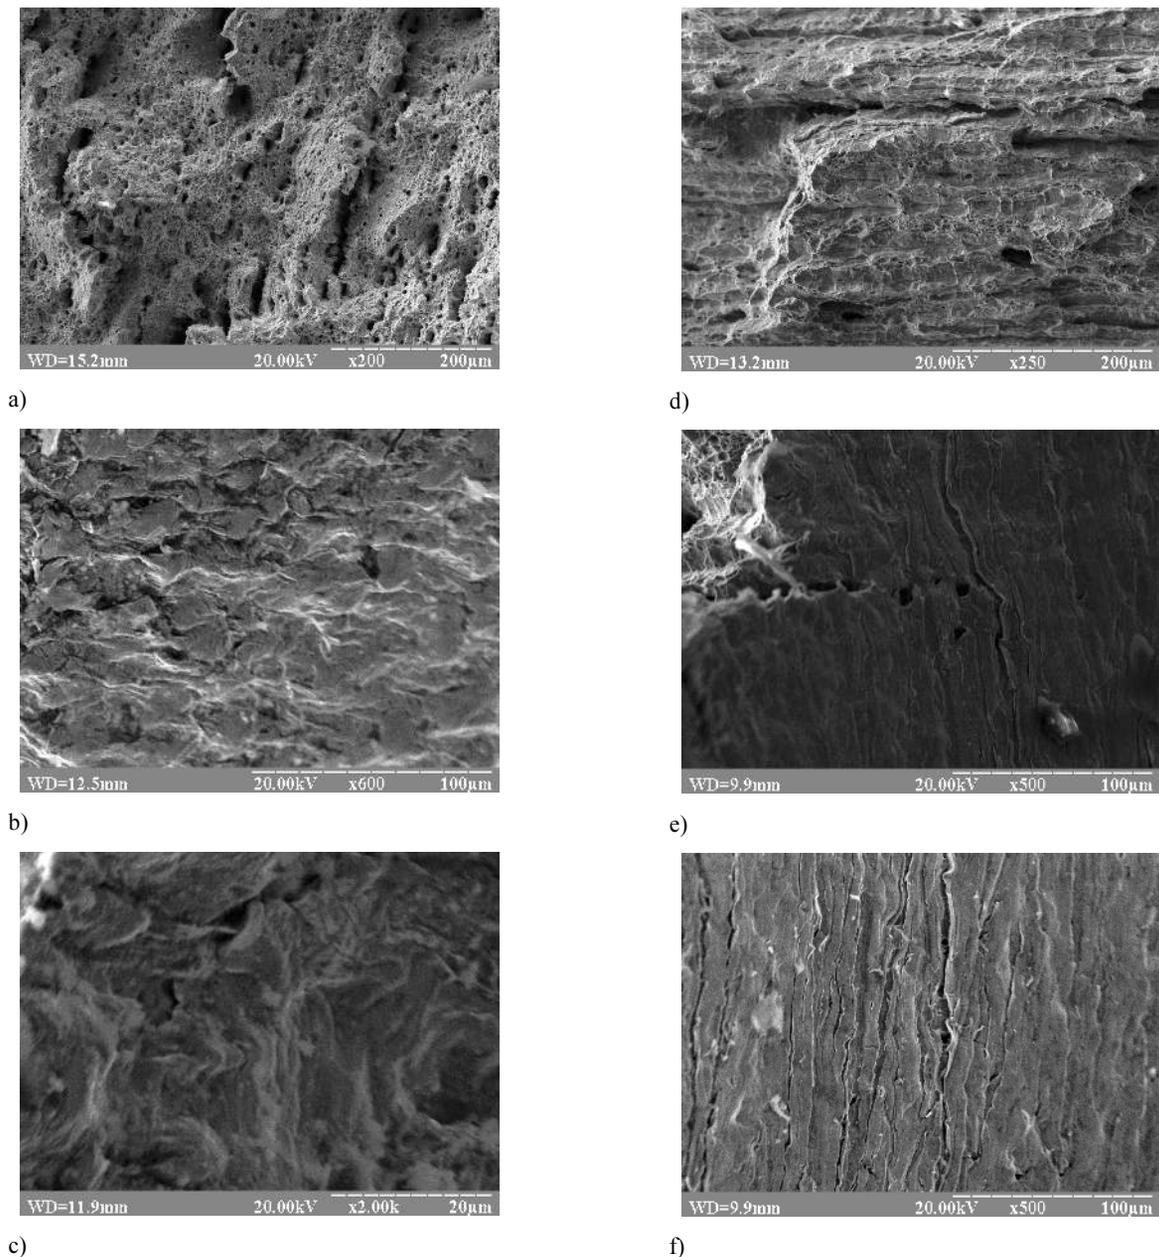
It is found that for the specimens of the *longitudinal direction of cutting*, the presence of the scattered damage causes intensification of the dimple separation. The fracture surface of the specimens cut from the service-exposed steel 17G1S is covered with a dense network of deep, large-sized dimples combined with numerous laminations, which are connected with damage propagation during operation.

For the specimens of the *transverse direction of cutting*, the presence of the “composite” structure of the fracture surface in the form of micro- and macroprotrusions was recorded experimentally. Thus, when hydrogen affects the structure of the gas-pipeline metal, a great number of ordered structures are formed in the investigated material (material states), each of which has new mechanical properties (Balokhonov 2010).

- the *transverse direction of cutting*. The view of the lateral specimen surface testifies to the brittle failure (Fig. 6d). At the same time, the presence of multiple cracks testifies to the partial relaxation of stresses during deformation. It is shown that due to the stress concentration in the vicinity of microcracks the first

Fig. 6. Fracture surfaces – a, d and lateral surfaces d, e, f of specimens from service-exposed steel 17G1S: (a) of the longitudinal (a–c) and transverse (d–f) direction of cutting after 40 years of operation
