Degradation of the performance of a YBCO-coated conductor double pancake coil due to epoxy impregnation

T.Takematsu^{1,2}, R.Hu^{1,2}, T.Takao², Y.Yanagisawa^{1,3}, H.Nakagome³,
D.Uglietti⁴, T.Kiyoshi⁴, M.Takahashi^{1,5}, and H.Maeda^{1,5}

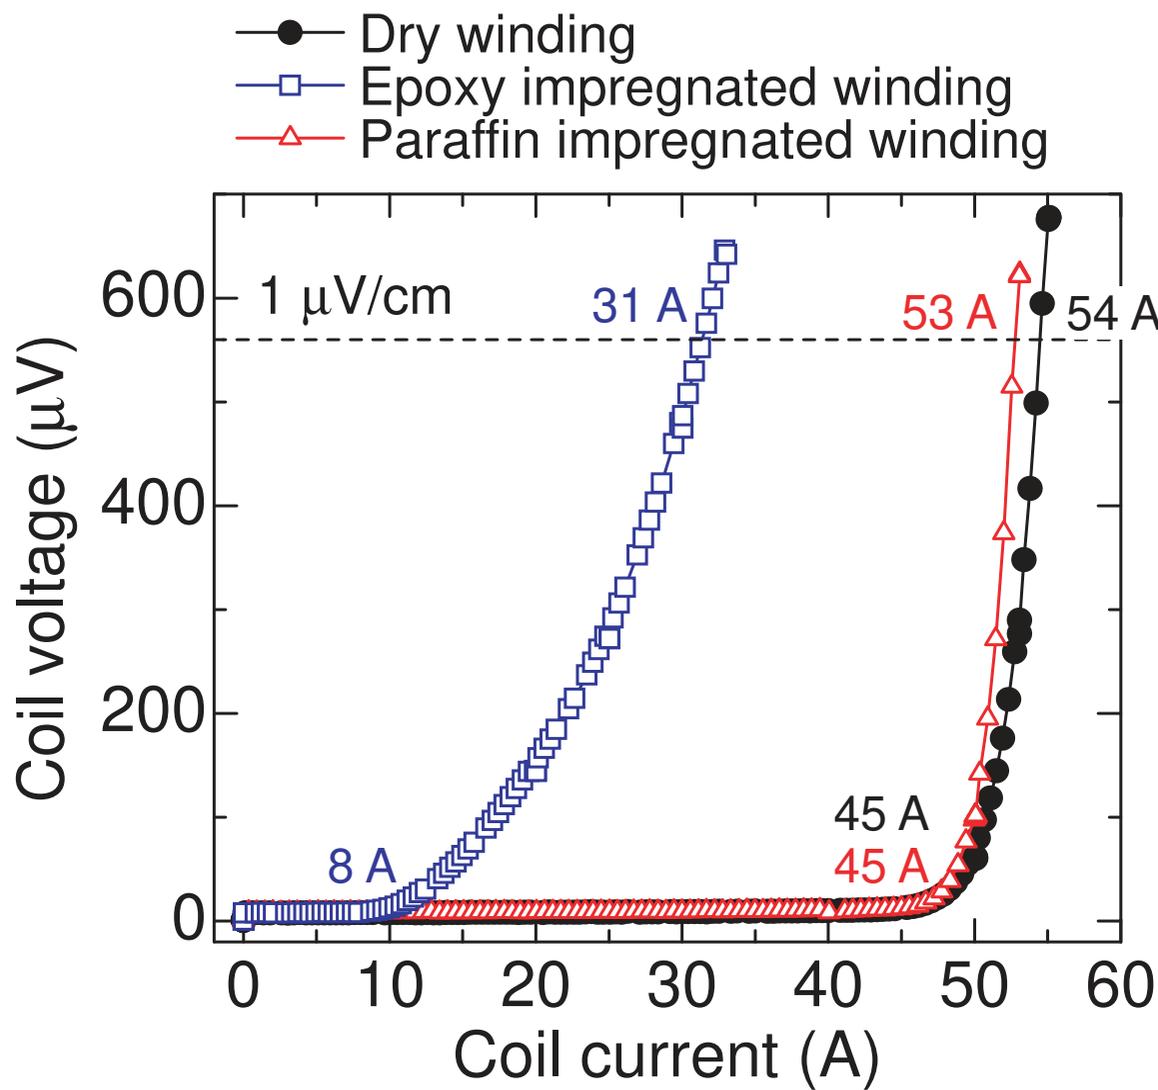
Figure 1

The current-voltage characteristic for the epoxy impregnated double-pancake is shown by the blue open squares in Fig. 1; coil degradation is obvious, as the normal voltage appears above 8 A, only 18 % of that (45 A) for the dry coil, and the coil critical current is 31.5 A, 58 % of that (54 A) for dry coil. The n -index is as low as 3. These results demonstrate that parts of the YBCO-coated conductor in the coil winding are damaged by cool down resulting in coil degradation as the Lorentz force in this experiment is negligible small ($\sim 0.1 \text{ MPa}$). The critical current for damaged sections may be as low as 8 A.

Figure 1. Current-voltage (I - V) characteristics obtained for a single YBCO-coated conductor double pancake. The I - V curve for epoxy impregnated coil shown by the blue open squares shows a significant degradation in the critical current, while those for a dry coil (black closed circles) and a paraffin impregnated coil (red open triangles) coincide with that of a short sample.

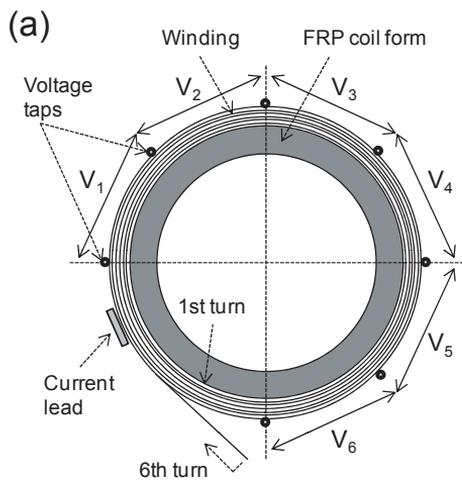
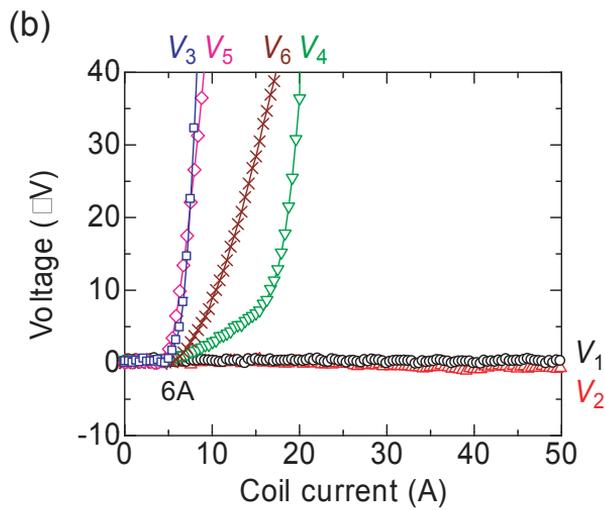
Figure 2

from the outer surface; voltage taps and current lead were soldered on each layer to measure the current-voltage characteristics. In this way, we could determine the damaged winding section. A schematic drawing of a current lead and voltage-tap pairs, V_1 to V_6 , on the 6th layer is shown in Fig. 2(a); the current-voltage curves for each voltage-tap pairs are shown in Fig. 2 (b). The normal voltages appear above 6 A for V_3 , V_4 , V_5 , and V_6 , while not for V_1 and V_2 . Thus, the winding section corresponding to V_3 to V_6 is substantially degraded; this turned out to be in the 6th layer.

Figure 2. (a) A schematic of a current lead and voltage taps soldered on the 6th layer. (b) Current-voltage curves taken for voltage-tap pairs; V_3 , V_4 , V_5 and V_6 show significant degradation, while those for V_1 and V_2 do not show degradation.

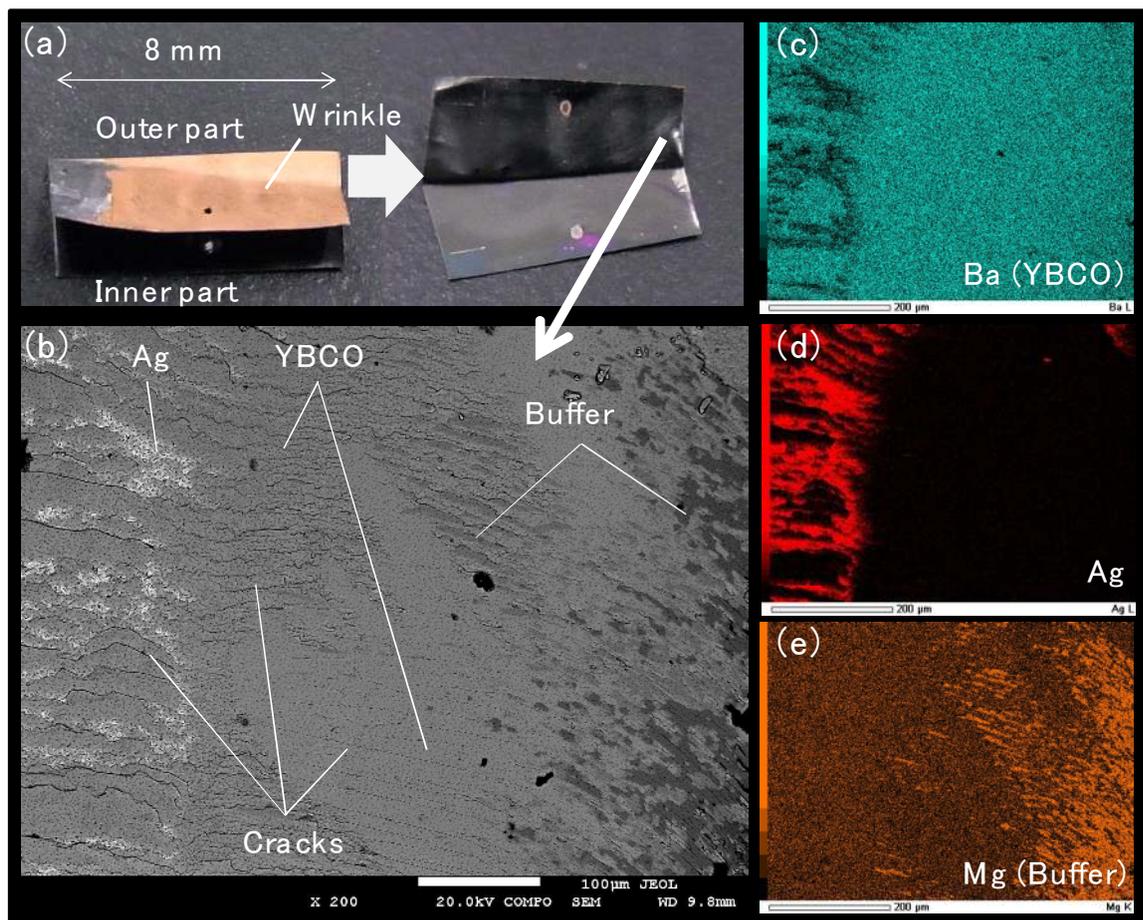
After the current-voltage measurements, we cut out a degraded section, V_3 , seen in Fig. 2(a). A wrinkle was found on the outer surface of the conductor and when we removed the edge of the conductor using sandpaper, the YBCO-coated conductor delaminated into two parts, as seen in Fig 3(a). Figure 3(b) shows the microstructure of a fracture surface of the outer part of the delaminated conductor, taken by a scanning electron microscope (SEM). Elemental composition analysis was simultaneously carried out with an energy dispersive spectroscopy (EDS). Figure 3(c), (d) and (e) show the EDS intensities for Ba (green), Ag (red) and Mg (orange). The presence of Ba corresponds to a YBCO layer, Ag to a silver surface layer on the YBCO[1] and Mg to a MgO buffer layer. As seen in Fig. 3 (c), YBCO (Ba) distributes over the fracture surface and cracks run randomly on the YBCO layer as seen in Fig. 3(b). However, Fig. 3(d)

shows that the YBCO (Ba) signal is rather weak on the left side, while that of Ag is strong in that area. Furthermore, the Mg buffer layer (orange) distributes on the right side as seen in Fig. 3(e). In summary, the YBCO layer itself is fractured on the left side, while a debonding occurs at the interface between the YBCO layer and the buffer layer on the right side. Note that the coil transport current is in the horizontal direction in these figures.

Figure 3. (a) A wrinkle on the 6th layer of the YBCO-coated conductor, which was found when we unwound the coil. The YBCO-coated conductor fractured into two just after its edge was removed by sandpaper. (b) Microstructure of the fractured surface for the outer part of the degraded conductor taken by SEM. Element distribution on the fractured surface for (c) Ba in the YBCO, (d), Ag in the surface layer and (e) Mg in the MgB₂ buffer layer. The coil transport current is in the horizontal direction.

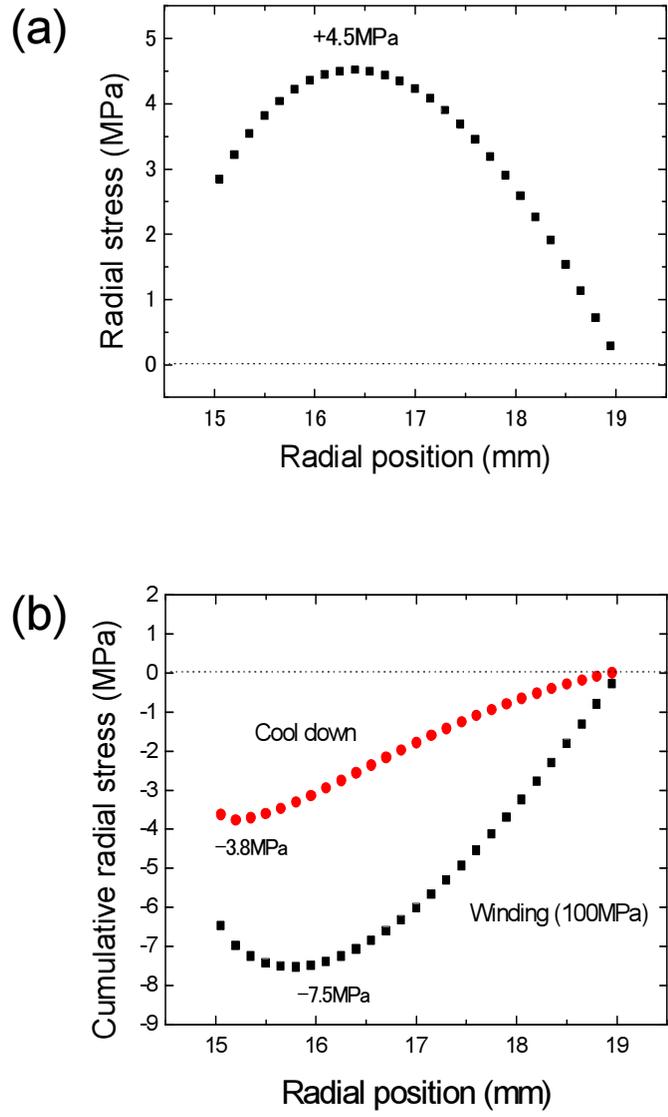
The radial stress distribution due to cool down in the double pancake is shown in Fig. 4(a); the effects of winding and Lorentz force are neglected in the calculation, as the winding tension is negligible and the Lorentz force is small. Due to large thermal contractions of the interlayer insulator and the FRP coil form, a tensile radial stress develops in the coil winding. It has a peak of +4.5 MPa in the 10th layer; the peak stress is close to the delamination strength of +10 MPa for the YBCO-coated conductor under transverse tensile stress.[6] Furthermore, the radial position of the peak is close to that of the degraded layer found experimentally and displayed in Fig. 3. Thus, we infer that if a YBCO coil is epoxy impregnated, the tensile radial stress developed during cool down delaminates the YBCO-coated conductor in the coil winding.

Figure 4. (a) The calculated radial stress distribution in the coil winding due to cool down from room temperature to 77 K. The stress shows a tensile peak of +4.5 MPa at the 10th layer. (b) The calculated cumulative radial stress distribution in the coil winding

due to winding, with a winding tension of 100 MPa, and cool down. The compressive stress dominates over the coil winding at 77 K.

If the winding tension is sufficiently large, such as 100 MPa, the cumulative radial stress is compressive over the double pancake after cool down as seen by the circles in Fig. 4(b); the cumulative radial stress here is the sum of the compressive radial stress due to winding (squares) and the tensile radial stress due to cool down.
