# Deterioration of Iowa Highway Concrete Pavements: A Petrographic Study

Paul E. Stutzman

December, 1999

## **Executive Summary**

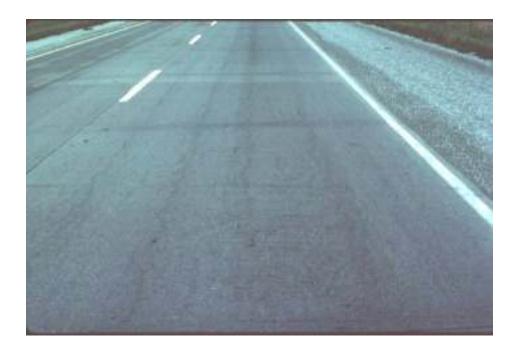
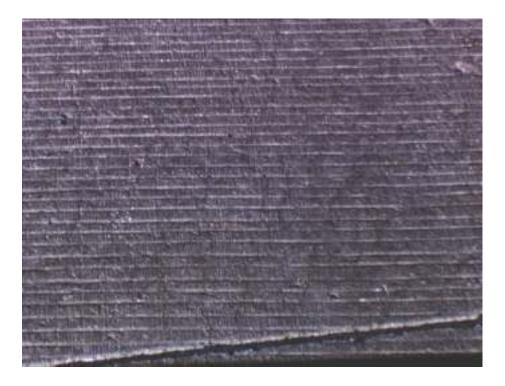
Figure 1. Onset of pavement deterioration is visible as a slight darkening of the concrete in the transverse joint region (top, I-80) and in pavements with advanced deterioration, a tightly-closed pattern cracking (bottom, US 20). Some of these pavements also have vibrator trails.

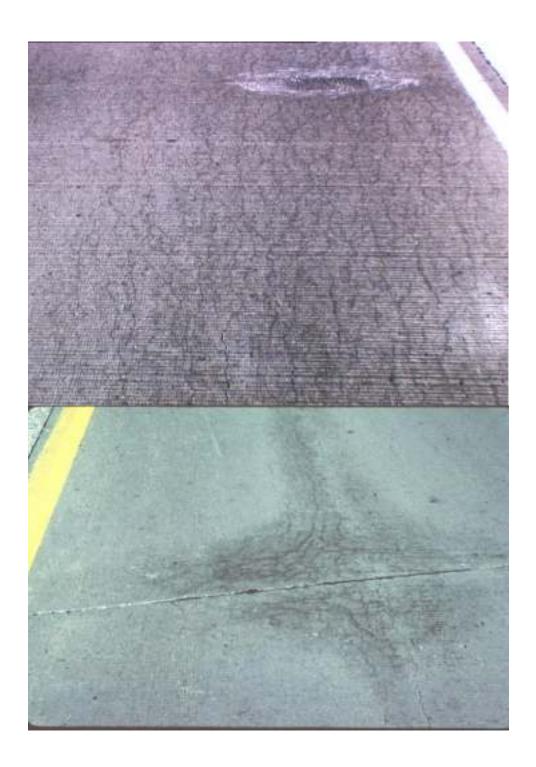
Figure 2. Map cracking oriented in the longitudinal direction of the pavement, interconnected by slightly finer cracks perpendicular to pavement direction becomes more prominent with progression of deterioration (top). Advanced degradation shows cracking paralleling the transverse joint and road edge, and along cracks within vibrator trails. The degradation would be characterized initially as "low" severity according to the SHRP Distress Identification Manual [17] and "moderate" as the deterioration progresses.

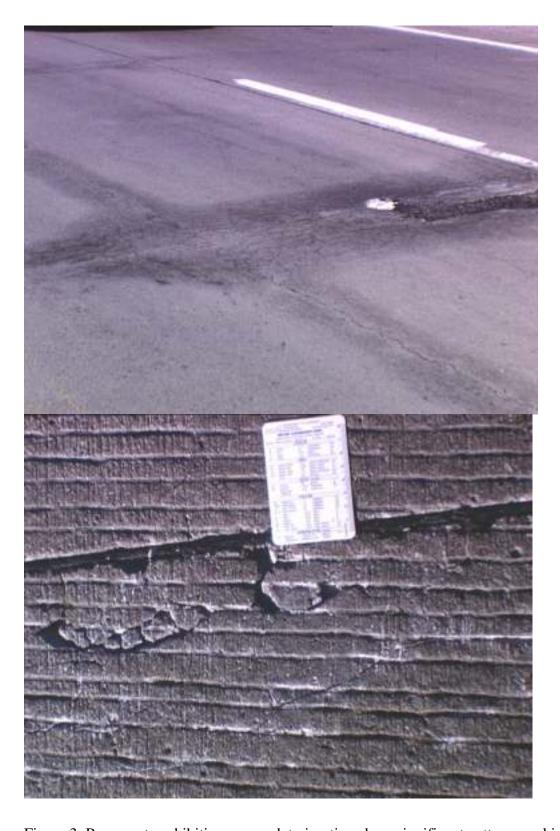
Figure 3. Pavements exhibiting severe deterioration show significant pattern cracking (here accentuated by moisture along the crack), cracking along joints, spalling along joint edges and white efflorescence. Open joints and lack of displacement along pavement slabs provides evidence against permanent expansive processes such as alkali-aggregate reaction and sulfate attack.

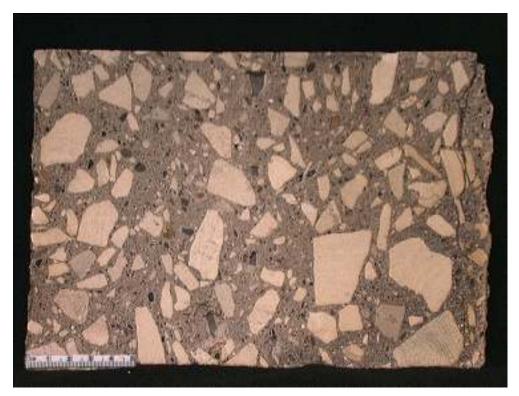
Figure 9: Iowa 175 Core 2 shows some aggregate / mortar segregation and cracking located near the core base (base to the right).

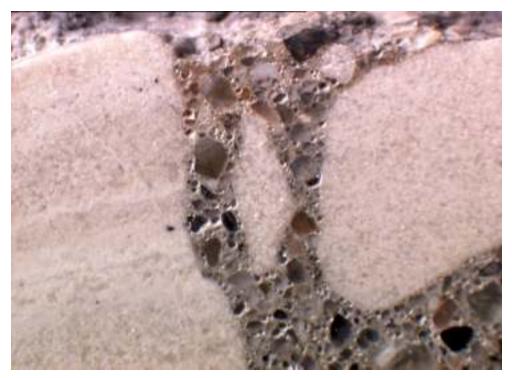
Figure 10. Iowa 175 Core 2 surface microstructure. Slight discoloration in the upper mortar indicates approximate depth of carbonation. Micrograph field width: 14 mm

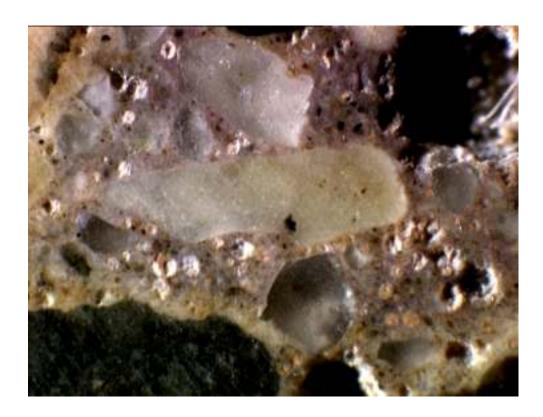
Figure 11. Iowa 175 Core 2 base mortar microstructure exhibiting partial filling of the entrained air void system. Micrograph field width: 4 mm

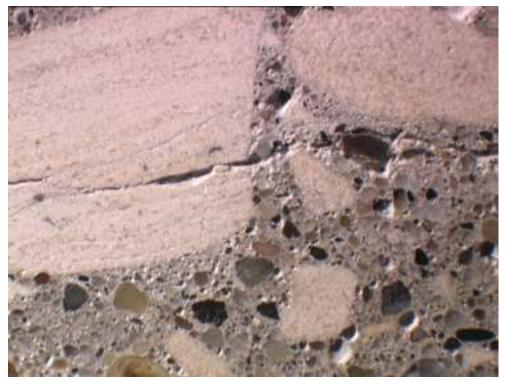
Figure 12. Iowa 175 Core 2 base microstructure exhibits cracking in the mortar and coarse aggregate. Micrograph field width: 14 mm.

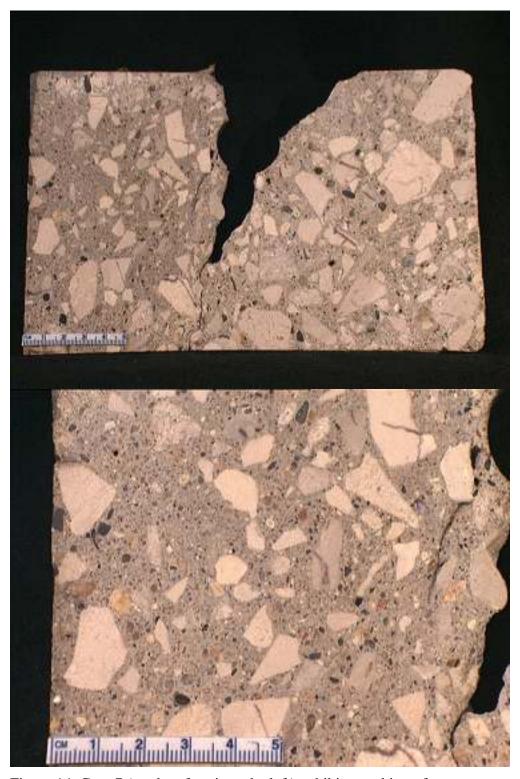
Figure 14. Core 7 (road surface is to the left) exhibits cracking of coarse aggregate, vertical cracks from the surface that are either drying shrinkage or freeze thaw-related. Segregation of mortar and coarse aggregate is visible in the whole core cross section (upper image) and the upper-core microstructure (lower).

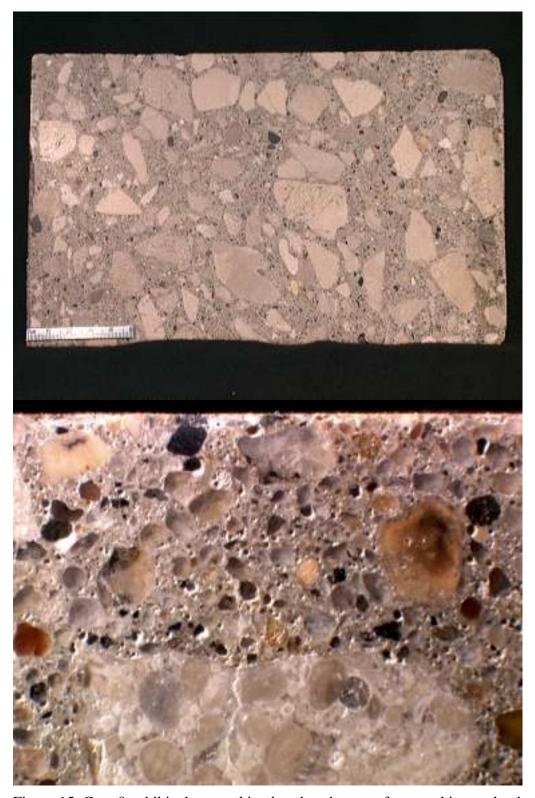
Figure 15. Core 8 exhibits less cracking but does have surface cracking to depths of 20 mm. Some of these cracks as seen in the lower image (13 mm field width) are associated with cracking within the coarse aggregate.

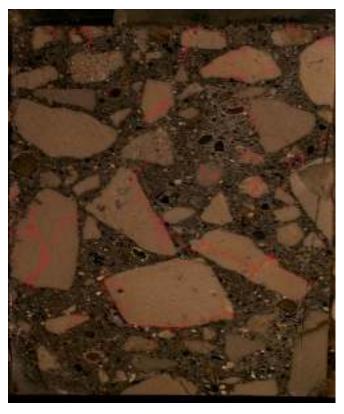
Figure 16. Cracking (red) and ASR (yellow) in Core 7 as observed using SEM. Cracking of aggregate is common. Surface cracks appear carbonated and terminate in both the mortar and the coarse aggregate. Micrograph field width is approximately 10 cm.

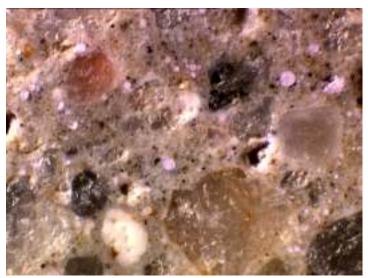
Figure 17. Filling of the smaller entrained air voids (purple) has significantly increased the air void spacing factor while only slightly decreasing the total entrained air void volume for both Cores 7 and 8. Field width: 4 mm.

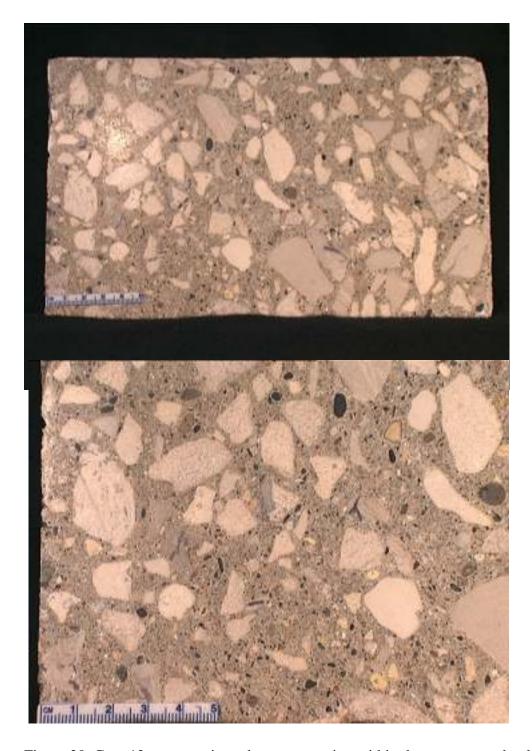
Figure 20. Core 13 cross sections show segregation within the concrete and only minor cracking of the mortar and coarse aggregate.

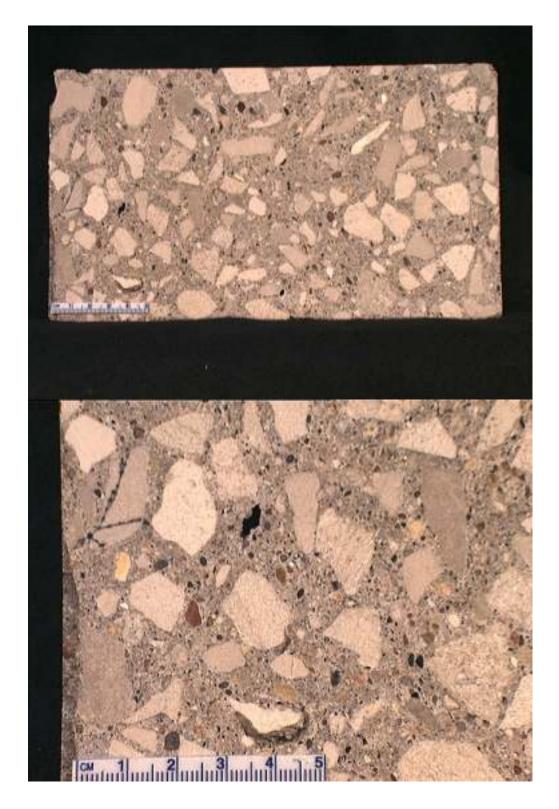
Figure 21. Core 14 exhibits some cracking of both the paste and coarse aggregate and some mortar / aggregate segregation in middle.

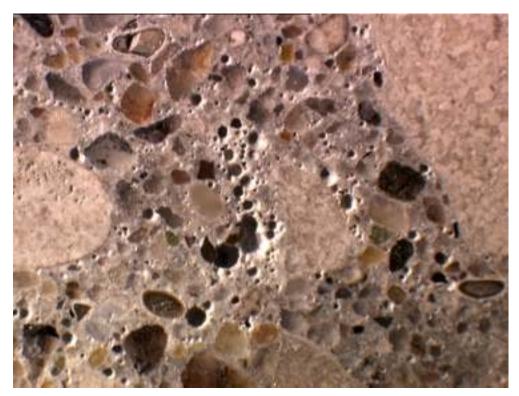
Figure 22. Clustering of air voids may indicate difficulties in mixing and development of a properly sized, disseminated entrained air void system. Field: 7 mm.

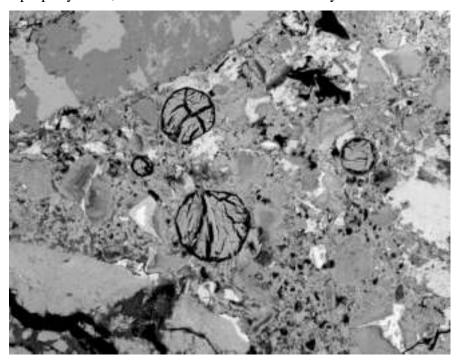
Figure 23. A SEM image of Core 13 paste shows ettringite-filled entrained air voids, the irregularly-shaped capillary voids (black), and a reactive shale grain in the lower-left. Note absence of cracking outside of this shale grain and lack of paste / aggregate gaps that would be typical of an overall paste expansion. Field:  $200 \, \mu m$ .

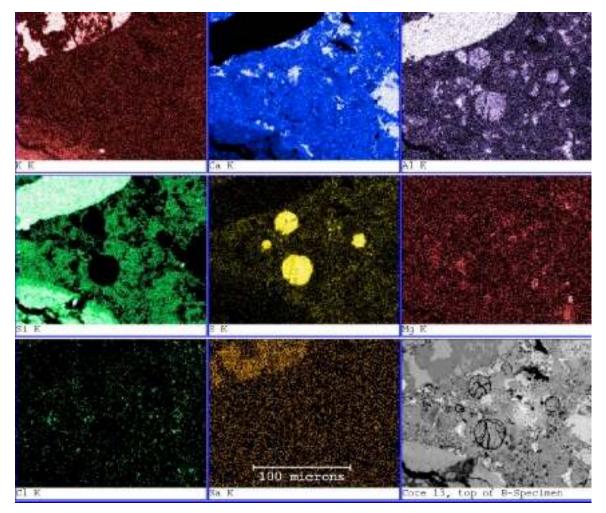
Figure 24. X-ray images corresponding to image in Figure 23. While the shale has undergone alkali-silica reaction, no cracking is apparent within the paste. Common locations of aluminum, sulfur and calcium in the X-ray images delineate ettringite.

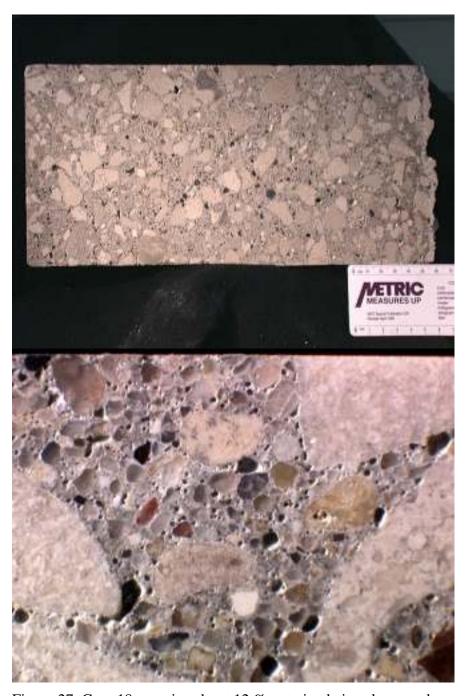
Figure 27. Core 18 contains about 12 % entrained air volume and a spacing factor of 0.08 mm. Aggregate gradation appears more uniform, and possibly smaller maximum size than the degraded pavement concretes. Low specific surface and common entrapped air voids are features common to other cores in this study.

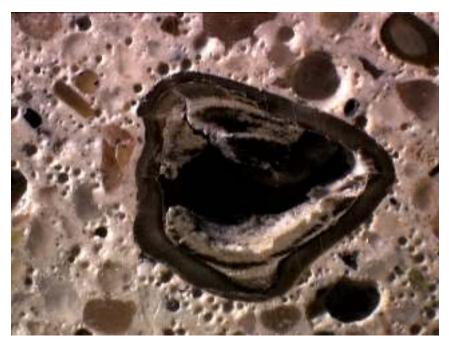
Figure 29. Core 18 mortar microstructure includes numerous shale fragments that appear to have undergone alkali-silica reaction, however little cracking of the mortar was evident. SEM examination indicated that some of the reaction product permeated the paste filling the capillary voids adjacent to the shale. Field width: 10 mm.

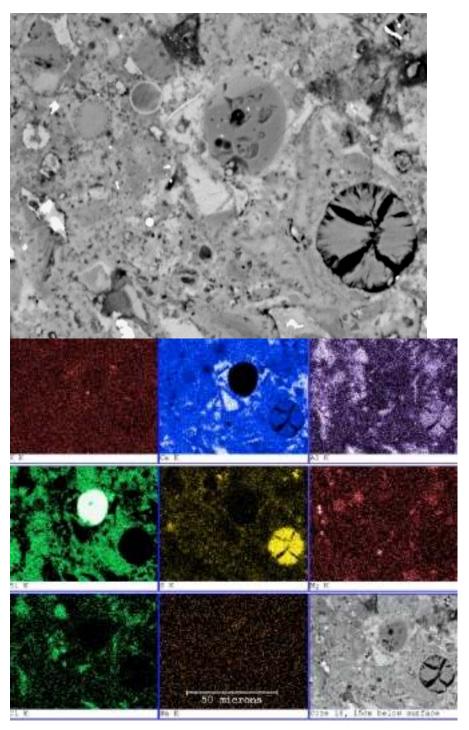
Figure 31. SEM of Core 18 shows an air void partially filled with ettringite (lower-right) and partially reacted fly ash particles (circular). X-ray element distribution (lower image) shows regions of high sulfur and aluminum that delineate locations of ettringite. Regions of chlorine and aluminum delineate regions of chloroaluminate. Field width:  $75~\mu m$ .

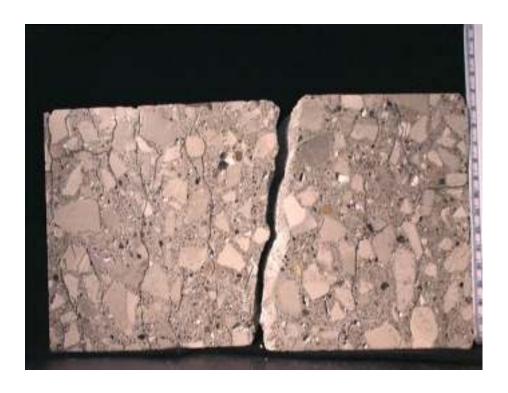
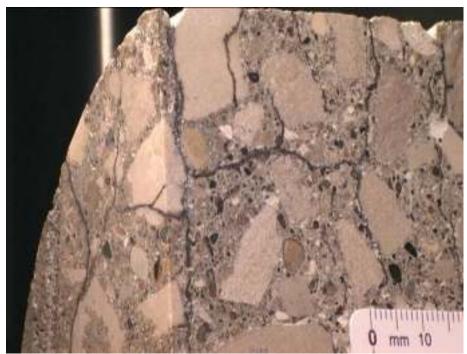
Figure 32. Core 19 exhibits extensive cracking of both the paste and coarse aggregate. Cracks trending parallel to the pavement surface (to the left) intersect perpendicular cracks; features typical of freeze-thaw cracking. The oblique view of the upper portion of core 19 shows cracking in both the surface (polished for clarity) and cross-section orientations.

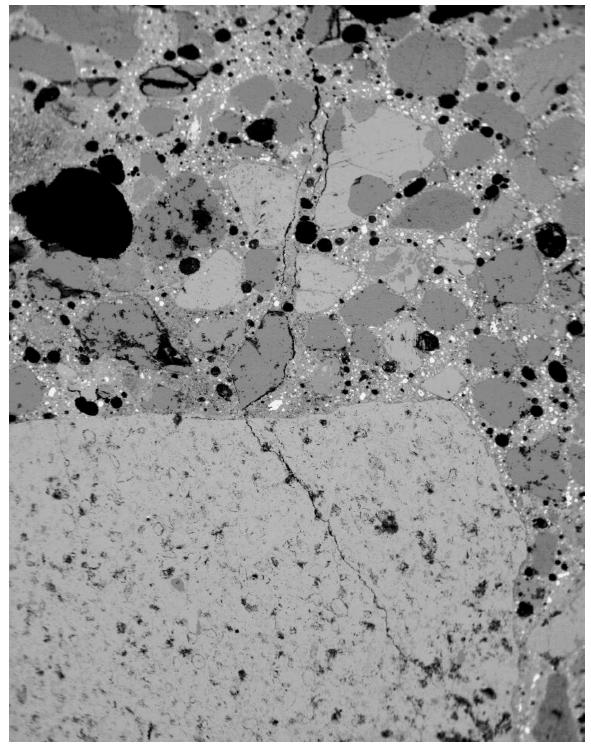
Figure 33. SEM image of a surface crack (road surface is at the top, 5 mm field width) extending through the paste portion of the mortar and terminating in a coarse aggregate.

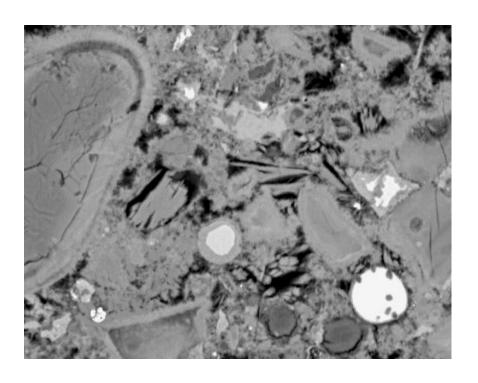
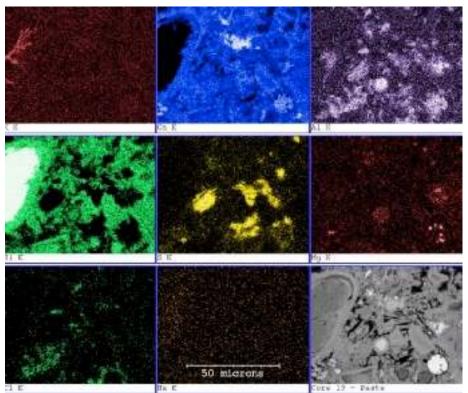
Figure 34 shows SEM images of the cement paste from Core 19. The upper, backscattered electron, image shows a region that includes a shale grain (left side), and hydration products, fly ash (circular), and pores (black). Alkali-silica reaction gel within the aggregate may be located using the potassium X-ray image (upper-left of the nine image series) yet no cracking is seen within the paste. Ettringite in the cement paste may be identified by its platy parting and by the combined X-ray images of intermediate aluminum, high sulfur, and intermediate calcium intensities. The occurrence of ettringite within the cement paste is common and may be either primary or a replacement of monosulfate. The gaps surrounding the ettringite grains are, in part, shrinkage phenomena due to the microscope vacuum but may also be a result of dissolution. The relatively large, irregular-shaped pores (black) may indicate dissolution of monosulfate and calcium hydroxide. Field examinations of this pavement did not find any evidence of overall expansion, making the occurrence of ettringite apparently innocuous. Regions of the chlorine (lower-left) and intermediate-intensity aluminum images delineate chloroaluminate, or Friedel's salt.

Figure 34. Back scattered electron image of Core 19 paste microstructure showing ASR-affected shale (left) and fly ash (circular). X-ray image regions of high sulfur (yellow) and intermediate aluminum (purple) mark locations of ettringite while regions of high chlorine (lower left image) denote locations of chloroaluminate.

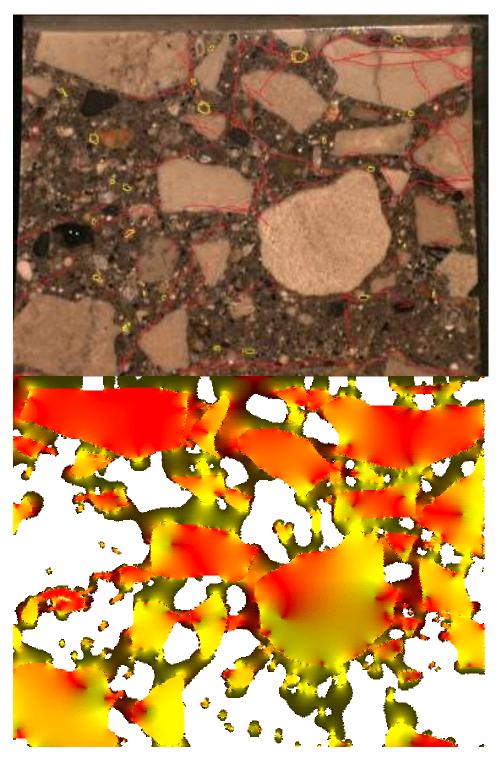
This data indicates that both coarse aggregate expansion and paste expansion may explain many of the cracks in this specimen. As no alkali-aggregate reaction products are associated with cracking in the coarse aggregate, these cracks must be attributed to freezing of water within the aggregate pore system. The paste expansion must be a result of freezing as the lack of evidence of a permanent expansion and lack of paste-aggregate interfacial zone gaps eliminates the overall, uniform paste expansion of delayed ettringite formation. Additionally, if the relatively coarser-sized pore systems of the aggregate are critically saturated, then the paste pore systems must also be saturated.

Figure 37. Top portion of core 19 with cracks (red) and ASR-affected shale grain (yellow) shows cracking through both the cement paste and coarse aggregate. A color-coded stress image resulting from a simulation of aggregate expansion showing regions of high stresses in red correlates well with some, but not all of the observed cracking.

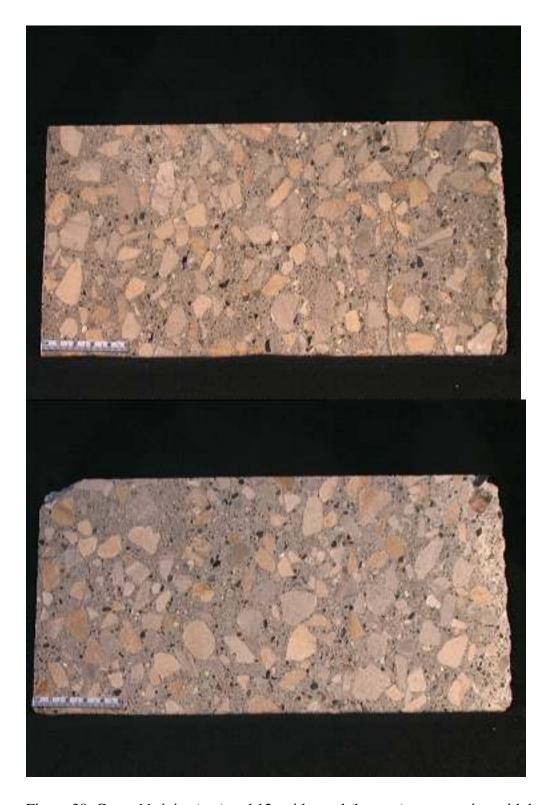
Figure 38. Cores 11, joint (top) and 12, mid-panel (bottom) cross section with horizontal crack in lower-most third. Some segregation is visible in both cores.

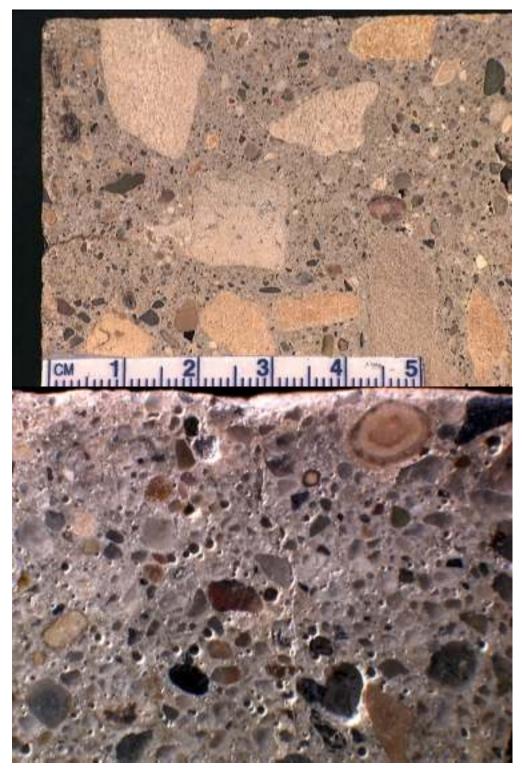
Figure 39. Surface cracking in Core 11 to about 20 mm passes through both the mortar and coarse aggregate. Lower image shows minor surface carbonation and cracking within the mortar. Field width 8 mm.

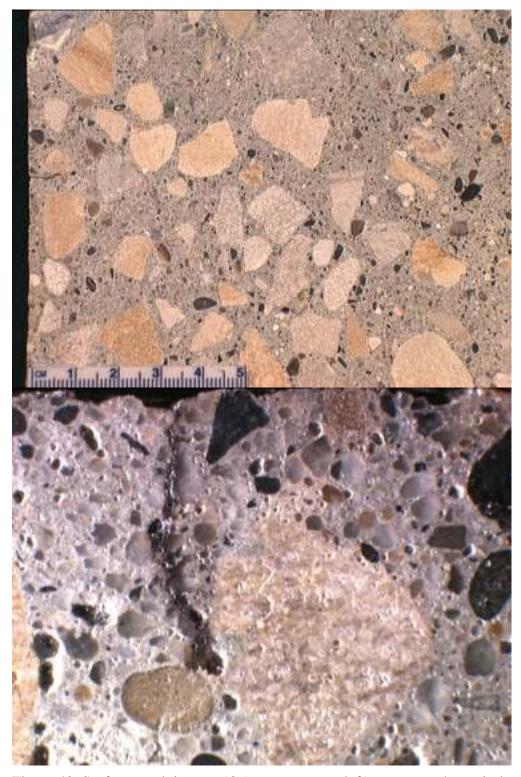
Figure 40. Surface crack in core 12 (approx. center-left) appears to be entirely within the mortar, and the lower image shows the crack plane through mortar highlighted using ink. 8 mm field width.

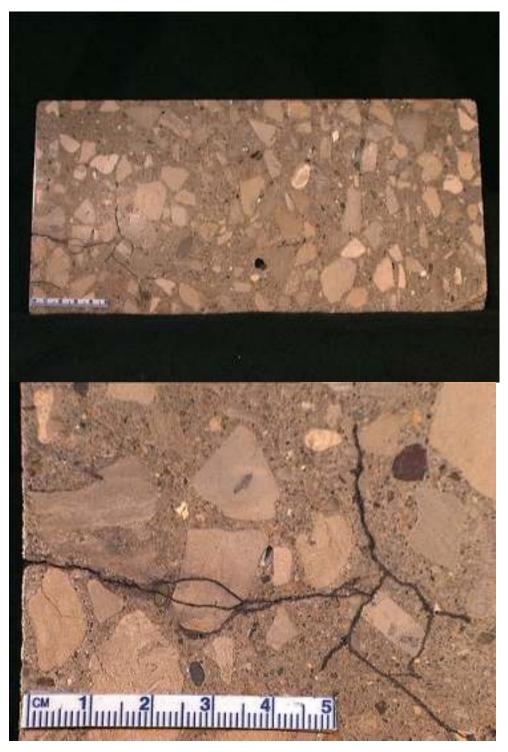
Figure 43. Core 29 cracking near surface passes through both the mortar and coarse aggregate. Cracking also follows close along paste-aggregate interface and is typical of a shrinkage crack. Cracking in aggregate and in the mortar at depth may reflect freeze-thaw damage, as the air void system in the upper half of this core is much poorer than that in the lower half.
