Direct and Indirect Influence of Mining Related Subsidence on Structural Damages - A Case Study

An investigation of causes of damages to a structure located at a toe of a hillside over an undermined area is described. The investigation included a finite element analysis and an analysis of landslide susceptibility of the hillside. Direct and Indirect influence of mining activity appears to be the cause of structural damages.

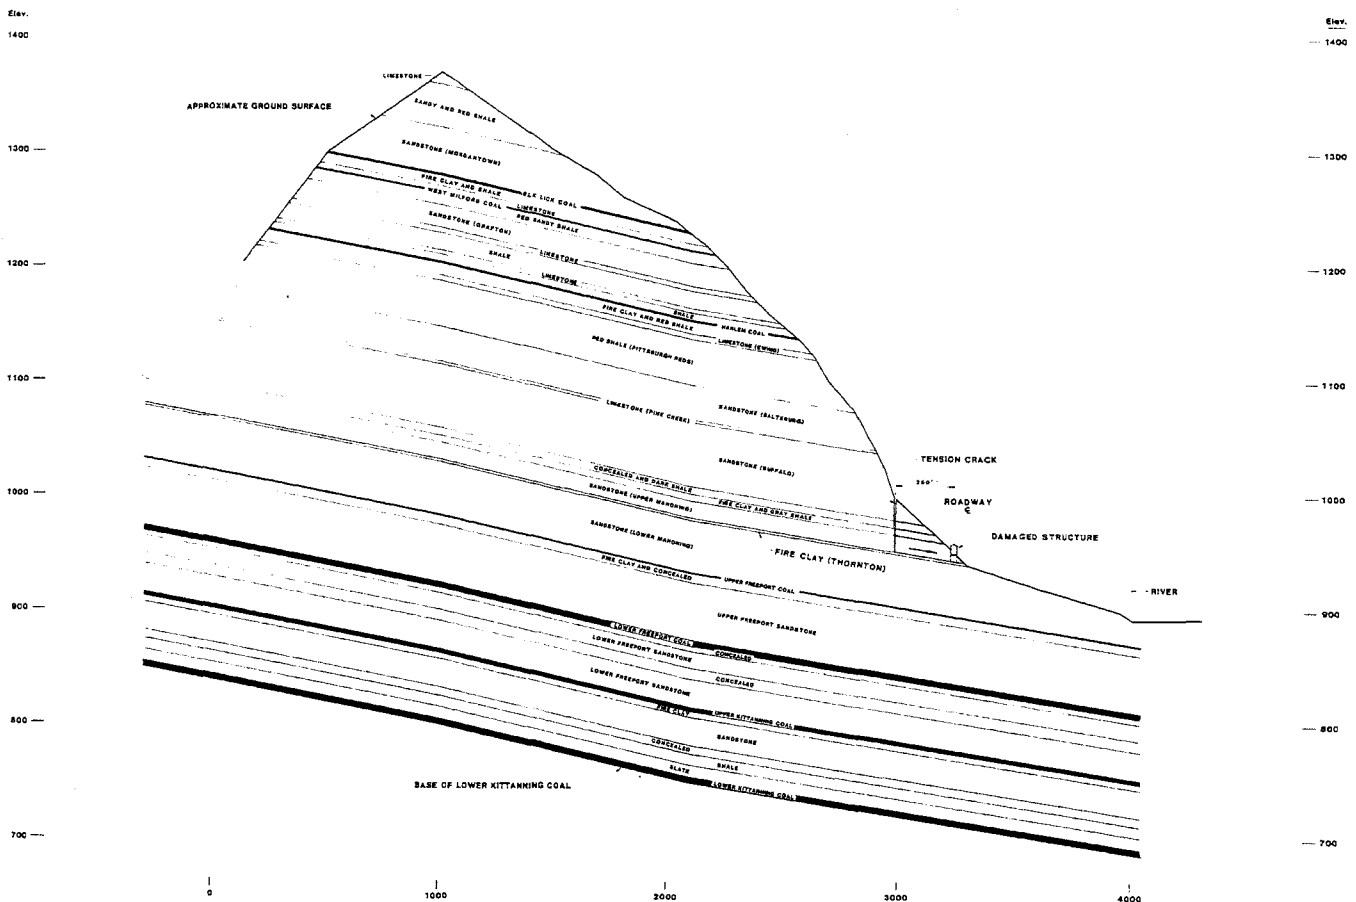
The one-story building under investigation was located at the toe of a hillside with a slope of 1 in 5 as shown in Figure 1. It was a wood frame structure with a brick veneer built over a concrete basement. There were no problems or any recognizable damage in this building for 17 years following its construction. Suddenly, some cracking in the basement was noticed, and this continued to grow worse, until the structure was abandoned due to excessive damages caused by ground movement. Damages to this structure appeared to have some links with a longwall mining activity in the Lower Kittanning coal seam which is approximately 230 feet below the elevation of the structure. After initiation of mining activity, some horizontal movements on the hillside walls of the house were noticed. This movement has continued and has caused severe damages to the structure in the form of wall and beam cracks. Subsequently, the hillside wall

Figure 1. Site Profile Showing Geologic Formation and Location of Damaged Structure at the Toe of the Hillside.

The fact that the slope behind the structure did fail with development of a block glide, described earlier, suggests that some modifications in geologic parameters did occur prior to the initiation of the observed slope movement. The geologic stratification in the hillside, Figure 1, shows the presence of Thornton fire clay (3) at about the basement level of the structure. This stratum represents a relatively weak planar surface along which the sliding could occur. The existence of the vertical crack in the ground surface behind the structure, the observed cracking in the back yard of the structure, and the presence of a potential surface of sliding, suggest that the block glide is in the form shown in Figure 1. It is highly likely that, once the tension crack developed

in the hillside, the redirected ground water coming down the hillside flowed downward into this tension crack to saturate and soften the Thornton fire clay, lowering its shear strength to the point that sliding began. Both the occurrence of the tension crack and the alterations of the ground water flow pattern represent changes in the existing geologic conditions that could have been caused by ground movements associated with subsidence.

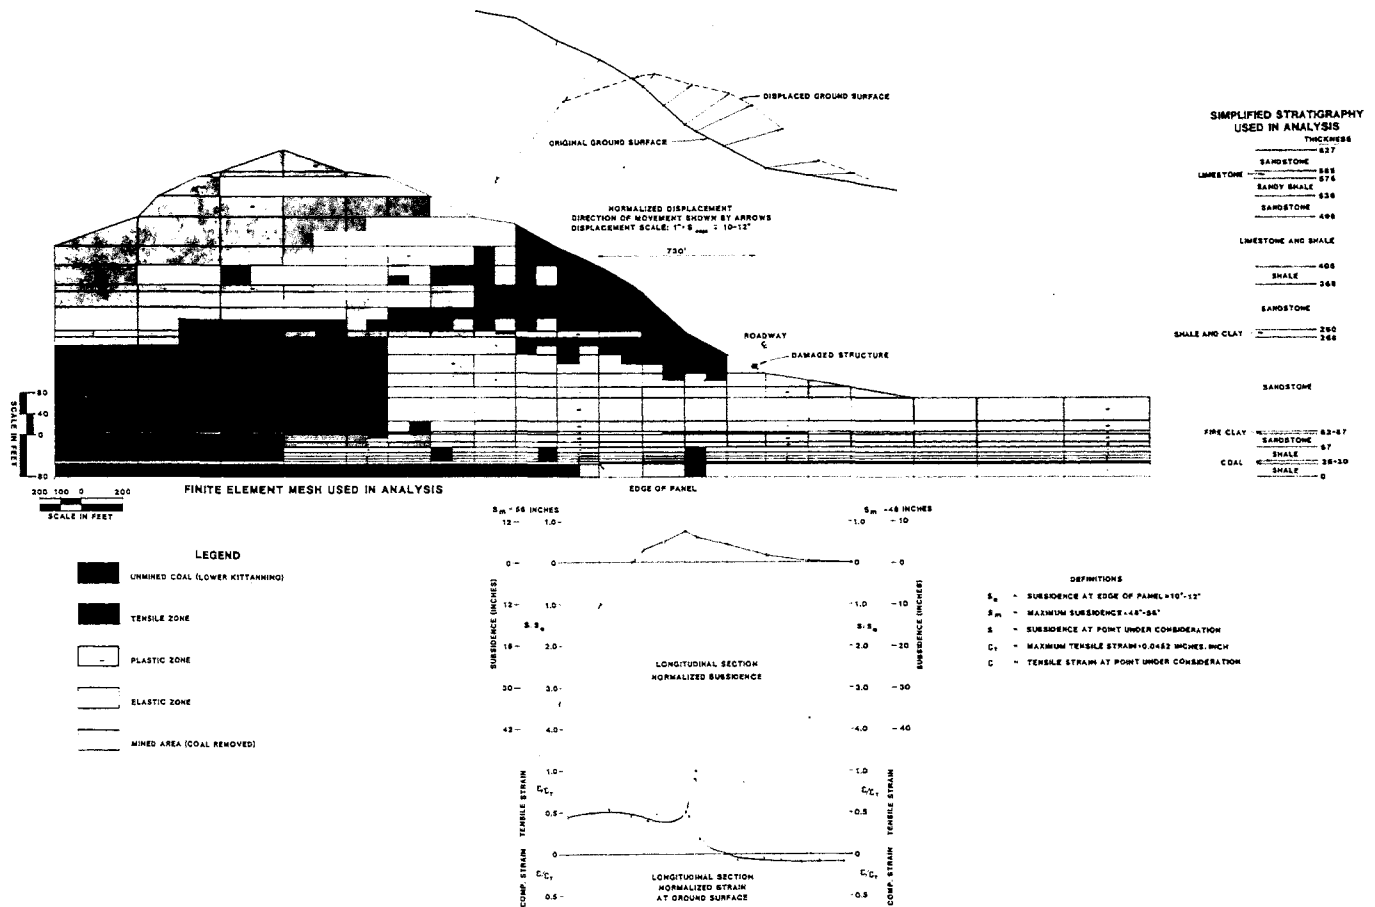
Figure 2. Finite Element Mesh Used in the Analysis, and Predicted Subsidence Profile and Tensile Zones in the Hillside.

the average length of the panels was taken as 5295 feet based on the available mine maps. The location of the structure relative to the mine panels is shown in Figure 2. The idealized geologic profile and the finite element mesh used in the analysis are shown in Figure 2. The overburden height at the edge of the mine is about 400 feet. The material properties used in the analysis are given in Ref. (8). These properties for each material are based on average properties reported by several researchers, as presented by Siriwardane and Amanat (8). Details of the analysis are also presented in reference (8), and only the results from the analysis of the longitudinal section are presented herein. The longitudinal analysis was carried out in three sequences (mining stages) in order to account for material nonlinearities. This incremental analysis provided information on the propagation of plastic and tensile zones in addition to providing displacements and stresses. The computed normalized subsidence profile is shown in Figure 2. The subsidence profile was normalized with respect to the vertical subsidence, S_{edge} , at the ground surface right above the edge of the mine, in order to display the relative deformations elsewhere with respect to a point at which there is obviously direct influence of the mining operation. The magnitude of the maximum subsidence over the mine area was estimated as 48 to 56 inches based on the information given in references (5 and 9). Thus, the subsidence at the edge of the mine could be expected to be 10 to 12 inches. The subsidence profile shown in Figure 2 indicates that there would be about 2 inches of heave at the location of the damaged structure. The predicted resultant of vertical and horizontal displacements is shown in Figure 2. Unlike the situation that can be expected with a horizontal ground surface, the predictions show large horizontal displacements, in excess of 12 inches near the location of the structure.

The developments of plastic and tensile zones resulting from the mining activity are also shown in Figure 2. It can be seen that a large tensile zone is developed behind the location of the structure. The tensile strain profile, Fig. 2, at the ground surface indicated that a very large tensile strain is developed at about 250 to 300 feet behind the structure. It is significant that this is also the approximate location of the large vertical crack that was observed in the hillside behind the structure.

The results of the finite element analysis of mining effects show very clearly that the location of the structure has been subjected to heaving and relatively large horizontal displacements as a result of the nearby long-wall mining operation. These horizontal ground movements explain the structural damages that were observed even before noticing any ground cracking. The sliding movement (block glide) behind the structure caused increased structural damages. The data would suggest that it was the tensile crack that triggered the block glide by permitting the hillside seepage to flow into the crack, lubricating the Thornton fire clay and resulting in the sliding movement.
