Dynamic investigation on the Mirandola bell tower in post-earthquake scenarios

Abstract After the seismic events of the 20th and 29th of May 2012 in Emilia (Italy), most of the monumental and historic buildings of the area were severely damaged. In a few structures, partial collapse mechanisms were observed (e.g. façade tilting, out-of-plane overturning of panels...). This paper presents the case-study of the bell tower of the Santa Maria Maggiore cathedral, located in Mirandola (Italy). The dynamic response of the structure was evaluated through operational modal analysis using ambient vibrations, a consolidated non-destructive procedure that estimates the dynamic parameters of the bell-tower. The dynamic tests were carried out in pre-intervention and post-intervention conditions in order to understand the sensitivity of dynamic measurements to safety interventions. Furthermore, a comparative study is made with similar cases of undamaged masonry towers up to the 6th mode. Finally, an investigation on the state of connections and of the building itself is carried out via FE model updating.

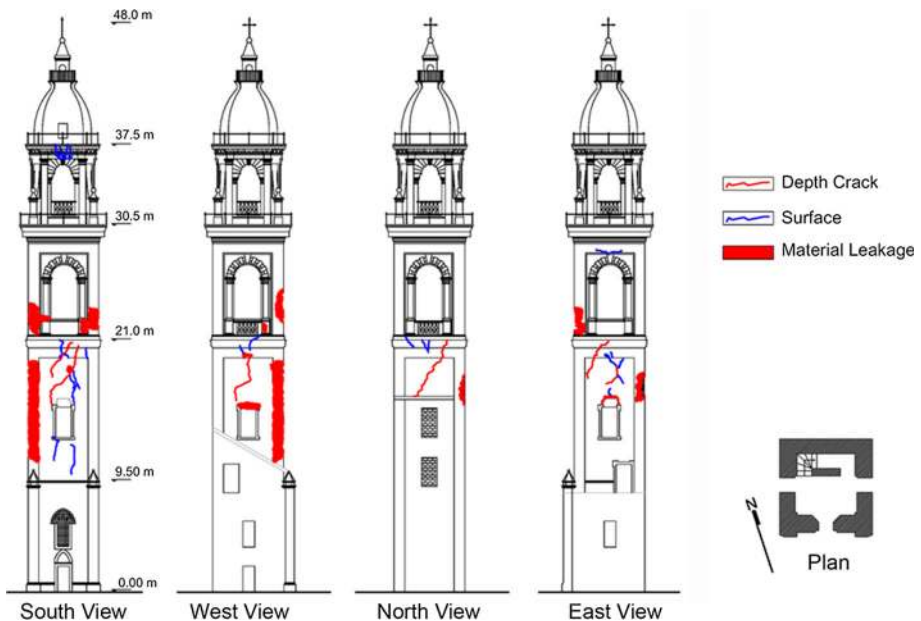
The May 2012 Emilia earthquake sequence severely damaged the cathedral, with two events on May 20th and 29th. The epicentre of the May 29th event was less than 1 km far from the site of the bell tower, which led to massive destruction to the historical city centre of Mirandola. It resulted in the collapse of the aisle, the side aisle, the roof and in several cracks on the bell-tower (Fig. 2).

An exterior laser scanner survey of the cracking patterns, carried out by the INGV (Istituto Nazionale di Geofisica e Vulcanologia) within the ILRIS 3D project (Pesci et al. 2012), highlighted the activation of a twisting mechanism leading to a rotation of about 1 degree of the building portion located between 20 and 32 m. The structural damages are mainly concentrated in this section of the bell tower, where deep diagonal cracks right below the first order of openings on all four sides can be noted, extending down to the openings of the underlying level. Furthermore, various lintels failed on the South, West and East fronts. The twisting mechanism and the high local stresses caused the crushing of masonry near the area of the tower in contact with the adjacent building, especially at the

Fig. 2 Post-earthquake damage survey of the Mirandola bell-tower

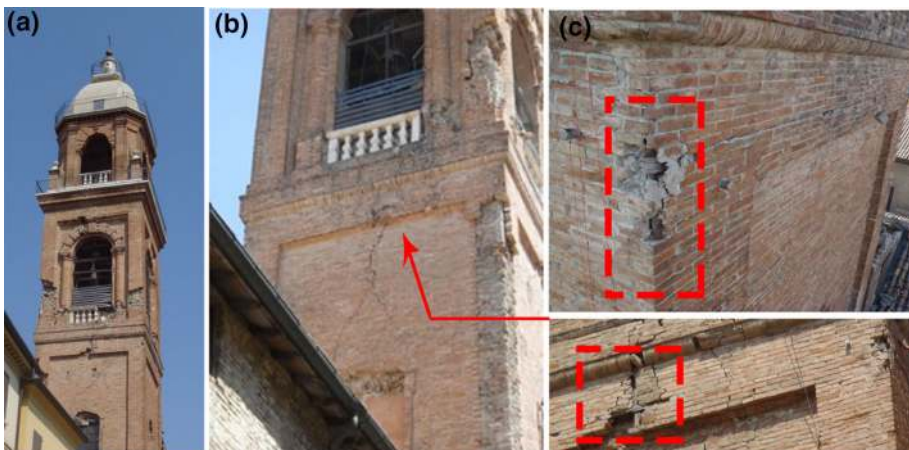
height of 21 m (Fig. 3a, b). Metal chains were revealed by the occurred damages inside the masonry layer around the perimeter at the base of this level of the structure, as shown in (Fig. 3c). The visual and laser scanner surveys did not confirm for the other levels.

Fig. 3 Damage at the level of the belfry of the bell-tower (a, b) and the metal chains (c) at 20 m

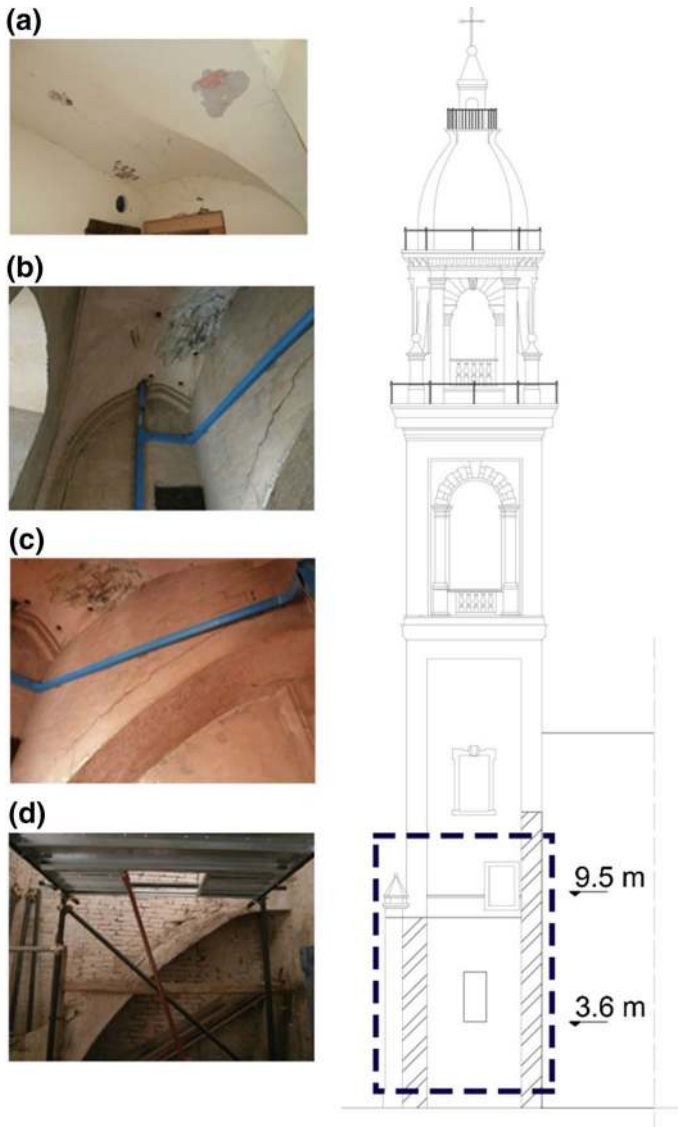
The internal state of the bell tower was assessed by visual inspection and this was compared to the laser scanner survey. Only two masonry vaults in the basement are still standing with clearly visible cracks (Fig. 4a, b). The internal staircases are partially collapsed and only the flight between 0 and 9.5 m (Fig. 4c) is still accessible. From this level up to the belfry all ceilings and stairs are collapsed as can be seen in Fig. 4d which depicts the remains of a flight of stairs at 9.5 m of height.

Fig. 4 Damage on vaulted slabs at 3.6 m (a) and at 9.5 m (b) and internal staircase (c, d)

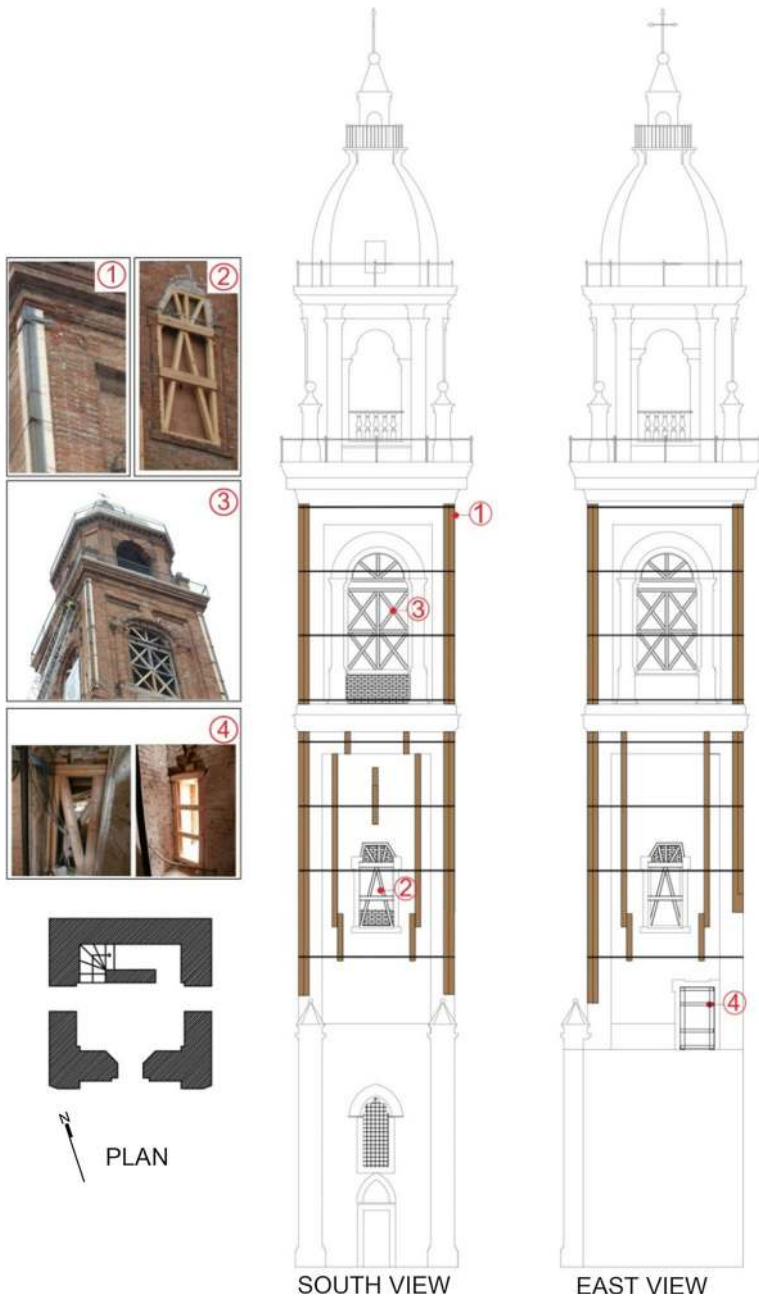
Fig. 5 Post-earthquake provisional safety-interventions: metal tie rods (1), wooden falsework in the small opening of the first and second level (2, 4), wooden falsework in the large opening of the third level (3)

In order to guarantee the stability of the building and to avoid further damages, provisional post-earthquake safety interventions were put in place by the authorities between the 14th and the 18th August 2012. The bell-tower of S. Maria Maggiore was reinforced with eight metal tie-rods located at two levels of the structure (see Fig. 5-1). Moreover, the main and large openings were reinforced using wooden falseworks, as shown in Fig. 5-2, 3, together with wooden ribs in the smaller openings (Fig. 5-4).
