Earthquakes and Structural Damages

Burak Yön, Erkut Sayın and Onur Onat

Abstract

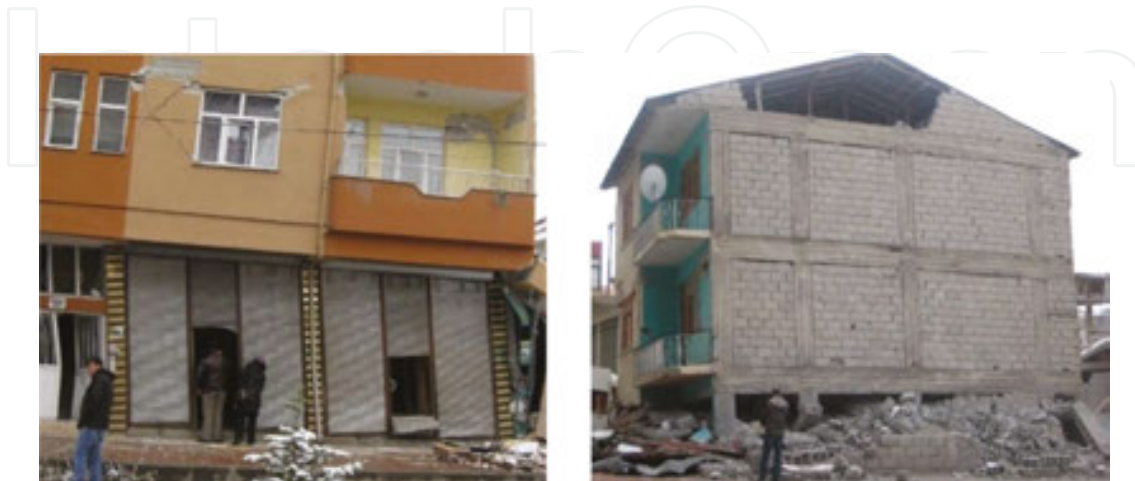
In some R/C buildings, especially at the ground floor, walls may not be continuous along to height of building for architectural, functional, and commercial reasons. While ground floor generally encloses with glass window instead of brick infill walls, partition walls are constructed above from this storey for separating rooms for the residential usage. This situation causes brittle failures at the end of the columns. In mid-rise reinforced concrete buildings, the most common failure mode is soft-storey mechanism, particularly at the first storey. Failures can be concentrated at any story called as weak storey in which the lateral strength changes suddenly between adjacent stories due to lack of or removing of partition walls or decreasing of cross section of columns. Thus, during an earthquake, partial and total collapses occur in these storeys. These types of damages can be seen in **Figures 10** and **11**.

Figure 10. Unexpected inter-storey drift due to soft storey during the Van earthquake.

the ground floor is lower than the upper storeys. Thus, this failure mechanism is triggered by earthquake. This type of failure is prevented during design phase by designing with more detail.

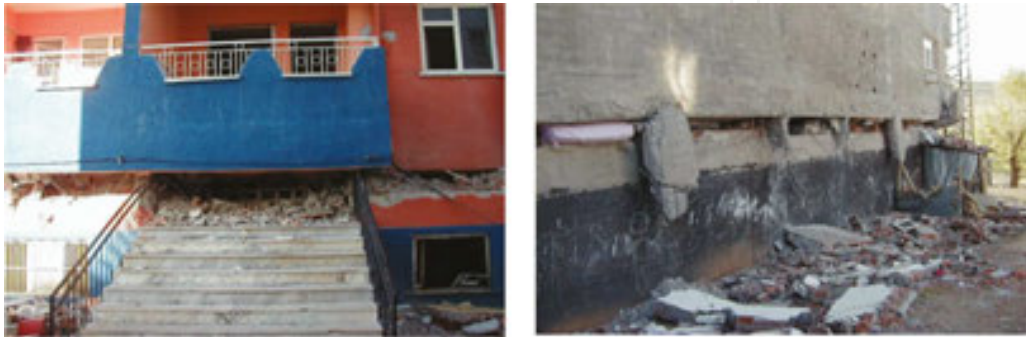
Figure 11. Weak storey mechanism during the Bingöl earthquake.

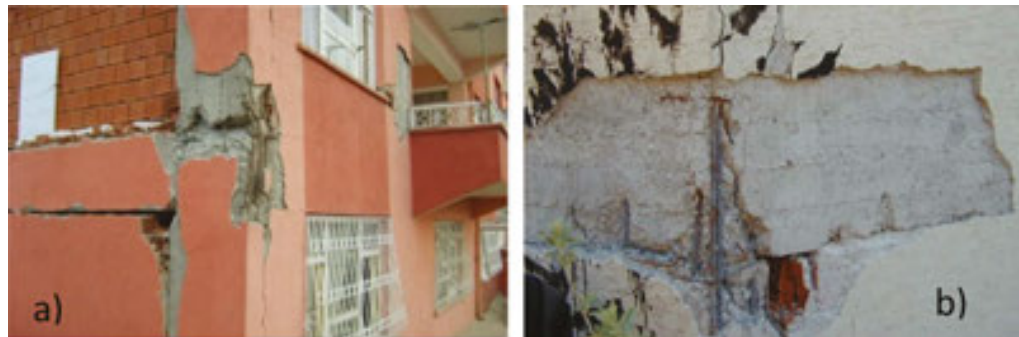
Shear forces increase during an earthquake especially at columns and beam–column joints. Consequently, special attention should be paid to construction and design of beam–column joints and columns. Seismic design requires increasing of ductility of structures for performance-based design approach. In particular, columns of buildings can be having insufficient transverse reinforcement in the plastic hinge region. Therefore, structural elements which have such details show low performance against to dynamic loads and lost their shear and axial load carrying capacity. **Figure 12** shows this failure below.

Figure 12. Damaged structure due to inadequate spacing between shear reinforcements during (a) Van earthquake and (b) Bingöl earthquake.

- Inadequate transverse reinforcement and no bending of hooks of ties in structural elements cause damages. This problem can be solved by using close-spaced stirrups and 135° bended hooks to increase shear resistance of structural elements.

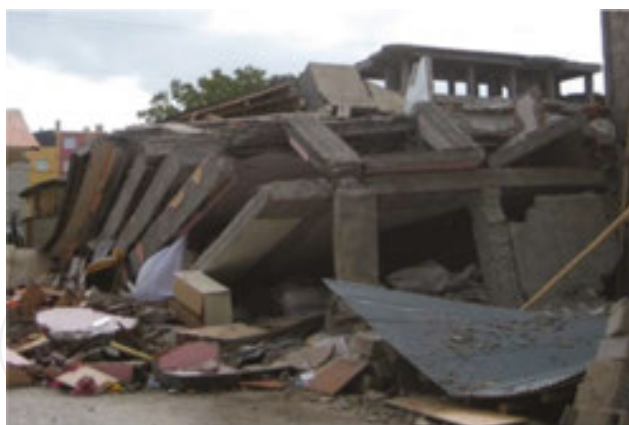
Deep and rigid beams are used with flexible columns in type of buildings. Therefore, these beams resist more moments, occurred by dynamic loads, than weak columns. In such a design during an earthquake while deep and rigid beams show elastic behavior, shear failure or compression crushing causes plastic hinges at flexible columns. Failure mechanism of strong beam–weak column can be seen in **Figure 15**.

Figure 15. Failure of a building due to strong beam–weak column effect during the Van earthquake.

- When deep and rigid beams are used with flexible columns, weak column–strong beam failure mechanism is developed. To refrain this type of problem, sum of moments at column connected to any of joint should be bigger than sum of moments at beam connected to the same joint.

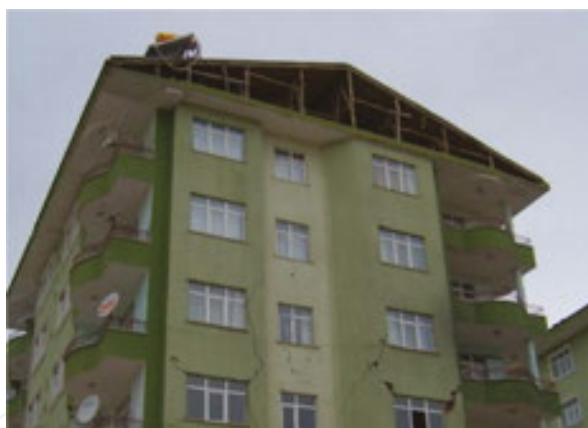
The most common failure mode at gable walls is out-of-plane collapse in the earthquakes. Although failures of gable walls are not structural damages, these damages may be cause loss of lives and properties. Stability problems and large unsupported wall lengths cause damages at these walls. Failure of gabble wall is presented in **Figure 16**.

Figure 16. Failure of gabble walls on top of the building during the Van earthquake.

- The reason of in-plane, out-of-plane, and gable wall failures is lower strength of infill materials than reinforced concrete frame. To prevent this type of failure, adequate connection and high-strength mortar between wall and reinforced concrete frame should be used.

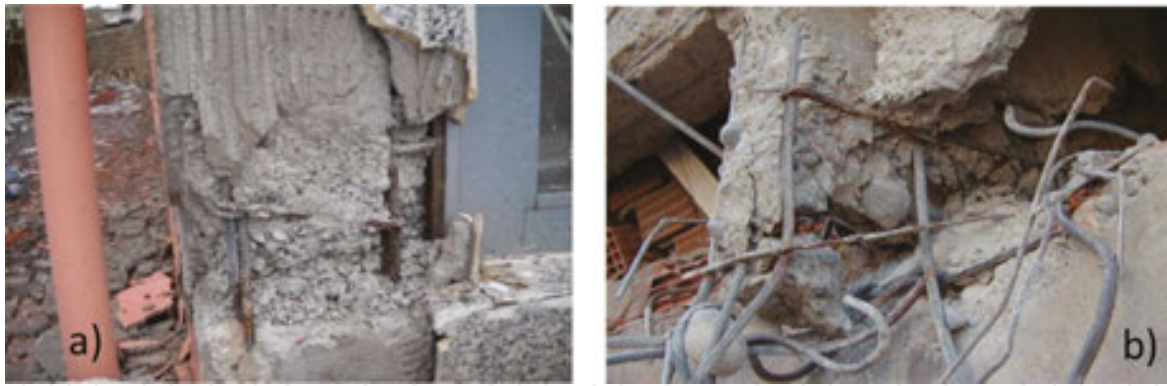
The other main reasons of damages are low concrete strength and workmanship. Concrete quality is an important factor for building performance against to earthquakes. Handmade concrete is used to without using vibrator in construction of old buildings. Thus, homogeny mixing was not obtained and expected compressive strength was not provided in these buildings. In addition to this, using of aggregates which have improper granulometry, corrosion which decreases reinforcement bar area, and using of smooth steel reinforcement effected strength of concrete. This type of damages is given in **Figure 17**.

Figure 17. Failure of column due to poor concrete quality during; (a) Van earthquake and (b) Bingöl earthquake.

- Low concrete strength, workmanship, and corrosion of steel bars decrease the lateral stiffness of the structural system. This important reason can be eliminated by inspecting concrete and workmanship.

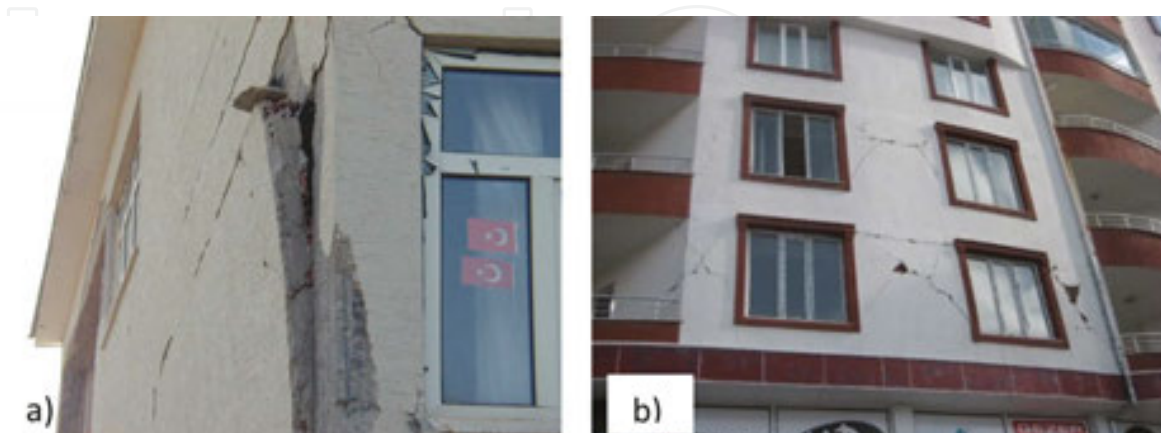
One of the most important reasons of life and economic loss during the earthquake is combined effect of in-plane and out-of-plane movement of the wall. In-plane and out-of-plane interaction is very complicated and should be analyzed well for this phenomena. For low-rise and mid-rise unreinforced masonry (URM) infilled R/C frames, ground story infill walls are expected to be damaged firstly, because they are subjected to the highest in-plane demands. However, under the effect of bidirectional loading, where the two components of a ground motion are equally significant, infill walls of the upper stories may fail under the combination of in-plane and out-of-plane effects. The in-plane demand reduces at the upper stories, while that of out-of-plane forces increases due to the increase of accelerations [40]. To prevent this problem, in-plane carrying capacity of the wall should increase and out-of-plane ductility should increase with possible and applicable developments like bed-joint reinforcements and wire mesh. These listed applications will prevent detachment of infill wall from reinforced concrete elements and will increase the stiffness of the total structural system. **Figure 18** shows out-of-plane and in-plane damages.

Figure 18. (a) Detachment of infill wall during the Bingöl earthquake and (b) In-plane damage of during the Van earthquake.

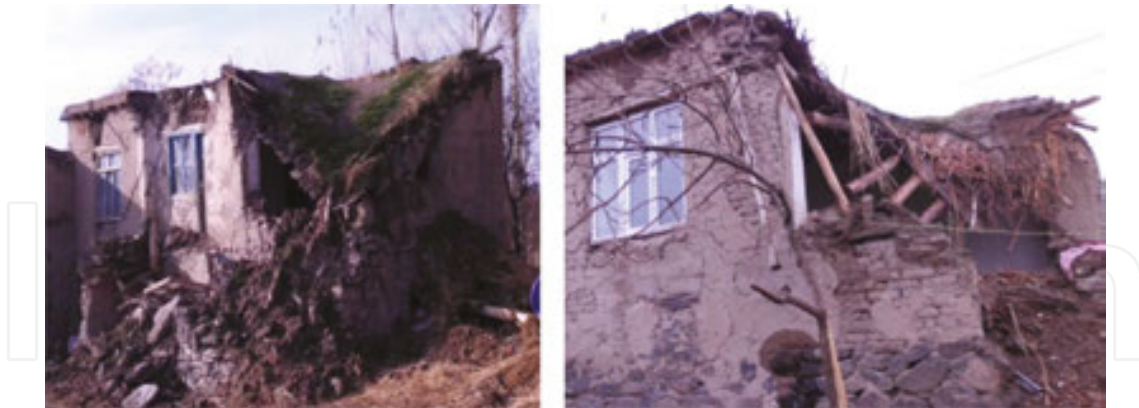
Generally, earthen roofs are constructed over wooden logs supported by two main walls of the buildings to provide thermal and water insulation. Also, heavy earthen roofs are constructed by the residents because a thick roof keeps the house cool or warm according to the seasons. However, these roofs lose their effectiveness because of weather conditions, such as rain and snow. Therefore, the residents place a new earthen cover on top of the existing roof to repair these roofs [16]. Thus, the weight and thickness of the roof increase over time. As a result of these heavy roofs, the structures are subjected to larger inertia forces during the earthquakes [41]. During the horizontal displacements, these heavy roofs are very vulnerable since they can easily slide over the walls [30]. **Figure 19** shows the damaged masonry buildings arising from heavy earthen roof at various earthquakes.

Figure 19. Damage to adobe structures due to heavy earthen roof during the Van earthquake [42].

- Thick and heavy earthen roofs are one of the reasons for the damages. The walls of the buildings could not support heavy mass during an earthquake, and the heavy roof partially or completely collapsed. This type of application should be refrained.

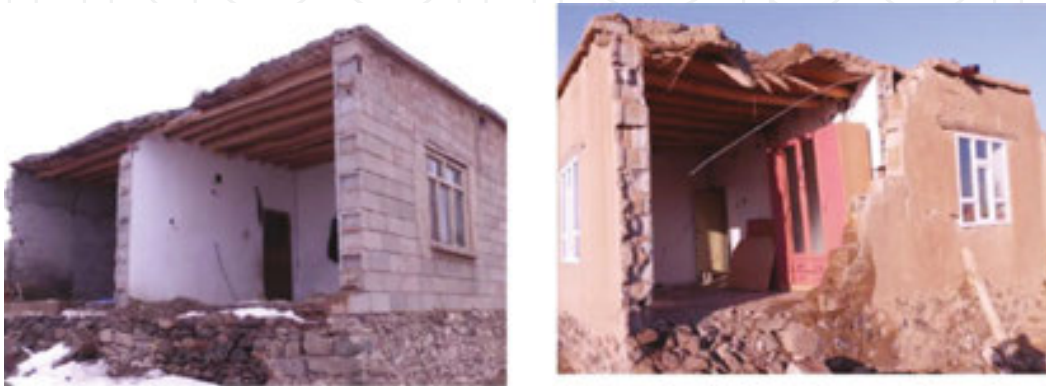
Out-of-plane mechanism may appear from the combination of several deficiencies. A lack of bond beams, poor connections among the walls and the roofs, and large unsupported wall lengths cause the separation of walls and cause damage to occur via the of out-of-plane mechanism. Thus, the whole or the significant parts of the wall fall down during the earthquake. Wooden logs that bear the weight of the floor of the building are generally placed on load-bearing walls in only one direction. Thus, earthquake loads are transferred to perpendicular walls by wooden logs. Therefore, the walls that are not supported by the wooden logs may easily overturn to out-of-plane direction during the earthquake. This failure mechanism can be commonly observed in the earthquake region. **Figure 21** shows the out-of-plane mechanism of the adobe and briquette masonry buildings, respectively.

Figure 21. Out-of-plane mechanism of the brick buildings [42].

- Another reason for the damages is the out-of-plane mechanism. The main reasons for this mechanism are the lack of bond beams, poor connections among the walls and roofs, and large unsupported wall lengths. Also, the gable walls of some masonry buildings are affected negatively by the out-of-plane mechanism. This problem can be eliminated by using proper connection defined in current codes. Constructing long and unsupported walls should be refrained. In addition to this, vertical and horizontal bond beams should be used.

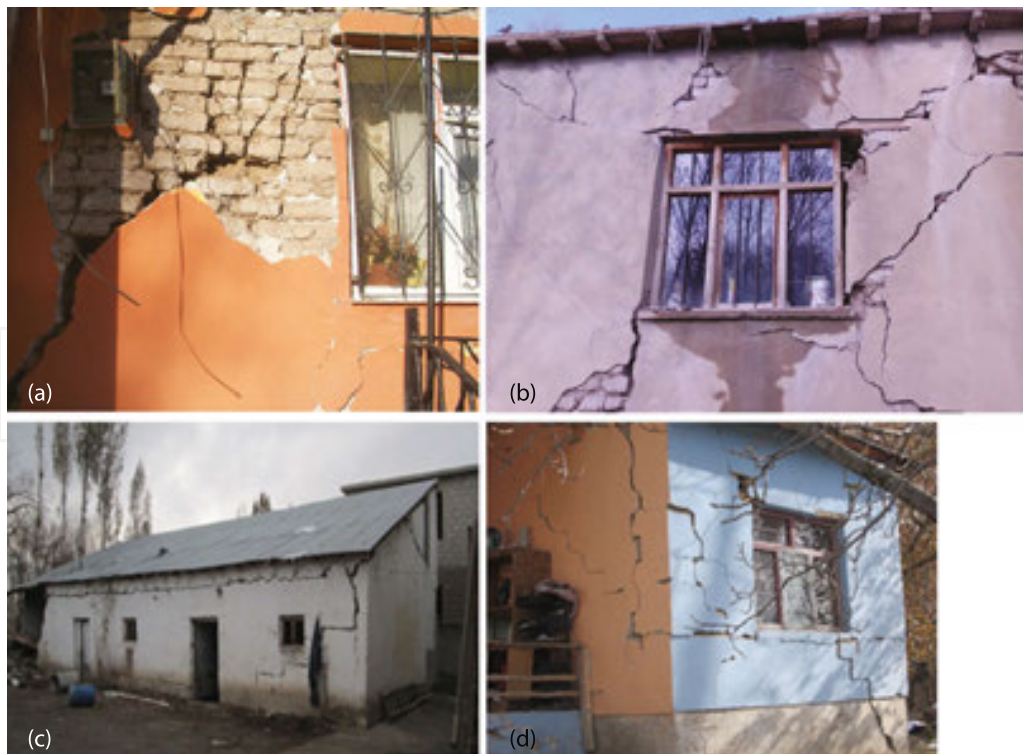
The seismic performance of the masonry buildings relates to the in-plane stiffness of the walls. In-plane mechanism is generally observed in most of the masonry buildings that are affected by shear cracking. Earthquake loads increase the shear force. It can damage walls and their connections. These damages generally occur near openings, because most of the masonry

buildings don't have sufficient and proper bond beams that distribute the lateral forces uniformly and enhance the lateral strength of the walls. During the earthquakes, excessive bending and shear can produce in-plane failures depending on the aspect ratio of the unreinforced masonry elements [41]. In the areas struck by earthquake, three failure modes of the shear damages in masonry buildings are generally observed, namely diagonal shear failures that proceed through masonry units and mortar (**Figure 22a–b**), sliding consisting of straight failure at the horizontal bed joints (**Figure 22c**), and stepped failures from the head to bed or bed to head joints (**Figure 22d**).

Figure 22. Diagonal shear (a-b), horizontal (c) and stepped (d) failures wall [42].

- However, a lack of bond beams and large openings that decrease the stiffness of the walls increase the shear effects and cause in-plane failures, such as diagonal shear failures, sliding consisting of straight cracks, and stepped failures. It should be refrained to construct large

window and door openings. In addition to this measure, vertical bond beams should be constructed near the openings.
