NASA TN D-8411

EFFECT OF LOW-VELOCITY IMPACT DAMAGE ON THE COMPRESSIVE STRENGTH OF GRAPHITE-EPOXY HAT-STIFFENED PANELS

*Marvin D. Rhodes, Jerry G. Williams,
and James H. Starnes, Jr.*

*Langley Research Center
Hampton, Va. 23665*

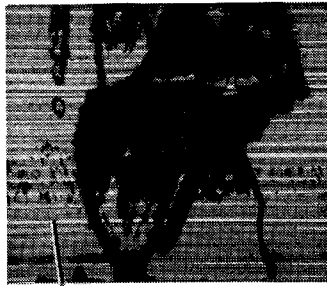
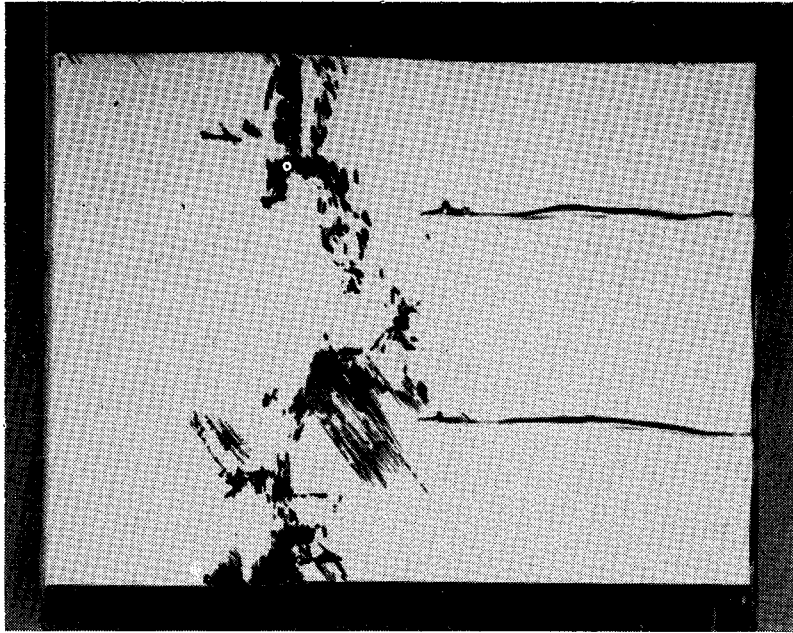
Photographs of the moiré-fringe pattern of panel A4 loaded prior to failure and of the failed panel are shown in figure 7. The moiré-fringe pattern (fig. 7(a)) is similar to that of the undamaged panel A1 (fig. 3(a)). The dark

spot in the center of the panel is the impact location where the paint has been removed for post impact inspection. Figure 7(b) indicates that the panel failure region is extensive and includes the impact location. The panel was inspected ultrasonically prior to failure, and a photograph of the oscilloscope record for the region in the vicinity of the impact location is shown in the insert of figure 7(a). The area represented by the insert is outlined on the photograph. The dark area shown in the insert indicates subsurface damage in the panel. This area is about 6.35 cm long and about as wide as the region beneath the hat which contains 0° plies. The results of tests on panels A4 and A5 were similar and both panels failed at applied strains near their design strain level (0.0034).

(a) Photograph of moiré-fringe pattern of buckled panel at applied axial strain of 0.0035. Insert shows region of subsurface damage.

(b) Panel after failure.

Figure 7.- Panel A4 (after impact in high-axial-stiffness region while at zero applied axial strain) before and after failure.

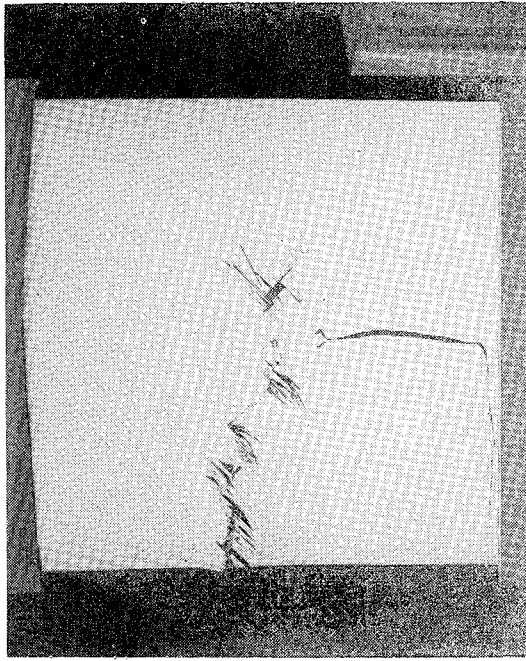
Photographs of the moiré-fringe pattern prior to failure and of the failed panel B6 are shown in figure 8. A small circular pattern in the region of impact was observed with the moiré-fringe technique indicating the presence of local damage. The development of this fringe pattern and an examination of the panel failure indicate that the impact damage precipitated the panel failure. Failure occurred at an applied strain of 0.0043 which is about 54 percent of the design value.

(a) Photograph of moiré-fringe pattern at applied axial strain of 0.0041 showing development of fringe pattern near point of impact. Insert shows region typical of subsurface damage in similar test panel.

(b) Panel after failure.

Figure 8.- Panel B6 (after impact in high-axial-stiffness region while at applied strain of 0.0003) before and after failure.

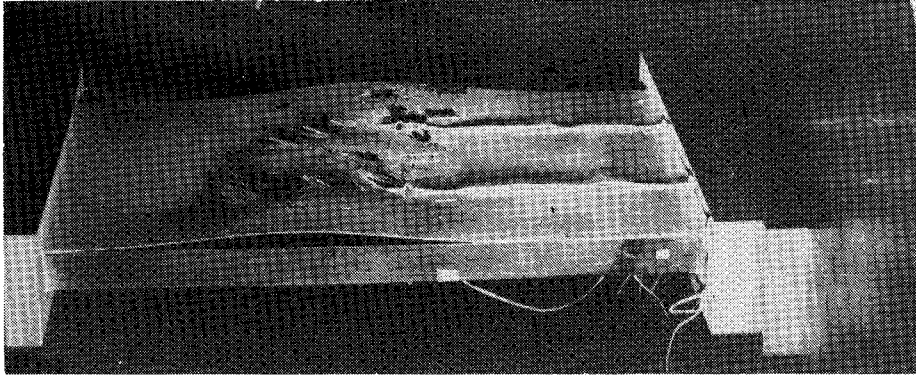
High axial strain at impact: Test panels A3, B7, and B8 were damaged by impact with a high axial load applied. (See table II.) Panels A3 and B7 which had an applied axial strain of 0.0034 and 0.0030, respectively, had a large region of visually detectable damage in the impact area. Instrumentation monitoring applied load indicated both panels had significant load reductions at impact due to loss in panel stiffness (table II). Both were subsequently loaded to failure to determine the panel residual strength. Panel A3 was ultrasonically inspected prior to the residual strength test and an extensive region of subsurface damage was detected. A photograph of the moiré-fringe pattern of the panel loaded prior to failure is shown in figure 10(a) where the subsurface-damage region is outlined. Even though the damage in panel A3 is extensive, it buckled at an applied strain near the design level and carried additional load after buckling similar to the undamaged panels. The panel failed in the region of the impact damage (fig. 10(b)) at an applied strain of 0.0037. Comparison of panel A3 with panels A4 and A5, all of which were designed for a load of 0.53 MN/m at an axial strain of 0.0034, indicates that

(a) Photograph of moiré-fringe pattern of buckled panel at applied axial strain of 0.0031.

(b) Panel after failure.

Figure 10.- Panel A3 (after impact in high-axial-stiffness region while at applied strain of 0.0034) before and after failure.

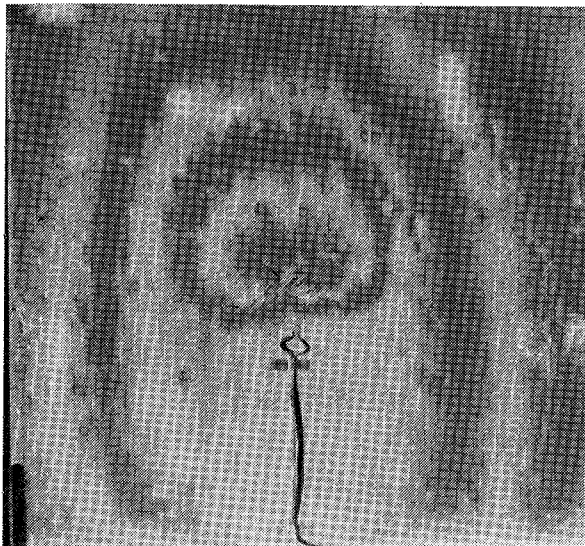
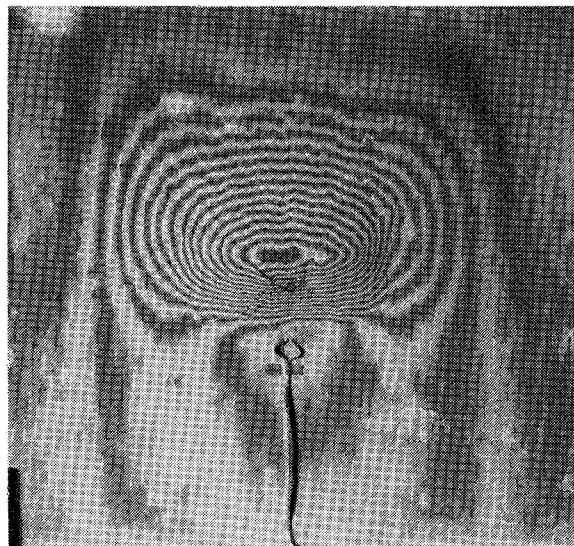
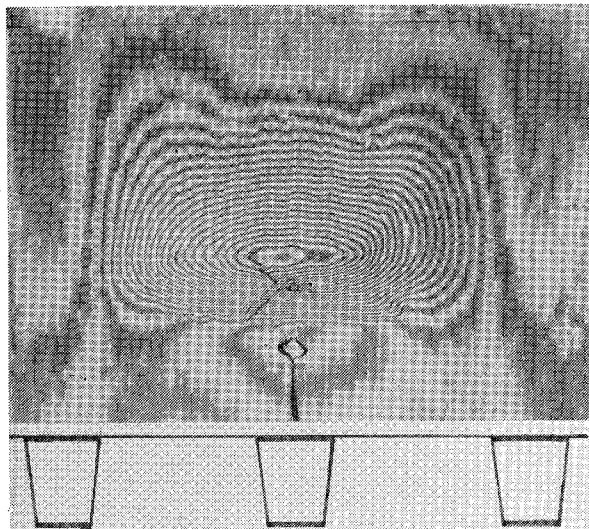
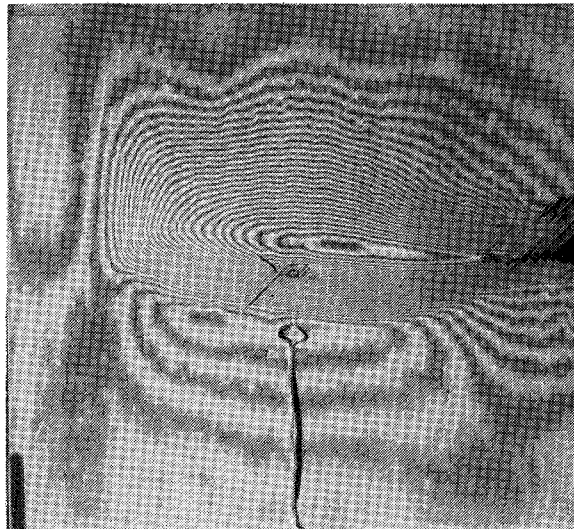
Several photographs of the moiré-fringe pattern taken during the residual strength test of panel B7 are shown in figure 11 along with a photograph of the failed panel. The moiré-fringe pattern shows considerable lateral deformation of the panel center, which may be due to impact-induced delamination or skin buckling. When the panel was damaged by impact, a reduction in applied load of 28.9 kN was measured. The 28.9-kN load reduction approximately corresponds to the load which the high-axial-stiffness region beneath the center stiffener is calculated to carry for an imposed strain of 0.0030. The panel failed at an applied strain of 0.0046 which is 58 percent of the design value.

Figure 11.- Panel B7 (after impact in high-axial-stiffness region while at applied strain of 0.0030) before and after failure.
