Ejection-Seat-Quick-Release-Fitting
Quantitative fractography and estimation of the local toughness using the
topography of the fracture surface

K.Wolf, Bundeswehr Research Institute for Materials, Explosives,
Fuels and Lubricants (WIWEB)
Landshuter Str. 70, 85435 Erding, Germany

ABSTRACT: A Quick-Release-Fitting of an Ejection Seat broke and investigations were made to estimate the fracture mechanism on the basis of fracture surface characteristics.

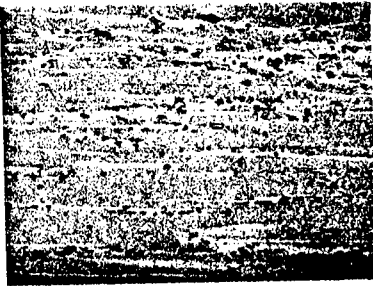
Metallographic samples were taken through the cross-section of the fracture origin on „S“, „N“ and „V8“. The cleanliness of the material was relatively good for the required alloy, despite of only few inclusions, but „N“ showed many precipitates and bands (Figures 5 and 6). Microhardness measurements were performed on cross-sections of these parts. The required hardness as specified on the governing engineering drawing

Figure 5 200:1
 Micrograph of a cross-sectional microstructure with only few precipitations - bell S

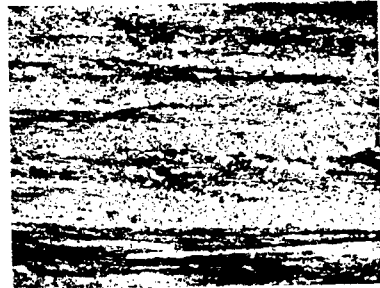
Figure 6 200:1
 Micrograph of a cross section of the new bell N with numerous precipitations and distinct grains

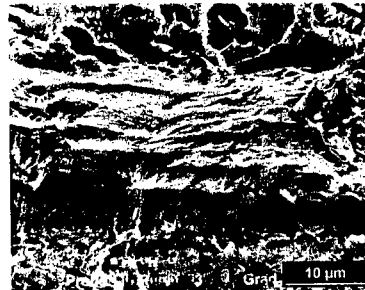
The stretched zone measurements were done on stereo image pairs by scanning electron microscopy on both corresponding fracture surfaces of the specimens „V1“ and „V2“ (Figure 14). Measurements along several base lines through the stretched zone achieved the stretched zone width (SZW) calculated by digital image processing [4;5;6;7]. Based on the ESIS P2-92 and DVM 002-Merkblatt the mechanical properties for the local crack initiation were calculated. The crack initiation toughness defined by the J-Integral is connected with the stretched zone and can be set as

By taking in the average SZW-values into this equation the bell V1 shows a J_i -value of 28 N mm/mm² and the bell V2 shows a J_i -value of 23 N mm/mm². On the other hand there exist a relation between J_i and K_{Ic} :

After calculation the value for bell V1 results in 47 MN/√m³ and the value for bell V2 results in 42 MN/√m³. Because of the little difference in local fracture toughness the results show that different materials by itself did not cause additional problems.

Figure 14
SEM-micrograph from the crack tip (SZW) - bell S1
