Electrical and Material Characterization of Field-aged 400 kV Silicone Rubber Composite Insulators

This paper presents the electrical and material characteristics of field-aged silicone rubber composite insulators, which have been deployed for 15 years on a 400 kV transmission line in a coastal region of the UK. There were no indications of reduced performance in service. Observations indicate non-uniform aging of the insulators on the different surfaces of the insulator sheds and core, along the insulator string length and in the different compass orientations. A uniquely large number of contact angle measurements, made on each of the insulators' different surfaces, confirm the visual aspect of non-uniform aging. Electrical investigations of the insulators have been performed in terms of leakage current analysis, ac flashover / withstand and switching-surge impulse flashover. A correlation is seen between the ac leakage current and the hydrophobicity measurements. Energy dispersive X-ray (EDX) and Fourier transform infrared spectroscopy (FTIR) analysis of the changes of the materials' surface chemistry is presented. The role of solar radiation and organic growth appears critical

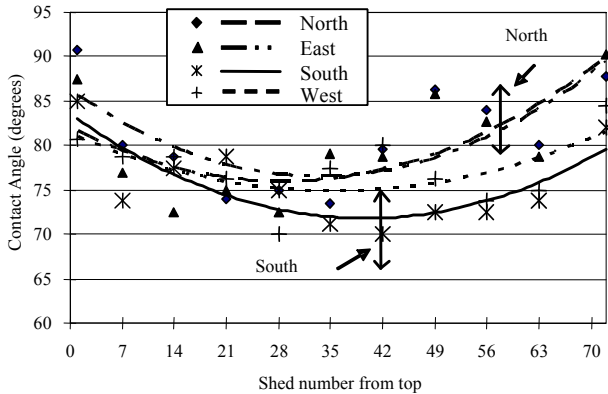
To assess the degree of hydrophobicity on the different insulator surfaces, contact angle measurements were carried out on all 18 strings. Measurements were made on 11 of the 72 sheds evenly distributed along the strings. For each shed, measurements were made on both the bottom and top surfaces in the four compass orientations. Contact angle analysis was performed with the insulator in a vertical orientation (upside down for the bottom surfaces). The receding angle of inclination of the top and bottom surfaces of the sheds were determined to be 10.6° and 7.4° respectively. Figures 2 and 3 show the average contact angle on the top and bottom shed surfaces along the insulator strings, respectively. The lines in these figures represent best fit second order polynomials. The arrows indicate the typical spread of results (max and min) around the average values plotted. These figures illustrate lower contact angle measurements on the exposed southern top and bottom surfaces of the insulator sheds than on northern facing surfaces. Shed surfaces in the mid-section of the string also indicated lower contact angles than the sections near the LV and HV ends.

Comparing top and bottom shed surfaces, the lowest hydrophobicity values measured were on the southern-facing shed top surfaces. This is indicative of a greater degree of aging on the top surfaces of the sheds. The highest values of contact angles were seen at the bottom, north-facing, HV end of the string, and associated with

Figure 2. Average contact angle on the top surface along the strings.

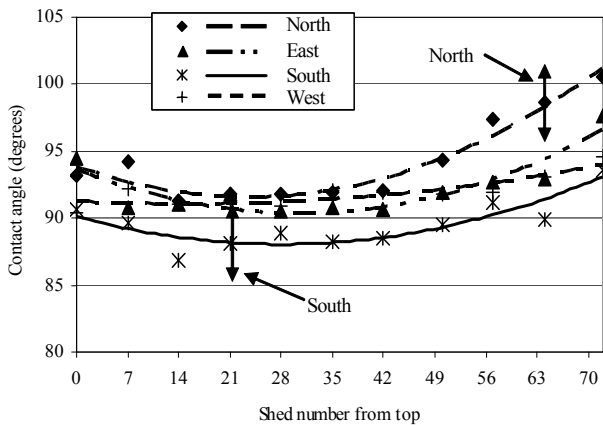
Figure 3. Average contact angle on the bottom surface along the strings
