Technical Report

Electrocardiographic "pacemaker pseudospikes" and radio frequency interference

Mark J Cleland BMET,* Edward T Crosby MD FRCPC[†]

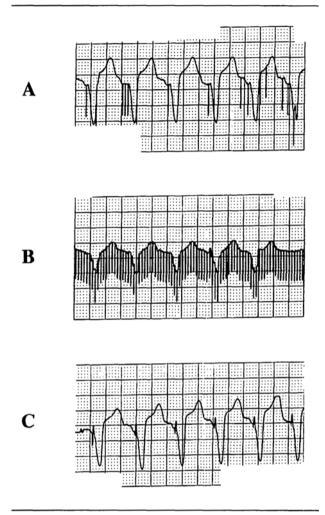
In the Post Anaesthesia Care Unit (PACU) the patient was connected to a Spacelabs[™] Medical PC1 (©Spacelabs Medical, Redmond, WA) monitor and a continuous ECG, arterial and central venous pressures and pulse oximetry were monitored. Markers were observed on the ECG trace that, although similar to pacemaker "spikes" in appearance, appeared at times other than that expected from a DDD pacemaker. These extra spikes produced no physiological responses in the patient and presented both as occasional signals (Figure 1A) and as a near-continuous signal (Figure 1B). Because of the typical pacer "spike" mark on the ECG trace, in the absence of an apparent physiological response to the pacemaker signal, concerns were expressed regarding the possibility of pacemaker malfunction as well as cardiac conduction abnormalities. A cardiology consultant offered no insight other than an opinion that the pacemaker was unlikely to be the source of the spikes.

Brief initial assessment by the hospital biomedical engineering department concluded that these markers were likely due to high frequency artifact. This was based on the short duration and fast rise-time ('spike' appearance) of the waveforms. However, given that the signal was present within an otherwise noise-free ECG trace, more extensive evaluation was felt to be indicated.

FIGURE 1 Electrocardiogram trace demonstrating occasional artifact spikes (A), near continuous artifact spikes (B) and the trace obtained with Pace Mode disabled (C).

voltage of any magnitude. The ground continuity assessment indicated that the grounds were secure and intact. The pin retention values of the electrical outlets within the PACU were also determined; all measured values were greater than 20 ozs., ensuring the integrity of the electrical receptacles. Finally, we concluded that the origin of the abnormal signals was RFI emitted from a source which was portable and has since been removed from the site.

As part of the evaluation of the phenomena, recordings were forwarded to both the manufacturer of the pacemaker and the PACU monitor. The pacemaker manufacturer, MedtronicTM, informed us that there was no circuitry within the pacemaker which would generate a signal similar to the one recorded. The Product Engineering Group at SpacelabTM Medical reviewed the tracing and suggested that the artifact was likely caused by 60 Hz interference in the monitor's environment which was interpreted by the monitor as pacemaker output.¹ They further commented that the interference wouldn't be noticed on the cardiac monitor with the *Pace Mode* off because of a 60 Hz notch filter.

Strategies to reduce excess RFI in patient care areas include: 1) not allowing patients or visitors to use conventional cellular telephones or other RF transmitting devices in the hospital; 2) ensuring that cellular phones brought into the hospital are turned OFF, not on standby, because transmission will occur in the standby mode even while the phone is not in use; ensuring that hospital users of RF-transmitting devices are aware of the possibility of interference with clinical equipment so that unnecessary transmissions can be avoided while in proximity (~1 metre) to medical devices in such areas as patient rooms, critical care units, emergency rooms, operating rooms, diagnostic and treatment areas, and clinical laboratories. Restrictions concerning patient use of transmitting devices may be relaxed in long-term rehabilitation areas, in which interference is unlikely because of distance from devices of concern and in which such use may enhance feelings of well-being and promote recovery.
