EXPERIENCE IN IN-SITU REPAIR WELDING OF STEAM TURBINE SHROUDS AND BLADES

S.K. Albert, V. Ramasubbu, C.R. Das, A.K. Bhaduri, S.K. Ray and Baldev Raj
Metallurgy and Materials Group, Indira Gandhi Centre for Atomic Research,
Kalpakkam 603 102, India

Abstract

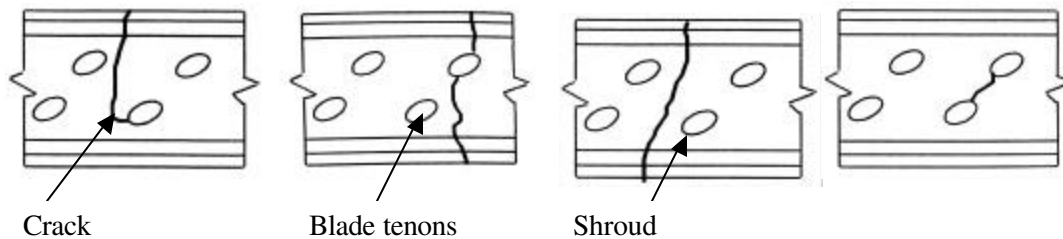
Under these circumstances, NPCIL considered the option of weld repair of cracked understraps, shrouds and blades. The understraps are made of a high strength titanium alloy, (Ti-6Al-4V), while both the shrouds and blades are made of martensitic stainless steel, (SS). The procedure for repair of understraps, shrouds and blades were developed in-house, and repairs were successfully carried out in different power plants of NPCIL. This paper describes the development of the welding procedure for repair of cracks in the blades and shrouds, its successful execution in various plants and the performance of the repaired component in service until now. Figure 1(a) shows details of cracking usually observed in the shrouds, while Fig. 1(b) shows a typical crack starting from the lacing hole of a LP stage -IV blade.

Fig. 1(a): Schematic of the type of cracks observed in the shrouds of stage-III LP turbine

Although the causes for the frequent cracking of the steam turbine shrouds and blades have not been analysed systematically, it has been observed that the cracks often originated from the tenon holes in the shrouds or lacing holes in the blades, (Fig. 1), without any indication of gross plastic deformation near the crack. In addition, minor variations in the grid frequency from 50 Hz can significantly increase the vibration levels during operation of the turbine. These suggest that the cracking could have been caused due to high cycle fatigue. Hence, it is important to study the performance of the repair-welded joints as also of the shroud/blade material under high-cycle fatigue conditions in order to increase the level of confidence of the repair-welding procedure adopted.

The first task for executing the actual repair is the removal of the existing crack by careful grinding. In the case of the shrouds, many cracks were observed to have initiated from the tenon holes. Hence, the blade tenons were partly ground off to expose the crack completely. The blade tenons were then subsequently built-up to their original shape by re-welding and

machining. After removal of the crack, Dye Penetrant Testing, (DPT), was carried out to ensure complete removal of the crack. Subsequently, using fine grinding tools, a weld groove with a groove angle of about 70° was prepared for weld deposition.

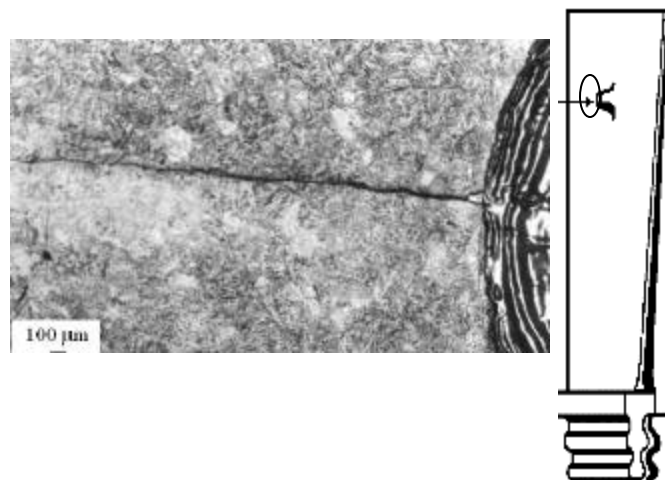
Fig. 1(b): Details of the lacing hole crack in the blade.

In the case of stage-IV LP blades, the cracks were very tight (Fig. 1b) and could be revealed only by the Wet Florescent Magnetic Particle Test, (WFMPT). Often these cracks initiated from the inner surface of the lacing hole and hence, to remove them, it was necessary to start grinding from the blade surface, where no crack was visible, and proceed in the thickness direction of the blade till the crack was reached. WFMPT was carried out at different stages of the grinding to ensure complete removal of the crack. Subsequently a smooth welding groove with groove angle of about 70° was prepared for weld deposition.

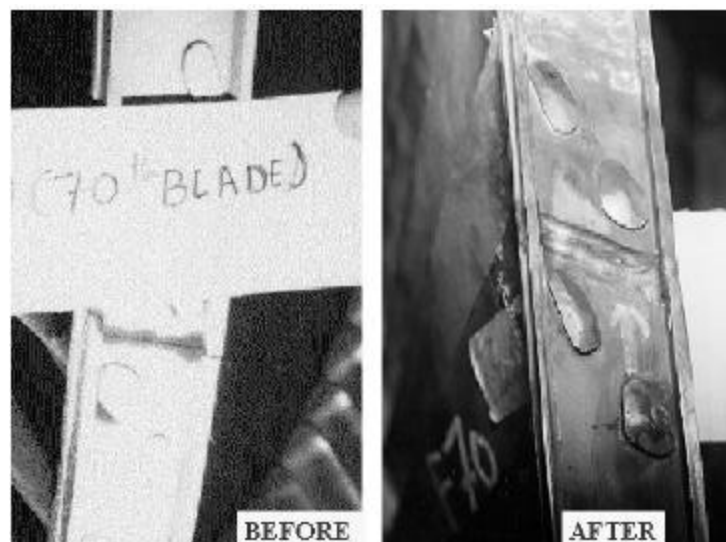
Fig. 4: A cracked stage-III LP turbine shroud, before and after repair welding

After ensuring that the edge preparation is complete in all respect, repair welding was taken up. The welding parameters employed were same as that used during the procedure qualification. In the case of shroud repair, it was often required to rotate the turbine so that welding could be carried out in the down-hand, (1G), position, as per the qualified procedure. After repair welding, DPT was carried out to ensure that no crack is present. Figure 4 shows the photographs of one of the cracked shrouds, before and after repair welding.

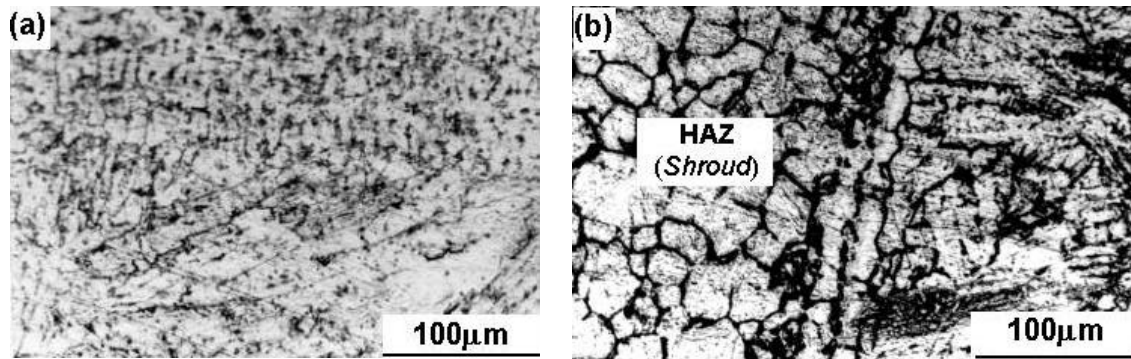
In order to ensure that adequate tempering has taken place in the HAZ of the shroud and blade material, it was necessary to examine the microstructure of the repair weld after PWHT by in situ metallography. The microstructure of the weld metal, (etched using Vilella's reagent), and of weld/base metal interface, (electrolytically etched using 10% ammonium persulphate solution), for the repair weld in a cracked shroud and a cracked blade material are shown in Figs. 6 and 7, respectively. In both cases, the microstructure of the HAZ clearly shows a tempered martensitic structure, while the weld metal structure, as expected, reveals a solidified microstructure. No defects, like micro-fissures, were observed in the weld metal.

Fig. 6: *In-situ metallography microstructure of: (a) 316L weld metal and (b) weld/base metal interface after PWHT of a repair weld in a cracked turbine shroud*

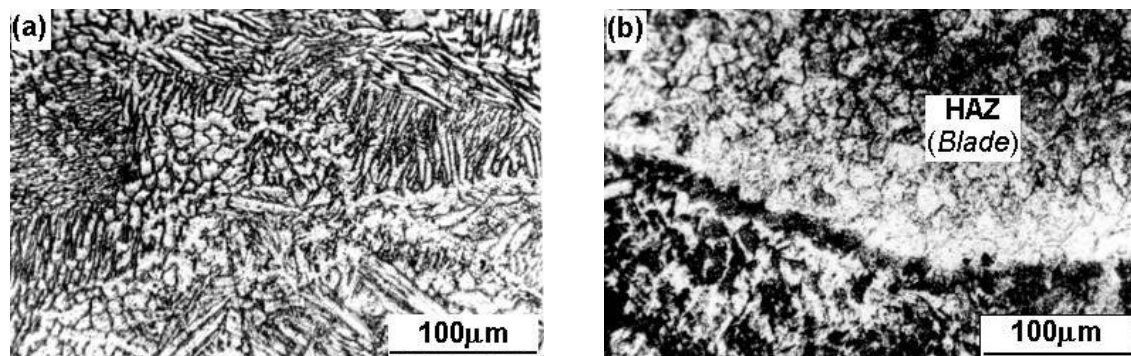
Fig. 7: *In-situ metallography microstructure of: (a) 316L weld metal and (b) weld/base metal interface after PWHT of a repair weld in a cracked turbine blade*

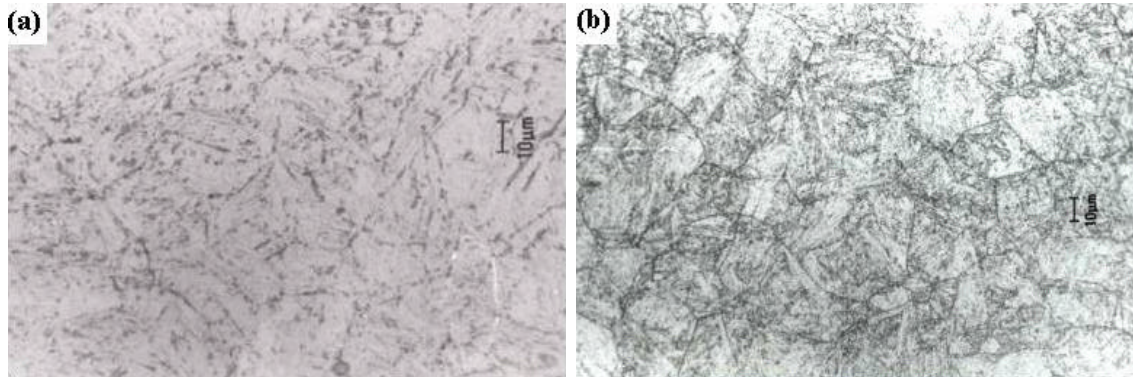
As mentioned earlier, the repair welding procedure was qualified using AISI 410 SS pipe material and not on actual shroud or blade material. Hence, microstructural examinations and hardness measurements on the actual shroud welds in the as-welded and PWHT conditions could not be carried out during the procedure development stage. Further, during actual repair welding, it was not possible to measure the hardness of the HAZ of the repair welds. However, confidence with respect to success of the repair welding procedure would be significantly better with the availability of HAZ hardness data in the as-welded and PWHT conditions on the actual shroud/blade material. During one of the repair welding operations, an actual shroud piece was made available for carrying out welding and subsequent laboratory investigations. A weld pad was prepared using this shroud piece employing the same welding parameters that were employed for the actual repair. One part of this welded test-piece was retained in the as-welded condition, while the other part was subjected to PWHT similar to that employed during the actual repair welding, and microstructural examination and hardness measurement were carried out on these two test-pieces. Figure 8 shows the microstructures of the HAZ in the as-welded and PWHT conditions. The microstructure of the HAZ in the as-welded condition (Fig. 8a) consists of fully untempered martensite, while that after PWHT (Fig. 8b) shows substantial tempering of the martensite with its microstructure being similar to that observed in the in-situ metallographs of the actual repair-welded shroud (Fig. 6). The

Fig. 8: Microstructures of the HAZ in the actual shroud material examined in the laboratory: (a) in as-welded condition and (b) after 873 K/1 h PWHT

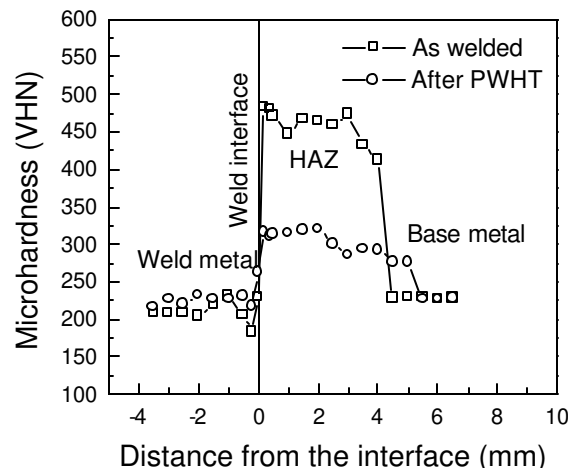
microhardness profile across the weld/base metal interface before and after PWHT (Fig. 9) shows that the hardness of the HAZ decreases from above 450 VHN in the as-welded condition to about 300 VHN after the 873 K/1 h PWHT, thereby confirming the adequacy of the PWHT carried out on the repair-welded shroud.

Fig. 9: Microhardness profile across the weld/base metal interface in the actual shroud material: (a) in as-welded condition and (b) after 873 K/1 h PWHT

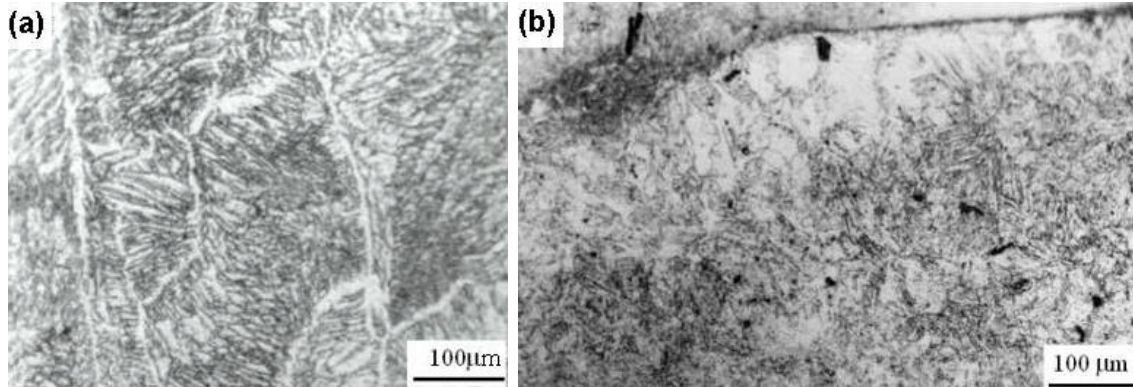
successful operation confirmed the good health of these blades. Comparison of the microstructure of one such repair-welded region of a blade after two years in service, (Fig. 10), with that before service, (Fig. 7), indicates no microstructural degradation during service.

Fig. 10: *In-situ metallography microstructures of the repair-welded region of a turbine blade after two years in service: (a) 316L weld metal and (b) weld/base metal interface*
