## **Exposure of Ceramics and Ceramic Matrix Composites in Simulated and Actual Combustor Environments**

**Karren L. More, Peter F. Tortorelli,  
Mattison K. Ferber, Larry R. Walker, and James R. Keiser**  
Oak Ridge National Laboratory  
Oak Ridge, Tennessee

**Narendernath Miriyala, William D. Brentnall, and Jeffrey R. Price**  
Solar Turbines Incorporated  
San Diego, California

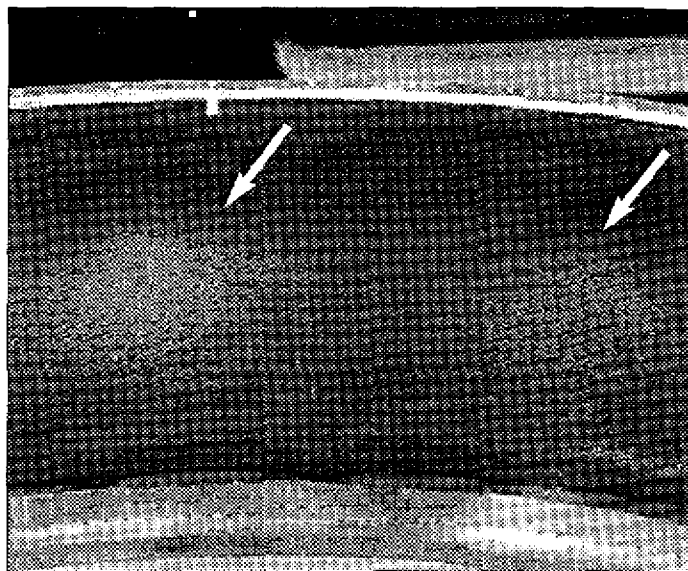
Visual inspection of the ARCO liners after 1000 hrs showed "white" areas on the working surfaces of both the inner and outer liners. These white areas were initially observed on the exposed liner surfaces after ~500 h during a visual borescope inspection. The localized white spots on the outer liners corresponded directly with the 12 injector impingement areas on the inner surface of this liner. The white spots indicated a range of localized temperatures since the surfaces between and around these white spots appeared relatively unchanged. The exposed surface of the inner liner, in particular, exhibited severe damage over most of its surface. Figure 4 shows the inner surface of the outer liner; note the localized white damaged regions that corresponded directly with the injector impingement areas.

Figure 4. Portion of the inner surface of outer liner; note two of the localized white damaged regions that corresponded directly with injector impingement areas (arrows).

Evaluation of the injector impingement areas on the inner surface of the outer liners showed similar microstructural damage as that observed on the inner liner, albeit to a much lesser extent; the SiC seal coat was completely removed in these localized areas, but only the top CG Nicalon™ fiber ply was adversely affected, as shown in Figure 8. In the areas surrounding the injector impingement regions, the SiC seal coat was somewhat thinned (the thickness of the remaining seal coat depended primarily on the local temperature), but remained intact. The surfaces of pores below the liner surface were oxidized (this was most pronounced below the injector impingement areas) and in many instances, matrix and fiber damage around these pores was observed well into the bulk of the underlying CFCC. Clearly, on both the inner and outer liner working surfaces, the "white areas" indicated complete loss of the protective SiC seal coat. This will be used in future borescope inspections as an indication of the point at which the protective seal coat is breached.

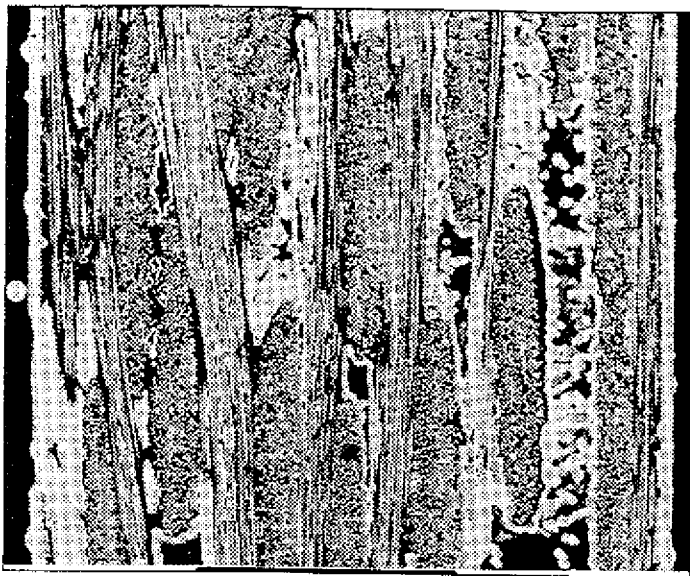
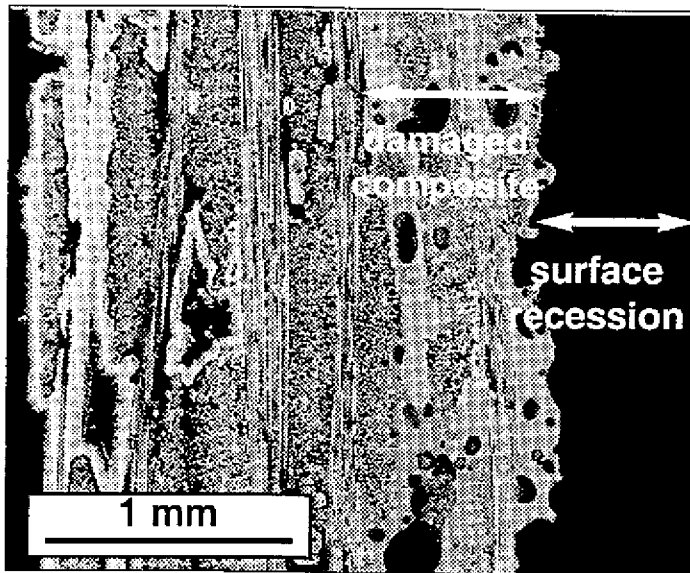
Microstructural examination of the inner liner showed that significant surface recession occurred during the ARCO test. As shown in Figures 5(a) and 5(b), comparing sections of the inner liner from the top surface (CFCC exposed to the lowest temperature during the engine test) and from the center of the exposed surface of the inner liner (near maximum damage area), respectively, recession of about 20% of the inner liner thickness was observed and another 25% of the CFCC exhibited microstructural damage (see arrows in Figure 5(b)). The damage assessment indicated that not only was the protective SiC seal coat (initially ~60  $\mu\text{m}$  thick) completely removed during engine testing, but the CFCC constituents themselves had reacted to form a low melting point glass at the liner surface. The oxidation of the SiC seal coat (and matrix) resulted in the rapid formation of surface silica; the silica then formed volatile reaction products in the water containing environment (Opila and Jacobsen, 1998, Robinson and Smialek, 1998) resulting in accelerated SiC recession. The projected CVD SiC recession after 1000 h under lean-burn conditions, estimated from burner rig studies performed at NASA Lewis, is ~150  $\mu\text{m}$  at 1200°C, 0.6 atm H<sub>2</sub>O, and a gas velocity of 33 m/s (Robinson and Smialek, 1998). The maximum temperature during the ARCO test could not be accurately measured since the thermocouples failed in the early stages of the field test. However, based on the intermittent visual inspections of the liners during the ARCO test, the seal coat on the inner liner (and locally on the outer liner) was breached relatively early in the test indicating that the temperature was ~1200°C, and possibly as high as 1260°C at the hot spots on the inner liner.

Figure 5. Microstructural damage at outer surface of inner liner after the ARCO test. (a) Section of liner taken from top (cooler) edge of liner showing intact SiC seal coat and non-damaged composite and (b) section taken from center of exposed surface showing significant surface recession, loss of most of the seal coat, and extensive composite damage below the surface. Damage regions below surface consist primarily of reacted matrix constituents that form glass and loss of fibers.

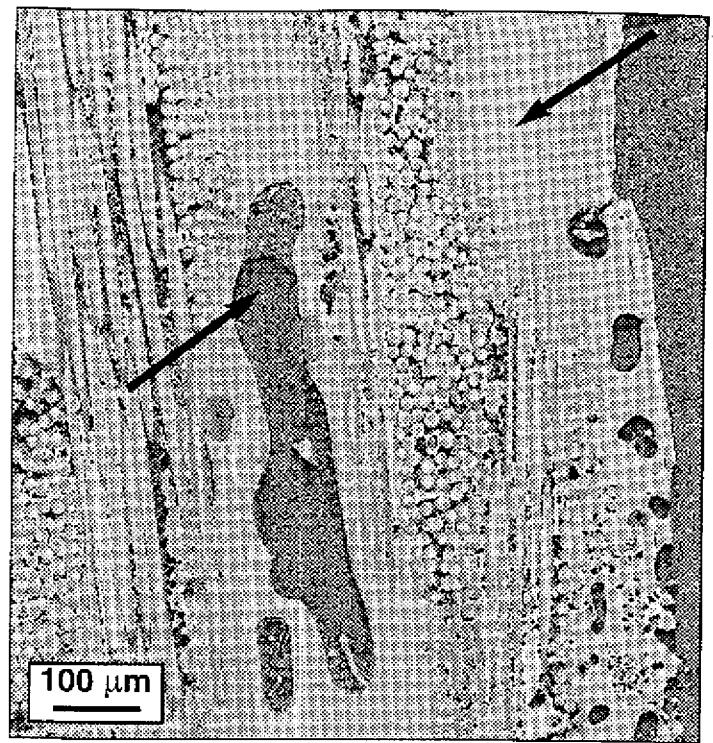
Typical microstructural damage observed at the outer surface of the inner liner is shown in Figure 6. Large "pools" of glass were observed; the CG Nicalon™ fibers and associated matrix constituents reacted with the glass and entire fiber tows were consumed during glass formation (as shown in Figure 7). While most of the glass was primarily silica, small amounts of

boron were found in these areas (additional matrix constituents were the source of the B), which caused a reduction in the glass melting point. Matrix constituents containing boron therefore contributed significantly to the glass formation. Similarly damaged areas were also identified well below the exposed surface of the inner liner (arrows in Figure 6) and were primarily associated with areas of large porosity (these composites typically were only about 85-90% dense), indicating significant oxidation in these areas also. Formation and subsequent recession of the glass product was the primary degradation mechanism of the outer surface of the inner liner. The process was accelerated by the damage formed below the surface.

Figure 6. Typical microstructural damage observed at the outer surface of the inner liner. Arrows indicate areas of "pooled" glass observed throughout damaged region.

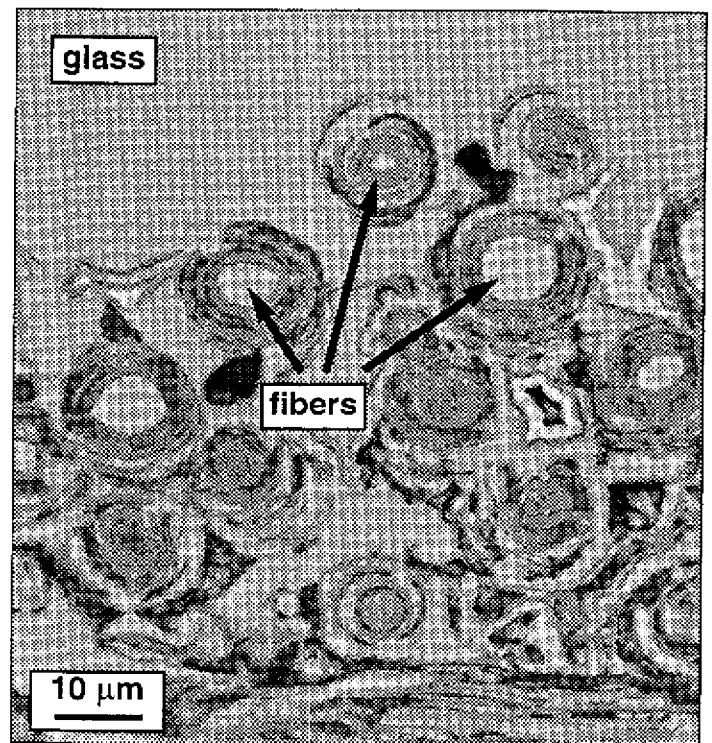
Figure 7. CG Nicalon™ fibers were consumed during extensive matrix glass formation within damaged regions near exposed surface of inner liner. Arrows indicate fibers at different stages of reaction with glass.

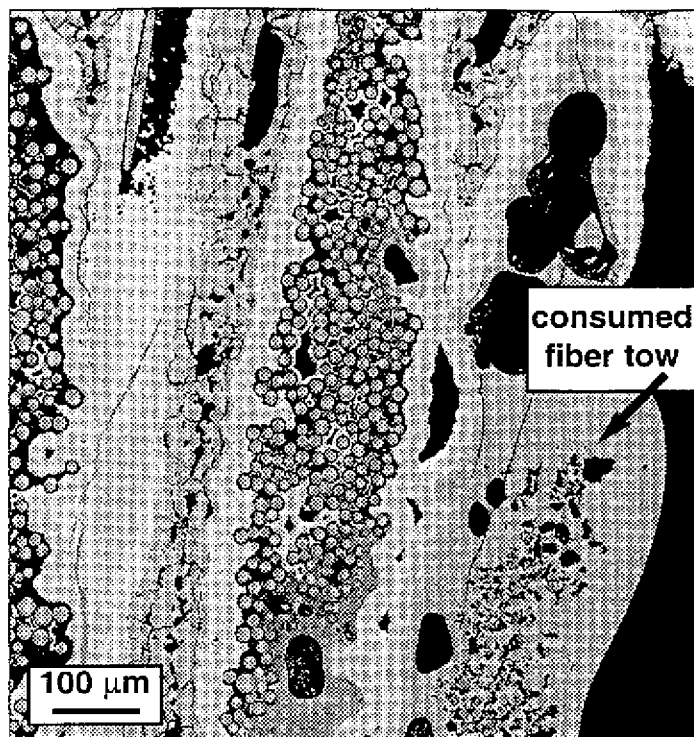
Figure 8. Typical microstructural damage observed at the inner surface of the outer liner after the ARCO test. Microstructural degradation was similar to that observed for the inner liner.

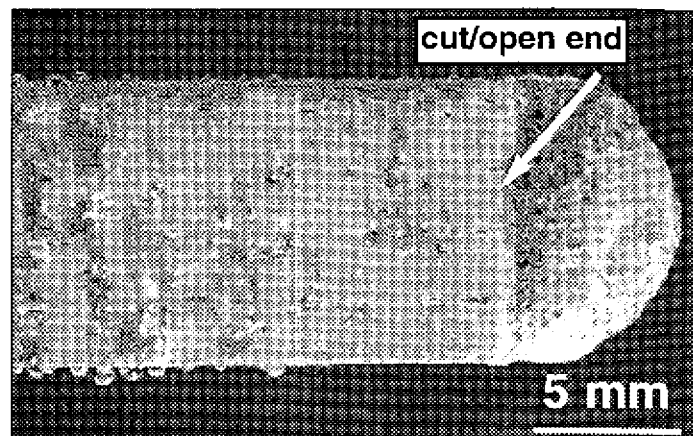
Visual inspection of the Enhanced SiC/SiC tensile specimen after the first 500 h run showed that all the surfaces were covered with a white oxide product and glass bubbles. An important observation made after the first 500 h exposure was that extensive degradation occurred at cut or open surfaces of the specimens. These areas had to be carefully avoided during microstructural evaluation since these could lead to excessive amounts of material degradation that would not be representative of the extent of damage found in combustor liners (which have no open or cut ends). Figure 9 is a

photograph of the Enhanced SiC/SiC specimen removed after 500 h. Note the excessive amount of glass protruding from the surface cut before the test; not only is there usually no seal coat on these ends, but the exposed fiber ends and open areas into the matrix contribute to accelerated degradation. The specimen for microstructural analysis was cut at least 1 cm below this open surface.

Figure 9. Surface of Enhanced SiC/SiC specimen after 500 h exposure in ORNL rig. Material was co-processed with CFCC liners in ARCO test. Specimen geometry contributed to significant glass formation at cut/open ends.

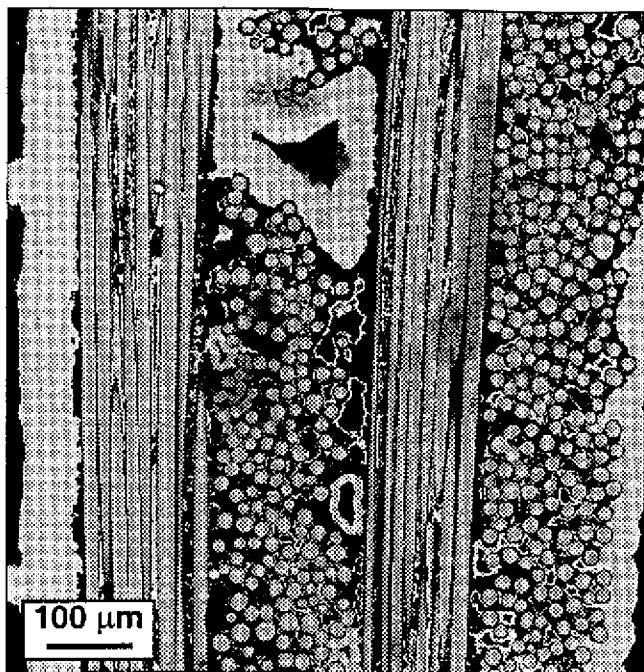
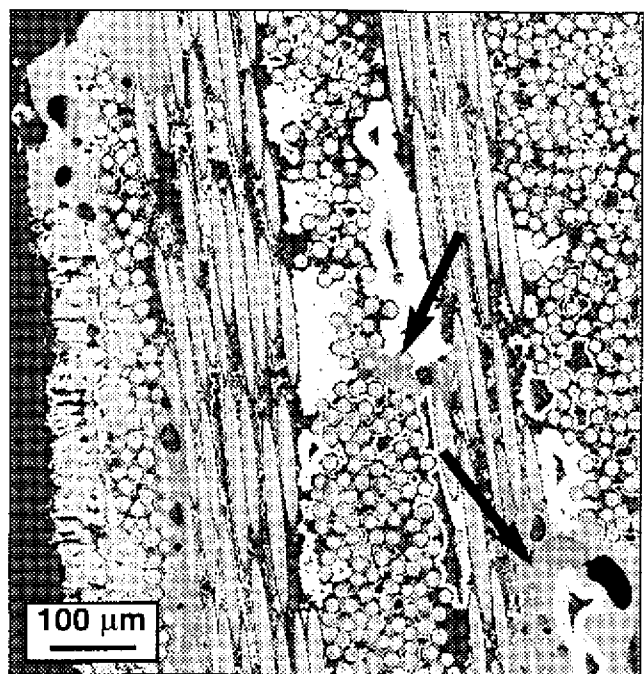
Cross-sections of the as-processed Enhanced SiC/SiC composite before and after exposure in the ORNL rig for 500 h are shown in Figures 10(a) and 10(b), respectively. The SiC seal coat was fully oxidized across the specimen surface and fiber tows below the surface showed areas of constituent reaction (arrows in Figure 10(b)). The damaged composite areas in the ORNL-exposed specimen were structurally similar to those observed for the same material after the ARCO test (see Figure 6); localized areas of constituent reaction (glass formation) are noted in Figure 10(b). The same specimen was placed back in the ORNL rig for an additional 500 h, thus exposing the material for approximately the same amount of time achieved in the ARCO test. After 1000 h in the ORNL rig, the microstructural degradation was extensive, as shown in Figure 11, and was nearly identical to that observed for the same material engine tested at ARCO. There was significant glass formation at the surface.

Figure 10. A comparison of cross-sections of the (a) as-processed Enhanced SiC/SiC material and (b) the Enhanced SiC/SiC CFCC after exposure in the ORNL rig for 500 h. Compare localized microstructural degradation (reacted matrix constituents) in Figure 10(b) (indicated by arrow) to inner liner degradation shown in Figure 6.

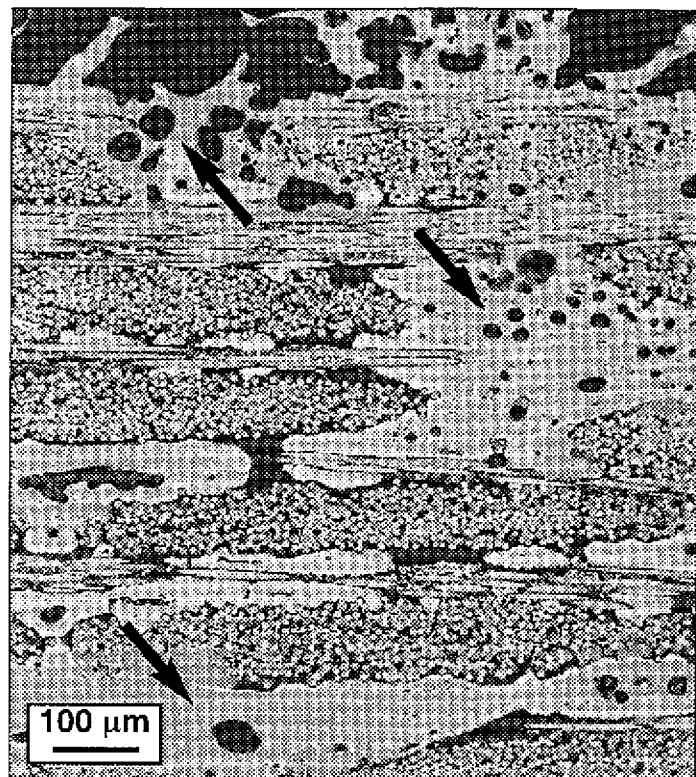
Figure 11. Microstructural degradation of Enhanced SiC/SiC CFCC after exposure in the ORNL rig for 1000 h. Compare microstructural degradation (reacted matrix constituents) in Figure 11 (indicated by arrow) to inner liner degradation in Figure 6.

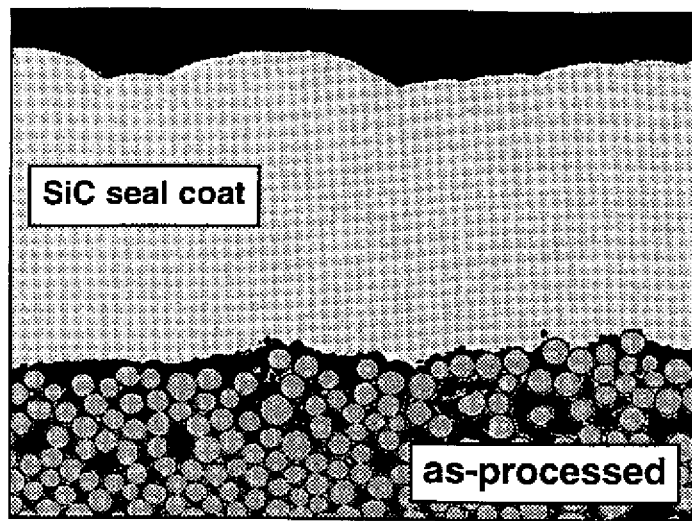
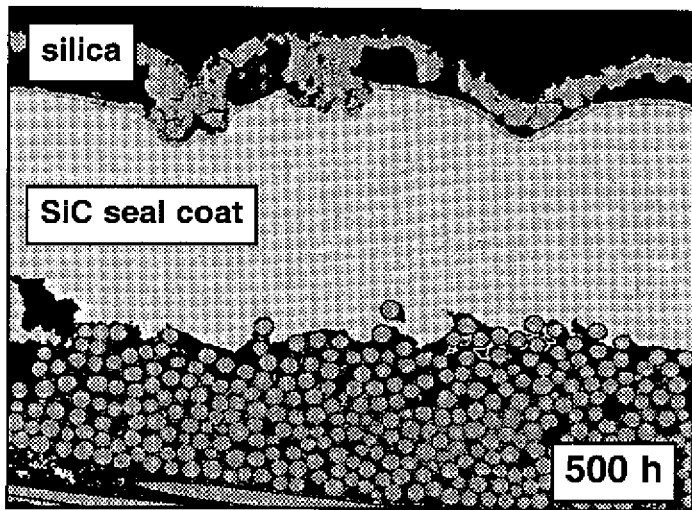
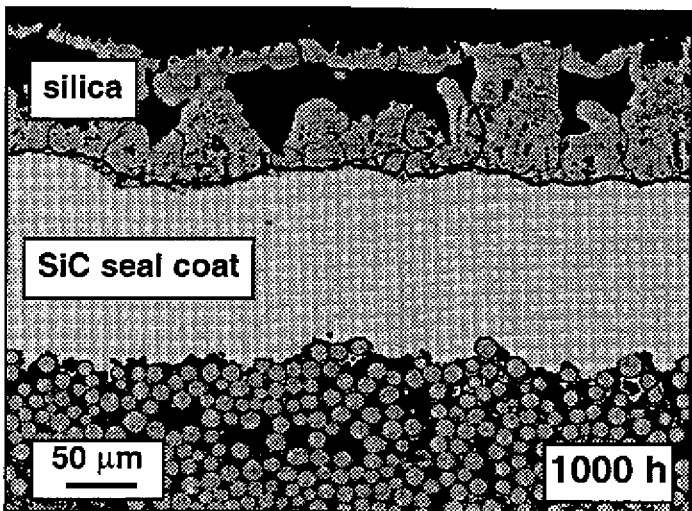
The Enhanced SiC/SiC sample with a thick CVD SiC seal coat was used to determine the CVD SiC oxidation/recession rate in the ORNL rig. Figure 12 shows the oxidation of the SiC seal coat for three sequential 500 h exposures. It was determined from direct microstructural measurements that the SiC seal coat recessed by oxidation at a maximum linear rate of approximately  $45 \mu\text{m}/500\text{h}$ . Clearly, the oxidation/recession rate of the SiC was accelerated in the ORNL rig compared to rates reported previously for CVD SiC exposed at lower water vapor pressures (Opila, 1994 and Opila,

Figure 12. CVD SiC seal coat oxidized for 500 and 1000 h. It was determined from direct microstructural measurements that the SiC seal coat recessed by oxidation at a linear rate of approximately  $45\mu\text{m}/500\text{h}$ .
