Failure analysis of carbon black filled styrene butadiene rubber under fatigue loading conditions

J.-B. Le Cam*¹, B. Huneau² and E. Verron²

Keywords: Fatigue crack growth, Microanalysis, Fracture mechanism

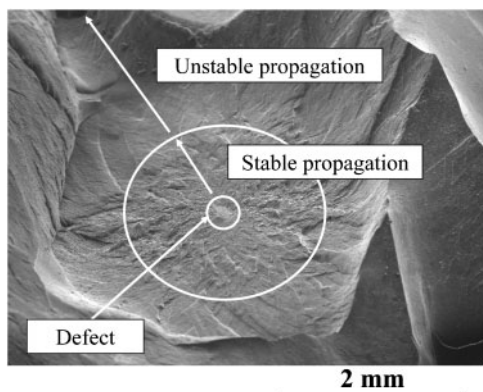
1 Photomicrographs of fracture surface in CB-SBR

The fracture surfaces are observed by SEM; an example of photomicrograph is shown in Fig. 1. To illustrate the discussion, we propose to describe fracture surface with the help of the schematic views presented in Fig. 2.

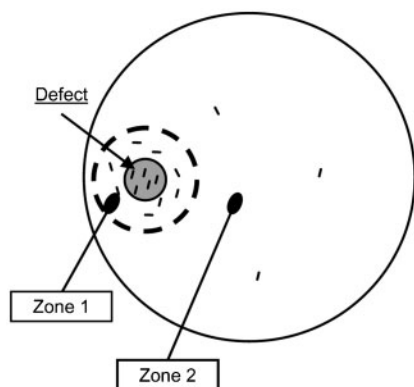
Except the nucleation defect area, only two different zones (denoted zones 1 and 2 in Fig. 2a) are observed, independently of the maximum stretch ratio applied.

2 Schematic view of fracture surfaces in CB-SBR

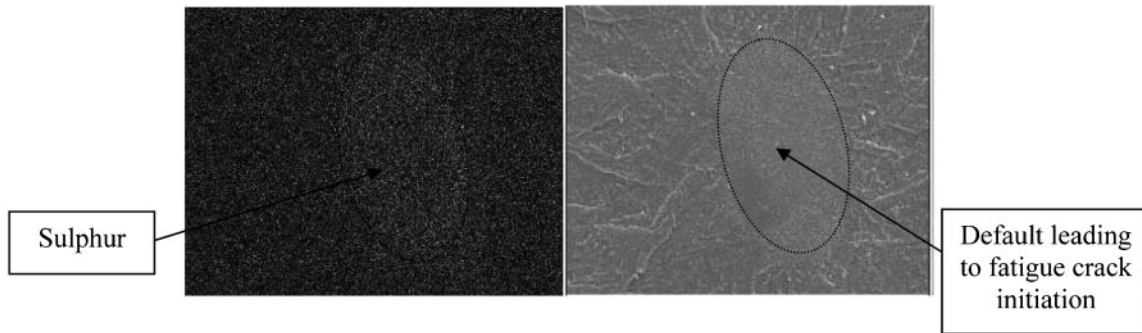
3 EDSX analysis of defects from which crack initiation occurs

Considering several samples, we observe that the nucleation defect is located between sample surface and 6 mm far from the surface and its maximum size is 300 μm in diameter. As shown in Fig. 3, the EDSX analysis demonstrates that these defects contain more sulphur than the rest of the material. Therefore, they correspond to overvulcanised zones in the section. Surface of Zone 1 is rough; it corresponds to a stable propagation of the crack and surrounds the defect. Its size can reach 6 mm in diameter. Zone 2, which surrounds Zone 1, represents the rest of the fracture surface. It corresponds to an unstable propagation of the crack. The surface is relatively smooth and slight bifurcations of the crack can be observed. No fatigue striations are observed for every loading conditions considered in this study.

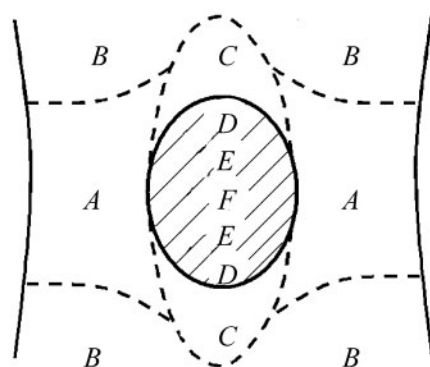
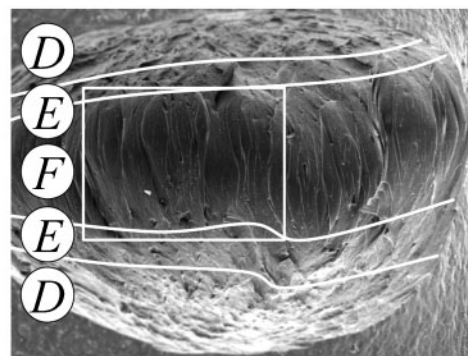
Figure 4 presents the fatigue crack and its surroundings: Fig. 4a shows the schematic view, and Fig. 4b presents a photomicrograph of the three zones D, E and F. As for CB-NR, six different areas can be observed as the samples is stretched to the elongation applied during the fatigue test. Before the occurrence of the crack, there are only two zones: the central zone of the sample, denoted A in Fig. 3a, which is the most stretched part of the specimen, and Zone B situated on both sides of Zone A. When the crack occurs, four new zones appear: Zone C which corresponds to the parts of Zone A that are relaxed during crack opening, and Zone D, E and F which constitute the crack itself. Figure 3b shows that Zone F stands for the crack tip, Zone D represents the smooth surfaces generated during crack growth and Zone E denotes the frontier between them. In fact, the major difference between Zones D and F is their stretching level. These three zones also exist for CB-NR, except that Zone D is covered with numerous wrenchings (*see* Fig. 4 in Ref. 5).

4 a schematic view of crack (D–F) and its surroundings (A–C) and b front view of crack for CB-SBR

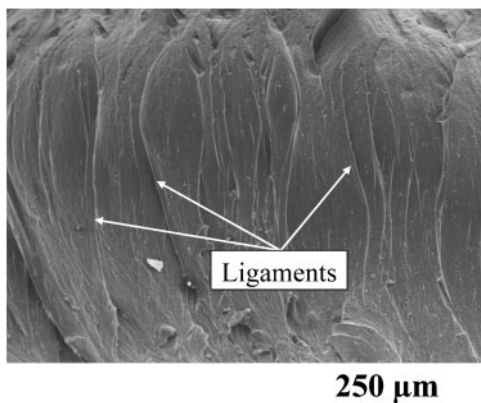
Figure 5 presents magnification of CB-SBR crack tip. This photomicrograph corresponds to the encircled zone in Zone F in Fig. 4b. Many of long ligaments take place at crack tip and the size of Zone E is revealed very small (*see* the top of Fig. 5). Therefore, it seems to indicate that the broken surface generated by crack growth immediately joins both sides of the crack (Zone F). To describe the zone in which the crack propagates, we should continue to zoom in at crack tip. Figure 6 presents two magnifications of the crack tip. As shown in Fig. 6a, every ligament comes from a line that crosses the crack tip (the white dotted line in the figure). This

5 Magnification of Zone F in CB-SBR

result is in agreement with the work of Gent¹⁰ who observed, for static loading conditions, a 'tear line' at crack tip in a precut carbon black-filled polybutadiene (a material that does not crystallise under loading) sample. In the following, the term 'tearing line' will be preferred to 'tear line' as suggested by Gent. Figure 6*b* is a zoom in of the encircled zone in Fig. 6*a*. Zinc oxides are present everywhere on the surface. Some of them are surrounded by elliptical cavities which walls are forming ligaments. The size of these oxides varies between a few hundred nanometers and 5 μm.

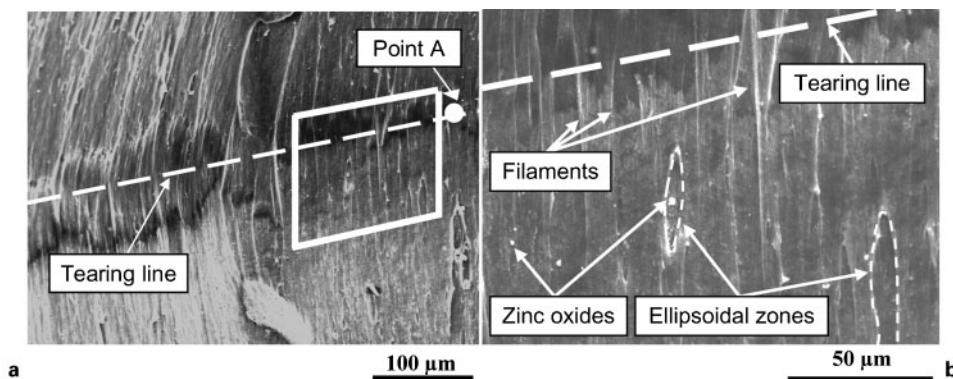
The zone propitious to microcutting corresponds to the tearing line previously described. It is the zone in which crack grows with the less energy. Thus, crack tip microcutting was performed by concentrating the electron beam at a point of this tearing line (point A, Fig. 6*a*). As material response, a microcut immediately initiates at this point and propagates towards the right side by revealing the zone located behind the crack tip. The artificial microcrack obtained is shown in Fig. 7*a*. It is to note that, for the same adjustment of the electron beam as in Ref. 5 for CB-NR, the time needed to initiate microcrack is inferior to 1 s instead of several seconds for CB-NR. Moreover, ligaments observed all over the crack tip fail without any resistance and for the same energy brought by the electron beam. It seems to indicate that the microstructure of ligaments in CB-SBR is the same whatever the deformation state, i.e. ligaments are not crystallised and the material microstructure is homogeneous at the crack tip. Figure 7*b* is a magnification of the encircled zone in Fig. 7*a*. Here, new ligaments are generated and the microcrack propagates through ZnO particles. Chemical links between ZnO and rubber matrix being highly weak, this zone looks like a cavity opened and stretched. This phenomenon generates two elliptical zones in which ZnO particles are observed. It is to note that elliptical zones observed on both sides of tearing line in Fig. 7*b* proves that this phenomenon takes place also

6 Details of crack tip for two magnifications

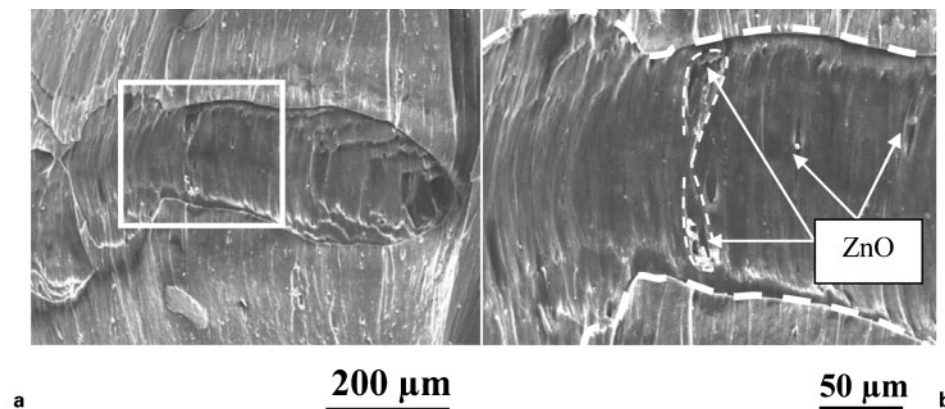
a artificial microcrack obtained after concentrating electron beam on point A in Fig. 6*a*; b magnified view of encircled zone of a

7 Chronology of microcut experiment

naturally (during natural crack propagation). If ZnO particles are not crossed by the crack in their middle, elliptical zones are only observed on one side of the tearing line (Fig. 7b). Finally, the size of revealed cavities being not superior to the one of ZnO particles, our observations do not allow to highlight cavitation from ZnO particles at the fatigue crack tip in CB-SBR. These observations demonstrate that the roughness of fracture surfaces is only due to particles (ZnO, carbon black agglomerates) encountered by the crack during its propagation into a linear zone.
