Failure Investigation and Restoration of Two Cellular Sheetpile Structures

FAILURE INVESTIGATION AND RESTORATION OF TWO CELLULAR SHEETPILE STRUCTURES

ABSTRACT

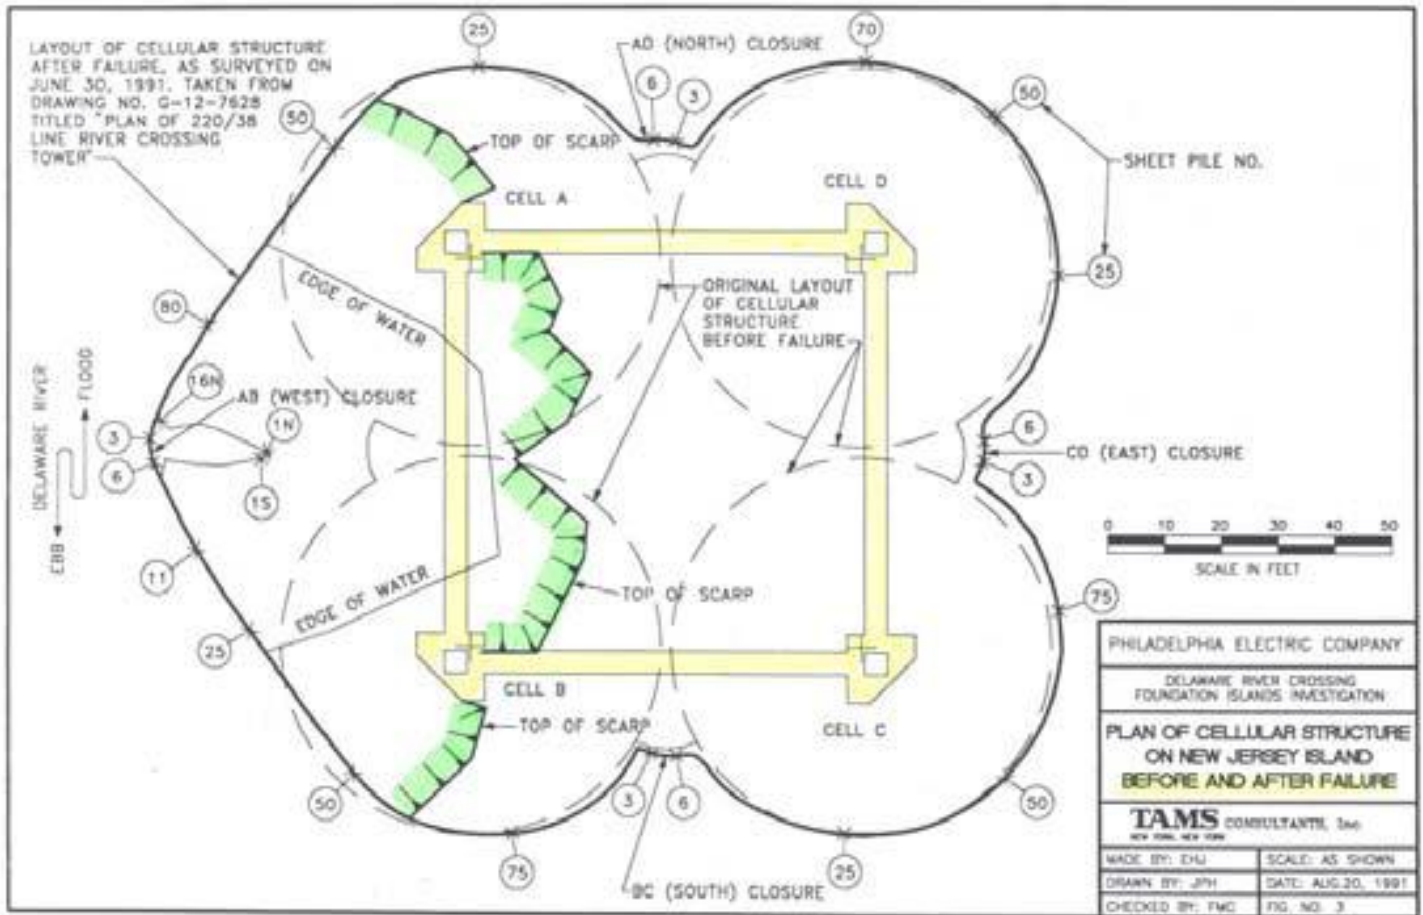
Fig. 3: Before and After Failure

New Jersey Island. Additional observations that may have a bearing on the failure of the New Jersey Island are summarized below. The numbering system used to identify specific sheetpiles that are discussed in this section is shown in Fig. 3.

- The failure appears essentially symmetrical when viewed in plan. Ruptured sheetpiles in Cells A and B are interior section MP-101 sheetpiles located under the North-South grade beam. Torch-cut holes, presumably for handling, were found on several sheetpiles near the failure zone between El. +1.0 and +2.0 ft USC&GS datum.

PECO personnel surveyed the New Jersey Island to record the present configuration of the island. A plan of the New Jersey Island before and after failure based on the survey data is presented in Fig. 3.

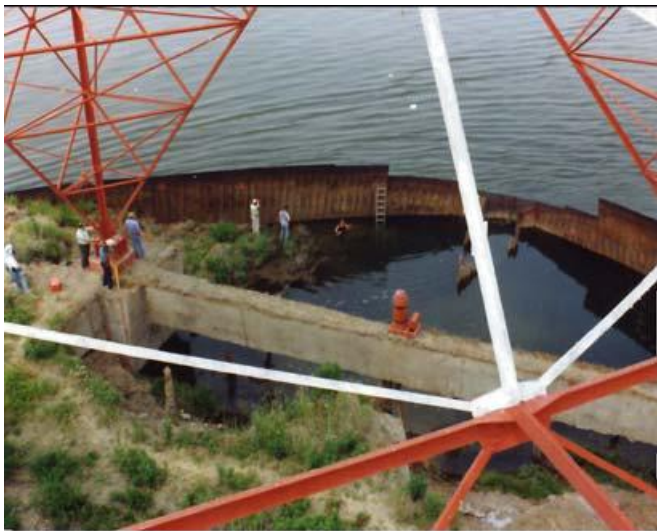
Fig. 5: Partial Collapse Exposing Pile Caps and Tie Beams

In early 1991 PECO performed a routine aerial survey in the vicinity of the transmission line crossing. The surveyors did not note any gross changes in the geometry of the New Jersey Island. A pre-existing sinkhole was observed, and it did not appear to have enlarged since the previous aerial survey. Nevertheless, on Sunday, April 14, 1991, a boater telephoned PECO to report that the New Jersey Island appeared damaged. PECO personnel visited the island on April 16, 1991 and corroborated the damage report. The two cells facing the channel had partially collapsed and leaned out toward the river. Sheetpiles were ruptured and severely distorted. This allowed the fill inside the cells to displace laterally downward, exposing two pile caps and the grade beam that connected them. Fig. 5 and Fig. 6 are photographs of the failure.

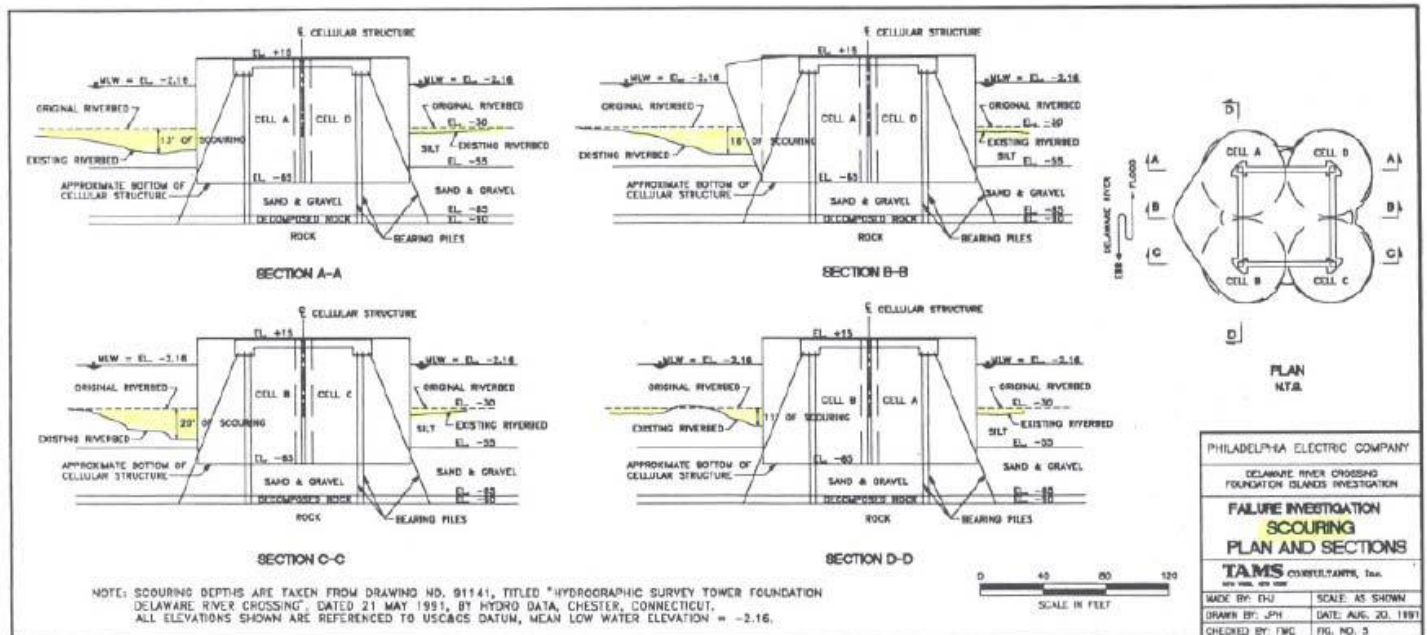
Fig. 7: Depth of Scour

The divers performed a pneumo-fathometer survey around the perimeter of the islands at the mudline. The results of this survey were consistent with the precision hydrographic survey, and indicated that about 20 ft of scour had occurred on the channel side of both islands since original borings were conducted in 1959. Divers observed several 1 to 6-ft vertical drops in the mudline profile around both foundation islands. These appeared to the divers to be at locations where current velocity increased.

Hydrographic surveys were carried out in order to investigate general river bottom conditions in the vicinity of the two islands and to document scour near the structures. Depth soundings taken by the Corps of Engineers in 1954 and riverbed elevations from the 1959 borings were compared with 1991 soundings. Soundings were not available for the period immediately before or after construction. Based on the comparison, approximately 20 ft of scour had occurred on the channel side of both islands.

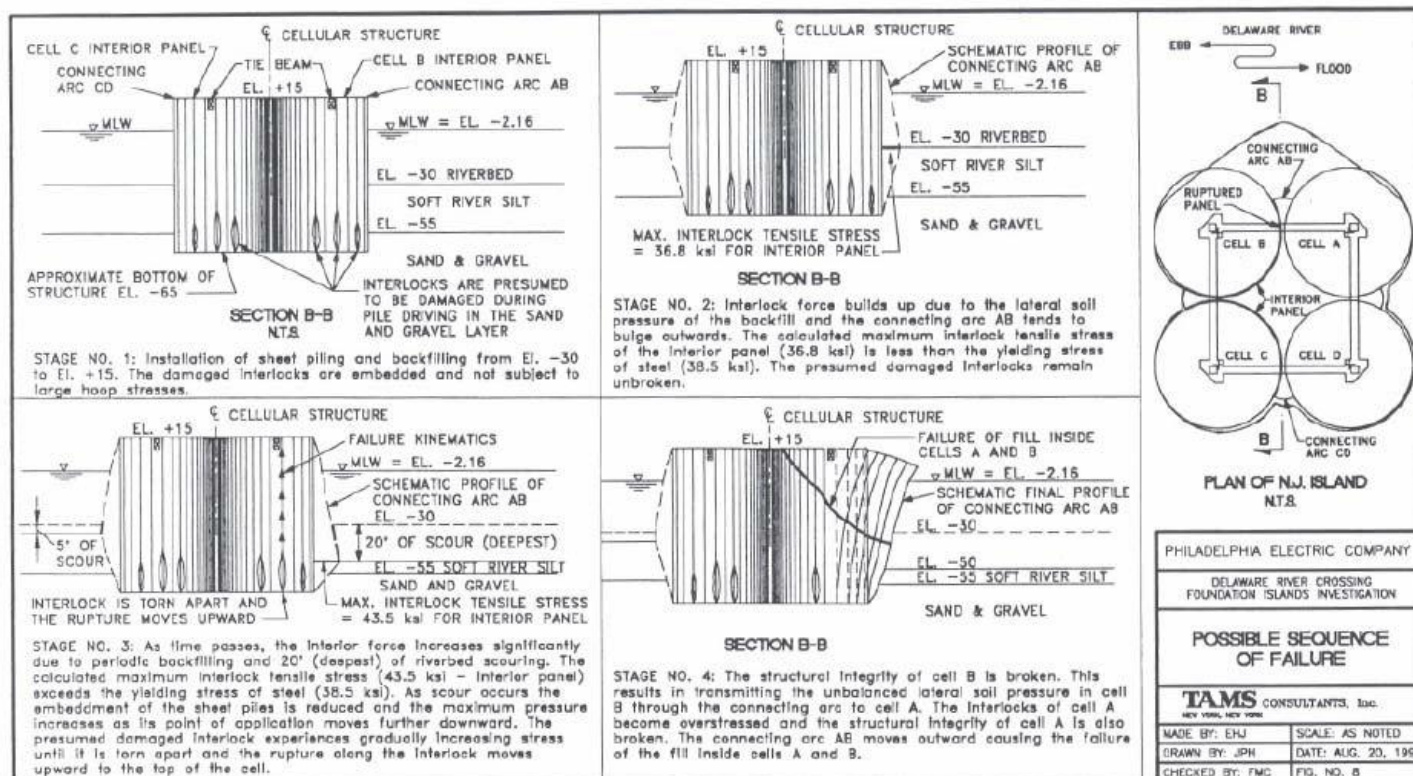
Fig. 8: Possible Sequence of Failure

The following paragraphs describe the several factors that contributed to the failure. The role of each of these factors in leading to the eventual failure mechanism constitutes a failure hypothesis. The inferred sequence of events leading to failure is depicted in Fig. 8.

1. Scour and Loss of Sheetpile Embedment. First, there was scour, probably over a long term. Scour is the process of soil erosion in which soil particles are lifted, moved and transported by the force of flowing water. Scour can be a gradual process or it can occur rapidly, depending on the velocity of water flow and the type and properties of the soil being eroded. Washing out or undermining of pier foundations due to scour of riverbeds is a common cause of bridge failures (Jumikis, 1971).

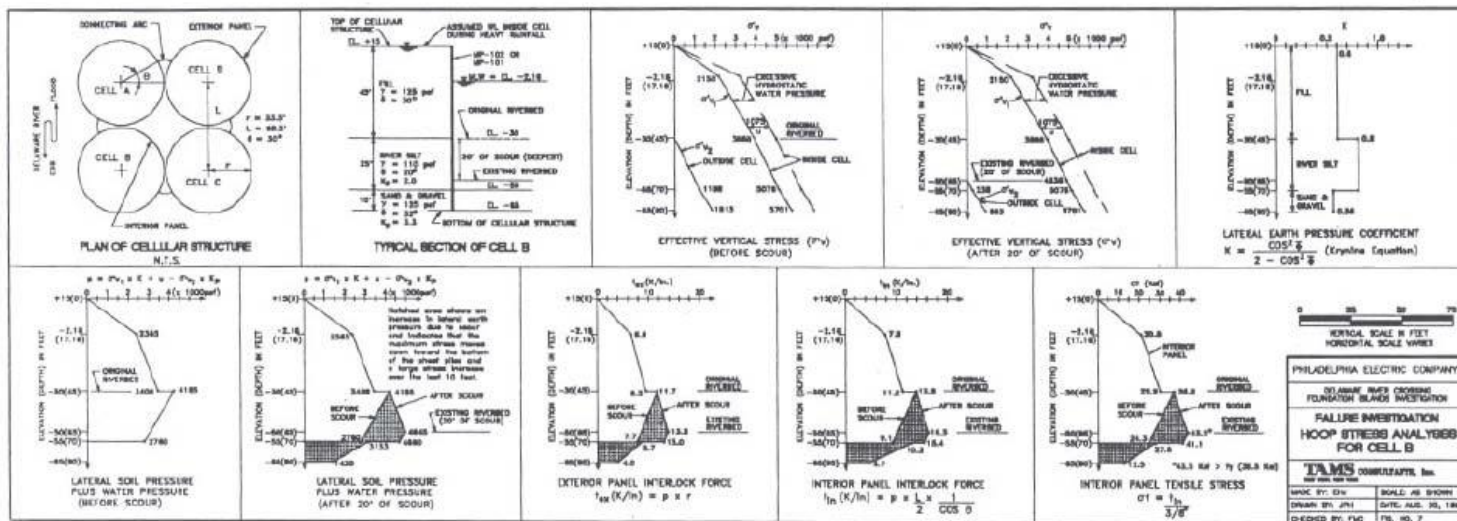
Fig. 9: Hoop Stress Analysis of Cell B

stress analysis of Cell B shown in Fig. 9 was conducted to estimate the maximum hoop stress in the cell, which occurs on the interior sheets at or near the connecting arc (TVA, 1957), the depth to the maximum stress was assumed to correspond to the depth of scour outside Cell B. This is based on Maitland and Schroeder (1979) who recommend a plane of fixity concept to estimate the location of maximum lateral earth pressure. The weaker the soil in which a cell is embedded, the greater the depth to the plane of fixity. Therefore, the maximum interlock tension should be calculated at a lower level for weak soils compared to strong soils, and may even occur at or below the dredgeline.

The analysis arrived at an estimated circumferential tension of 16.3 kips per inch under the conditions of scour, saturation of the backfill above MLW, and the presence of soft sediments inside the cell. This value exceeds the allowable force (8 kips per inch) as well as the ultimate interlock strength of 16 kips per inch. The corresponding stress is 43.5 ksi, which exceeds the yield point of 38.5 ksi. The analysis demonstrates that the tension was sufficiently high to exceed the ultimate strength for separation of interlocks and the yield point of the webs on the interior sheetpiles.

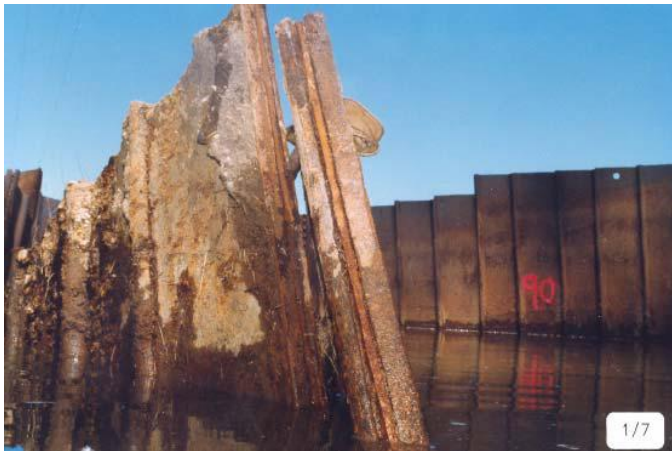
Fig. 10: Brittle Fracture through Interlock

In the majority of interlock failures the contact friction between the interlocking fingers and thumbs holding adjacent sheetpiles together is overcome by circumferential stress and separate entirely one sheetpile from the other. However, this mode of failure was not evident at the New Jersey Island. Instead the failure mechanism consisted of the steel fracturing vertically through the narrowest dimension (root) of an interlocking thumb, leaving it behind and inside the thumb and finger of the other interlock. That is, the steel fractured before the interlocks could separate (Fig. 10).

The fracture occurred along a vertical plane. Chevron or herringbone markings pointed downward, an indication that the fracture began below the mudline and proceeded upward unabated.

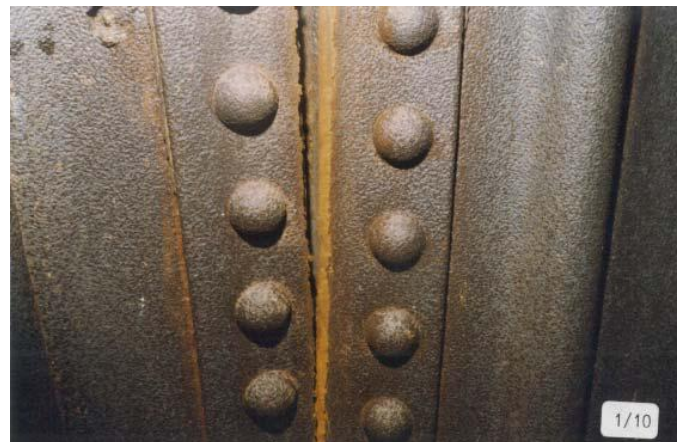
Fig. 11: Connecting Arc A-B in Distress

As the two cells failed behind the connecting arc they lurched outward trying to individually open up, but were restrained by their mutual connecting arc, as evidenced by the distortion and slight pulling apart of the T-connection from the top of the sheeting to a point several feet down (Fig. 11). This latter damage is a result of the collapse, not the cause.

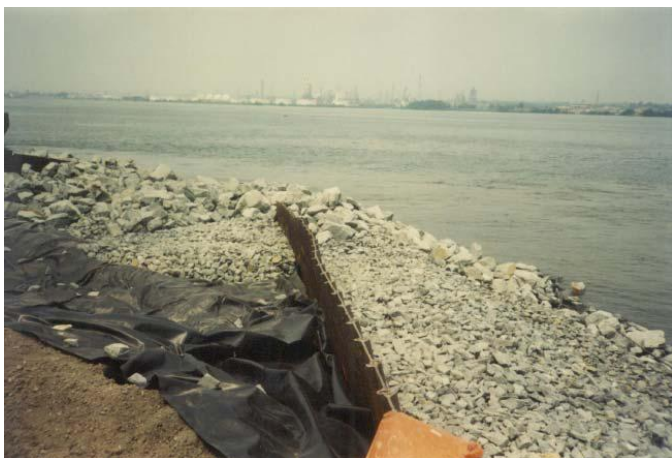
Fig. 14: Buttress of Crushed Stone, Riprap and Geotextile

Based on the above evaluations a large island-encompassing rock buttress was recommended for the New Jersey Island (Fig. 12) and a small localized rock buttress for the Pennsylvania Island. The buttress is shown under construction in Figs. 13, 14 and 15.
