Fault rupture–foundation interaction: selected case histories

E. Faccioli · I. Anastasopoulos · G. Gazetas ·
A. Callerio · R. Paolucci

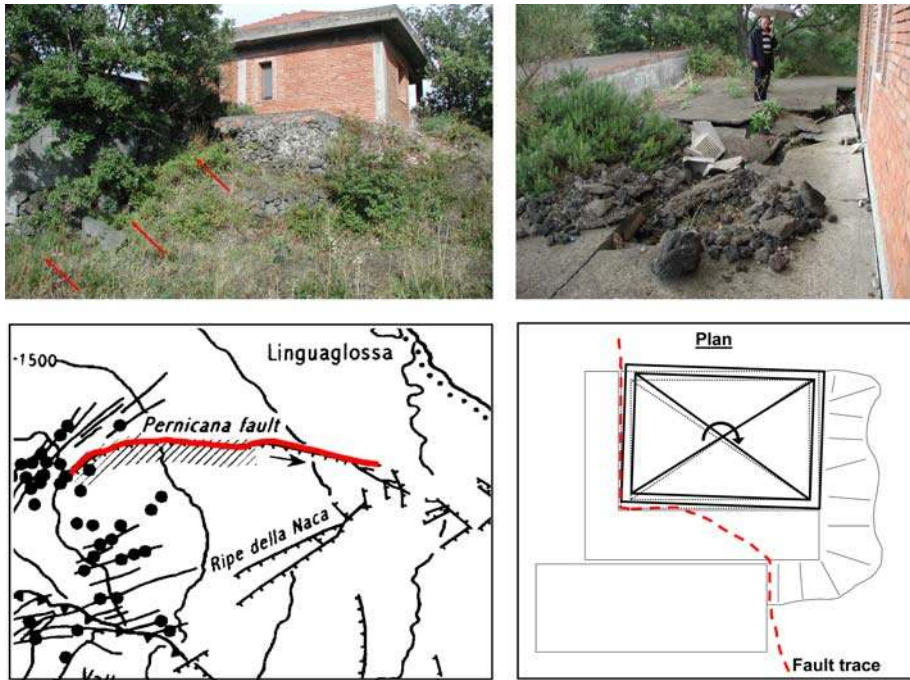
Fig. 4 Mt. Etna—Pernicana strike-slip fault: 1-story building resting on a rigid raft foundation. The continuity and stiffness of the foundation forced the surface fault rupture to divert away from the structure, leaving it almost completely unscathed, but with some rigid-body torsion around its vertical axis

a rigid and continuous raft foundation with reinforcing ring beams at the perimeter. During an earthquake sequence that lasted from 1981 to 1988, the structure was crossed by the surface trace of the strike-slip Pernicana fault almost diagonally. But the greatest amount of the imposed deformation was most likely caused by continuous “aseismic” creep over the years. Interestingly, the fault rupture did not cause significant structural damage to this modern but modest structure. In fact, the continuity and stiffness of its foundation (mainly provided by RC ring beams as shown in Fig. 5), seems to have forced the surface fault rupture to divert, leaving the building largely unscathed, but causing visible rigid-body torsion around its vertical axis. Severe non-structural damage, in the form of cracking of partition walls, occurred at a lower level on the side of the building opposite to that shown in Fig. 4. The similarities with Banco Central de Nicaragua (Duncan and Lefebvre 1973) are notable, despite the differences in the foundation system (slab, instead of a vault).

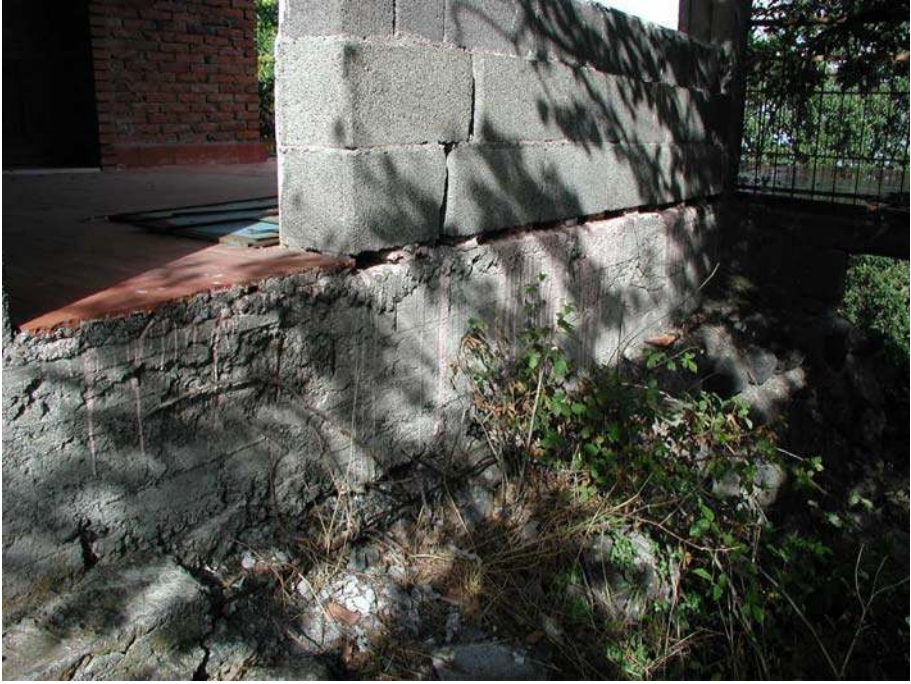
Fig. 5 Mt. Etna—1-story building of Fig. 4. Detail of the reinforced concrete ring beam around the raft foundation

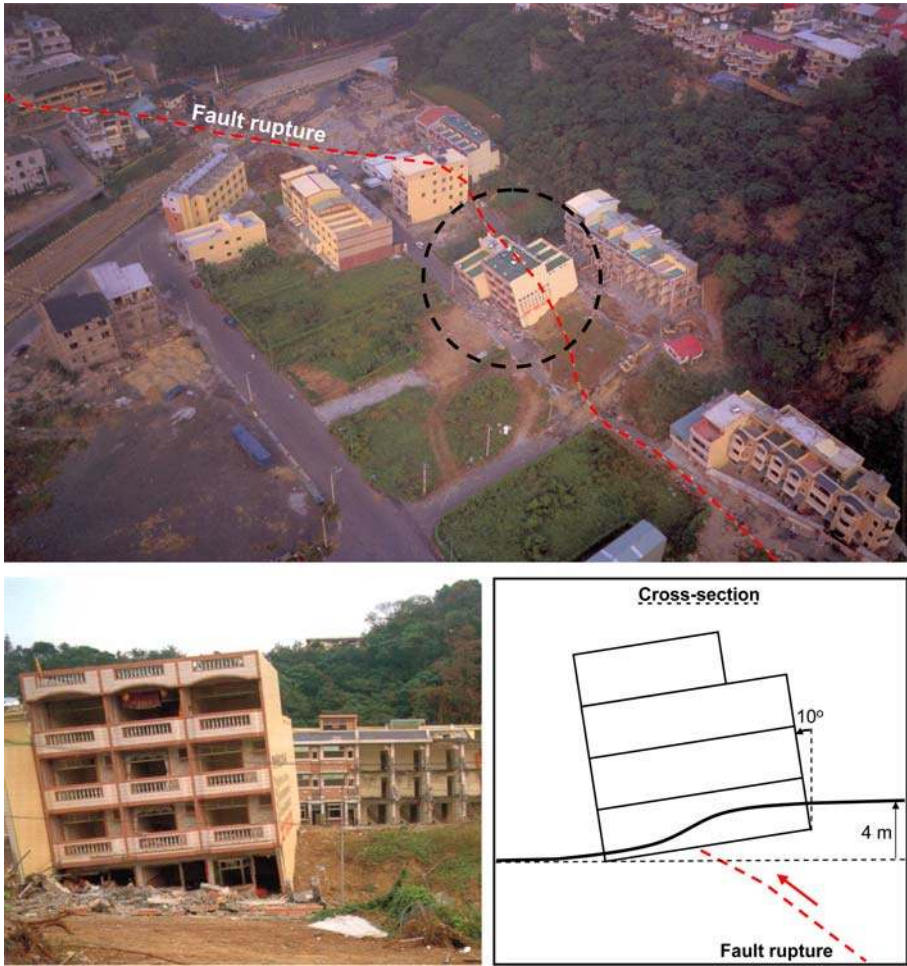
As already said, during the 1999 Chi–Chi earthquake in Taiwan a great variety of structures were crossed by the Chelungpu thrust fault. Among several other rural areas, the fault passed through Fung-Yan City in Chung-Cheng Park (see Fig. 2). Although several buildings were severely damaged or even collapsed, there were some cases of exceptional performance (see also [Dong et al. 2003](#)). One such case is the 4-storey reinforced concrete building of Fig. 7 (photos adapted from [Hwang 2000](#)). This structure survived almost 4 m of upthrust, without substantial structural damage (given the circumstances). As in the case of the 1-story building of Roccampana, due to the rigidity and continuity of its foundation system, the building underwent a rigid-body rotation (with respect to its horizontal axis, this time) of approximately 10° , without suffering much distortion.

Fig. 7 Chelungpu thrust fault, Chi-Chi, Taiwan 1999 earthquake—Chung-Cheng Park, Fung-Yan City: 4-story building resting on a continuous and rigid foundation (photos adapted from Hwang 2000). The building survived 4 m of upthrust without substantial structural damage, but subjected to approximately 10° of rigid-body rotation

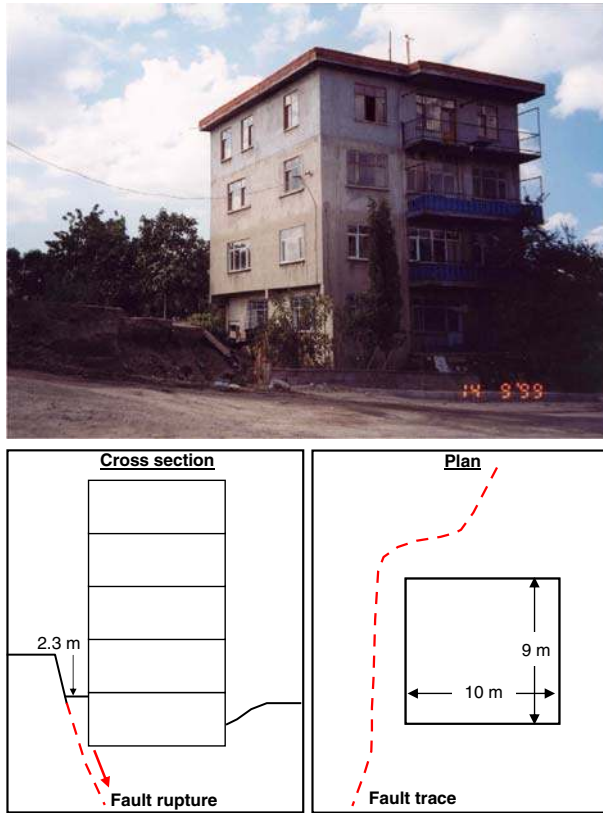
illustrates the main features of one such example, i. e. a 4-storey building with basement, resting on a continuous rigid box-type foundation. This building survived 2.3 m of downward displacement without any visible damage and, moreover, it effectively diverted the surface rupture.

Fig. 9 Normal fault east of Gölcük, Kocaeli, Turkey 1999 earthquake—Denizevler: 4-story building with basement resting on continuous and rigid box-type foundation. The building survived 2.3 m of downward displacement without any visible damage. Moreover, the surface rupture was diverted away from the building

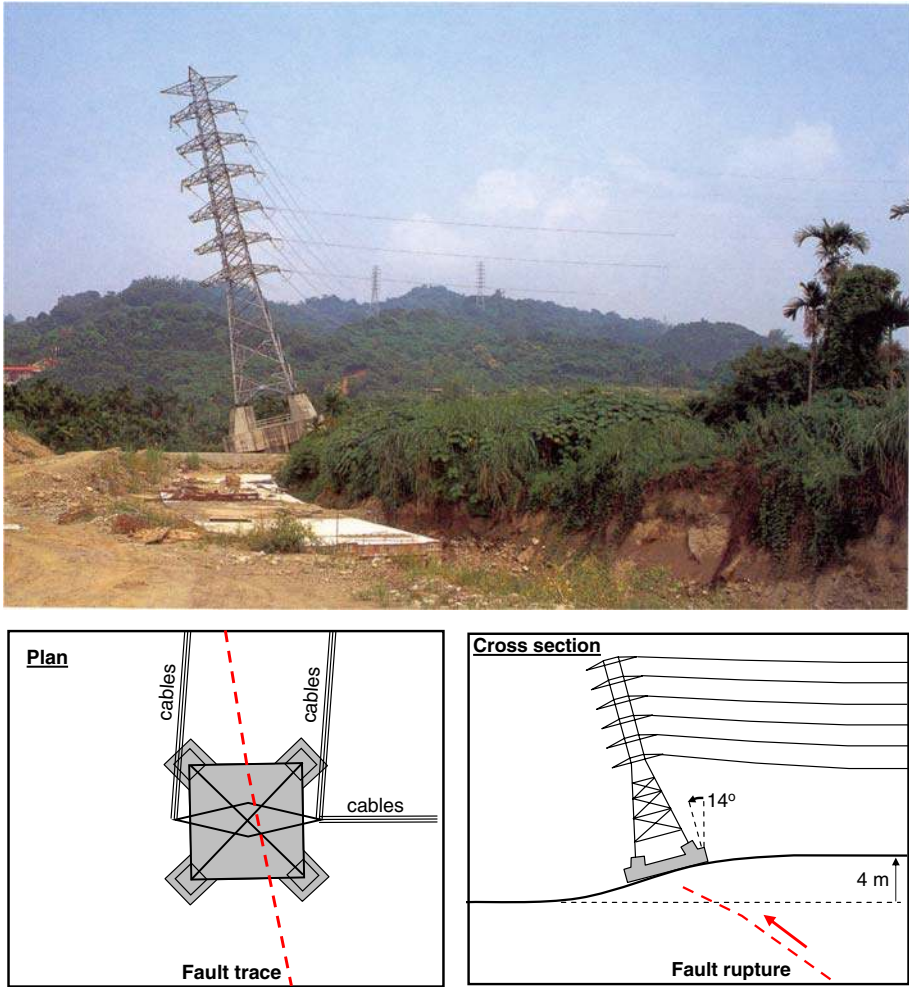
Figure 11 (photo adapted from Hwang 2000) depicts one final example from the Chi–Chi 1999 earthquake in Taiwan. It refers to a high-voltage electric line pylon in Min-Chien City (see Fig. 2b). The Chelungpu thrust fault crossed this pylon almost perpendicularly, imposing an upthrust of about 4 m. Quite interestingly, due to its rigid caisson foundation, the pylon survived the dislocation without any visible structural damage, although it underwent substantial rigid-body rotation of approximately 18° . This case-history is believed to be of particular significance, proving beyond doubt the beneficial role of such foundation systems. In the previous cases, one might conceivably have argued that the rigidity of the superstructure may have played an equally important role. However, in this case the superstructure is definitely quite flexible, and the survival of the structure can be attributed solely to its foundation.

Fig. 11 Chelungpu thrust fault, Chi-Chi, Taiwan 1999 earthquake—Min-Chien City: High-voltage electricity pylon resting on a continuous and rigid foundation (photo adapted from Hwang 2000). The pylon survived 4 m of upthrust without any visible structural damage, but subjected to approximately 14° of rigid-body rotation

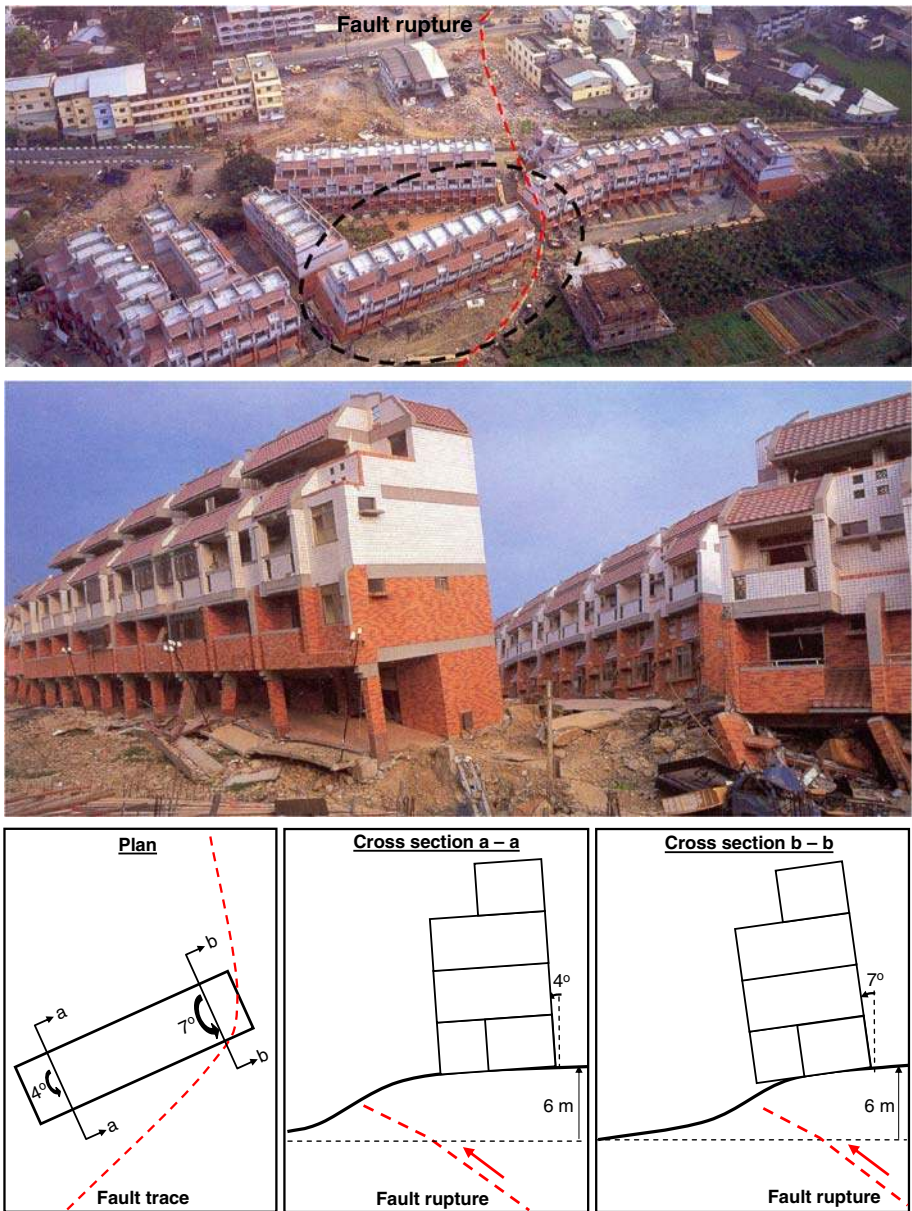
Figure 12 (photos adapted from Hwang 2000) illustrates a first such example from the Chi–Chi 1999 earthquake. It refers to a 4-storey reinforced concrete building in Fung-Yan City (see Fig. 2), the corner of which was crossed by the Chelungpu thrust fault. Subjected to 6 m of upthrust, this building barely survived the imposed deformation, having experienced substantial structural damage. Apparently, its relatively flexible foundation system did not manage to convert all of the differential displacement to rigid-body rotation. The latter ranged from approximately 7° close to the corner that was crossed by the rupture (section b-b in Fig. 12), to about 4° at the other end (section a-a). This indicates that the building did not only rotate with respect to horizontal axis, but was also subject to some torsion. Had the foundation been stiffer, the rotations at the two edges should have been almost the same.

Fig. 12 Chelungpu thrust fault, Chi-Chi, Taiwan 1999 earthquake—Fung-Yan City: 4-story building resting on a relatively flexible foundation (photos adapted from Hwang 2000). The building survived 6 m of upthrust but with substantial structural damage. The rigid-body rotation ranged from 4° to 7°

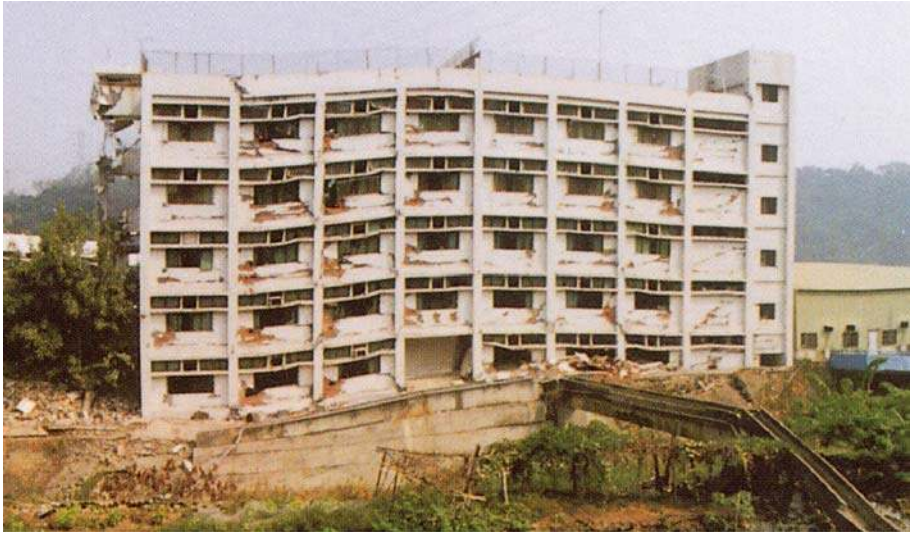
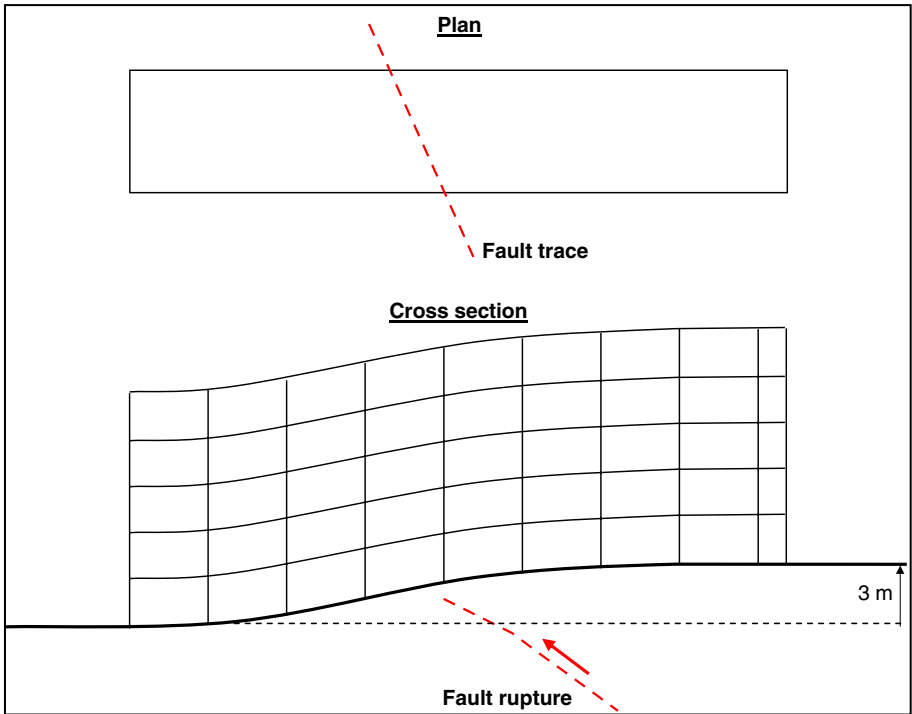
Another example from the same earthquake is given in Fig. 13 (photos adapted from Hwang 2000): a 5-storey building of the Tze-Min Commerce and Technical College in Wu-Fung Hsiang (see Fig. 2). This reinforced concrete building was crossed by the Chelungpu fault, was subjected to 3 m of upthrust. Resting on a relatively flexible foundation, this structure survived the earthquake but with heavy structural damage. Observe that there was practically no rigid-body rotation: the structure essentially followed the imposed ground

deformation profile. Compared to the previous case (Fig. 12), a noticeable difference is that this building was crossed perpendicularly to its large plan dimension. This difference in the geometry of crossing is quite crucial: the same foundation behaves much more flexibly when subjected to bending along its larger plan dimension.

Fig. 13 Chelungpu thrust fault, Chi-Chi, Taiwan 1999 earthquake—Wu-Fung Hsiang, Tze-Min Commerce and Technical College: 5-story building resting on a relatively flexible foundation. The building survived about 3 m of upthrust, but with substantial structural damage

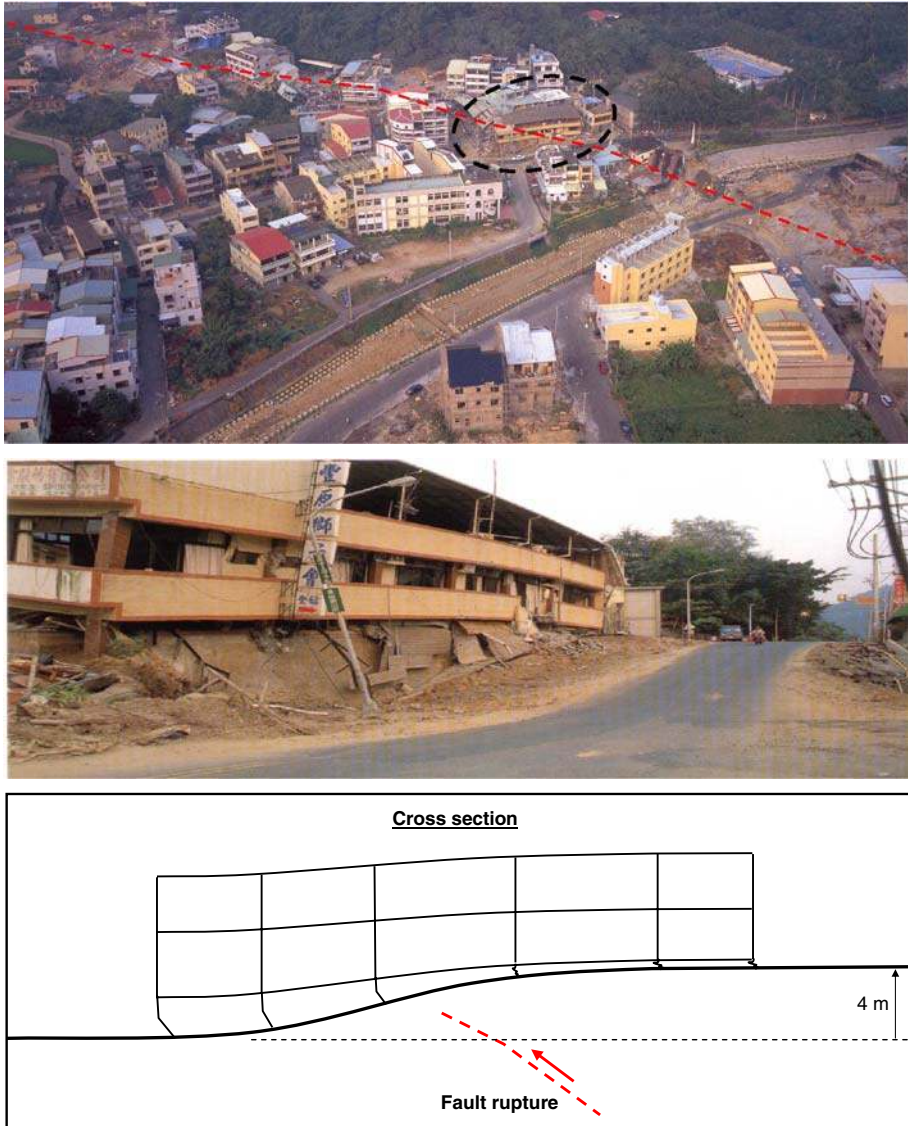
Figure 14 (photos adapted from Hwang 2000) depicts a 3-storey building in Fung-Yan City, Chung-Cheng Park (see Fig. 2). This building was also intersected by the Chelungpu fault perpendicularly to its larger dimension. Subjected to about 4 m of upthrust, the first floor of the building “pancake” collapsed. Evidently, the flexible foundation did not offer any significant bending resistance: the imposed ground deformation was practically transmitted unaltered to the superstructure, leading unavoidably to the observed collapse.

Fig. 14 Chelungpu thrust fault, Chi-Chi, Taiwan 1999 earthquake—Chung-Cheng Park, Fung-Yan City: 3-story building resting on flexible foundation (photos adapted from [Hwang 2000](#)). Subjected to 4 m of upthrust, the first floor of the building partially collapsed

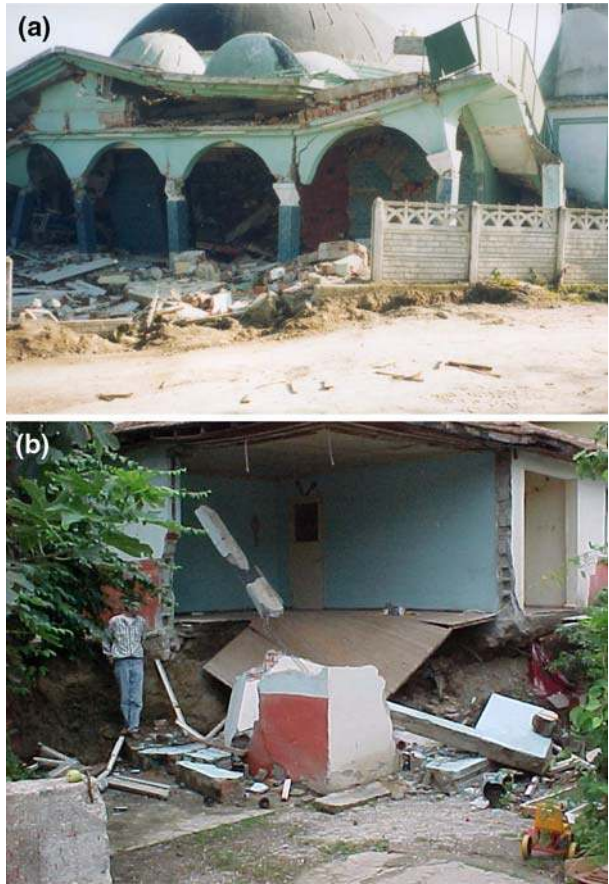
Two examples from Denizevler (Kocaeli 1999 earthquake) are illustrated in Fig. 15: (a) a Mosque resting on isolated footings (definitely a flexible foundation), and (b) a modest 1-storey cinder-block building (photo adapted from Youd et al. 2000) directly founded on the ground (an extremely flexible foundation). Both buildings were crossed by the normal fault rupture close to their corners. Subjected to about 1.5 m of differential displacement, the two structures partially collapsed, and were later demolished. As in the previous case (Chi–Chi), the differential displacements were transferred to the superstructures practically unaltered. In stark contrast to the previous case, the intensity of ground shaking is not believed to have played a major role here: the minaret of the mosque did not collapse.

Fig. 15 Normal fault east of Gölcük, Kocaeli, Turkey 1999 earthquake—Denizevler: **a** Mosque resting on flexible foundation (isolated footings), and **b** 1-story cinder-block building (photo from Youd et al. 2000), directly founded on the ground (very flexible foundation). Both buildings were subjected to about 1.5 m differential displacement and partially collapsed

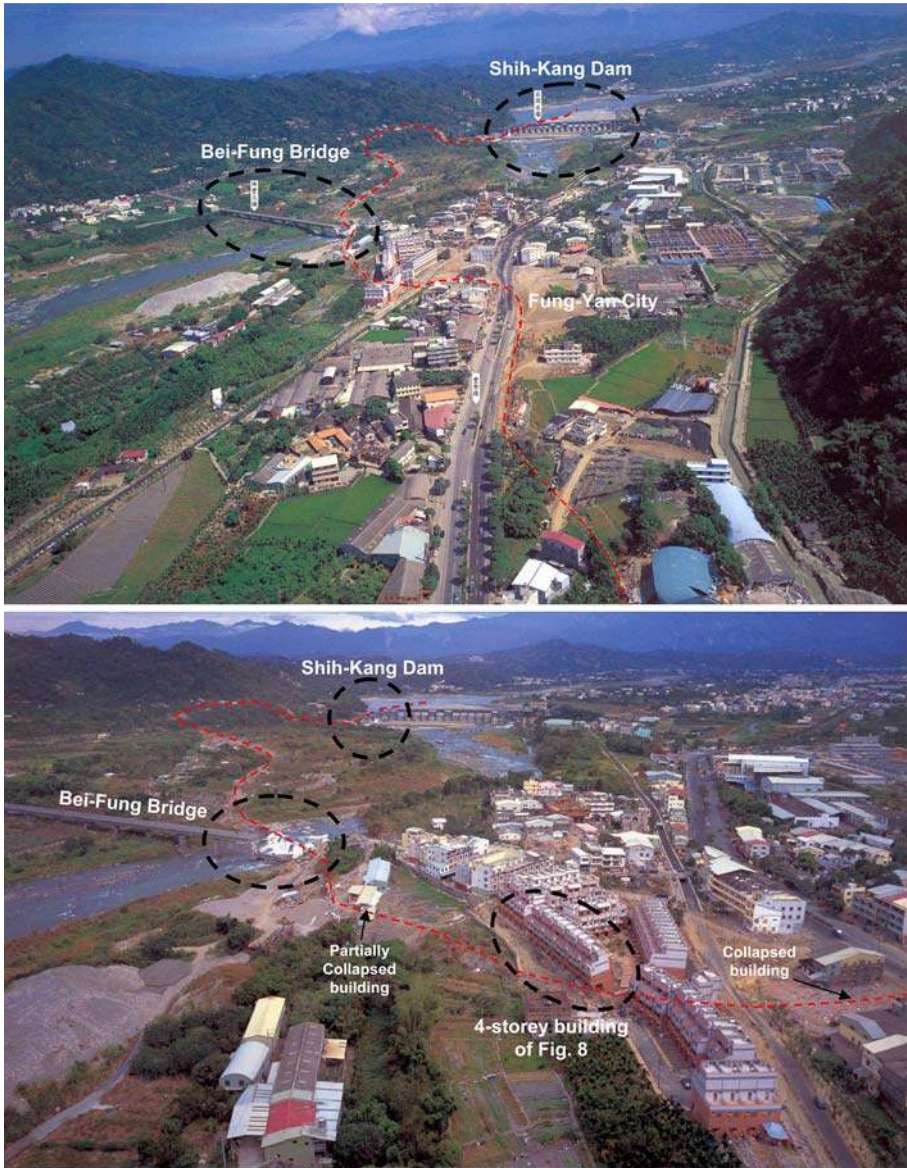
A final example from the Chi-Chi 1999 earthquake is the failure of the Shih-Kang Dam. As illustrated in Fig. 17 (photos adapted from Hwang 2000), the Chelungpu fault passed through Fung-Yan City (see also Fig. 2b). With about 7 m of upthrust, the fault rupture caused complete collapse of one building (the details of which are unknown to us), substantial damage to three other buildings (shown in detail in Fig. 9), partial collapse of a light 1-storey structure, collapse of two spans of the Bei-Fung Bridge, and the failure of the Shih-Kang concrete gravity dam. As shown in Fig. 18, the fault rupture crossed the northern part of the dam with an upthrust of about 9 m, destroying its spillways and gates. Due to its length of about 700 m

Fig. 17 Chelungpu thrust fault, Chi-Chi, Taiwan 1999 earthquake—Fung-Yan City. From bottomright to top-left: The fault rupture, of about 7 m of upthrust, passed through Fung-Yan City causing complete collapse of one building (the details of which are not known), substantial damage to three other buildings (shown in detail in Fig. 8), partial collapse of a light 1-story structure, collapse of two spans of the Bei-Fung Bridge, and failure of the Shih-Kang Dam (photos adapted from Hwang 2000)

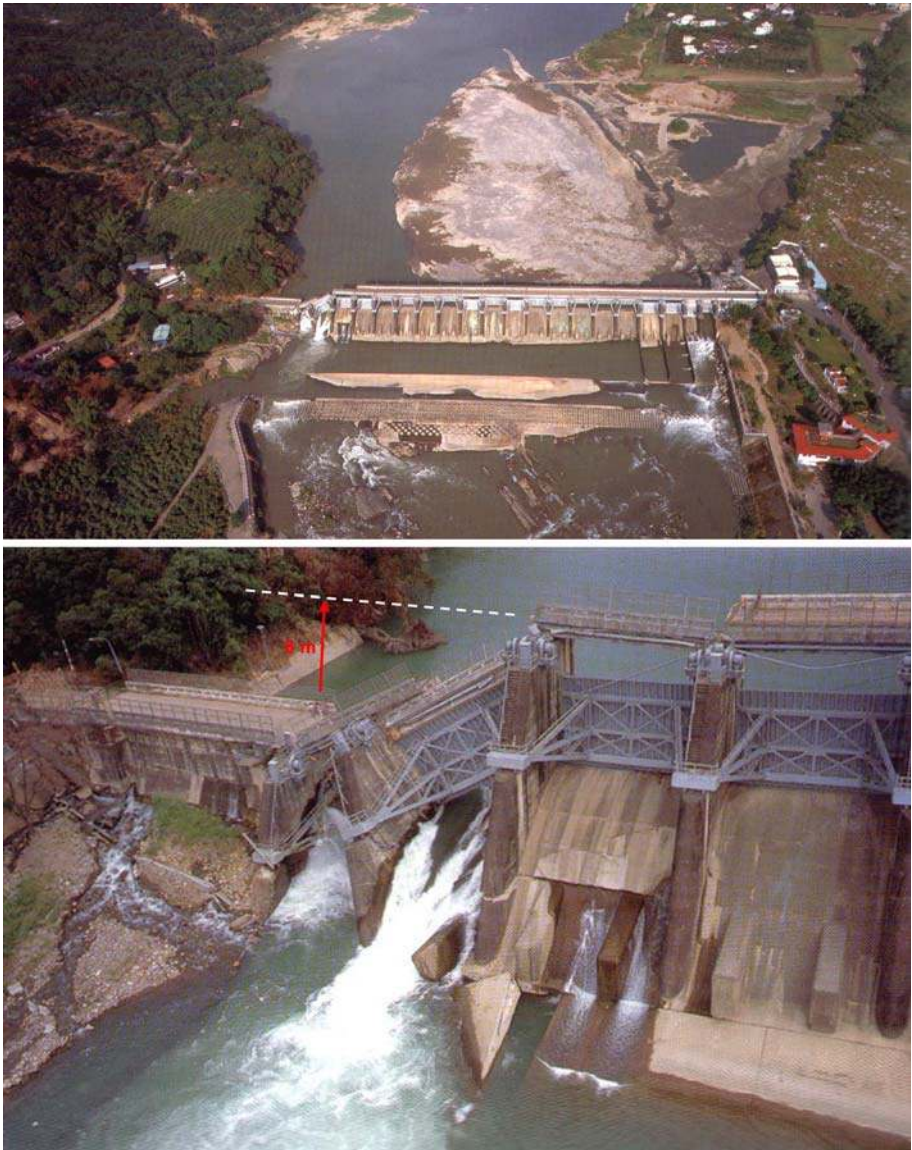
(Chen-Shan et al. 2001; Sugimura et al. 2001), the dam seems to have behaved as a structure on flexible foundation and, as in the previous examples, practically followed the imposed deformation, sustaining substantial structural damage. Despite the obvious differences with the previous case-histories (the superstructure of this dam is certainly different from that of a building), from a behavioral point-of-view the response is rather similar.

Fig. 18 Chelungpu thrust fault, Chi-Chi, Taiwan 1999 earthquake—Shih-Kang Dam. The fault rupture passed through the northern part of the dam with an upthrust of about 8 m, destroying spillways and gates. Due to its length of 700 m, the dam behaved as a flexible structure, practically following the imposed deformation (photos adapted from [Hwang 2000](#))

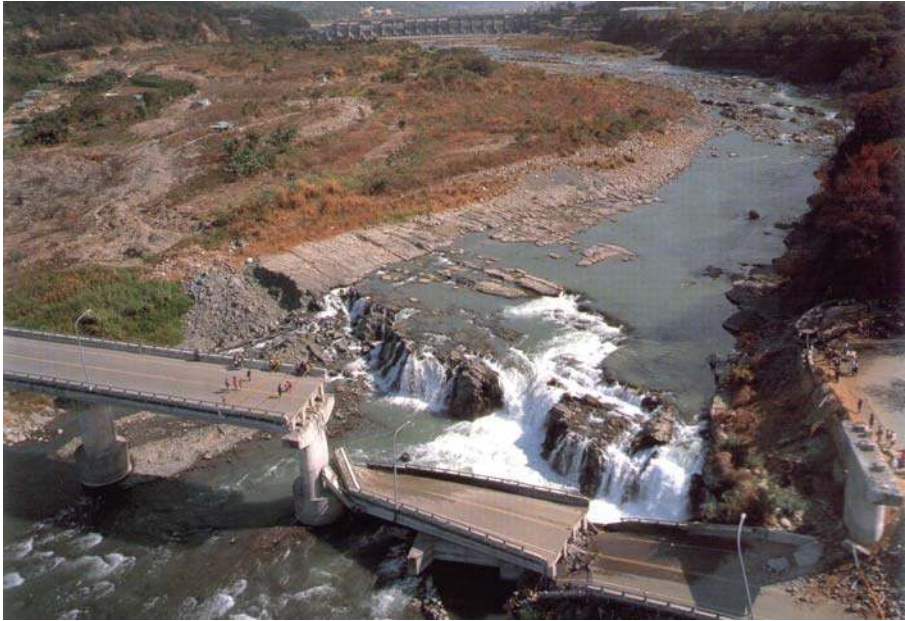
development of a small but impressive waterfall, the result of the faulting-induced deformation was the collapse of two spans of the bridge. It is evident that the differential displacement between the discrete supports (piers) of the structure (deck), was larger than the available seating. In fact, the same performance was also observed in similar bridges, such as the Shi-Wei bridge (Pamuk et al. 2005). Had the deck been continuous, it would still have collapsed, but not due to un-seating: the differential displacement would have generated dramatically large bending moments in the bridge deck.

Fig. 19 Chelungpu thrust fault, Chi-Chi, Taiwan 1999 earthquake—Fung-Yan City. The fault rupture passed through the south abutment of the Bei-Fung bridge with an upthrust of about 7 m, causing the collapse of two spans and the development of a small, but impressive, waterfall (photos adapted from [Hwang 2000](#))

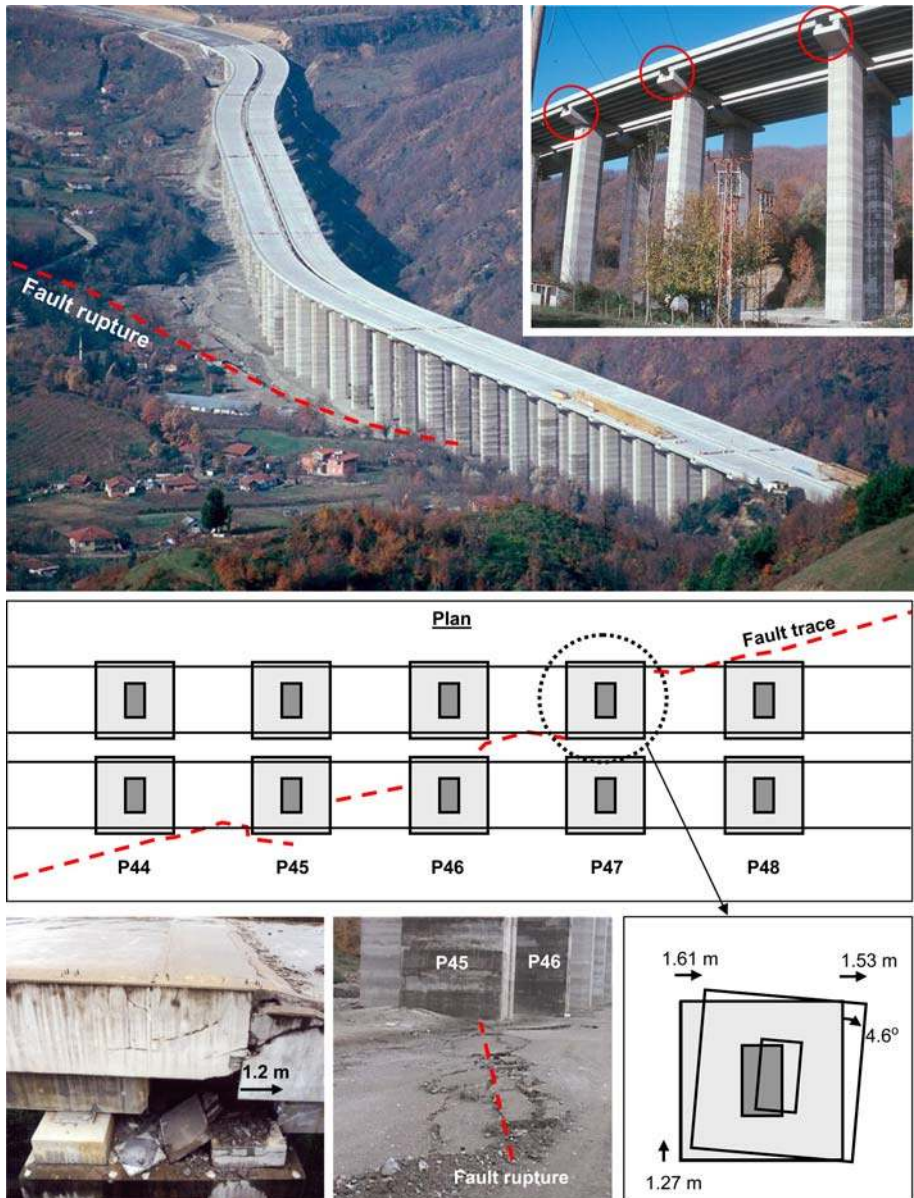
Figure 20 shows the Kaynasli Viaduct of the Trans-European Motorway in Turkey. During the Düzce-Bolu 1999 earthquake, the seismically-isolated Viaduct was crossed by the North Anatolian fault and was subjected to a strike-slip offset of the order of 1.5 m. The Viaduct consisted of two separate decks, of 58 and 59 spans. With an average span of 40 m, the bridge was about 2.3 km in total length, and was supported on 10 m to 49 m high piers, founded on pile-groups consisting of 12 piles 1.8 m in diameter. Each deck consisted of seven pre-stressed concrete beams, connected together with a reinforced concrete slab on top. The decks were supported through pot bearings, with a capacity for multi-directional sliding. Joints were installed every 10 spans, to provide temperature deformation relief. At each joint, special energy dissipating units, viscous dampers, and stoppers were installed

(Kawashima 2001). As illustrated in Fig. 20, the faulting-induced deformation was responsible for the development of substantial horizontal displacements and rotations of the piers (i.e., the discrete supports). The seismically-isolated deck experienced 1.2 m of differential displacement, barely avoiding collapse thanks to the restraint provided by the stoppers.

Fig. 20 The North-Anatolia strike-slip fault, Düzce, Turkey 1999 earthquake—Düzce-Bolu Viaduct: The fault rupture passed through the bridge generating substantial horizontal displacements and rotations of bridge piers. The seismic-isolated bridge deck was subjected to about 1.2 m of differential displacement, avoiding collapse at the last moment due to restraint provided by stoppers
