NBSIR 73-135

Fire Endurance Tests of Steel Sandwich Panel Exterior Wall and Roof/Ceiling Constructions

December 1972

Final Report

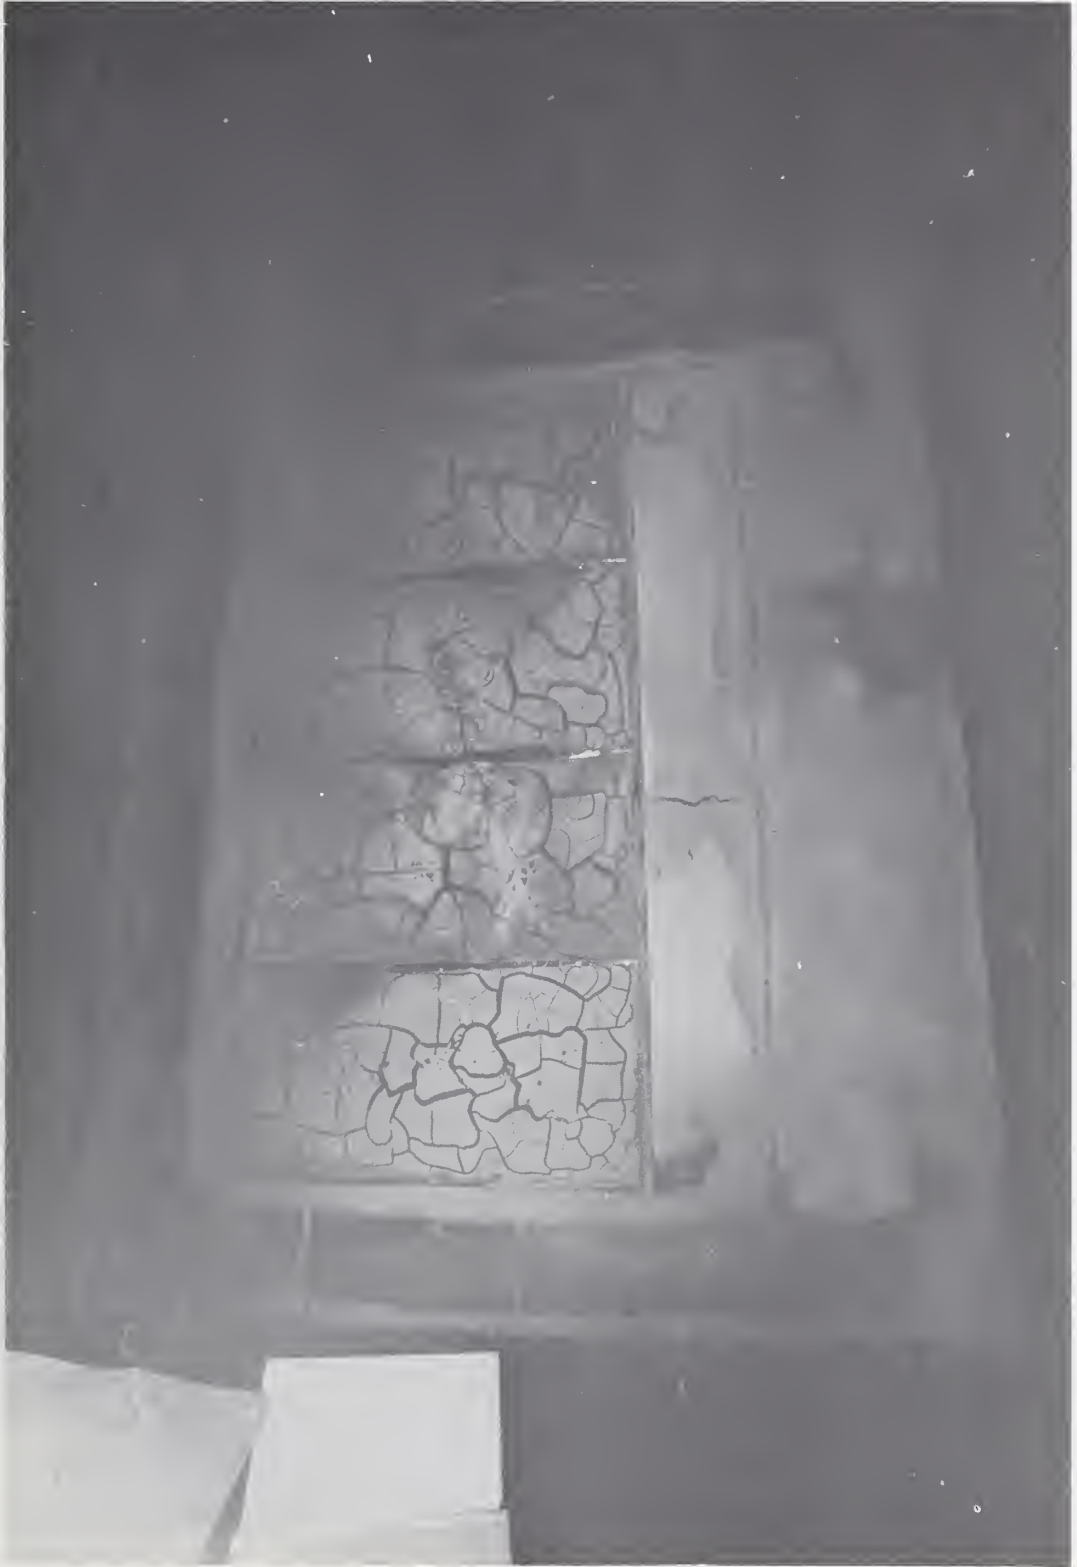
Figure 17 is a photograph showing the fire side of the panel after it was removed from the furnace just before extinguishment of the fire. Surfaces were buckled and most of the wood members, paper honeycomb, and polyurethane foam were consumed.

Figure 17. The fire side of the wall panel after it was removed from the surface just before extinguishment of the fire.
