Floating Breakwater Field Experience, West Coast

by
Eugene P. Richey

MISCELLANEOUS REPORT NO. 82-5

JULY 1982

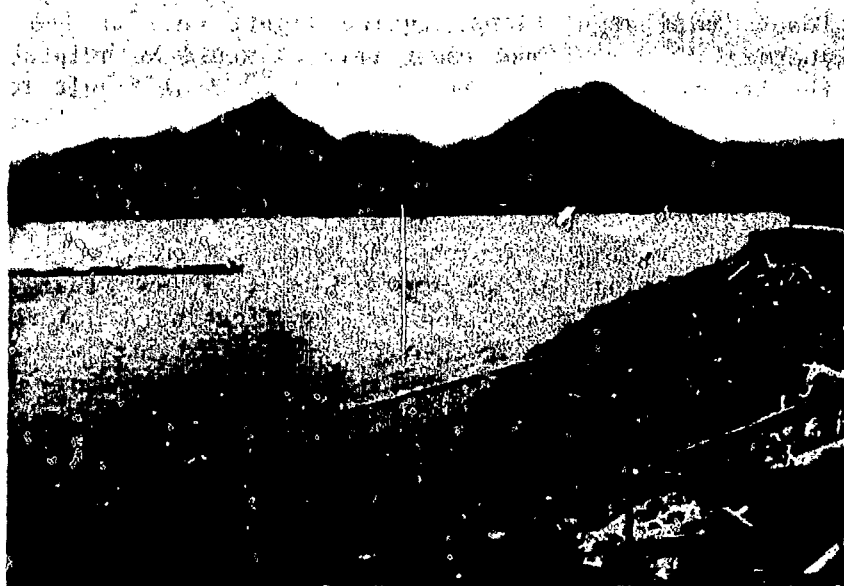
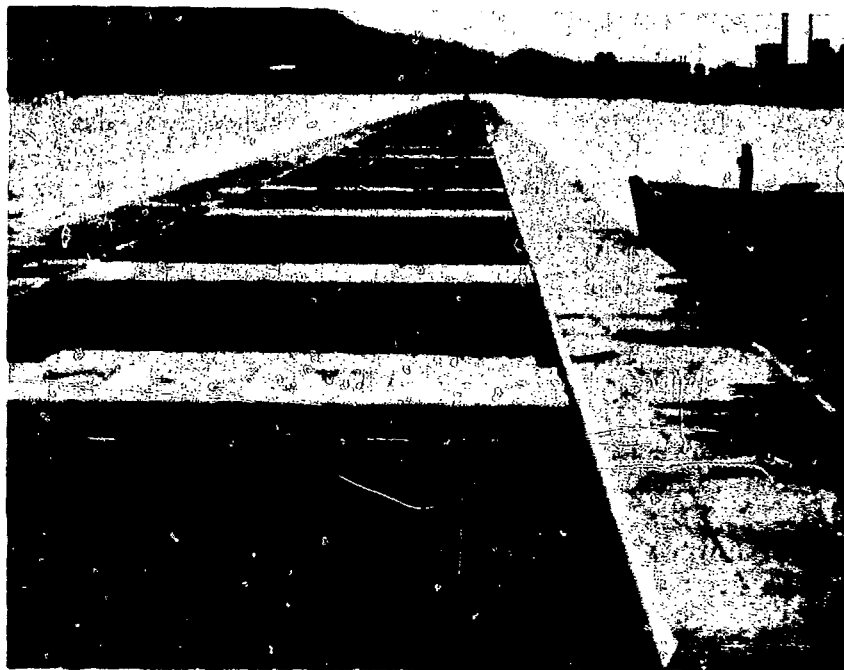
a. North end of harbor.

b. South end of harbor.

Figure 5. Photos of gaps at both north and south of harbor, Ketchikan, Alaska.

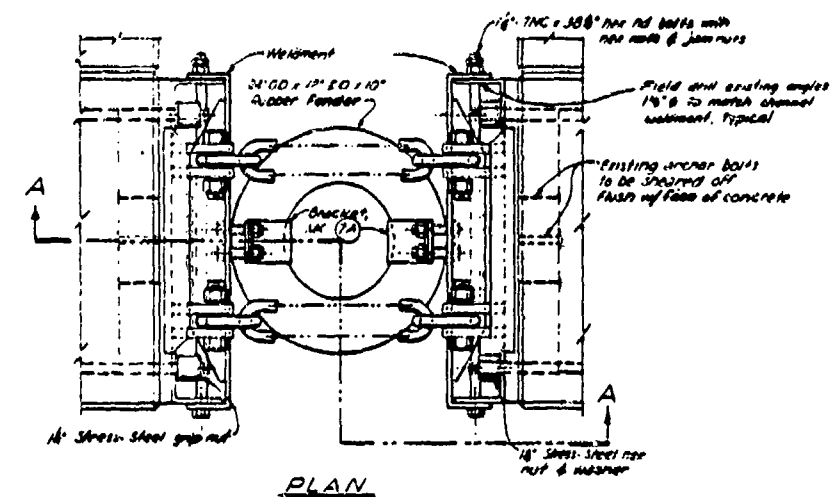
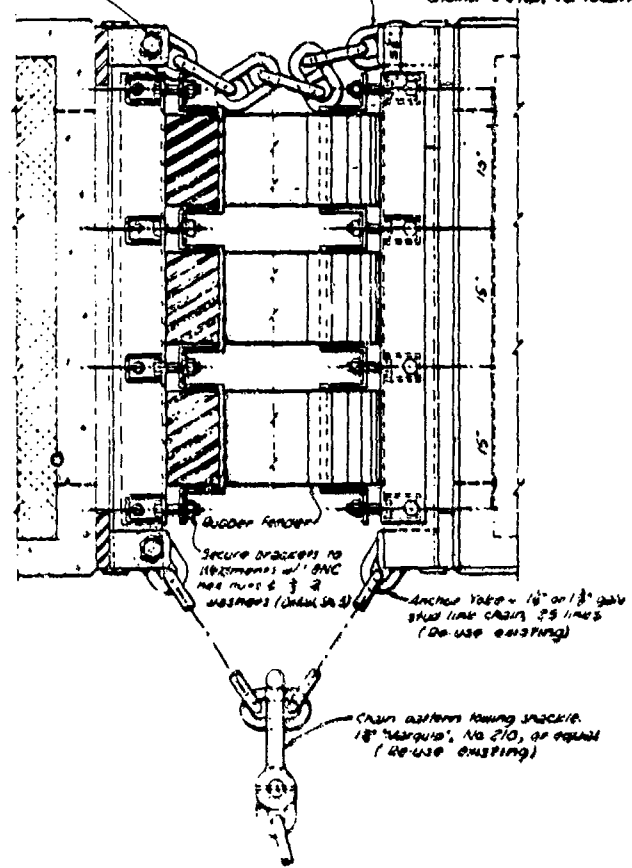
Figure 13. Replacement module connector for floating breakwater, Tenakee Springs, Alaska.

1 1/2" - 5/16" x 3 1/2" Hrc-Tensile Bolt,
 1/2" max the length and 1/2" from
 end for 1/2" collar key. Provide
 serrated hex nut

NOTE: Replace all 3-link Safety Chains
 with 7-link 1 1/2" stud link
 chains. 2 @ top, no location

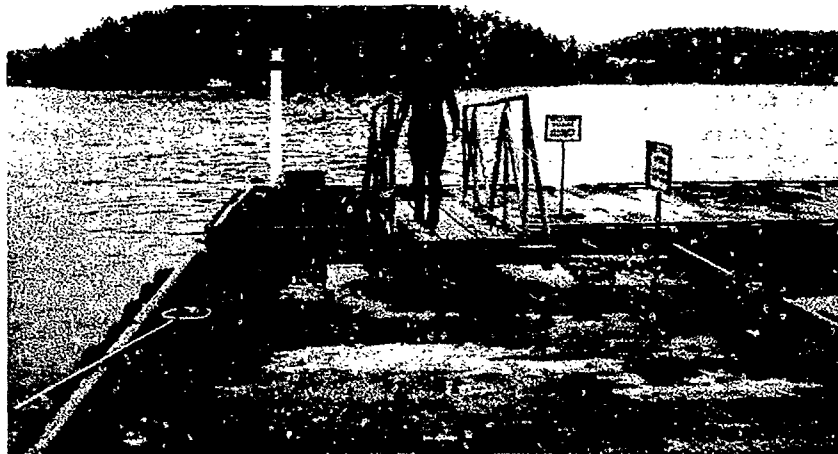
Some adjustments in the breakwater were necessary after installation. The gangways between the sections had to be redesigned to provide greater freedom of movement to avoid being overstressed. One of the sections did not

b. Gangway between sections.

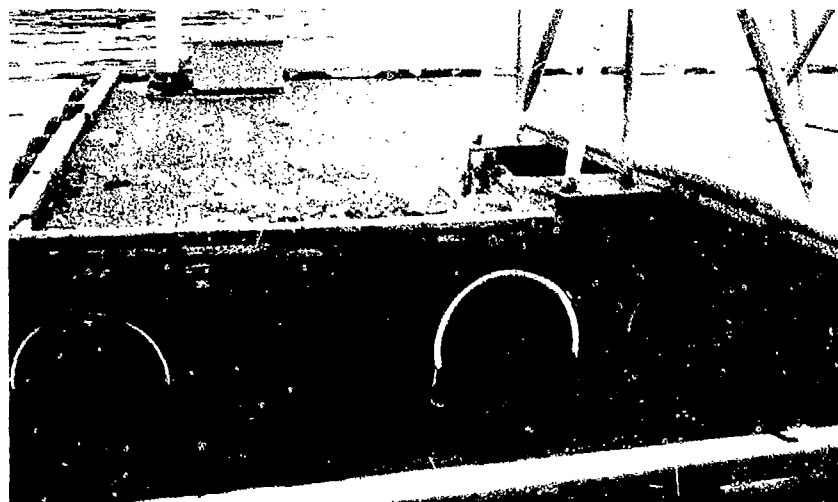
c. Bull rail detail.

The 2- by 4-inch tie piece on the bull rail is too light for its purpose and has broken in a few places. This member should be at least 4 by 4 inches. The installation of the anchors required extra, expensive site preparation which might have been avoided with more informative foundation surveys and better matching of anchor type to bottom conditions. No special maintenance problems have developed.

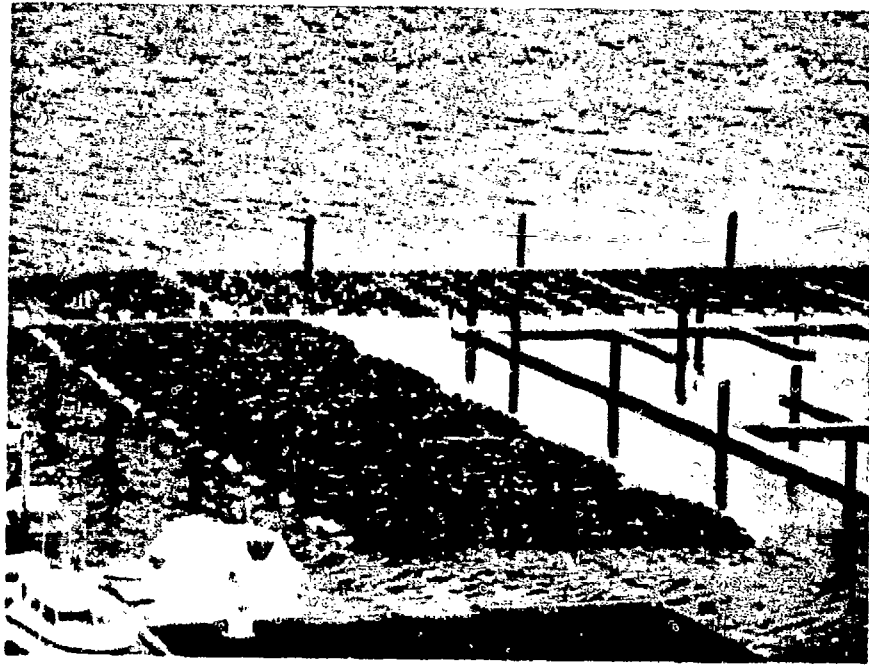
(2) Performance. The breakwater reduces the short-crested waves satisfactorily, but transmits too much energy in the lower frequencies. Connections in the boat slips were overstressed, and boats have not been permitted to use them. The slips were removed for the 1980-81 winter season. The north end of the east breakwater has been sinking, possibly due to the combination

Figure 29. Photo of floating tire breakwater, Langley, Washington.

of current drag and loss of buoyancy. Reports on other Styrofoam-filled tire breakwaters state that the foam breaks down under the continuous flexure experienced in the wind wave exposure.
