## **Fundamentals for remote structural health monitoring of wind turbine blades - a preproject. Annex E. Full-scale test of wind turbine blade, using sensors and NDT**

# **Fundamentals for Remote Structural Health Monitoring of Wind Turbine Blades – a Preproject**

## **Annex E – Full-Scale Test of Wind Turbine Blade, Using Sensors and NDT**

**Abstract** A 19.1 metre wind turbine blade was subjected to static tests. The purpose of the test series was to verify the abilities of different types of sensors to detect damage in wind turbine blades.

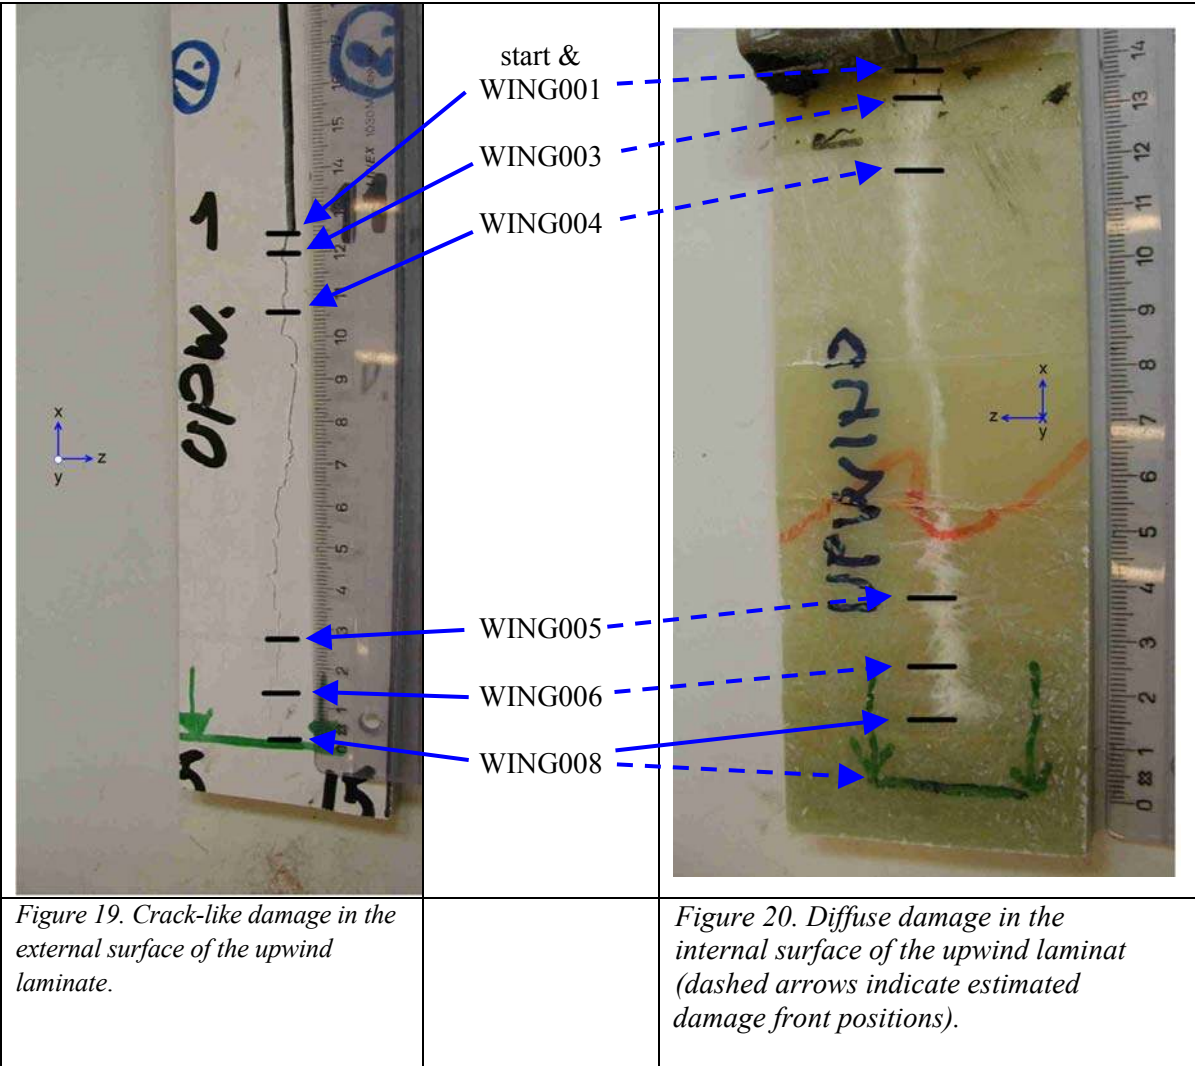
Figure 19. Crack-like damage in the external surface of the upwind laminate.

The damage extending from the pre-cut notch appears as a hair-line, crack-like damage on the gel-coated external surface, Figure 19. The same damage, as seen on the internal un-coated surface, is of a more diffuse nature, displaying a greater width (between 3 mm and 12 mm) with signs of delamination and bifurcation, Figure 20. In addition, the ultimate damage extension is less on the internal surface, as compared to the external surface. The damage is not like a crack, since the two faces of the damage are linked by fibres bridging the faces.

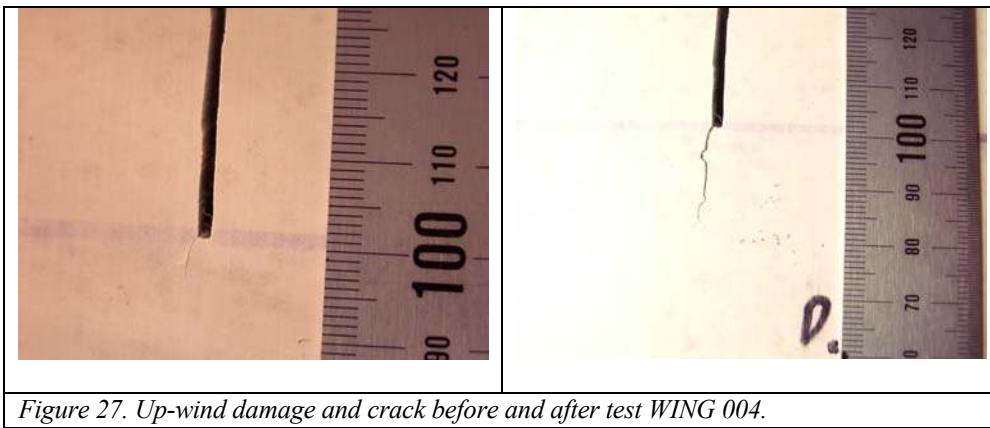
As the load was applied to the blade a linear related increase in strain level was measured on all the strain gauges. The relation in strain level between the strain gauges was also linear in correspondence to the distance from the neutral line of the blade, except for the 4 strain gauges (SG-no. 1, 6, 11, 16) in the line of the tip of the damage, which showed a lower strain level. The linearity ruled for tests “WING001 to “WING003”. During test “WING004” the strain level for the gauges (SG-no. 1, 6, 11, 16) nearest the trailing edge decreased while the next gauges (SG-no. 2, 7, 12, 17) were increasing in strain level, this change is indicated in the red arrows in Figure 26. The change in strain level was highest on the up-wind side of the blade; this corresponds with the growth of the damage during this test. This change in strain level between the strain gauges corresponded to the propagation in the crack length.

Figure 27. Up-wind damage and crack before and after test WING 004.

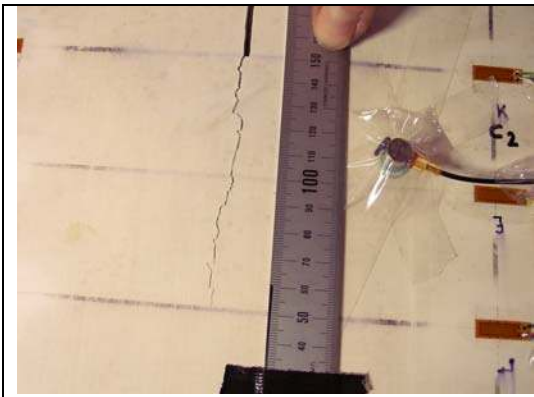
Figure 29. Up-wind damage after WING005  
(note AE sensor , right side)

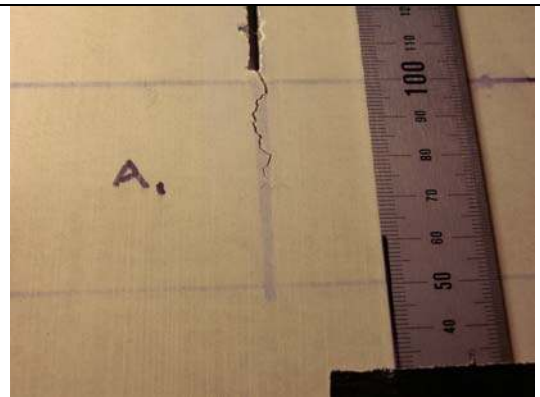
Figure 30. Down-wind damage after WING005

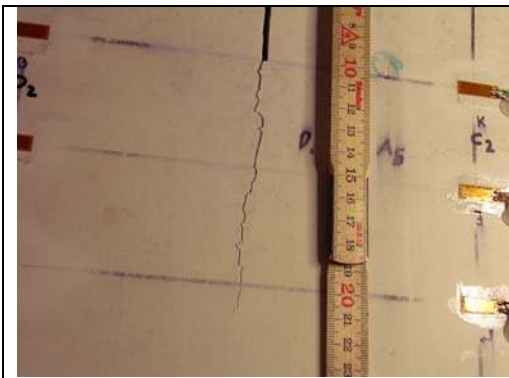
Figure 31. Up-wind damage after WING006

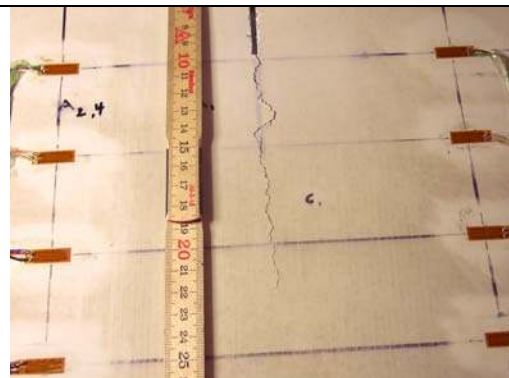
Figure 32. Down-wind damage after WING006

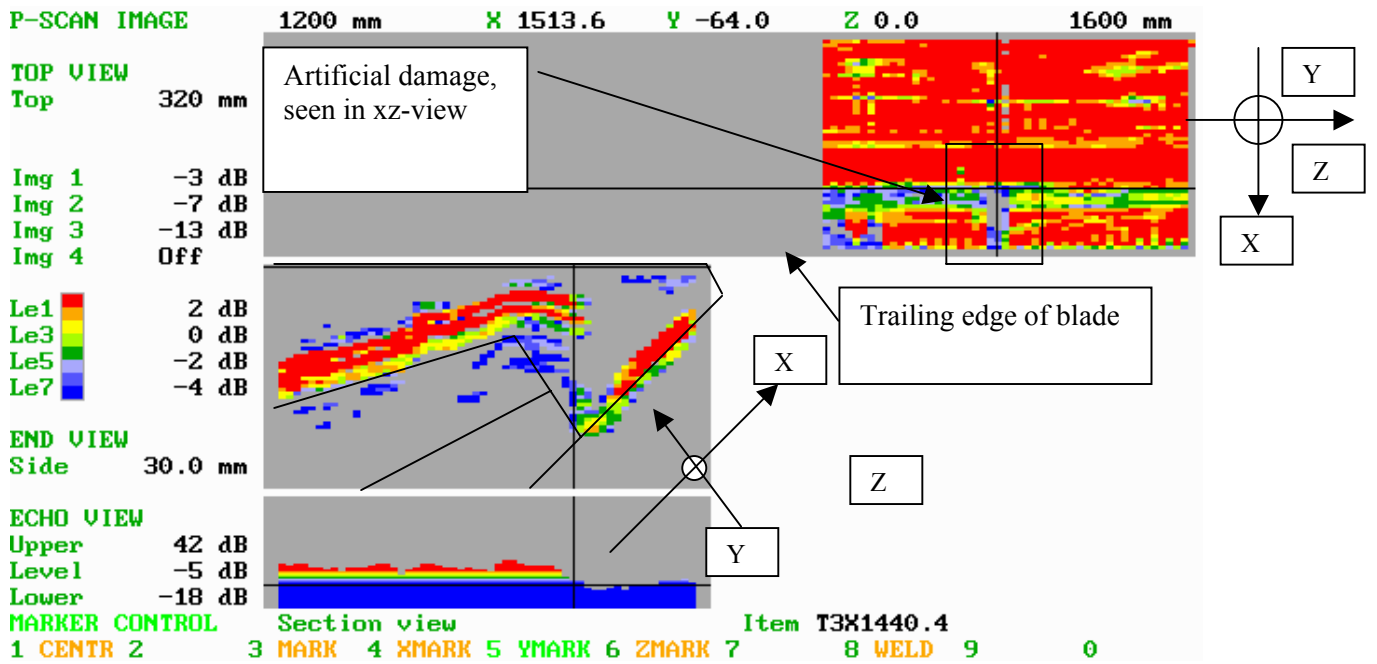
Figure 44. Image showing the result of the ultra sonic inspection of the up-wind surface of the blade after WING 001.

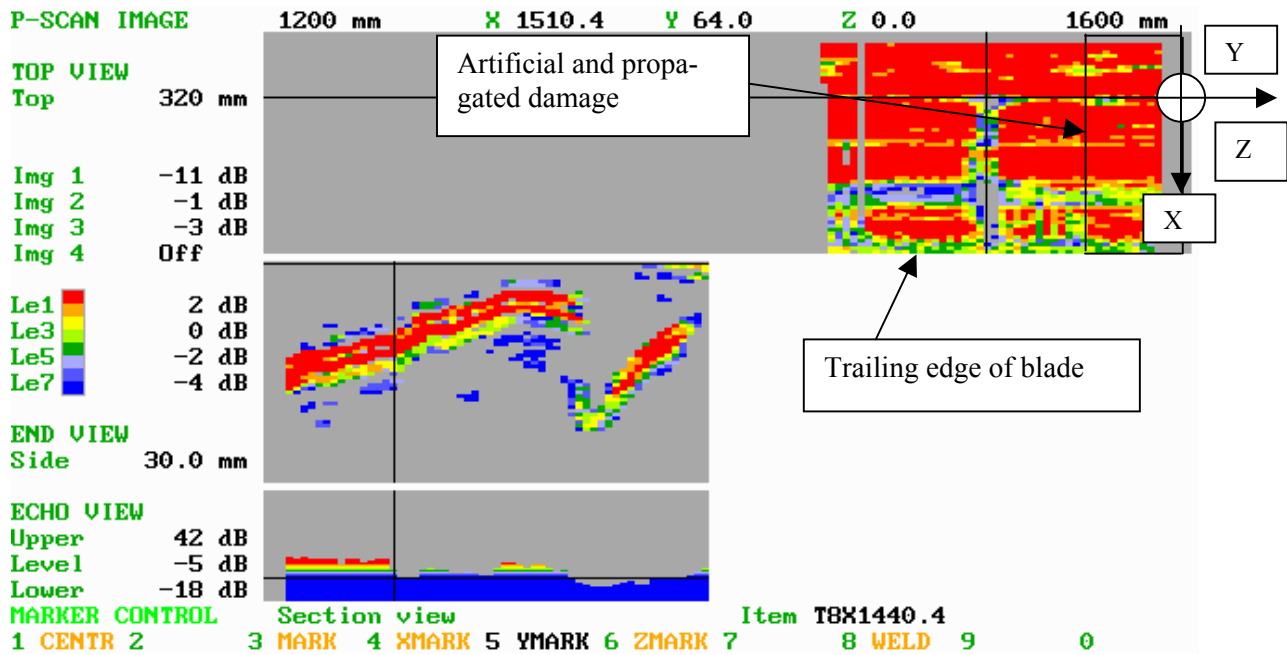
Figure 46. Image showing the result of the ultra sonic inspection of the up-wind surface of the blade after WING 008.

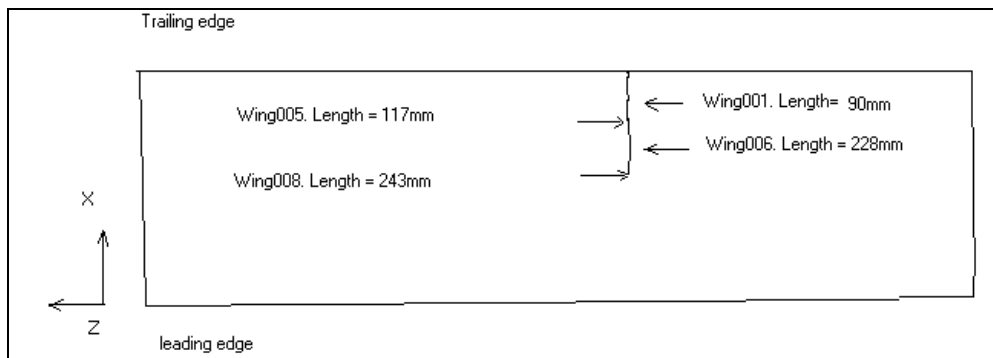
Figure 47. Sketch of propagated damage on down-wind surface after WING008, based on ultrasonic inspections

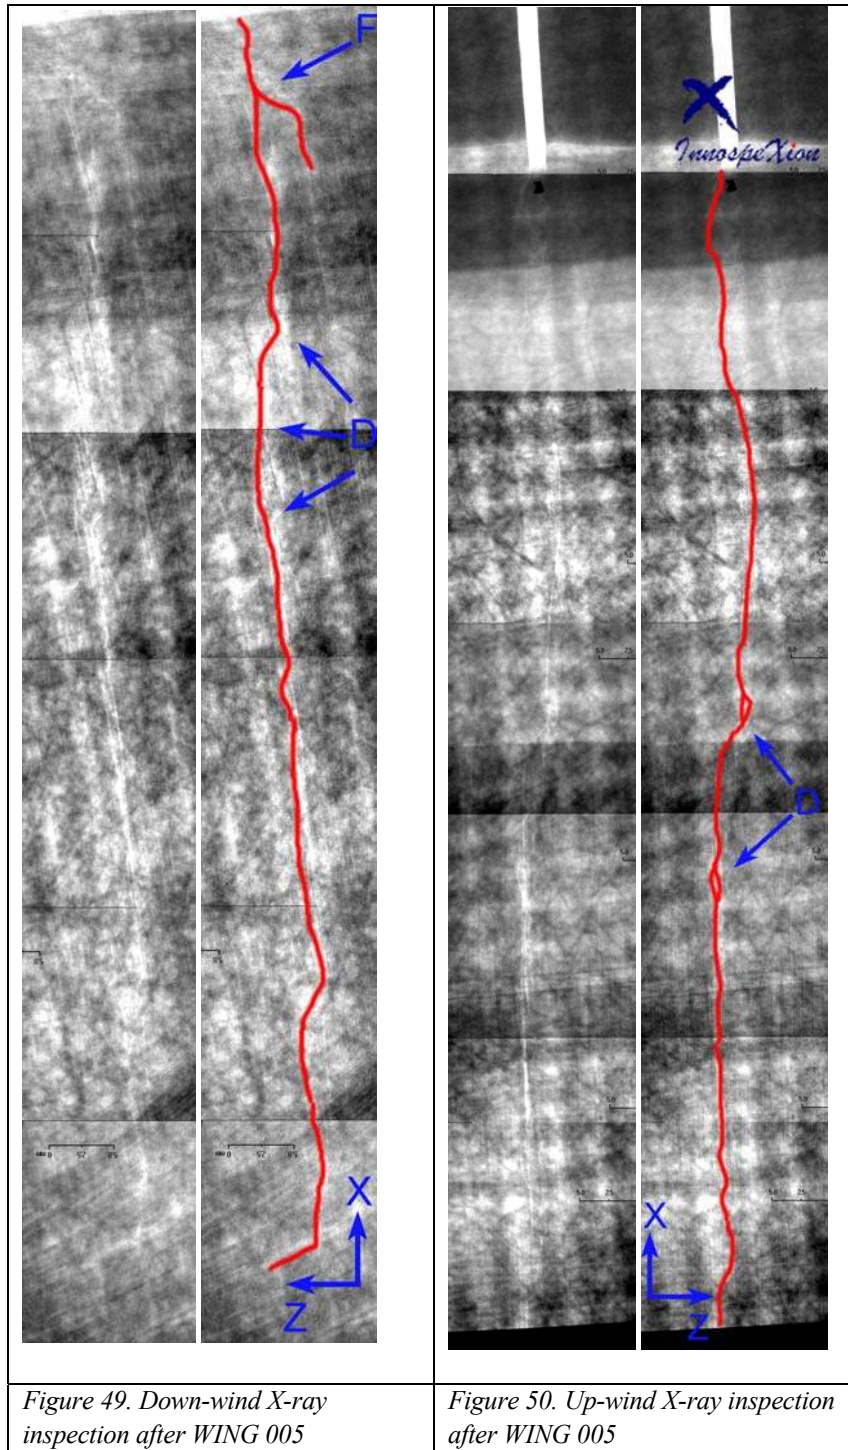
Figure 49. Down-wind X-ray inspection after WING 005

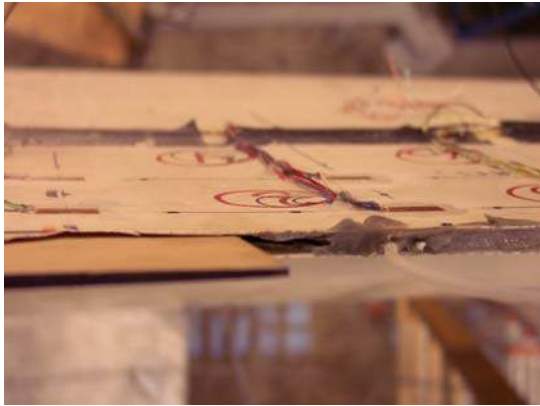
*Figure 55. Trailing edge after WING 106*

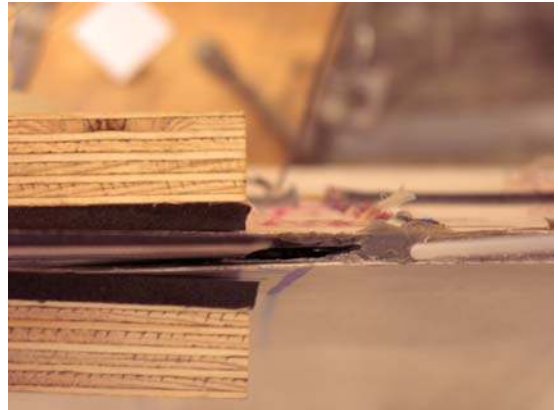
*Figure 56. Trailing edge before WING 109*

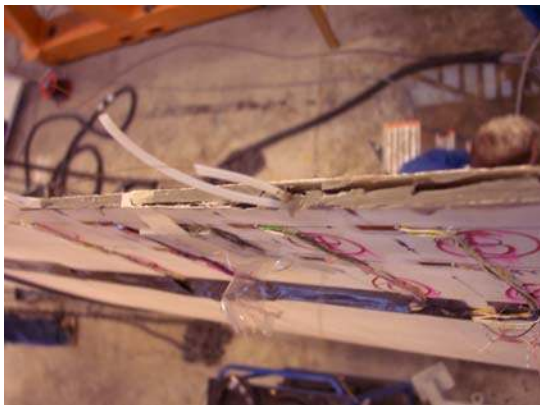
*Figure 57. Trailing edge after WING 118*

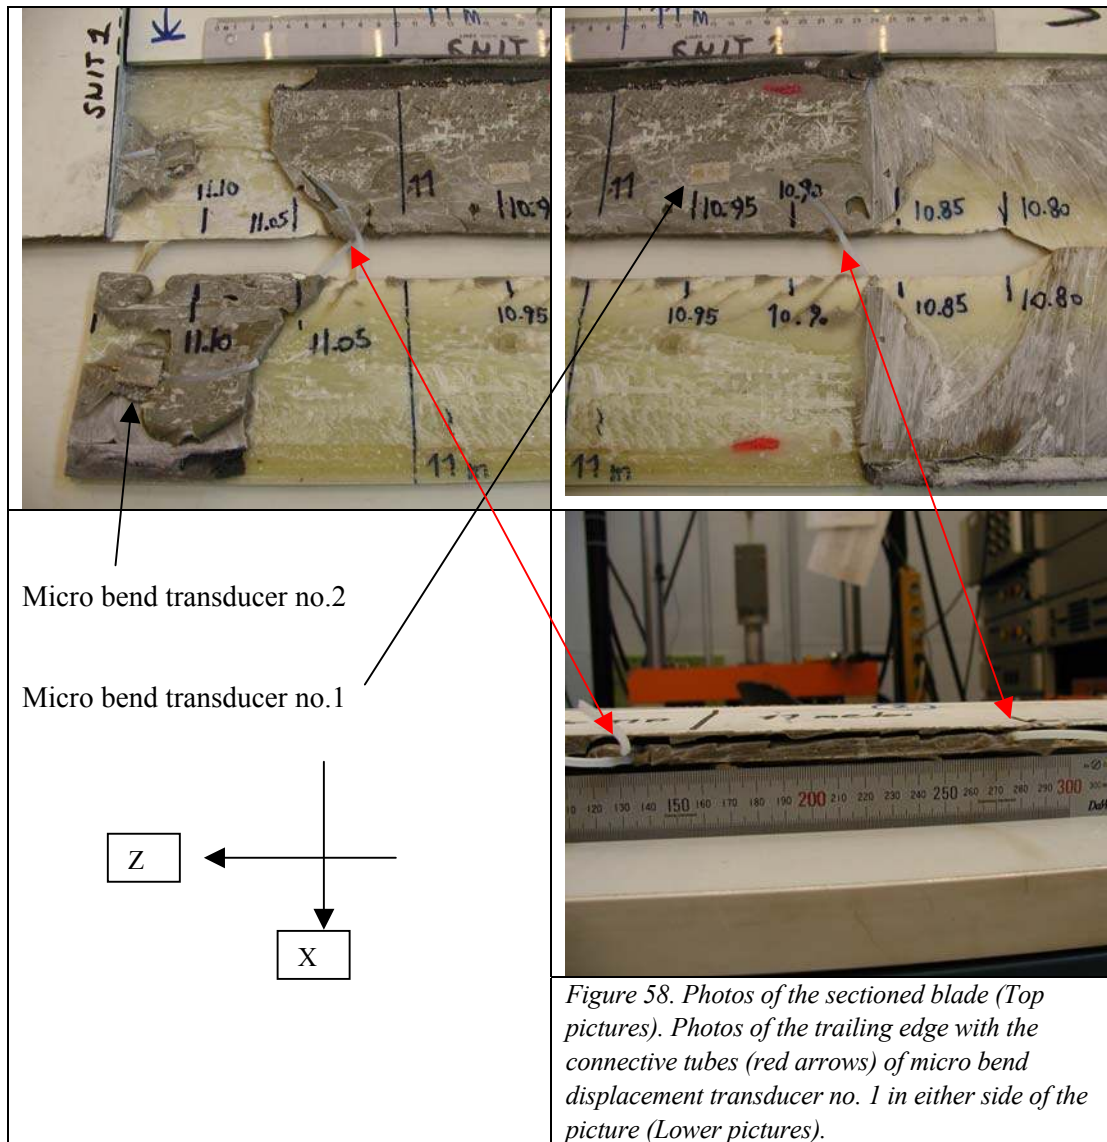
On these pictures it appears as the damage is propagating in an angel of 30° to 45° relative to the trailing edge and with direction towards the tip. This corresponds very well to the ultrasonic inspections as described in paragraph 6.5.

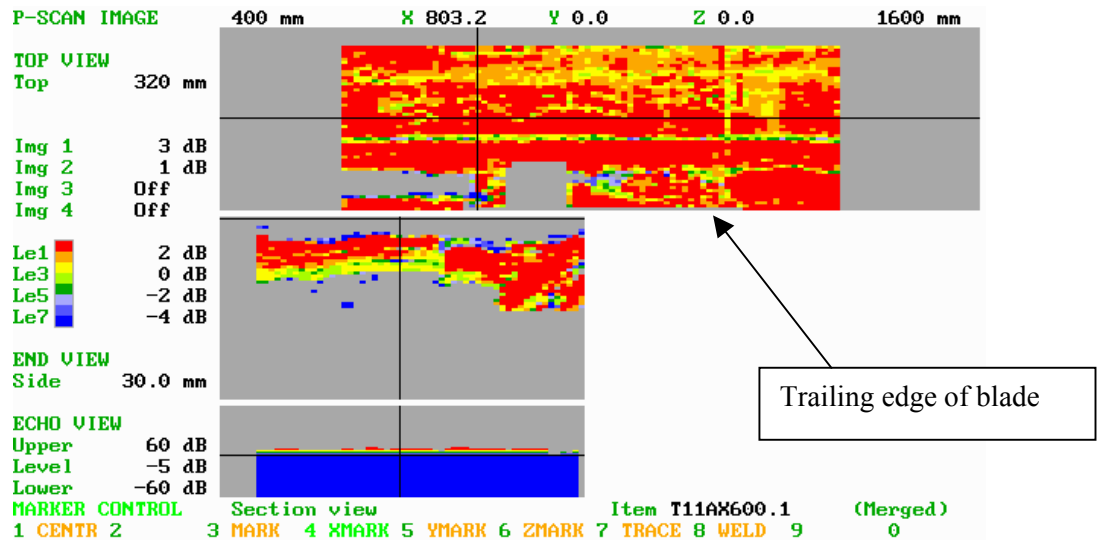
Figure 68. Image showing the result of the ultra sonic inspection of the up-wind surface of the blade after WING 118.

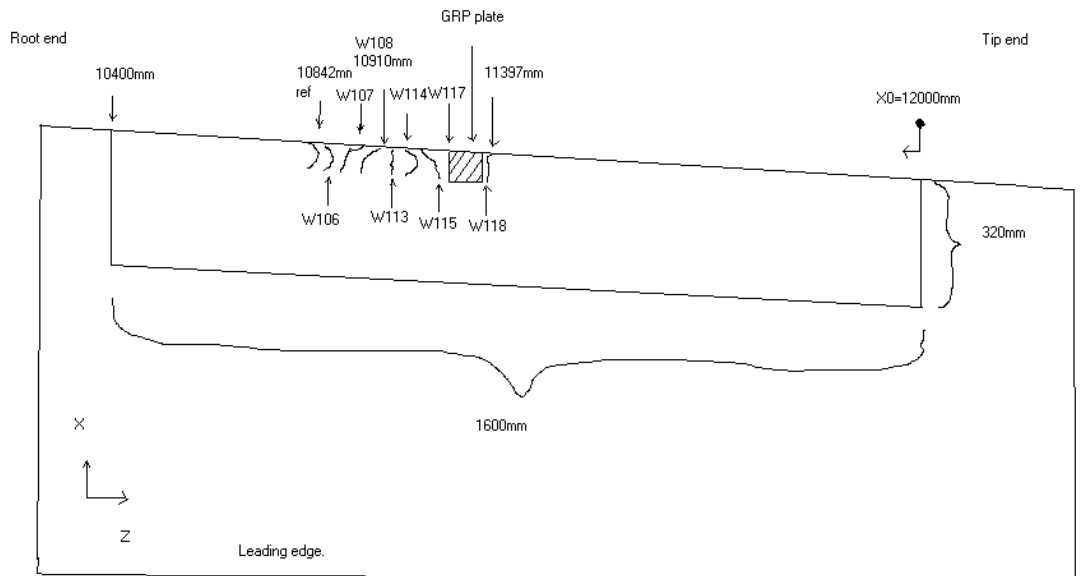
Figure 69. Sketch of damage propagation based on the ultrasonic inspections
