GANSBAAI FISHING HARBOUR - THE DESIGN AND CONSTRUCTION OF A BREAKWATER
ON A HOSTILE COAST

ABSTRACT

This paper describes the design and construction of a fishing harbour on a rocky coastline exposed to the prevailing south westerly swell of the South Atlantic and to severe westerly gales.

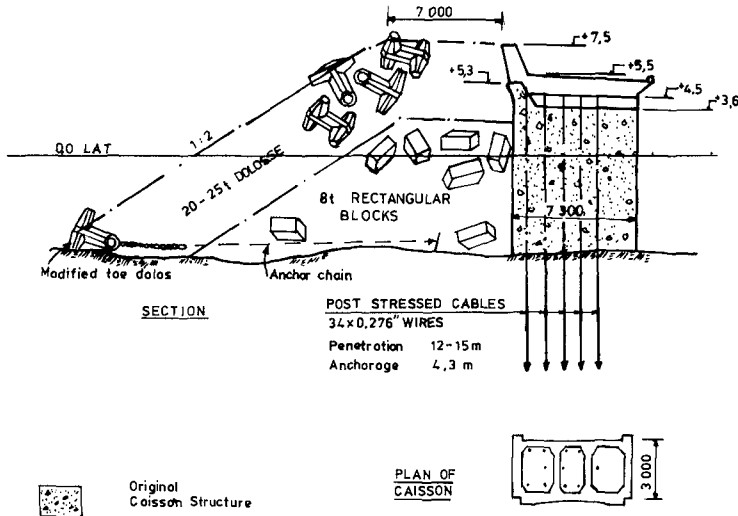
Fig 4. Caisson Breakwater (with armouring added later)

The rock formation on the sea-bed proved to be highly fractured which made sealing of the holes for the stressing cables very difficult. The grouting and redrilling often had to be repeated several times before the hole could be considered watertight. (This method eventually proved to be ineffective in protecting the cables against corrosion. This was proved by ultrasonic tests on the stressed cables in 1977 and confirmed when a portion of the wall was demolished during a subsequent contract.)

An even more serious problem was the uncertainty regarding the stability of the caisson wall. This wall which had originally been designed with a factor of safety against overturning of 1,5, had subsequently been raised from an effective height of 3,6 metres above low water to 4,5 metres above low water and was also being subjected to attack from waves higher than the original design wave height. New calculations had shown that the factor of safety was lower than originally intended. Factors such as the force taken up by the higher splash wall, an occasional higher still water level due to set up and transverse resonance (recorded locally and confirmed by a mathematical analysis by the Danish Hydraulic Institute) were taken into account. The higher SWL also accounted for higher overtopping than expected.

A series of two dimensional tests confirmed that the factor of safety was nearer 1,0 and in some sections of the wall probably less than 1,0. The 2 dimensional tests which were being conducted to investigate the caisson stability were extended to explore various ways of reducing the overtopping of the wall (such as different shapes of splash wall and a lower splash wall on the seaward side with a secondary splash wall on the leeward side).

Serious doubts had also arisen regarding the soundness of the stressing cables which supplied the major proportion of the moment of resistance against overturning. Ultrasonic tests conducted in 1977 (ref FDC report F92-2) revealed that these wires were in fact seriously corroded especially at the interfaces between the caissons and the sea-bed and the caissons and the deck slab. The continued stability of the wall could probably be ascribed to the angle of wave attack which resulted in the forces on the wall only reaching maximum values over very short sections of wall at any given instant and the transfer of these forces to adjacent caissons through the deck and the keys between the caissons.

20 and 25 t dolosse placed to a slope of 1:2 on a core of 8 t corrugated rectangular blocks were used on the outside of the caisson wall as shown in figure 4 and 25 t dolosse placed to a slope of approximately 1:1,75, were used to protect the rubble mound breakwater as shown in figure 7. A horizontal 7 m wide berm at splash wall level (7,5 m) was used for additional absorption of wave energy.

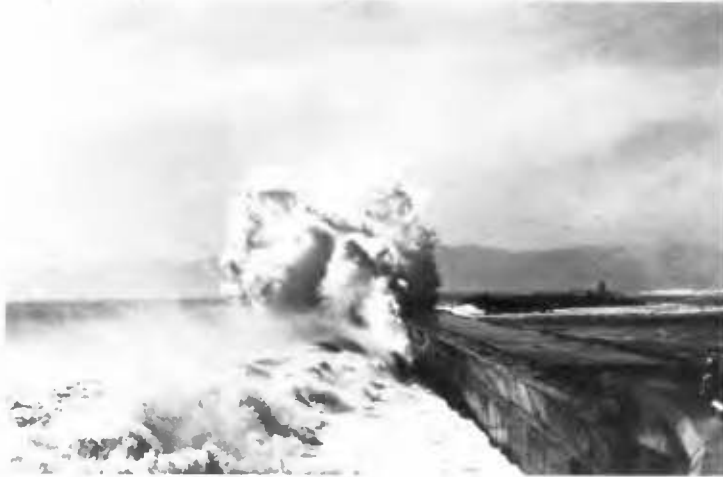
Fig 5. Wave attack on vertical breakwater

During construction of the wall, sea conditions were found to be more severe than anticipated. Placing of caissons was only possible when the wave height was less than about 1,5 metres. Overtopping hampered the work to such a degree that the level of the deck had to be raised from 3,6 m to 4,5 m above low water and the splash wall had to be re-designed at a very early stage of the work.

During storms the gantry crane which was specially built for the work and ran on rails concreted into the deck had to be moved back onto land. The crane was washed off the breakwater twice during the course of the work. It also became apparent that it would not be possible to use the wall as a quay and that boats would not even be able to moor near the wall because of the excessive overtopping.

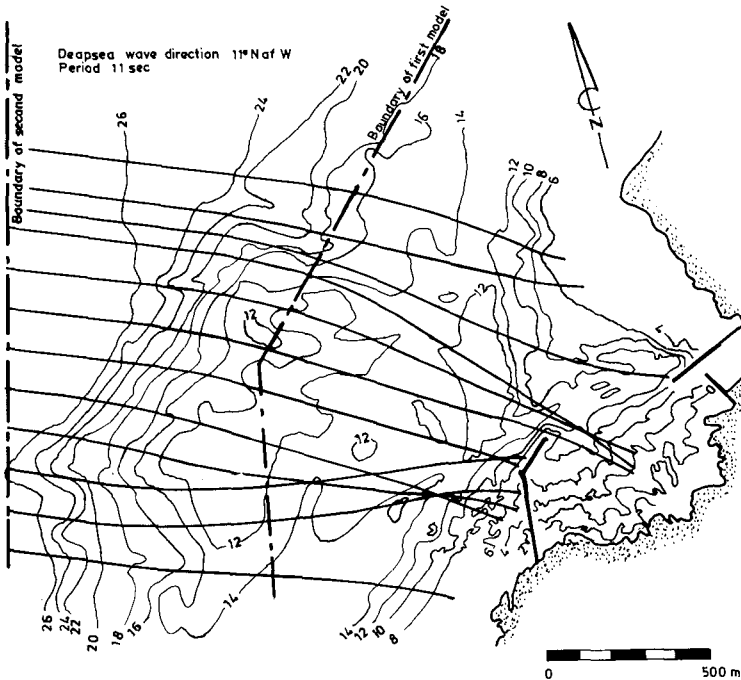
Fig 6. Wave Refraction

The adoption of this unusual alignment was unfortunate because it moved the breakwater towards deeper water and a concentration of wave energy near the proposed bend. Refraction diagrams based on more extensive hydrographic surveys carried out later confirmed this focussing effect. An example is shown in figure 6.

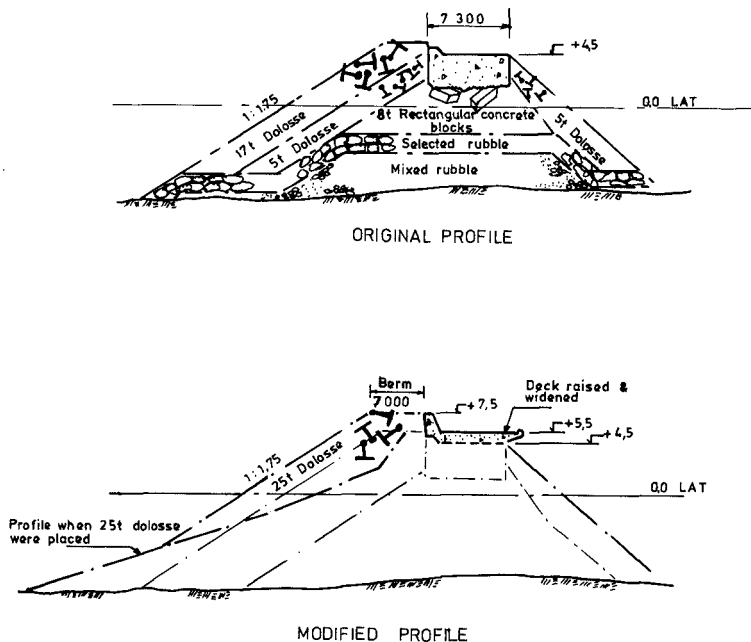
Fig 7. Armoured Rubble Mound Breakwater

Construction of this rubble mound extension of the breakwater proved to be no less difficult than construction of the caisson wall. The fractured quartzitic sandstone available for rubble in the core contained a high percentage of fines of which large quantities were washed away. Due to the shortage of the specified selected rubble a layer of 5 ton dolosse was initially placed over the rubble core. Later 8 ton rectangular blocks were used for this purpose. These units helped to prevent the immediate loss of core material but allowed considerable quantities of fine material to be leached out with the passage of time. This loss of core material combined with the structural weakness of the 5 ton dolosse, resulted in marked settlement of the deck over several sections. One section of the deck had to be demolished and rebuilt in order to fill the large cavity which had developed under the deck.

The weakest section of the rubble mound breakwater was found to be at the interface with the vertical wall. This was probably due to the focussing of waves on to this section of breakwater and the lack of interlock between the vertical wall and the rubble mound breakwater. The deflection of wave energy off the flat end of the caisson wall could also have contributed to the damage which occurred repeatedly to the breakwater along this section. Several unsuccessful attempts were made to reproduce this damage in a wave flume and in a later 3 dimensional model study. The damage was probably aggravated by fracturing of the 5 ton dolosse between the core and the deck or the overlying 17 ton dolos layer and possibly by low packing density of the dolosse.

The leeward slope of the rubble mound breakwater which was protected with 5 ton and later 12 ton dolosse also suffered considerable damage in the first year after completion because of heavy overtopping and because of the penetration of wave energy through the highly permeable 5 ton dolos layers underlying the deck. Reasonably successful attempts were made to repair the erosion of the inner face by sealing the cavities with concrete pumped into filter cloth bags and providing a steeper leeward slope so that overtopping waves could expend their energy into the enclosed basin.

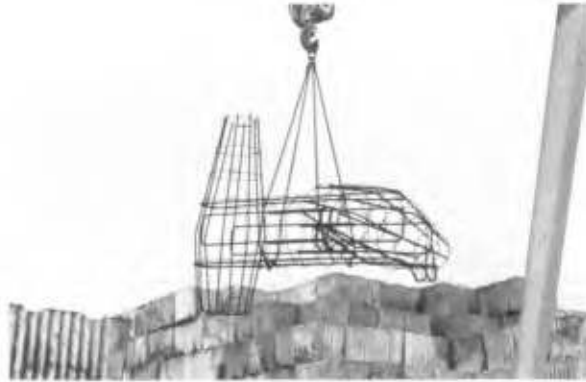
Fig 9. Reinforcing of toe dolos

Specific attention had to be given to the stability of the toe of the dolos layers because of the relatively smooth sea-bed seawards of the caisson wall coupled with reflected wave energy from the wall. Model tests indicated that the toe line of dolosse would move out of position at relatively low wave heights (1,5 m). A special reinforced "toe dolos" was developed with a lowered centre of gravity to prevent overturning and with two projections on the ends of the lower fluke to prevent rocking (see figure 9). To prevent sliding these dolosse were tied back into the mound with heavy chain and a rudimentary anchor.

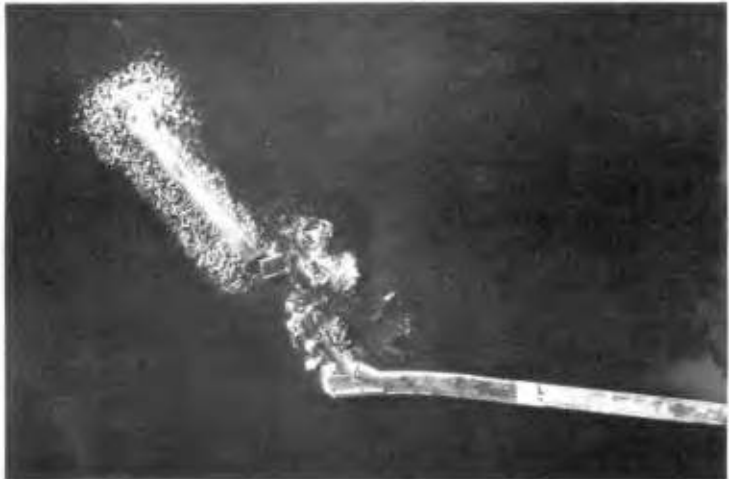
Fig 10. Storm damage to rubble mound breakwater

The contract for the above work was awarded at the beginning of 1979, but in August of the same year, before any remedial work could be carried out, a major storm breached the existing rubble mound breakwater. Other storms followed and eventually almost 60 m of the breakwater was destroyed as shown in figure 10. Model studies were again carried out to determine the most effective way of repairing the breach, and a construction method using 8 t corrugated concrete blocks as a core with a double layer of 25 t dolosse as armouring was eventually successfully used. During the repairs to the breach the junction between the vertical wall and the rubble mound breakwater was reconstructed. The section of the vertical wall extending beyond the rubble mound breakwater was eliminated and a smooth curve introduced. Fortunately no severe storms occurred during these critical stages of the work.
