GEOTECHNICAL ASPECTS OF THE 22 FEBRUARY 2011 CHRISTCHURCH EARTHQUAKE

¹ *Department of Civil and Natural Resources Engineering, University of Canterbury, Christchurch, New Zealand*

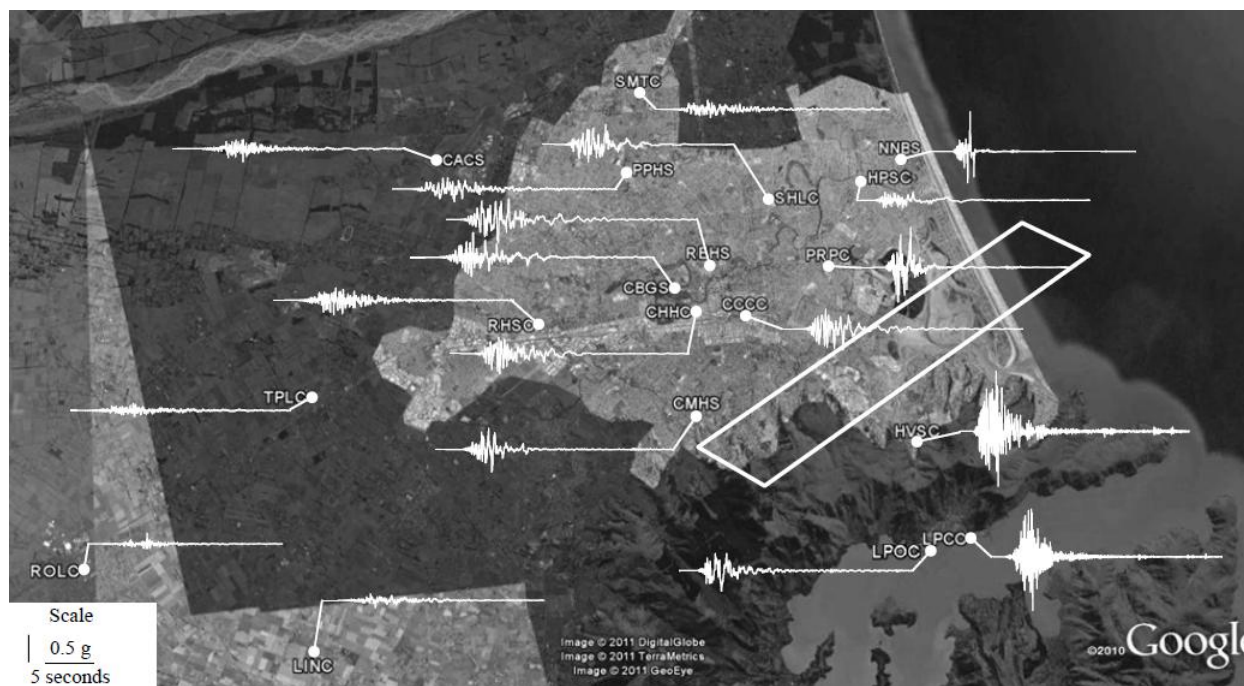
Figure 1: Observed fault-normal horizontal acceleration time histories at various locations in the Christchurch region from the 22 February earthquake with reference to the inferred surface projection of the causative fault which dips to the south-east (Bradley and Cubrinovski, this issue).

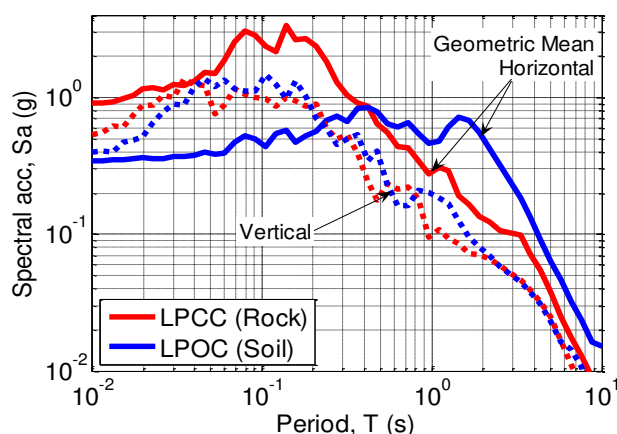
Figure 2: Comparison of geometric mean horizontal and vertical response spectra observed at two nearby strong motion stations in Lyttelton, one on outcropping rock (LPCC), the other on soil (LPOC) [8].

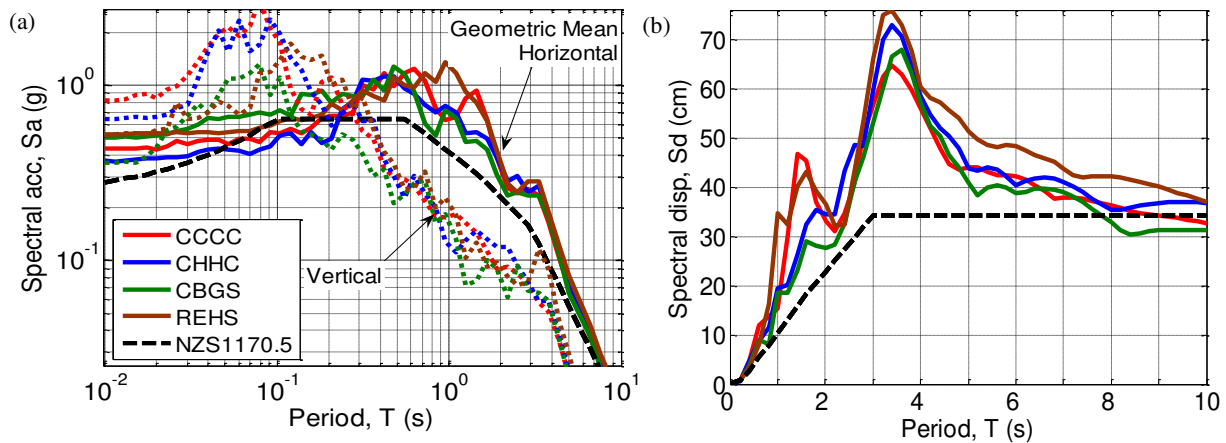
Figure 3: Comparison of response spectra from four strong motion stations located in the Christchurch central business district: (a) horizontal and vertical pseudo-acceleration response spectra; and (b) horizontal displacement response spectra [8].

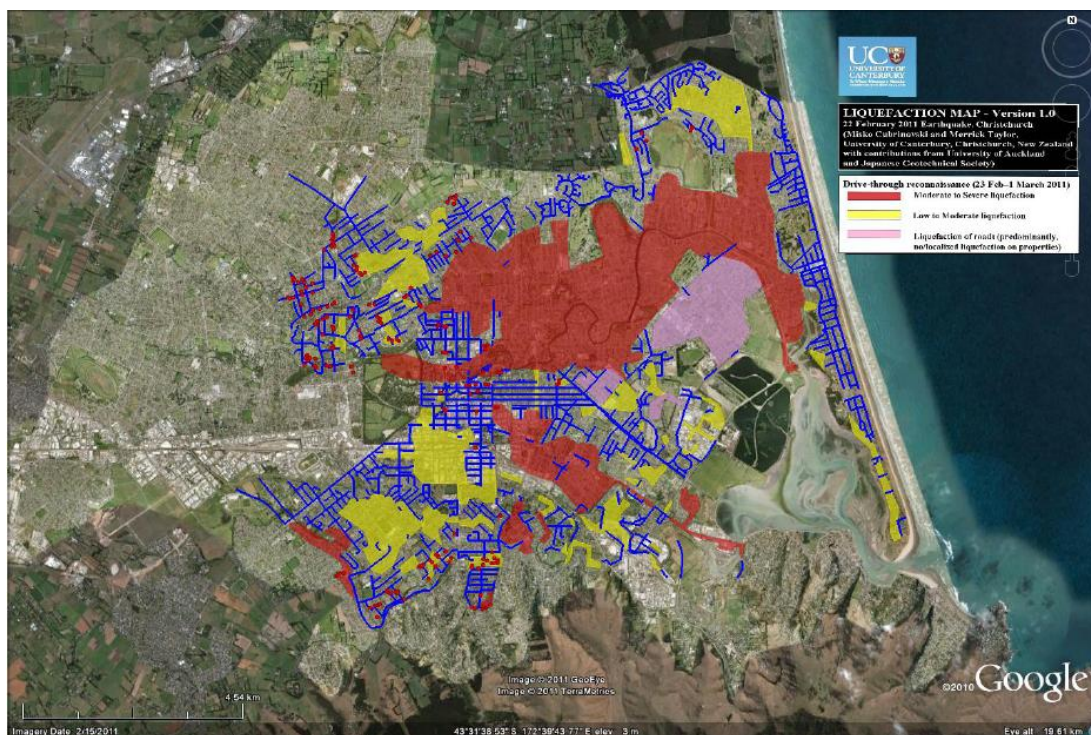
Figure 4: Preliminary liquefaction map of Christchurch from drive-through reconnaissance [10]

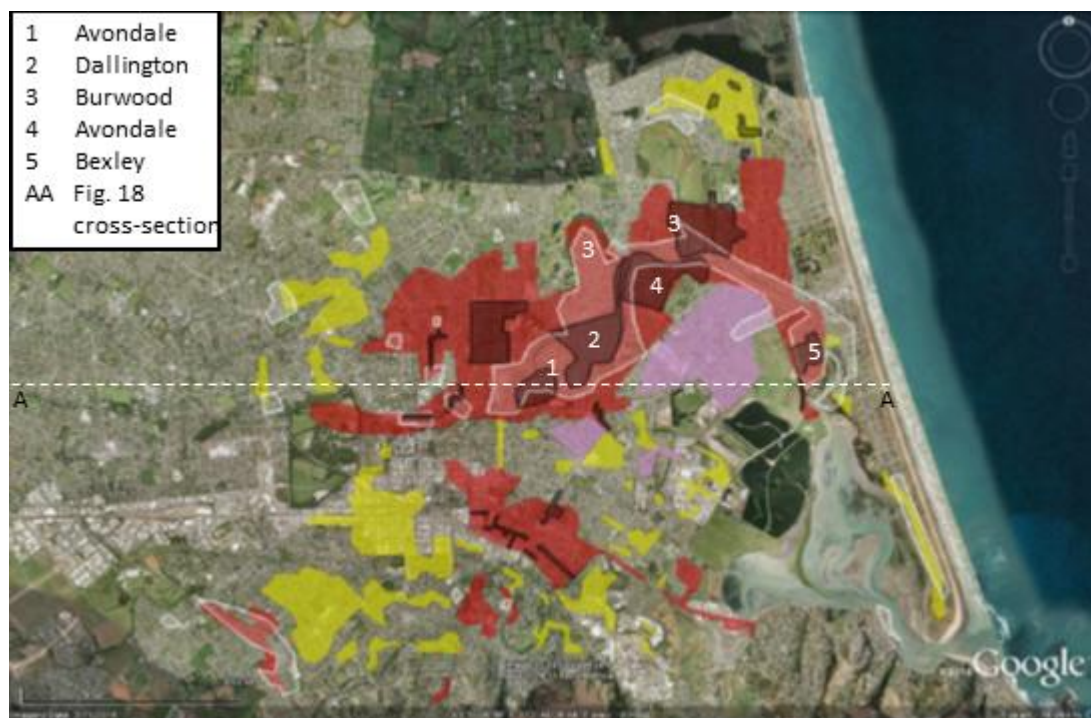
Figure 5: Preliminary liquefaction maps documenting areas of observed liquefaction in the 4 September 2010 (white contours), 22 February 2011 (red, yellow, magenta areas), and 13 June 2011 (black contours) earthquakes [12].

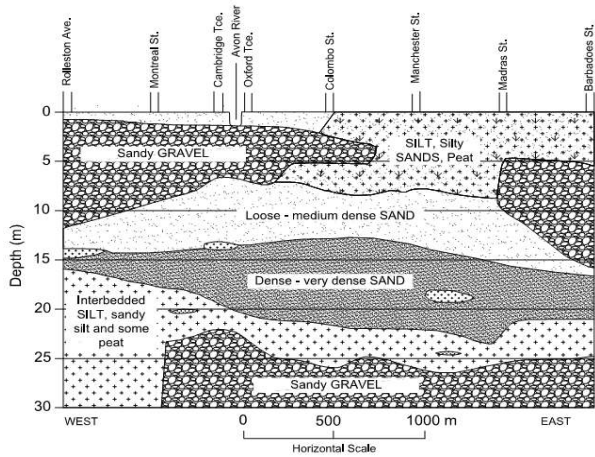
Figure 6: Representative subsurface cross section of Christchurch CBD along Hereford Street [11].

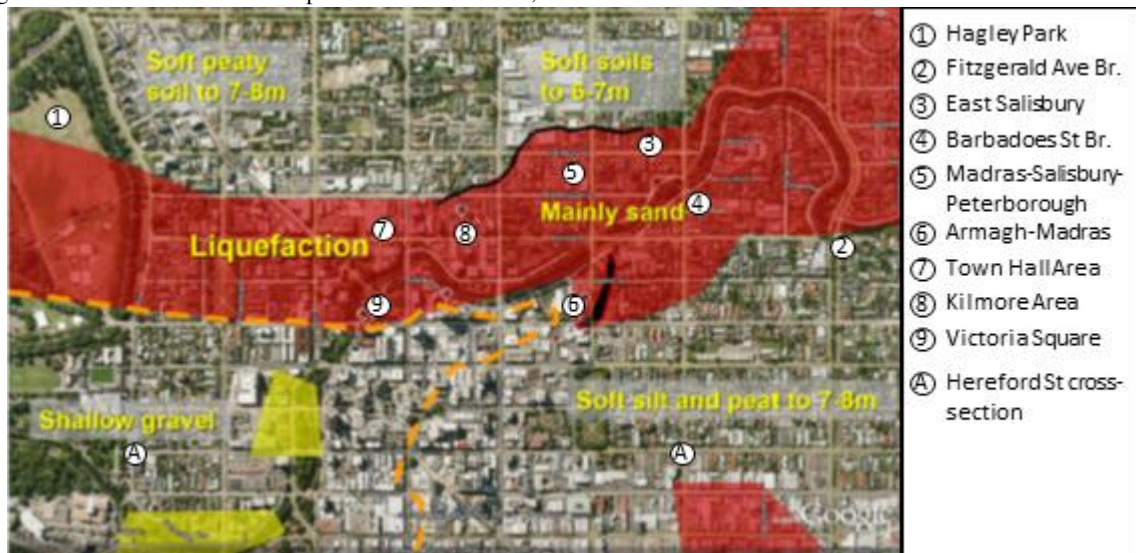
Figure 7: Preliminary CBD liquefaction map for the 22 February earthquake [10]; predominant soils in the top part of the deposits are also indicated [12].

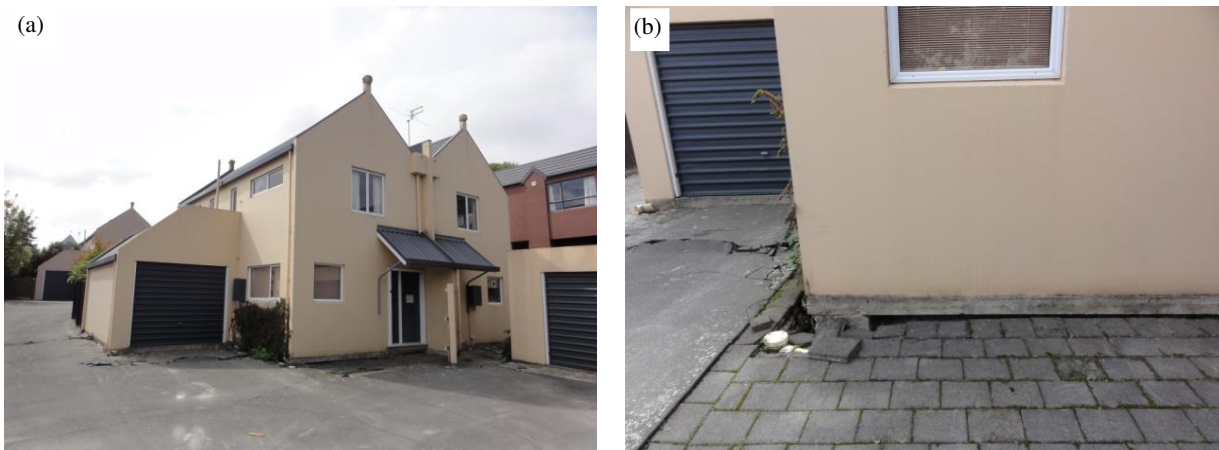
Figure 11: Duplex housing complex: (a) looking north at centre building, and (b) close-up of ground settlement next to centre building [7].

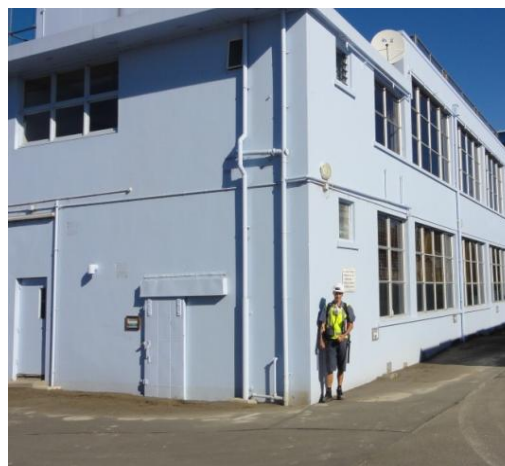
Figure 12: *Two-storey building that underwent liquefaction-induced punching movements [7].*

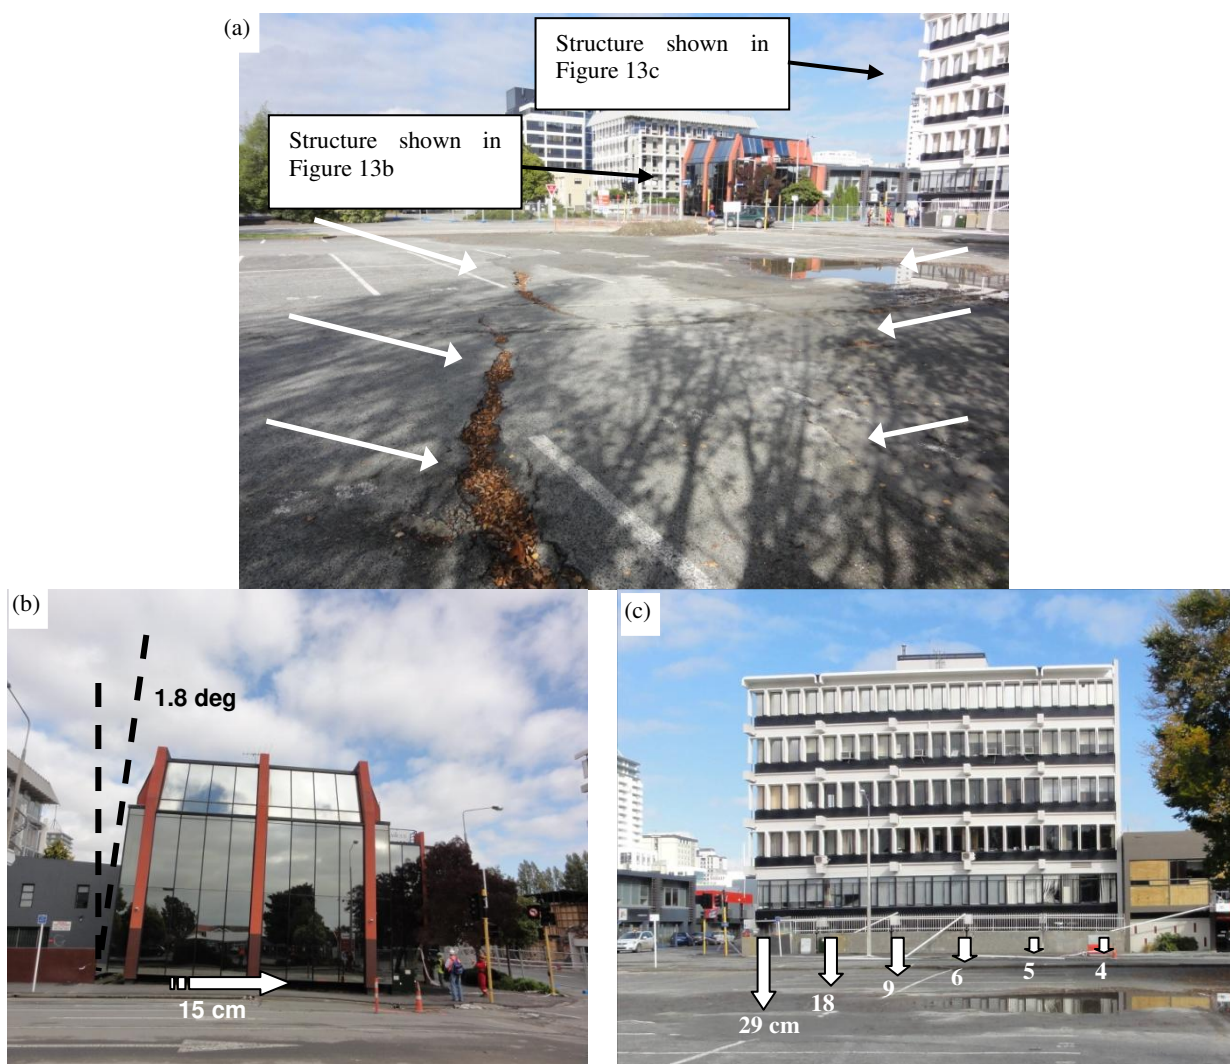
Figure 13: Relatively narrow liquefaction-induced feature and induced differential settlement and sliding of buildings [7].

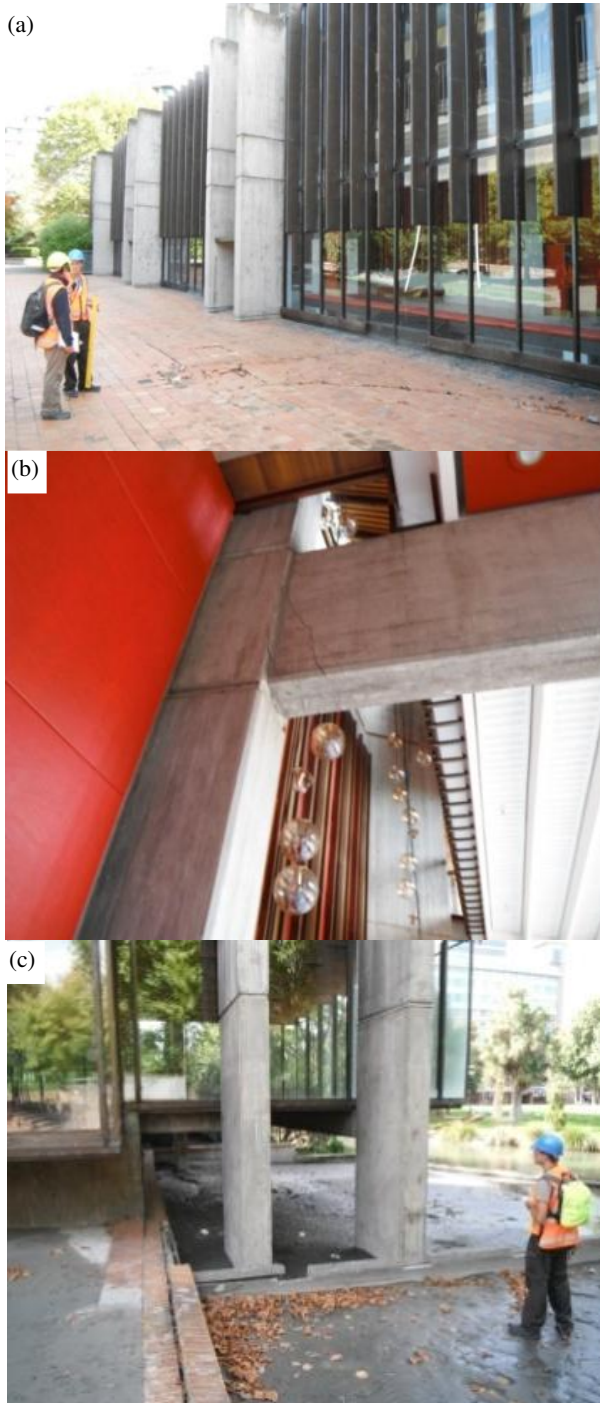
Figure 14: Town Hall auditorium and adjacent dining facility undergoing significant liquefaction-induced differential settlement and lateral movements [7].

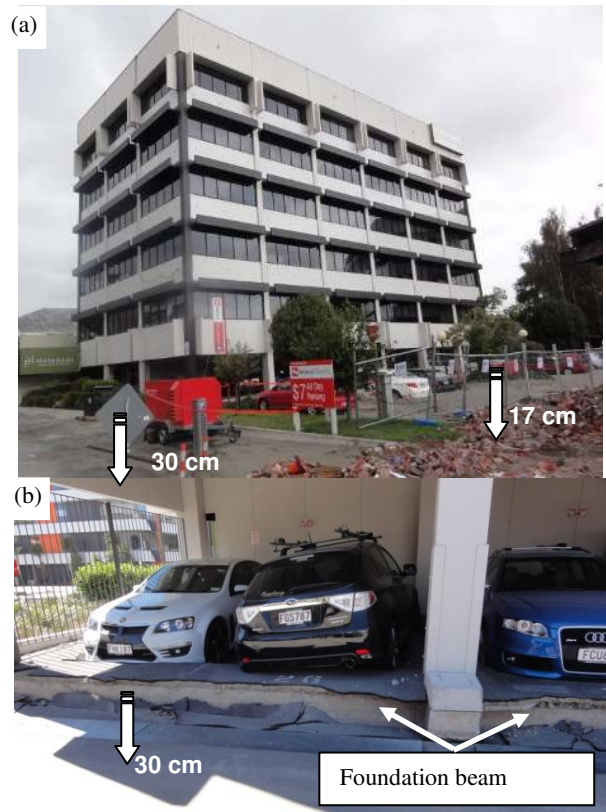
Figure 16: Building on pile foundations in area of severe liquefaction showing large settlement of the surrounding soils relative to the foundation beams [7].

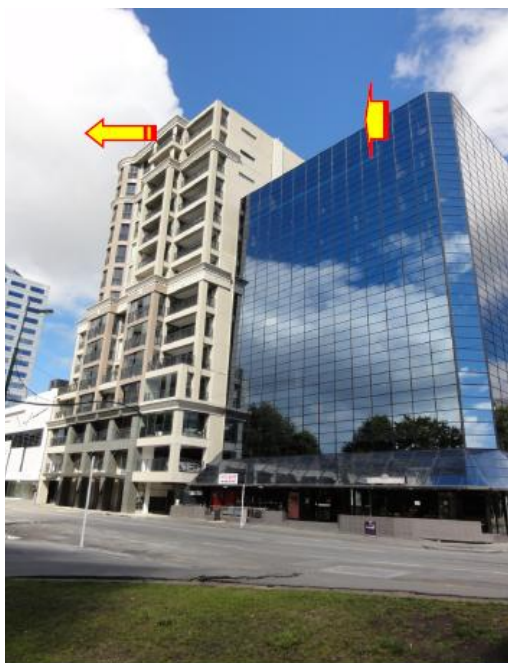
Figure 17: Buildings on shallow and hybrid foundations in transition area from moderate liquefaction to low/no liquefaction; arrows indicate direction of tilt of the buildings [7].

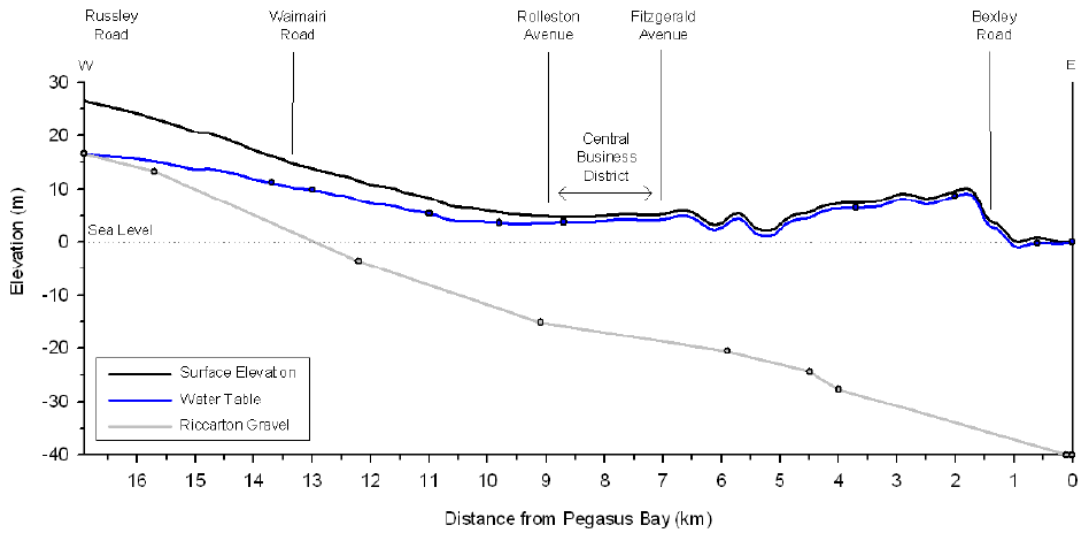
Figure 18: East-west cross-section of surface elevation, water table and Riccarton gravel horizon at Bealey Avenue in the North-South direction [12].

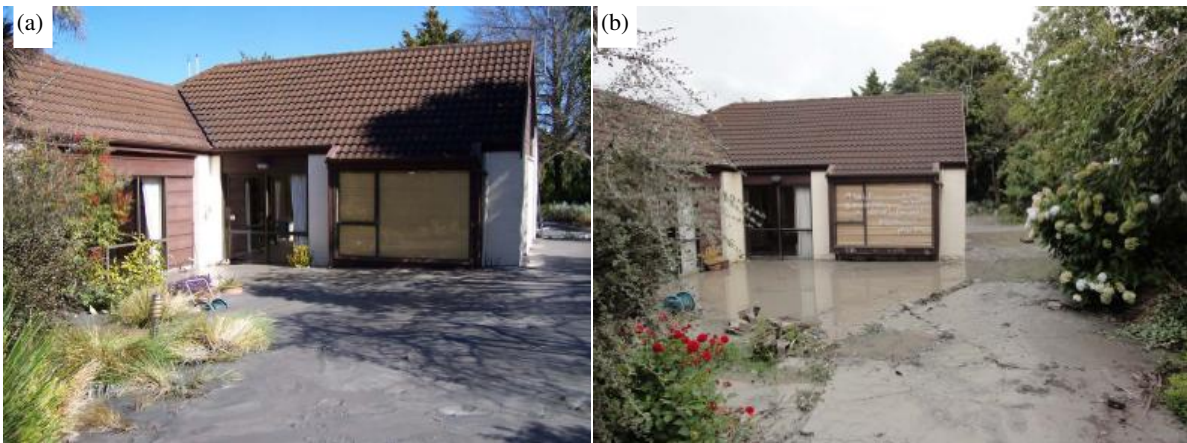
Figure 20: Illustration of a house in Kaiapoi which sustained liquefaction in both the (a) 4th September 2010 Darfield; and (b) 22 February 2011 Christchurch earthquakes.

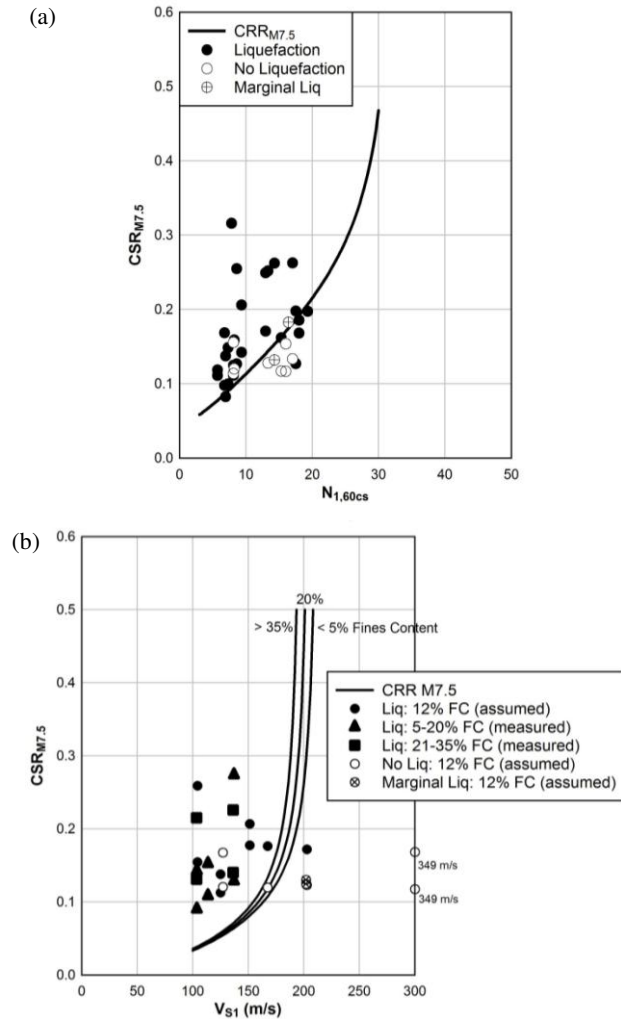
Figure 23: Summary of the: (a) DCP tests; and (b) SASW tests at all sites illustrating the computed cyclic stress ratio (CSR_{M7.5}) of the inferred liquefiable layer as well as whether surface manifestation of liquefaction was evident. Test data includes both the 4th September 2010 and 22nd February 2011 earthquakes [13].

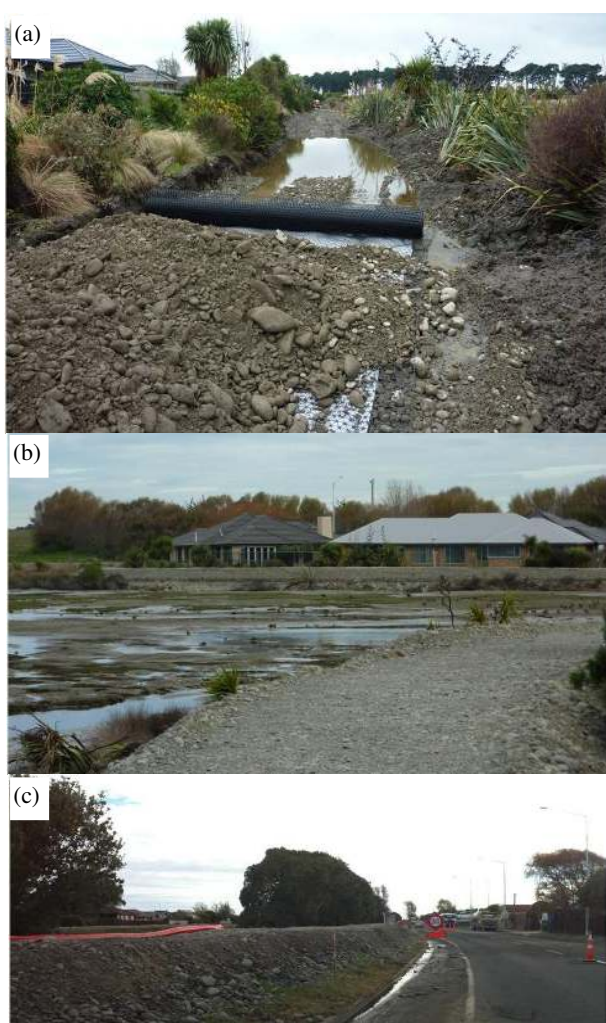
Figure 25: (a) Fill material used for construction and geogrid/liner for temporary stop banks; (b) position of residences below temporary stop banks in Bexley wetland; and (c) stop bank construction along New Brighton Rd.

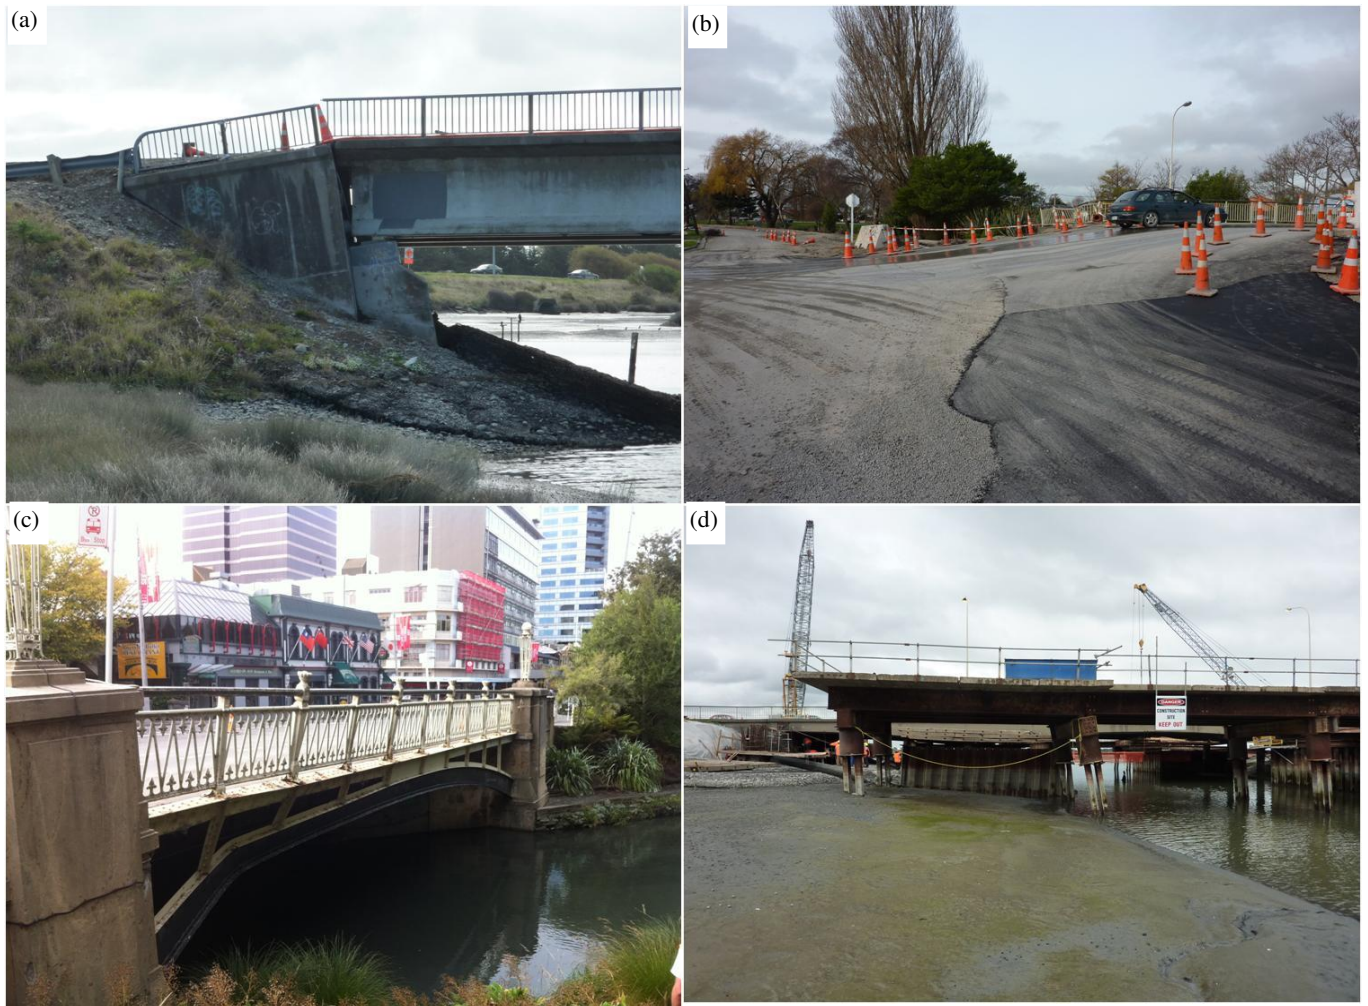
Figure 26: Summary of bridge damage: (a) back-rotation and settlement of the western abutment of South Brighton bridge; (b) settlement of the northern approach of Gayhurst Road bridge following the June 13 2011 earthquake; (c) abutment back-rotation and buckling of the steel arches of Colombo Street bridge; and (d) movement of temporary construction platform for Ferrymead bridge due to lateral spreading.

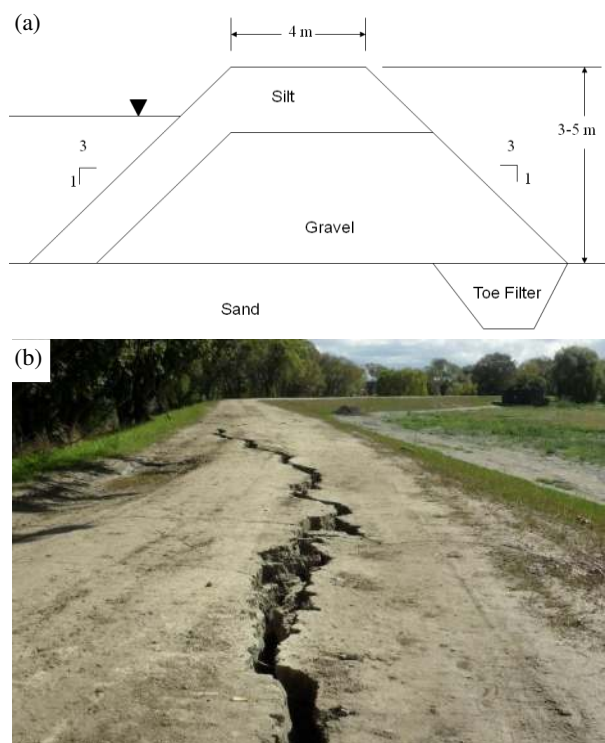
Figure 27: (a) Typical geometry and soil composition of stop bank cross section; and (b) typical longitudinal cracks running along the crest [17].

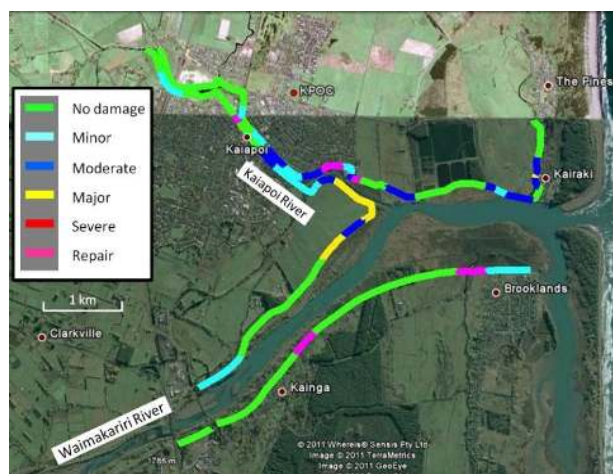
Figure 28: Observed damage to stop banks following the Christchurch earthquake [20], [19]

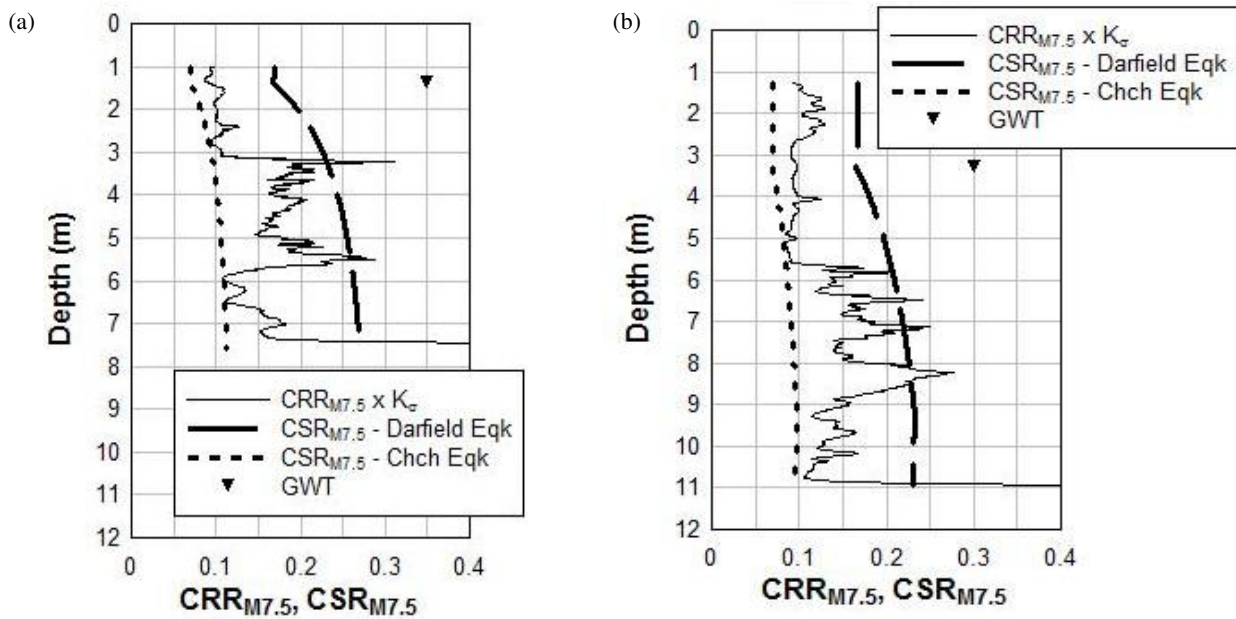
Figure 29: Liquefaction evaluation for representative sites on the: (a) north bank; and (b) south stopbank of the Kaiapoi river in the Darfield and Christchurch earthquakes.

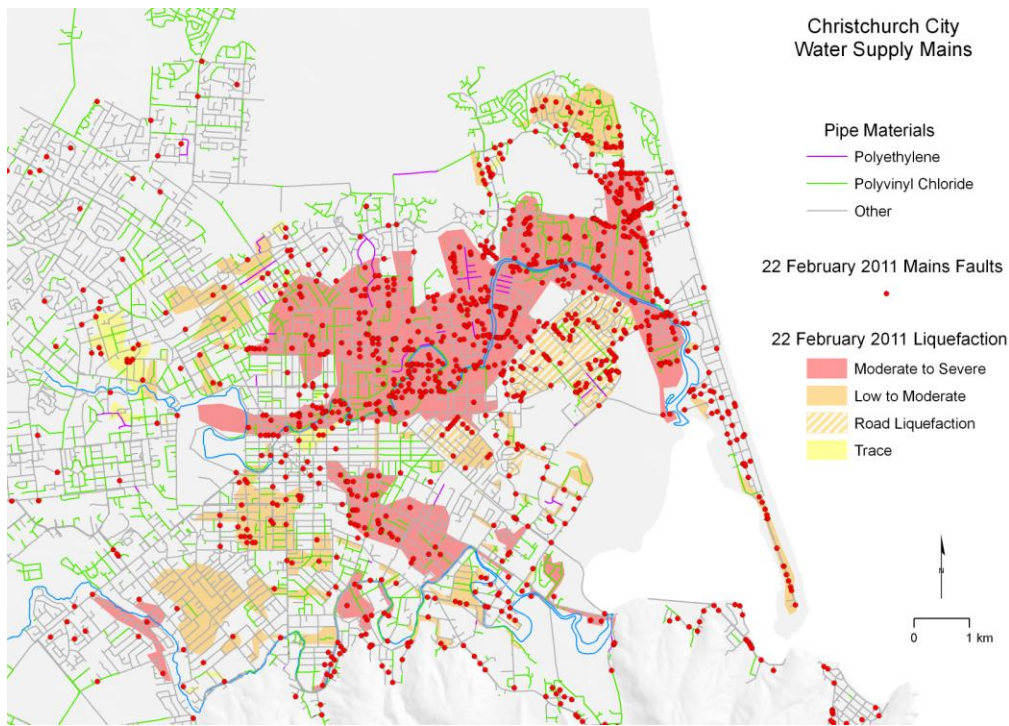
Figure 30: Water mains pipe network and location of breaks (faults) caused by the 22 February 2011 earthquake; coloured lines indicate pipe materials; coloured areas indicate liquefaction severity as defined and mapped in Figure 4.

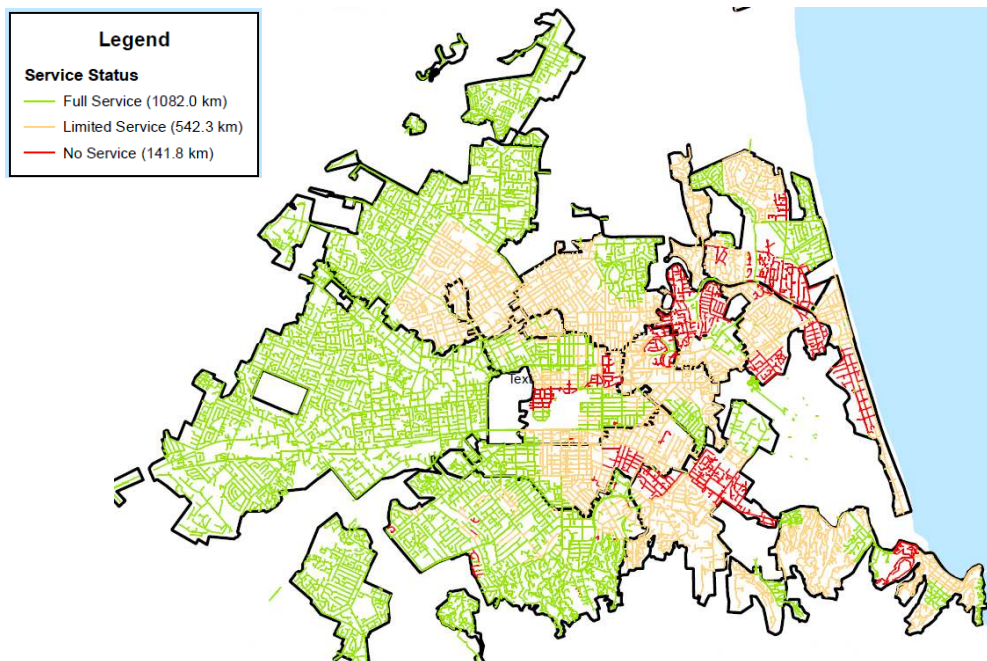
Figure 31: Waste water service status on 16 March 2011. (M. Christison, pers. comm.)

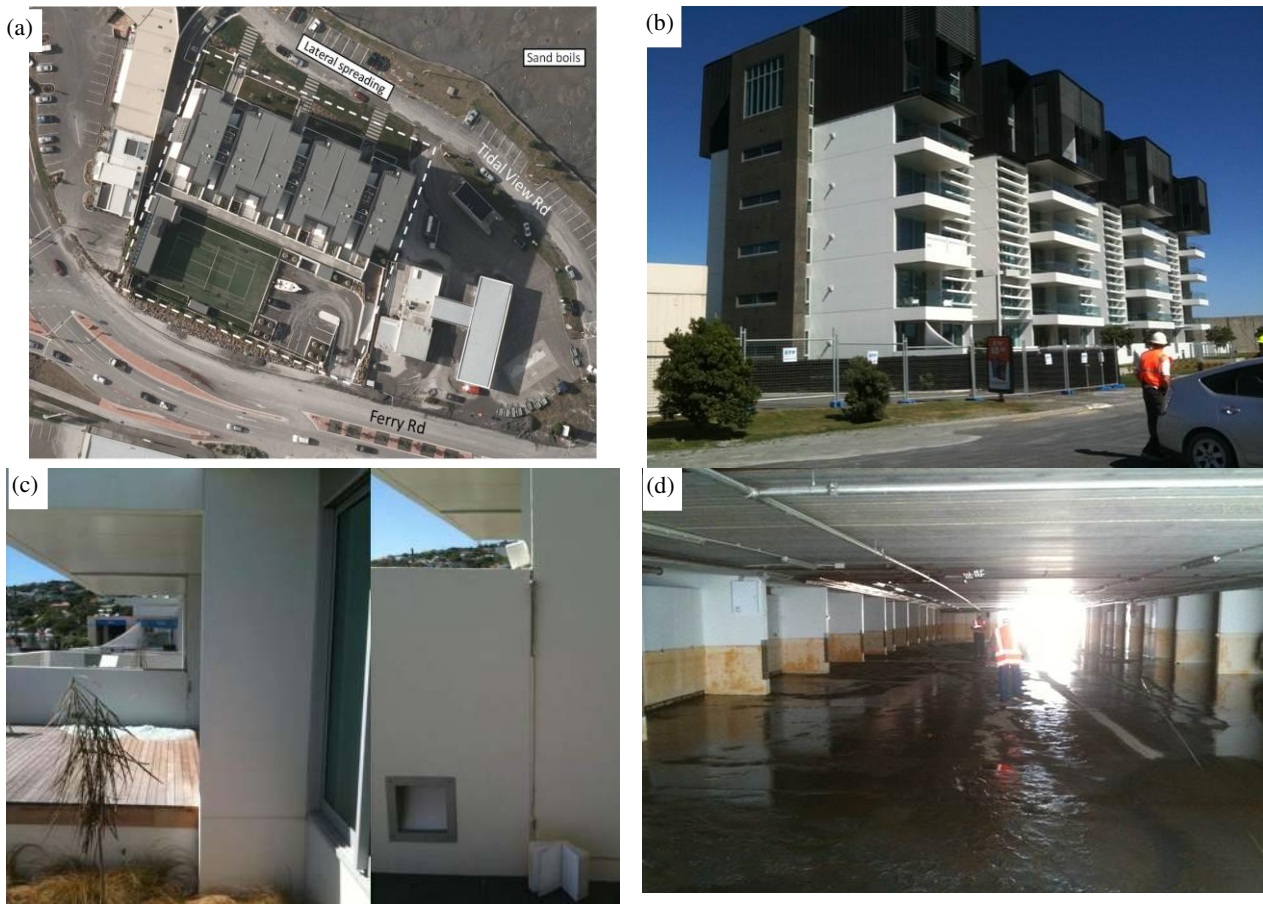
Figure 32: (a) Aerial view of Ferrymead apartment building indicating surrounding ejected material; and (b) south-west looking view of the apartments; (c) separation of walls on the north side of the building, including sloping of the separation walls and shattered glass panels, and compression of caulk at top of expansion joint; and (d) the basement parking garage. Note the high water mark on the walls.

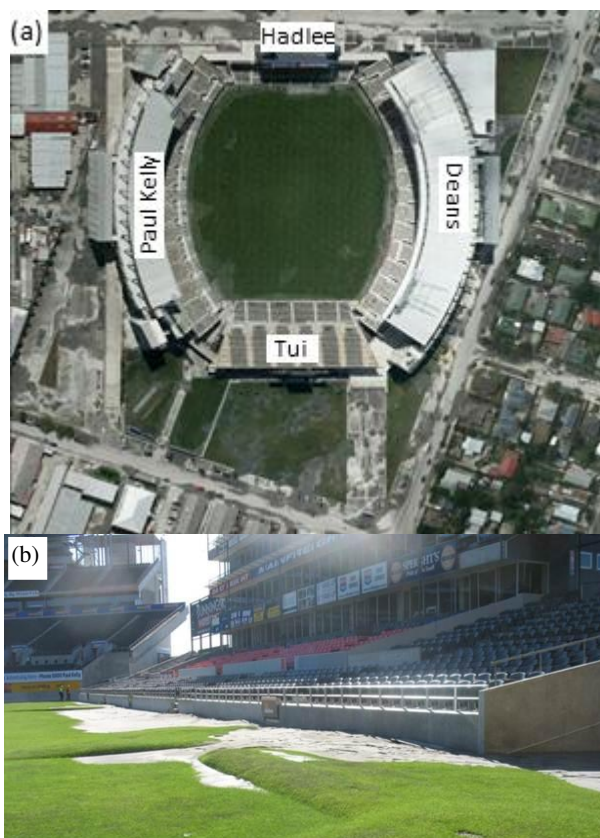
Figure 33: (a) Aerial photo of AMI Stadium indicating liquefaction damage; and (b) Liquefaction damage to the stadium field.

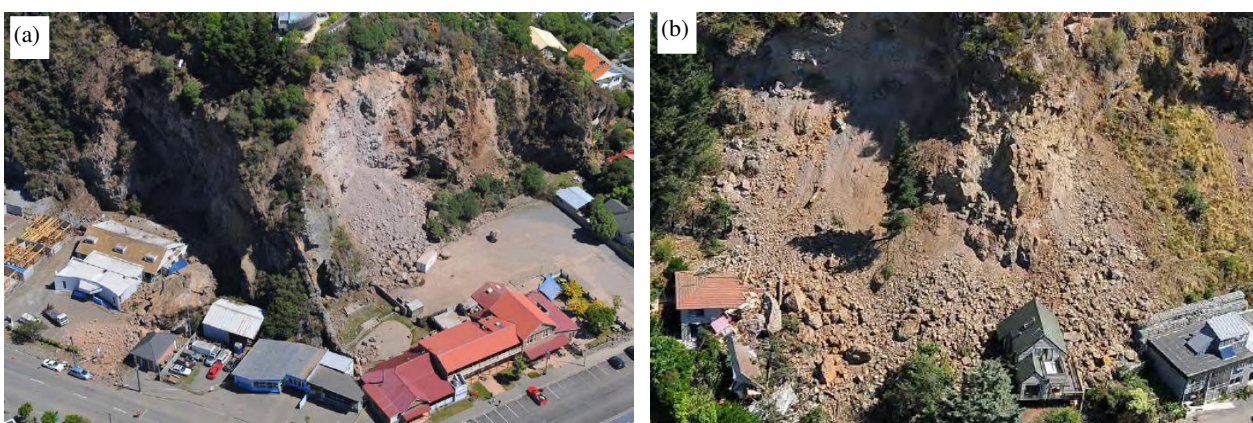
Figure 34: Examples of rock falls on the Ports hills.
