## GEOTECHNICAL RECONNAISSANCE OF THE 2010 DARFIELD (CANTERBURY) EARTHQUAKE

Editors: **Misko Cubrinovski<sup>1</sup>, Russell A. Green<sup>2</sup>**

This paper summarizes the observations and preliminary findings from this early reconnaissance work.

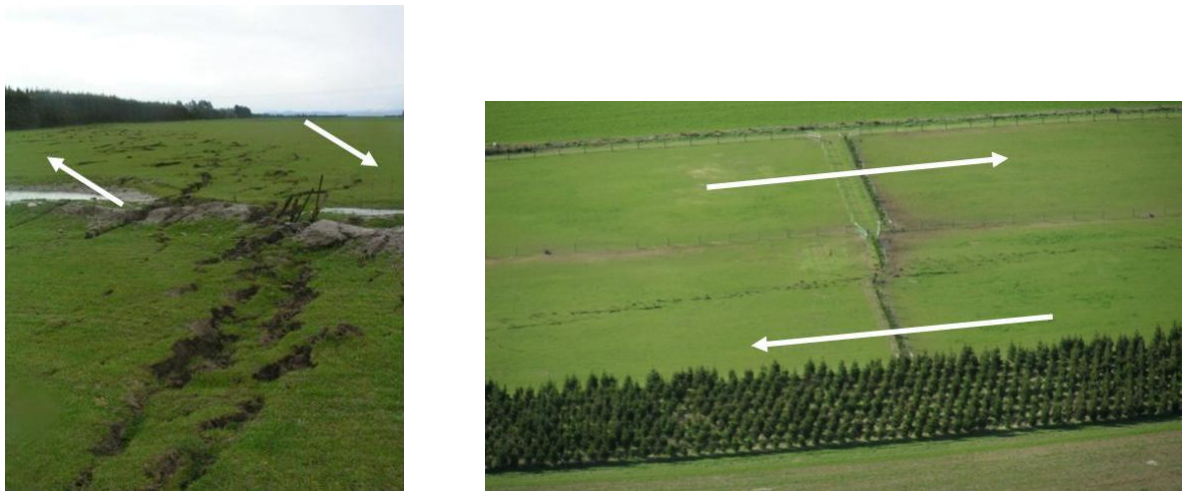
**Figure 2.3:** Photographs of surface fault rupture on the Greendale fault. (Left photo: <http://daveslandslideblog.blogspot.com/2010/09/images-of-darfield-canterbury.html>).

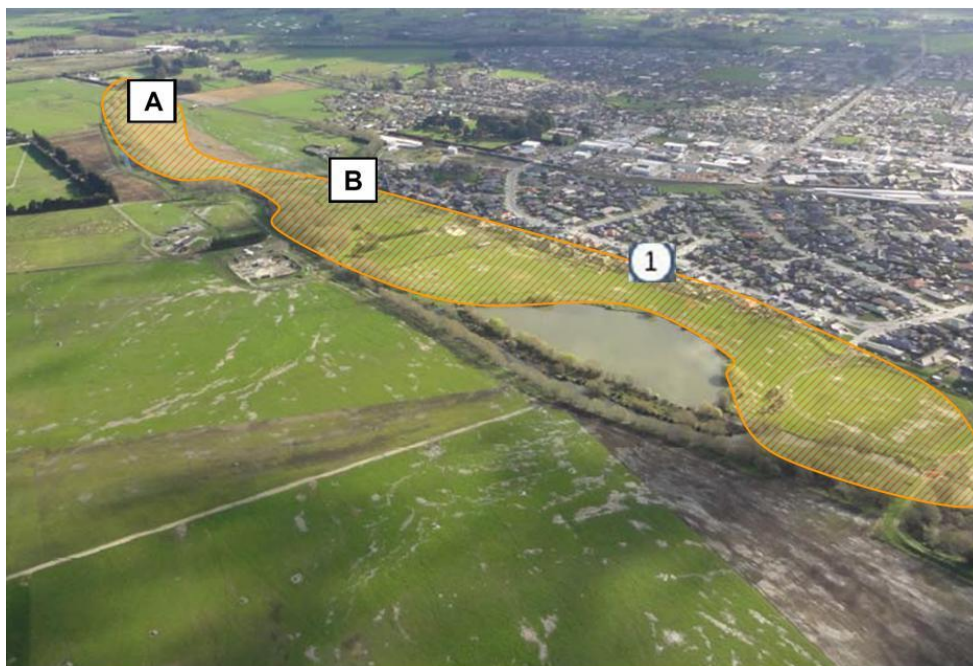
(a) Sand boils and area affected by lateral spreading around Courtenay Lake (from a helicopter flyover on Friday September 10).

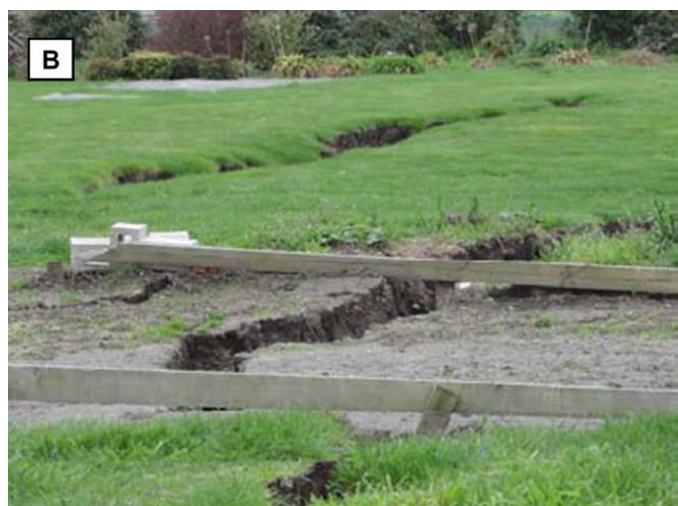
(b) Large lateral spread cracks in farm land (at B: 43.3941389°S, 172.659750°E).

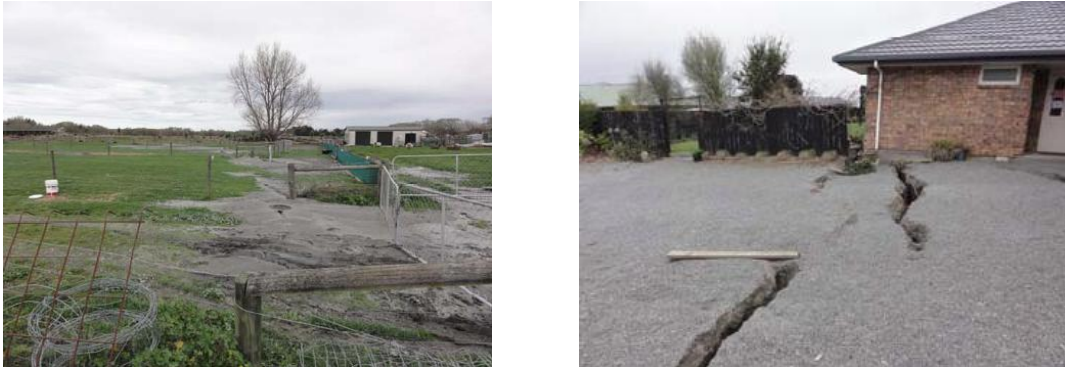
(a) Sand boils and lateral spread cracks.

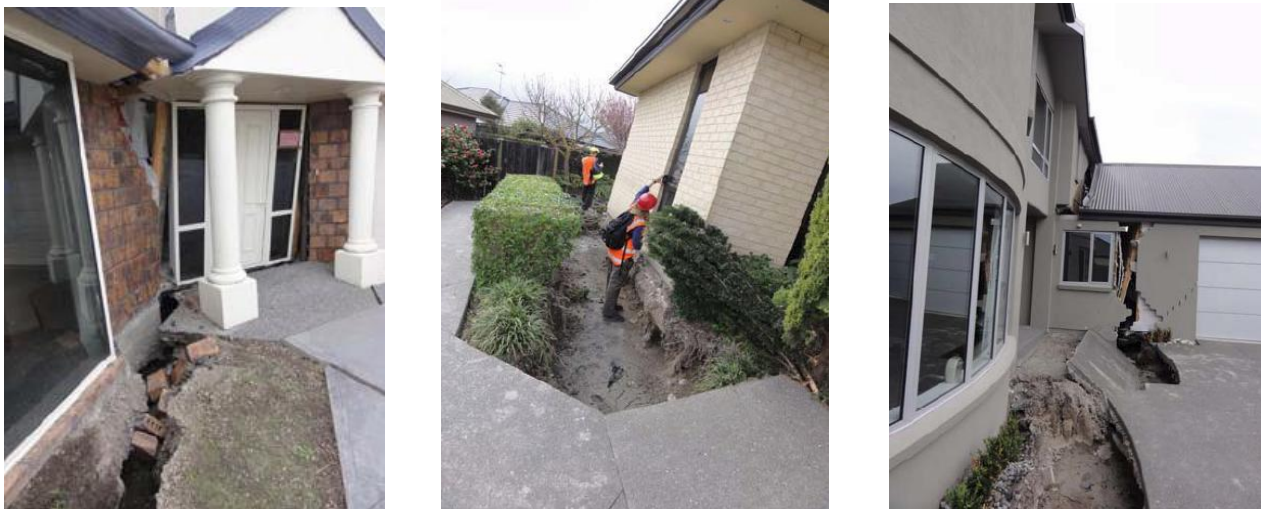
(b) Effects of lateral spreading in residential area.

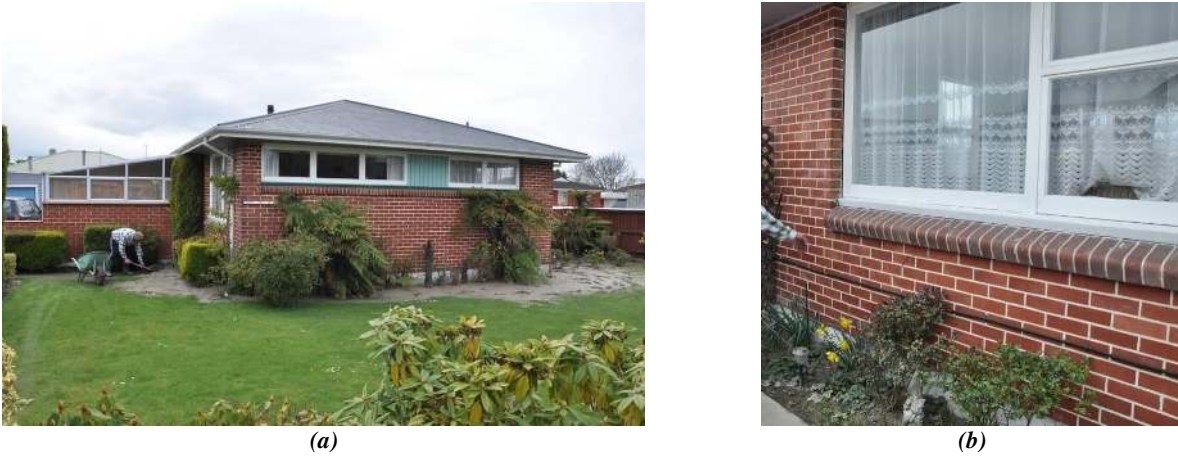
**Figure 5.15:** Residence along Charles Street. (a) Ejecta surrounding home and (b) owner points out shear cracking and gapping developed between window and brick due to structures movement.

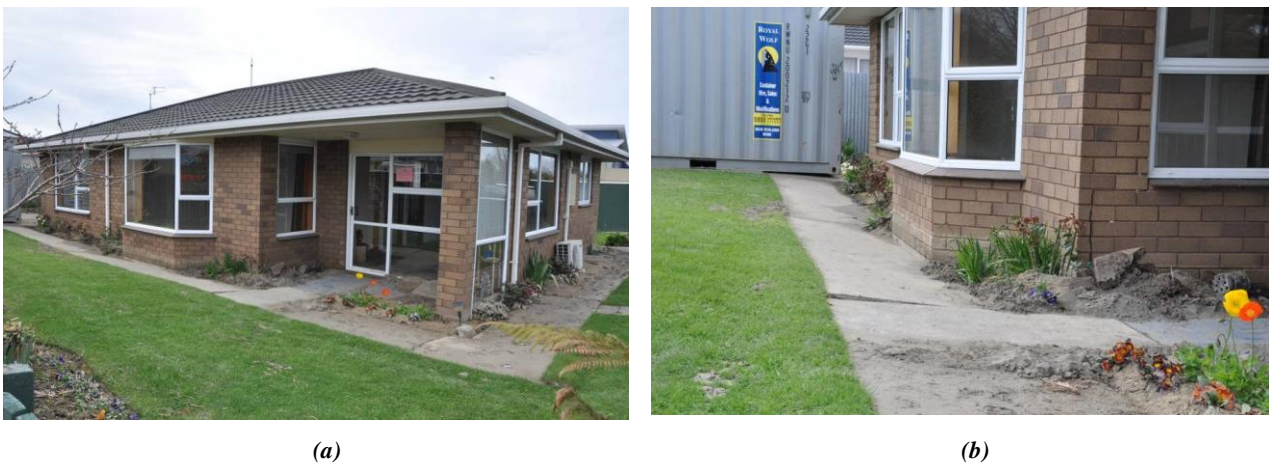
**Figure 5.17:** Red tagged residence on Charles Street. (a) View looking east and (b) north end of house, view looking North-East.

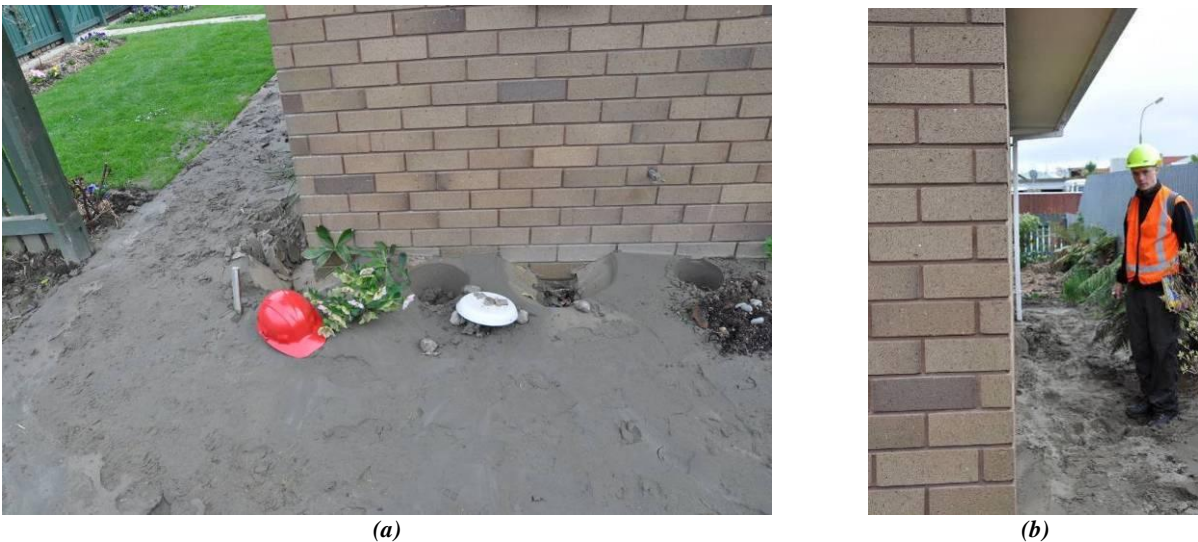
**Figure 5.18:** Red tagged residence on Charles Street. Extensive surrounding ejecta at perimeter of home.

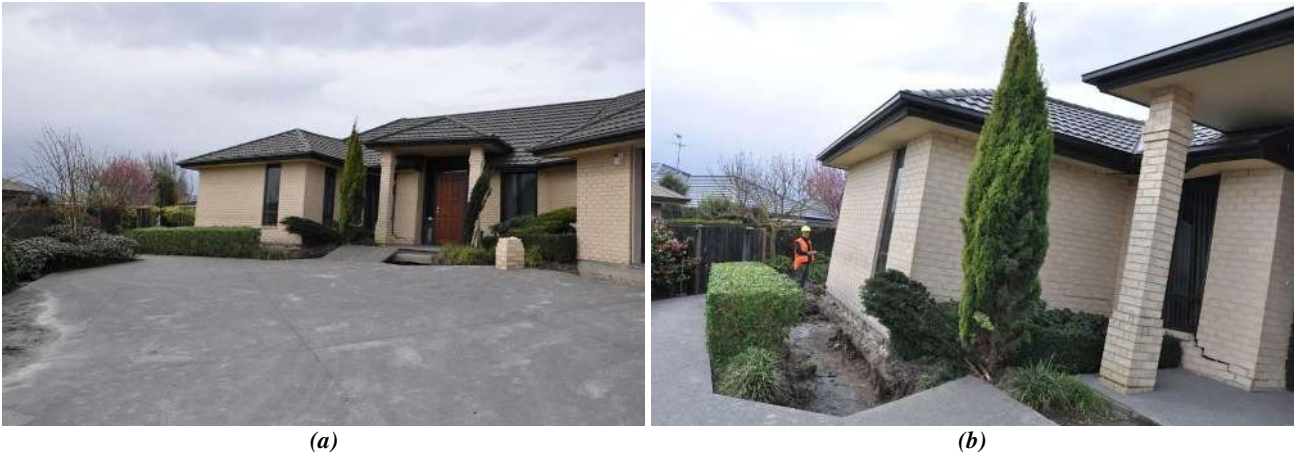
**Figure 5.21:** *Damage to a residence at Courtenay Drive in the South Kaiapoi residential community (front of home articulating excessive tilt and separation of foundation from surrounding hardscape).*

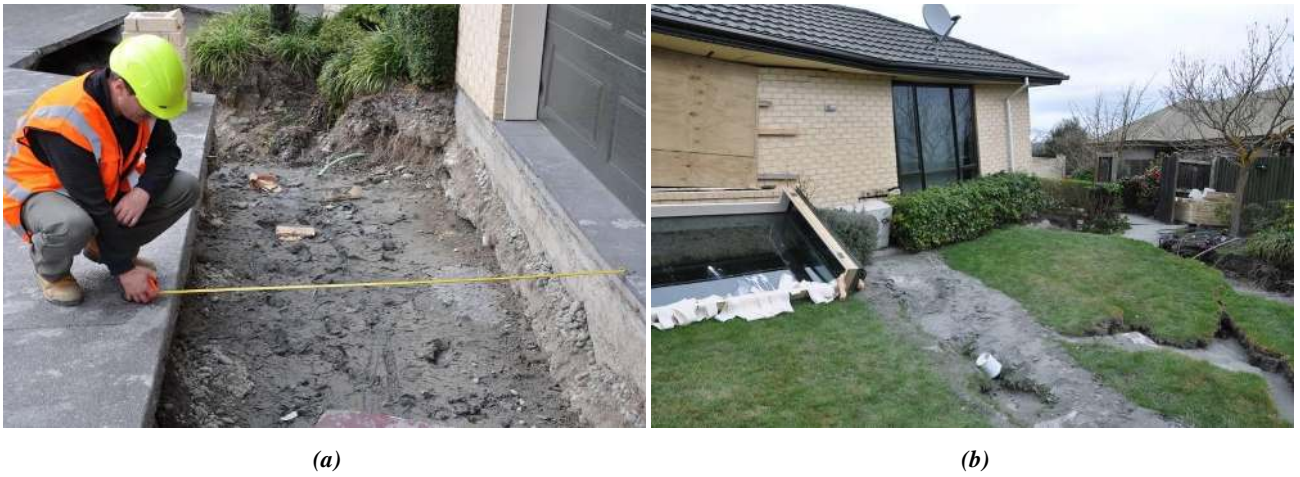
**Figure 5.22:** *Damage to a residence at Courtenay Drive in the South Kaiapoi residential community (a) front of home (1.5 m separation between garage and approach slab) and (b) back of home.*

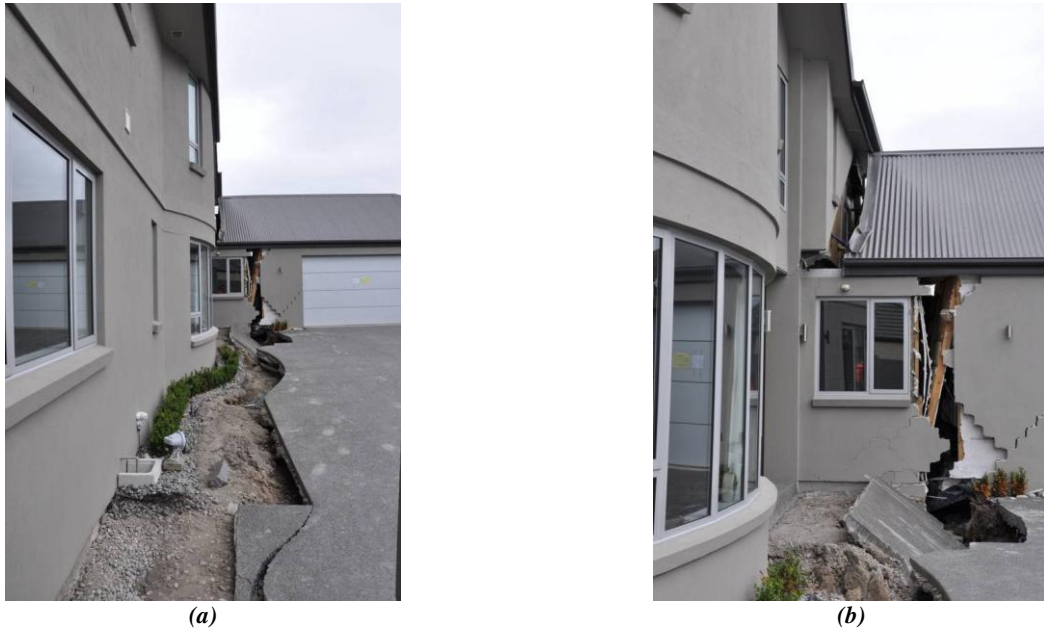
**Figure 5.24:** *Damage to a residence along Courtenay Drive in the South Kaipoi residential community. Front entry articulates extensive damage as large ground spreading subtends into the superstructure.*

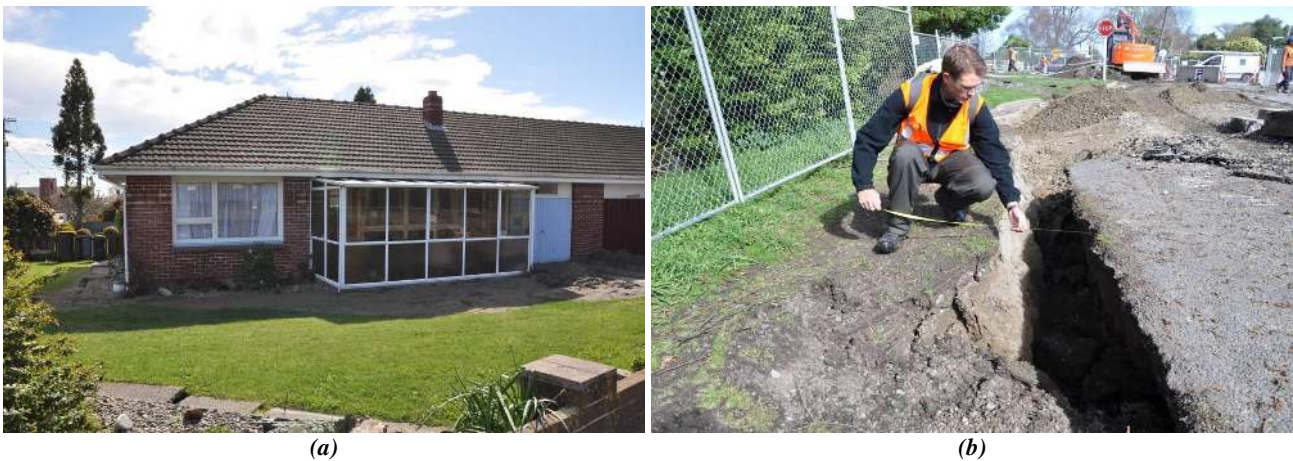
**Figure 5.25:** *(a) Rigid body rotation of a residence in Dallington (Locksley Avenue) due to liquefaction and (b) lateral spread features directly fronting the home. Surveys of ground features at this location are associated with T7 (refer to Figure 5.27).*

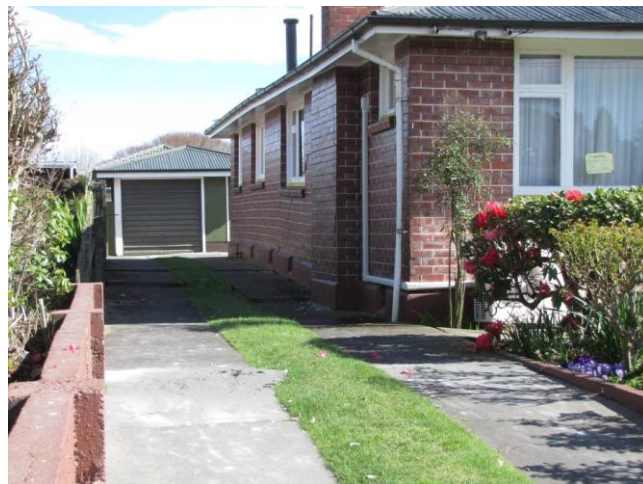
**Figure 5.26:** Residence affected by lateral spreading along the driveway which has induced differential settlement between the front and rear of the house. (Note that this is not a slab-on-ground house, rather an older style of construction with a concrete perimeter beam and the timber floor being supported on shallow foundations; Locksley Ave).

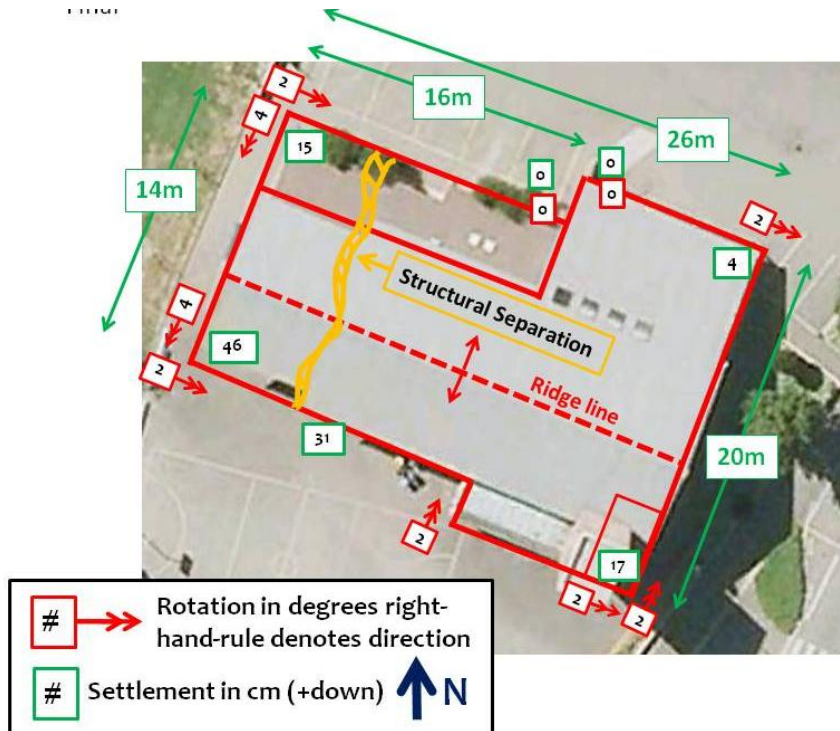
Figure 5.29: St. Paul’s church damage map – survey conducted 12 September 2010; Global dimensions approximate (extracted from Google Earth image), deformation obtained directly in the field.

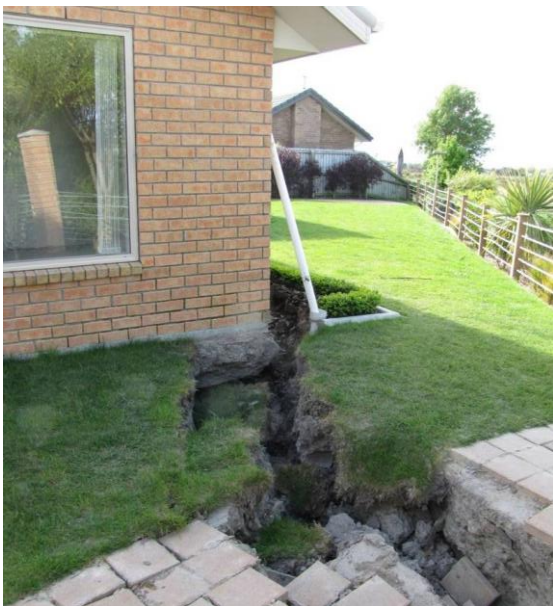
Figure 5.38: Lateral spreading compromising ground support beneath the concrete slab-on-grade house foundation. (Kokopu Street).

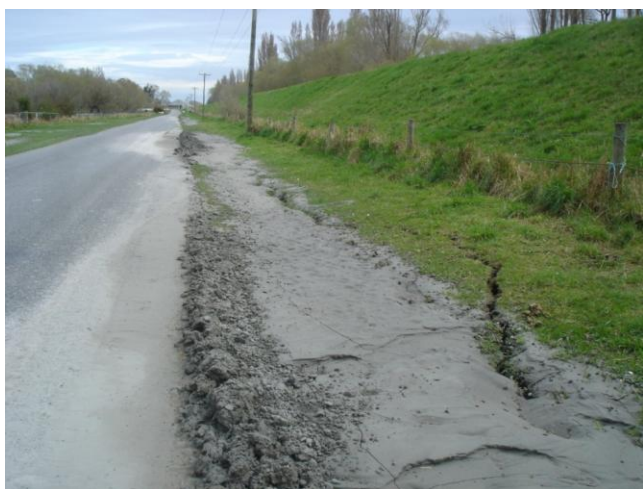
**Figure 6.5:** *Photo 2: Crack running along base of stopbank on Coutts Island Rd (landside) and liquefaction ejecta. (43.424466°S, 172.629907°E).*

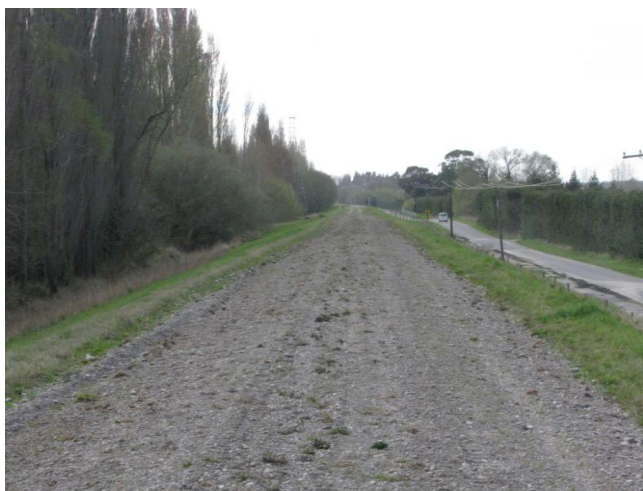
**Figure 6.7:** *Photo 4: Road on top of stopbank that had recently been regraded, presumably after the earthquake to fill in longitudinal cracks formed during the earthquake. Liquefaction was observed along the base of both sides of the stopbank along this stretch. (43.423943°S, 172.631045°E).*

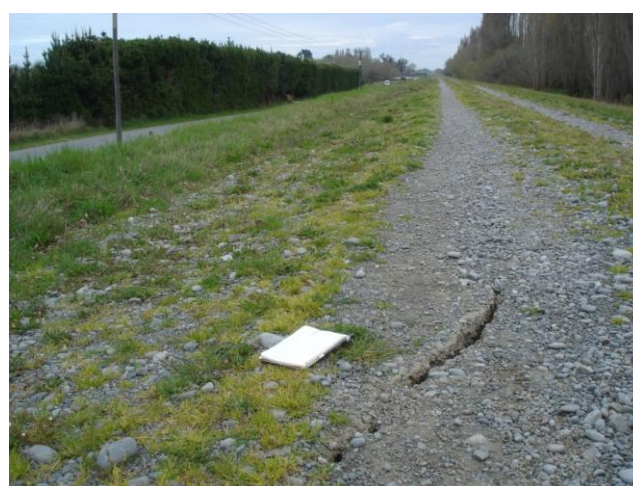
**Figure 6.8:** *Photo 5: ~20 mm wide crack running lengthwise along the top of the stopbank on Coutts Island Rd. This crack was at the edge of the ~0.5 km stretch of the stopbank where significant liquefaction was observed. Photo taken looking southwest (43.423440°S, 172.632349°E).*

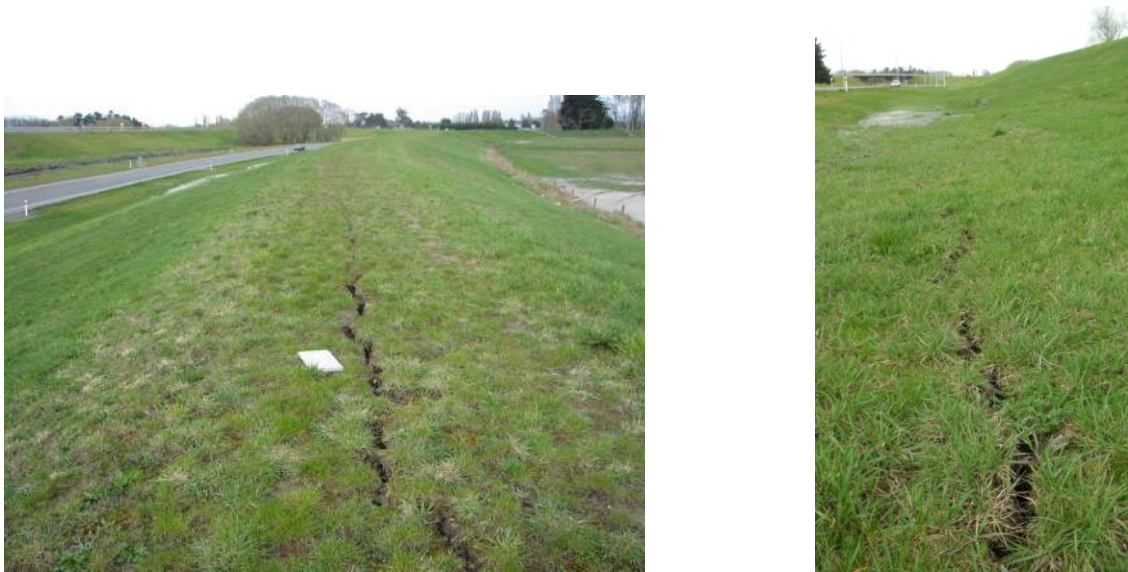
Figure 6.15: Photos 9 and 10: ~50 mm wide longitudinal cracks running along the crest (left) and base (right) of a secondary stopbank for the Waimakariri River. Photo taken looking southwest; SH1 on left of stopbank (43.430108°S, 172.643434°E).

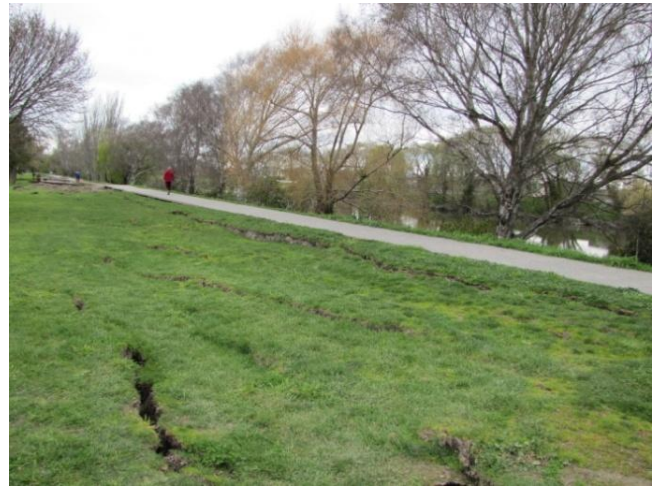
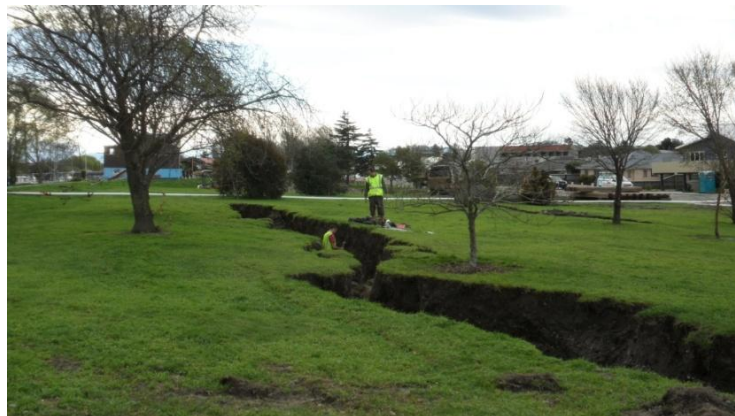
**Figure 6.18:** Photos 16-18: Lateral spread cracks along landside of the stopbank on the north side of the Kaiapoi River. The locations of these photographs are denoted in Figure 6.2. (43.384484°S, 172.660653°E).

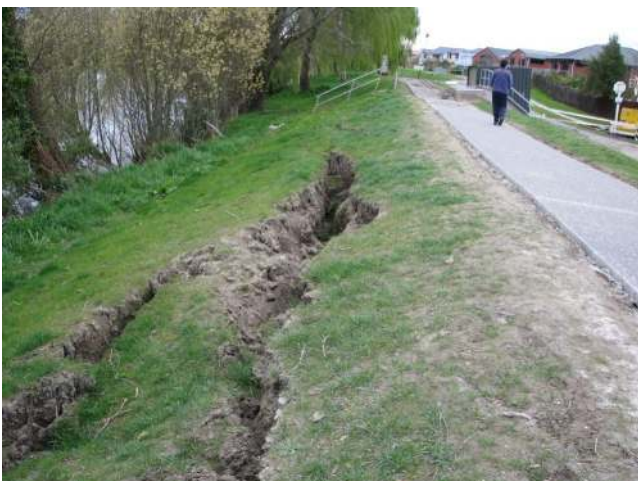
**Figure 6.23:** *Photo 25: Lateral spread cracks along riverside stopbank on the south side of the Kaiapoi River. The location of this photograph is denoted in Figure 6.2. (43.385254°S, 172.660131°E).*

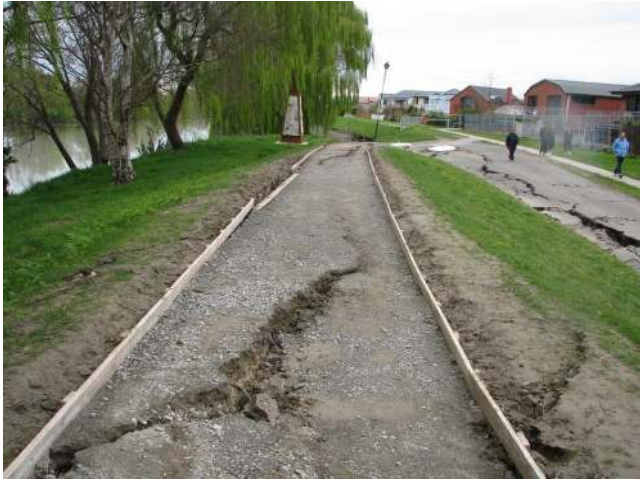
**Figure 6.25:** *Photo 27: Lateral spread cracks along the top of the stopbank on the south side of the Kaiapoi River. The location of this photograph is denoted in Figure 6.2. (43.385693°S, 172.660688°E).*

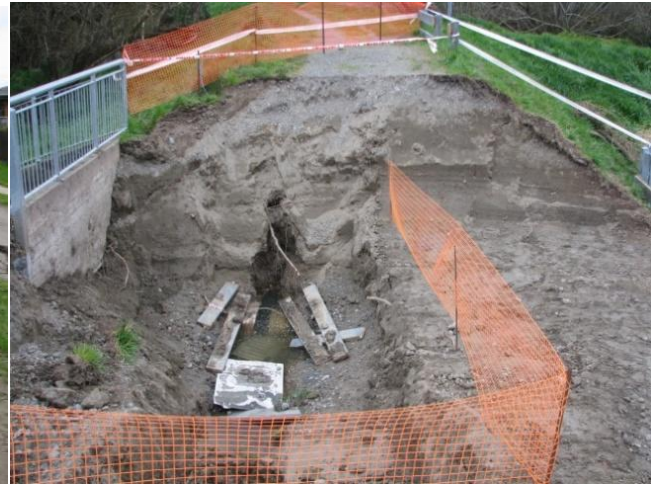
**Figure 6.26:** *Photo 28: Failed drainage conduits running underneath the stopbank on the south side of the Kaiapoi River. The location of this photograph is denoted in Figure 6.2. (43.388679°S, 172.666203°E).*

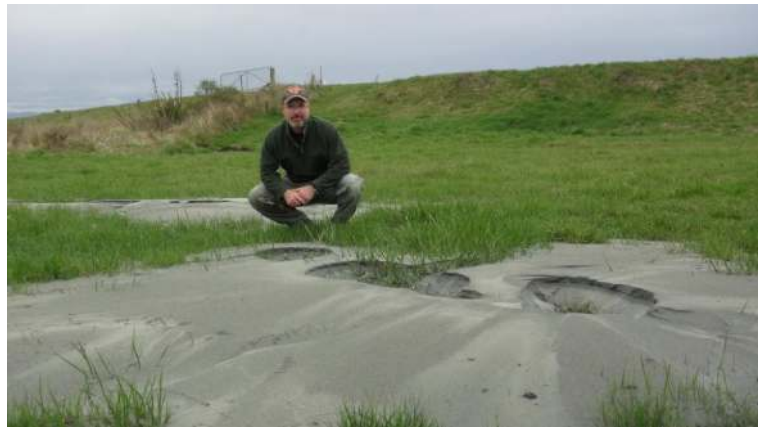
**Figure 6.28:** *Liquefaction and lateral spread features on or near stopbanks located about 100 to 200 m west of the Kaiapoi Sewage Treatment Plant. (upper left: 43.389175°S, 172.683235°E; upper right: 43.389701°S, 172.683390°E; bottom left: 43.389519°S, 172.682203°E; bottom right: 43.389432°S, 172.6682060°E).*

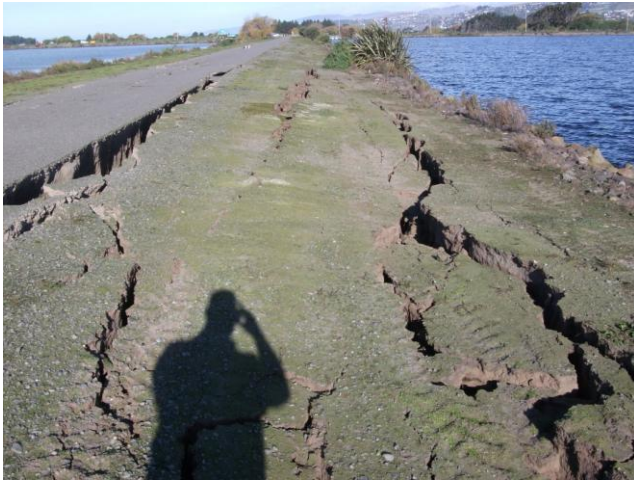
**Figure 6.31:** Lateral spread cracks running parallel to Dyers Road adjacent to Pond 2A. (-43.531393°, 172.712473°).

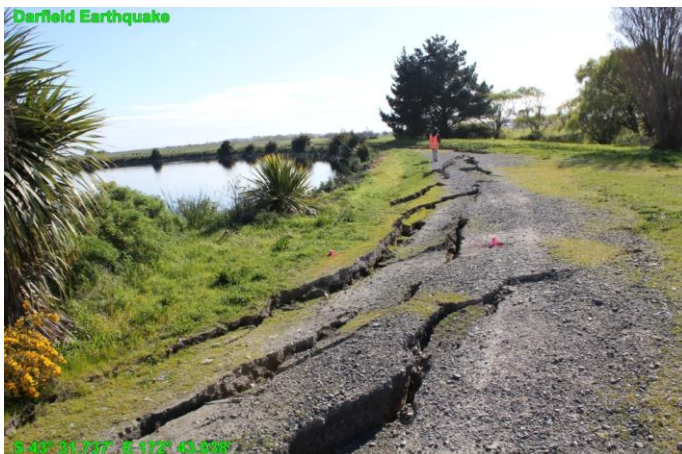
**Figure 6.33:** Lateral spread cracks at the eastern end of Pond 2B. The sink hole in the foreground of the photo on the right formed over the top of two outlet pipelines. (-43.52895°, 172.717300°).

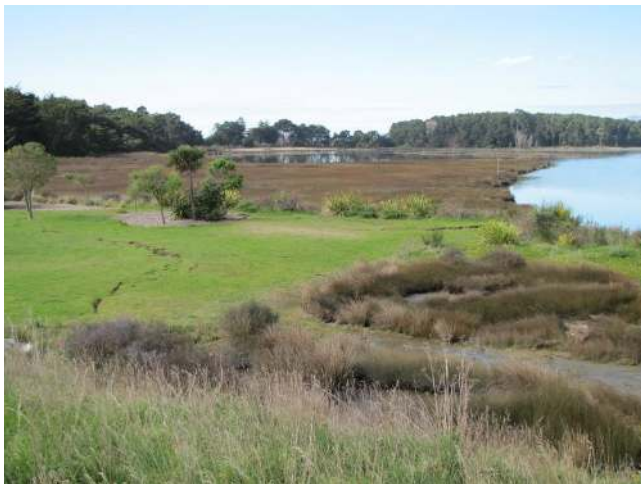
**Figure 7.3:** *Lateral spreading of east banks adjacent to the Bridge Street Bridge.*

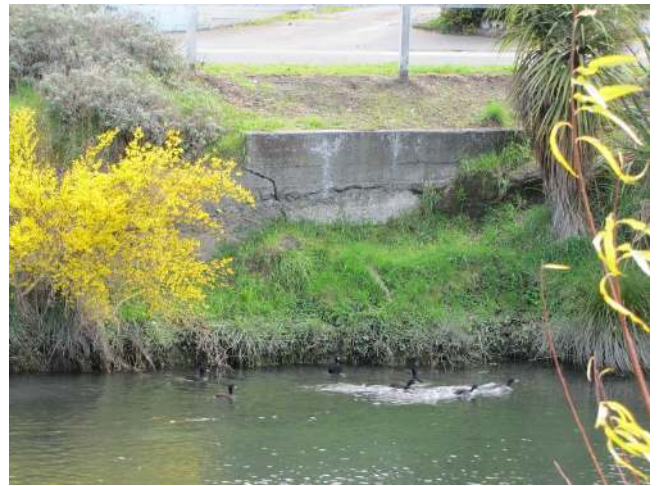
**Figure 7.15:** *Cracking of retaining wall, north bank of the Avon River.*

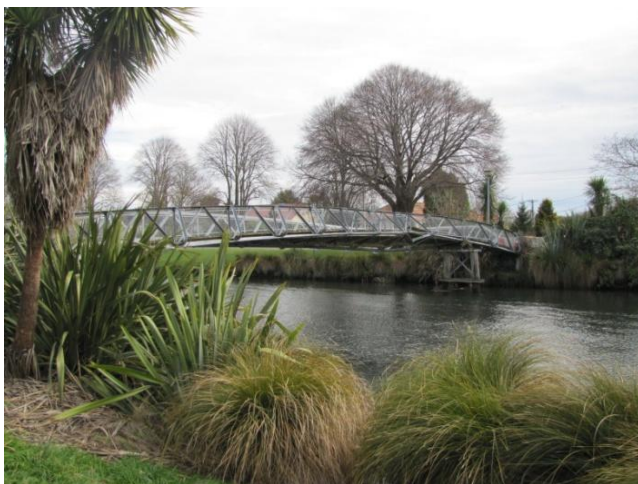
**(a)** *Buckled span.*

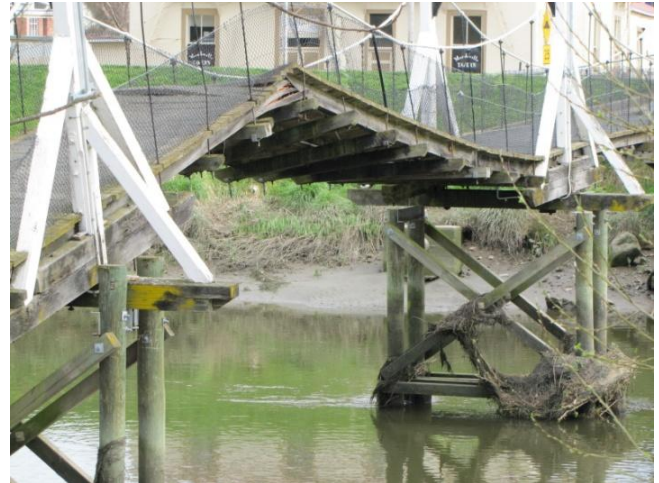
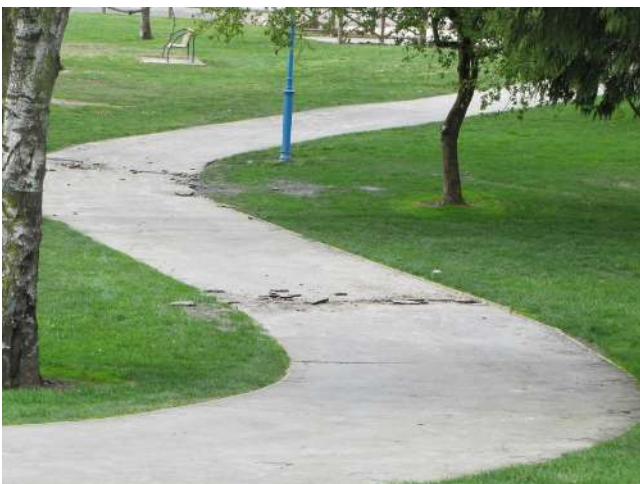
**Figure 7.20:** *Cracking of sidewalk and evidence of liquefaction in Trousselot Park.*

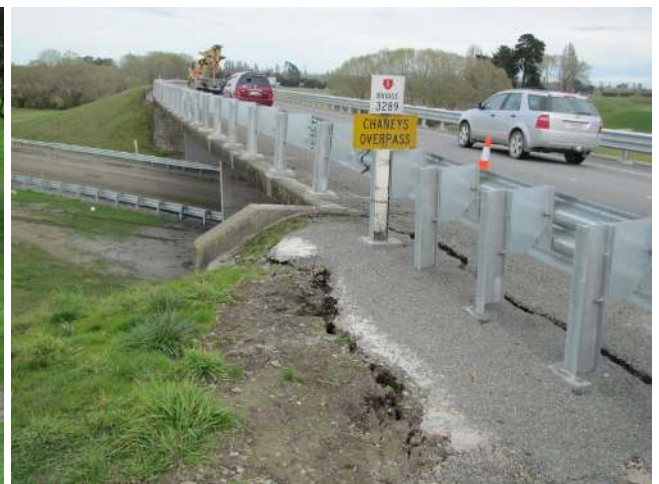
**Figure 7.21:** *Incipient lateral spreading at Chaney's Overpass north abutment.*

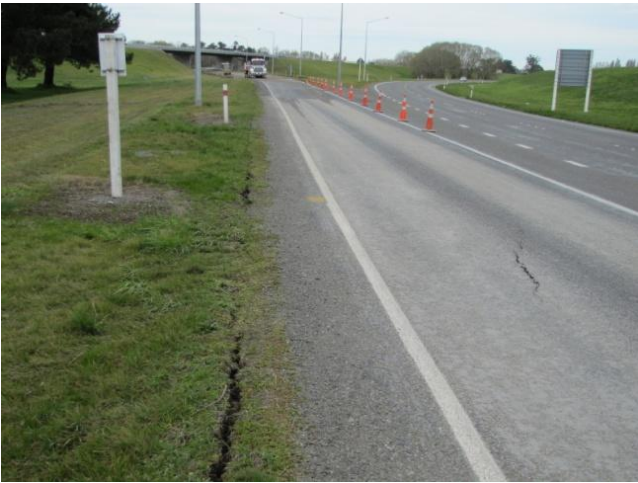
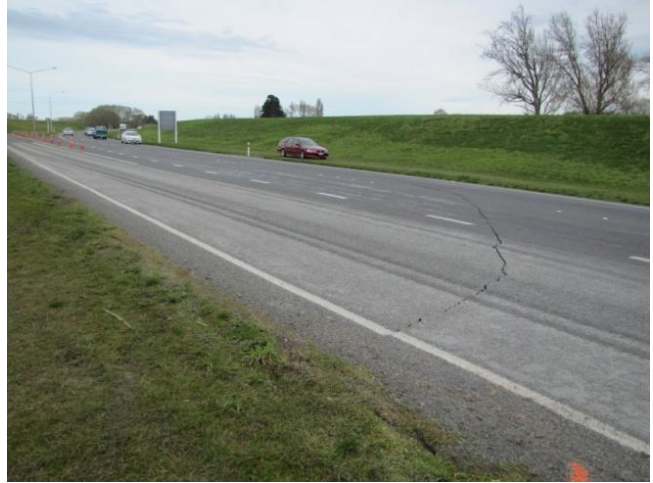
*Figure 7.26: Cracking in and along roadway adjacent to Chaney's Overpass.*

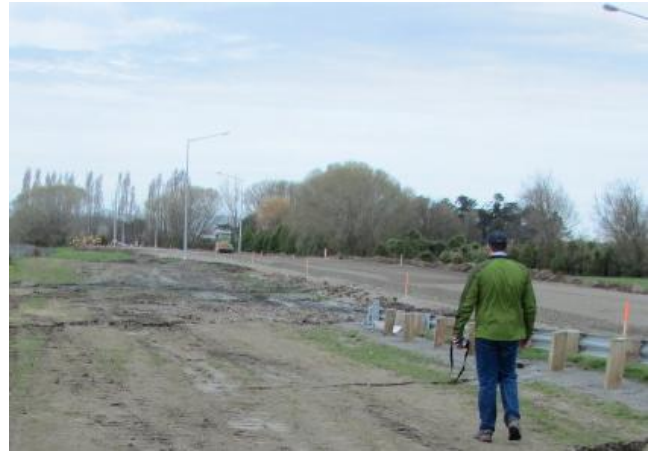
*Figure 7.27: Road being repaved adjacent on south approach to Chaney's Overpass.*

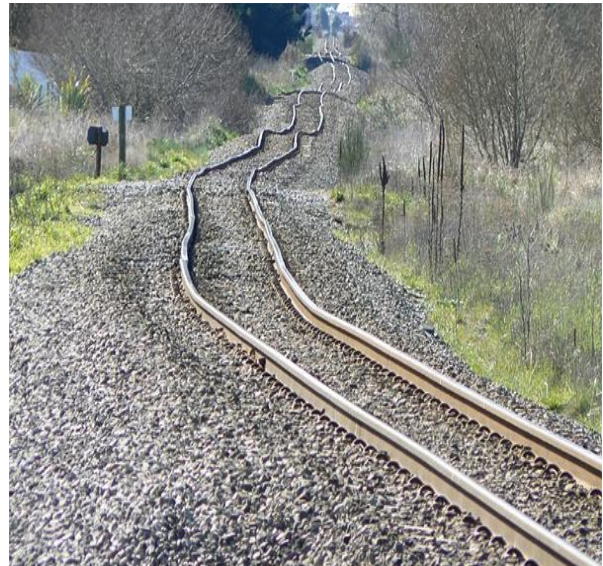
Figure 7.36: Damage to rail line at Woodford Glen (photo by L. Matthews and J. Overend).
