NASA Technical Paper 3223

Hot Fire Fatigue
Testing Results
for the Compliant
Combustion Chamber

Albert J. Pavli, John M. Kazaroff, and Robert S. Jankovsky

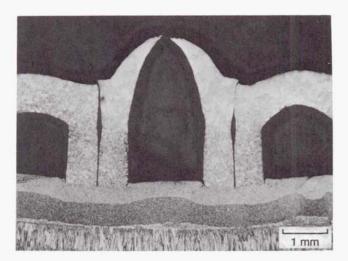
Figure 4.- Failure site.

The failure appears to be a pressure rupture caused by the insufficient strength of the OFHC (oxygen free, high conductivity) copper at excessively high temperatures. The absence of evidence of compressive cyclic yielding indicates that the failure was not of the type experienced on conventional milled-channel copper-alloy combustion chambers. It also indicates that the design feature of structural compliance provides significant improvement in chamber life. Figure 4 shows the failure site and the deformation in the two adjacent cooling passages. The failure occurred at the throat of the combustion chamber. Evident in figure 4 are two separate deformations. The first is the bulging of the cooling passage wall because of insufficient flexural strength. The second is the thinning, or necking down, of the rib tops because of insufficient tensile strength. Both of these deformations are caused by the cooling pressure force of 8224 kN/m² (1200 psia), and the yielding is caused by the reduced strength at the excessively high temperatures. The nature of the yield at the failure is clearly indicative of a purely tensile yielding with no evidence of any cyclically alternating tensile and compressive yielding.

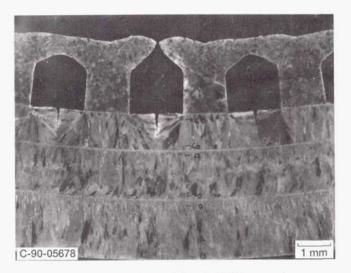
Figure 5.- Standard fatigue failure in OFHC copper liner.

Cyclically alternating compressive and tensile yielding, called thermal ratcheting, is the scenario of typical standard chamber fatigue failures, as shown in figures 5 and 6. Its absence in the current case indicates the effectiveness of the structural compliance present in this configuration. Notice the blunt shape of the standard failure in figure 5 and the thickening of the wall material near the ribs as a result of material movement during the compressive yielding part of the cycle. Also notice the fine grain structure near the failure in figure 6. This is also the result of the material movement in the compressive direction causing grain structure breakup and strain hardening similar to a worked material.

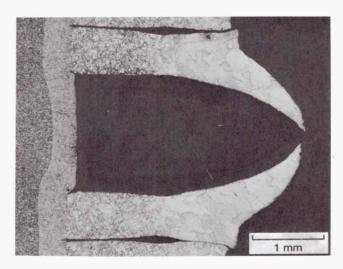
Figure 7.- Failure site.

Figure 7 shows the failure of the compliant chamber at a slightly higher magnification. Notice the variation in the grain size from the bottom to the top of the channel. The fine grain structure at the bottom is what the entire channel was

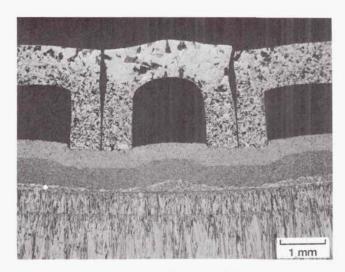
Figure 9.- 0.84 cm Upstream of failure site.

Another specimen was taken at 0.84 cm (0.33 in.) upstream of the failure site (throat). Figure 9 shows the etched specimen with the adjacent coolant channels. What is apparent is the lack of the severe distress evident in the previous specimens. This is what would be expected as the appearance of the throat specimen some time prior to the failure. Some plastic yield of a tensile nature is obvious, there is no evidence of any thermal ratcheting, and some evidence of grain growth is seen.

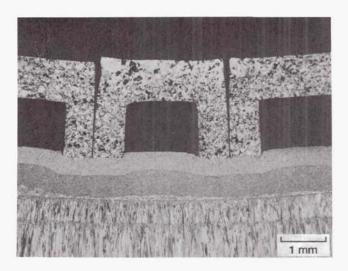
Figure 10. - 1.3 cm Upstream of failure site.

The next specimen (fig. 10), taken at a location 1.3 cm (0.5 in.) upstream of the throat location, shows only slight deflection and slight grain growth at the top of the coolant channel. Upward bulging as a result of the forces produced

by coolant pressure seem almost nonexistent. Notice the well-formed expansion gaps at the upper corners of the channels. These are the gaps that close on each cycle to form a smooth combustion side wall. It is evident that the self-design feature of these gaps was successful. The structural compliance feature seems also to be successful as there is no evidence of thermal ratcheting on any of the metallographic specimens.

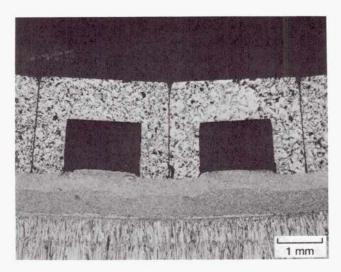
Figure 11. - 2.5 cm Upstream of failure site.

The final specimen was taken at a location of 2.5 cm (1.0 in.) upstream of the original failure site. Figure 11 shows the etched specimen at this location. The only evidence that this specimen was fired exists in the expansion gap that plastically formed during the first fire cycle. The expansion gap is considerably smaller on this specimen because of the less severe environment at this location. Lower heat fluxes cause less thermal expansion, and the required expansion gaps are smaller as a result. The grain structure of the specimen appears completely unaffected, with the grain size at the top looking the same as the grains at the bottom. This grain structure appears similar to what would be expected at the throat after only one cycle.

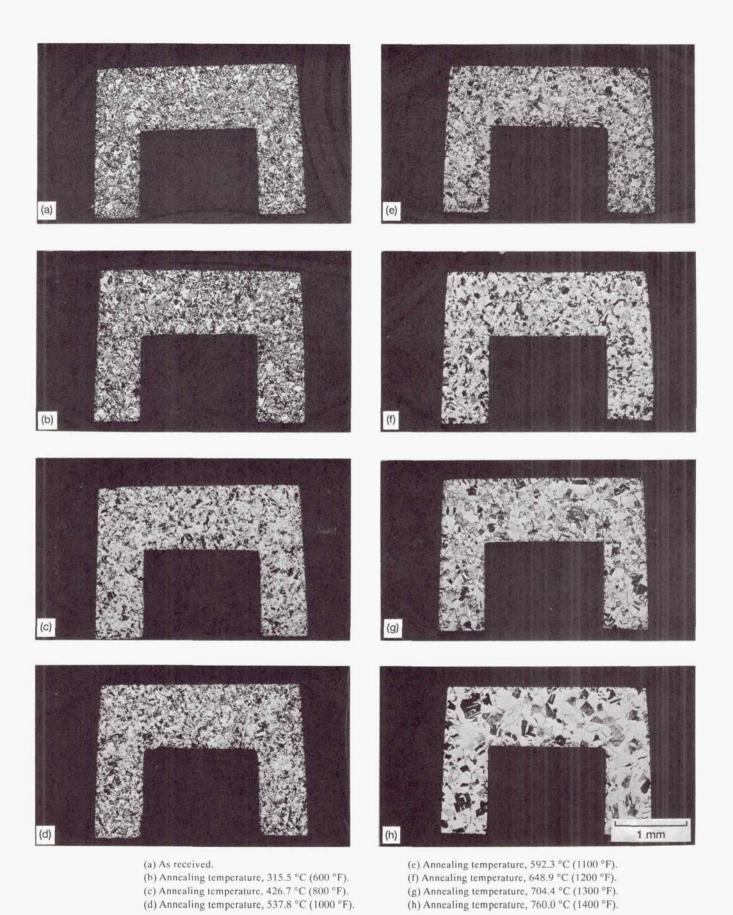
Figure 12. - Channel grain structures after 10-min anneal.

Figure 12 shows various annealed grain sizes for each of several temperatures. Figure 12(a) shows the as-received channel grain structure. (A magnification of 25× was used for all the annealing test specimens.) The annealing test was performed by heating the as-received channel material at temperatures varying from 315.5 to 760.0 °C (600 to 1400 °F) for 10 min. The annealing time was selected as equivalent to the exposure time of the chamber channels during the hot-fire tests. Figures 12(b) to (h), photomicrographs of the annealed test specimens after polishing and etching, show the changes in grain structures. The specimens in parts (b) to (e) were annealed at 315.5 to 593.3 °C (600 to 1100 °F) and show only slight, if any, grain growth. Parts (f) to (h), however, for specimens annealed at 648.9 to 760.0 °C (1200 to 1400 °F), show a progressive increase in grain size. These figures were used to compare the grain size with that of the channel specimens taken from the fired chamber. This comparison shows that figure 7, which is at the failure site (throat area), has a larger grain size at the top of the channel than the figure12(h) (760.0 °C anneal) grains. This indicates that the temperature at the top of the fired specimen was greater than 760.0 °C (1400 °F). Figure 11, at a location of 0.42 cm (0.16 in.) upstream of the failure site, also shows a larger grain size at the top of the channel than does figure 12(h), again, indicating a temperature greater than 760.0 °C (1400 °F). Only at 0.84 cm (0.33 in.) upstream of the failure site (fig. 9) do grain sizes approximate those shown in figure 12(h), indicating a region in the chamber where the wall temperature was about 760.0 °C (1400 °F).
