Identification and improvement of critical joints in CLT construction without weather protection

Kristo Kalbe^{1*}, Villu Kukk¹, Targo Kalamees^{2,1}

¹ nZEB Research Group, Tallinn University of Technology, Tallinn, Estonia

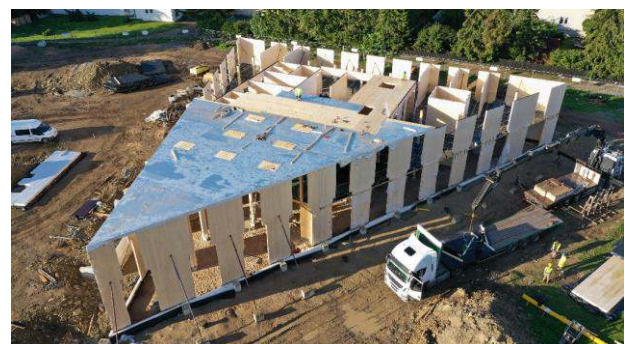
Fig. 1. Observed CLT construction without weather protection.

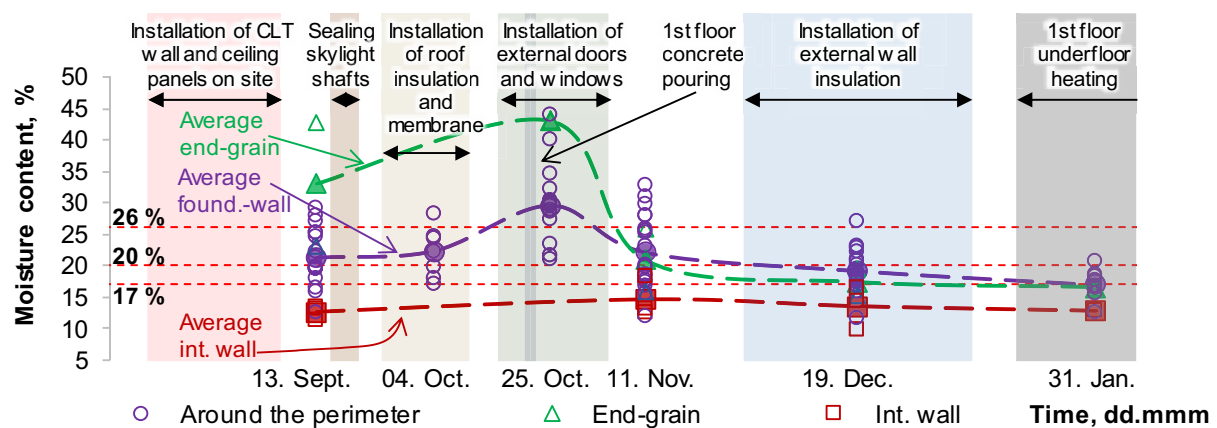
Fig. 4. MC of the CLT panels during distinct phases of construction. The filled markers show the average values of the measurements and the dashed lines represent the trend of average values. There were no measurements for the end grain on 4th October. The red dotted lines represent limiting values for mould growth and decay initiation.

We observed that the bottom edges of the CLT panels at the exterior wall to foundation connection were repeatedly exposed to rainwater and the measured MC of these regions remained consistently high throughout the observation period. The measurements from the end-grain showed that the initial high moisture content decreased after the installation of windows and external doors to a level at which the risk of moisture damage would not be expected. The areas where we could measure the MC in end-grain were open to indoor air and moisture dry-out was favourable. The MC measured from intermediate ceiling to intermediate wall connection remained low (< 17%) during the entire construction period. The intermediate walls were covered with ceiling and roof structures early during the installation of CLT panels and became protected from rain.

These results suggest that weather-protected structures stayed dry, and structures that were exposed to drying also reached a low MC over time, but in structures where drying was prohibited, the MC remained critical. This confirms our initial assessment as well as the need for weather protection for exterior wall to foundation connection. Schmidt *et al.* [18] also found in their laboratory test that the end grain of CLT panels in

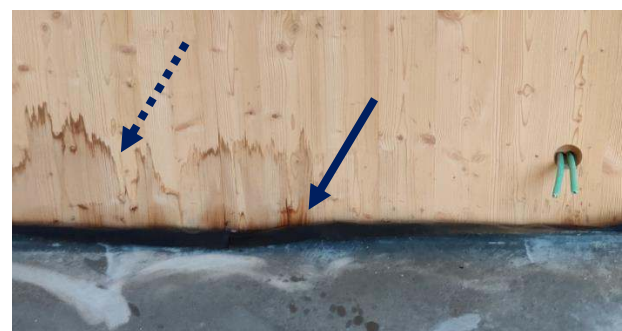
Fig. 5. CLT exterior wall and newly poured 1st floor concrete screed. Note the discoloration of timber from the previous wetting incident (dashed arrow) and new wetting mark (solid arrow) possibly from the concrete pouring.

Wetting not only poses a risk of microbial growth, but also affects the appearance of the wood surface by producing non-aesthetic stains. In the observed building, the CLT external wall panels will be used as interior decoration. Unfortunately, we noticed the “wetting marks” in numerous panels (e.g. Fig 5.). These proved to be difficult, costly and time-consuming to remove or alleviate. Drying out of moisture also causes volume shrinkage of the wood, which can result in noticeable cracks on the surface if the moisture content has been high. Large cracks were observed on the surfaces of the CLT panels in the given construction, which may result in lower airtightness of the building. V. Kukk *et al.* [21] and H. Skogstad *et al.* [22] found in their researches that cracks caused by volumetric shrinkage due to large changes in moisture content significantly increased the air leakage of CLT panels.

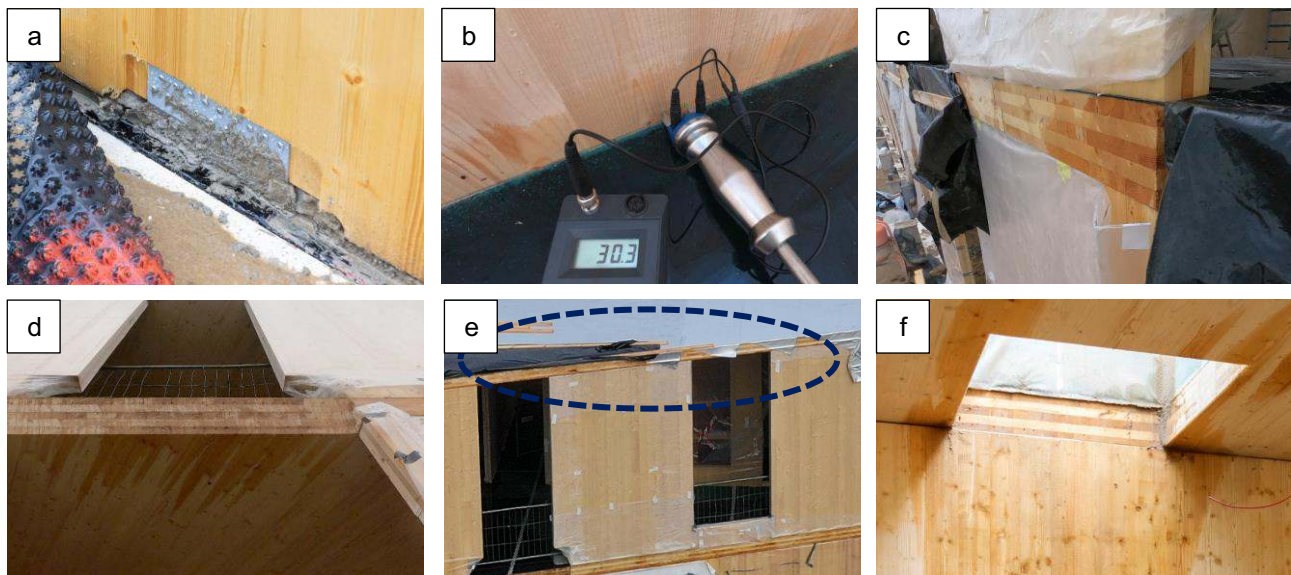
The most critical junction proved to be the exterior wall to foundation connection. There was a rubber band under the exterior wall edge to prevent moisture ingress,

Fig. 6. Photographs of CLT junctions where wetting occurred frequently during our observation: a) exterior wall to foundation connection; b) intermediate ceiling to intermediate wall connection; c) intermediate ceiling to external wall connection; d) intermediate ceiling to window connection; e) roof to exterior wall connection and f) roof to skylight shaft connection.

but in many cases this solution did not prevent the wetting of the CLT (e.g. Fig. 6a). Water got between the rubber band and timber, thus decreasing the effectiveness of the rubber band. Moreover, the end-grain part around the fastening bracket was directly exposed to water. It was evident that sealing the fastening area with a rubber band is a complicated task. Therefore, in addition to the rubber band, we suggest using a liquid-applied membrane (Fig. 7), which must be installed in the factory and which will cover the whole cut-edge of the CLT panel regardless of cut-outs for fastening or other irregularities. Additionally, we suggest using a clear foil to protect the sides of the CLT panels from direct water contact. The foil must be clear, because it is then easier to detect accidental water flow behind it. The foil should also withstand strong winds. Thin packaging foils are thus not recommended. The foils must be fixed to the plinth immediately after installation with a water-resistant tape to prevent splashing water getting under the foil. An extra moisture-sealing adhesive strip is necessary to make the CLT to concrete connection airtight. This adhesive strip will also further prevent water from getting under the CLT panel.

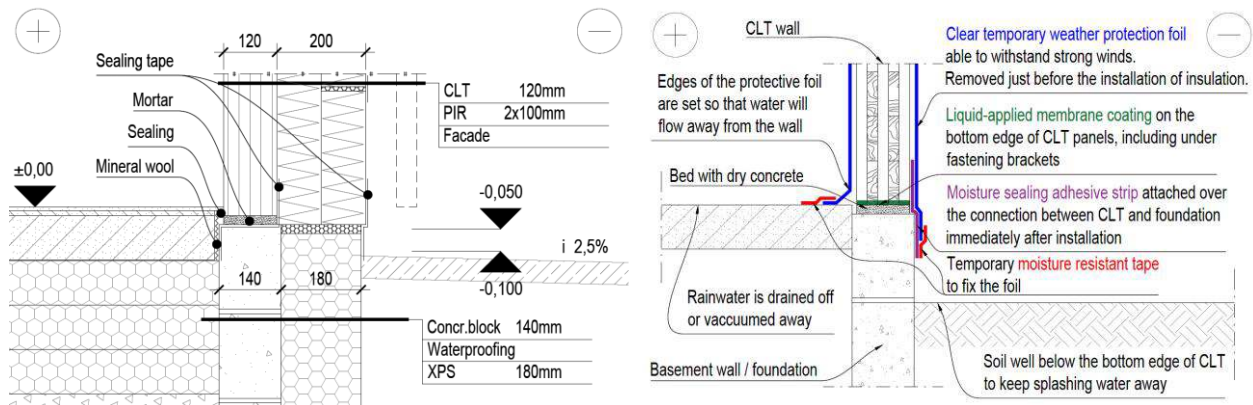
Fig. 7. Design drawing (left) of the exterior wall to foundation connection and our proposal (right) of wetting mitigation practices.

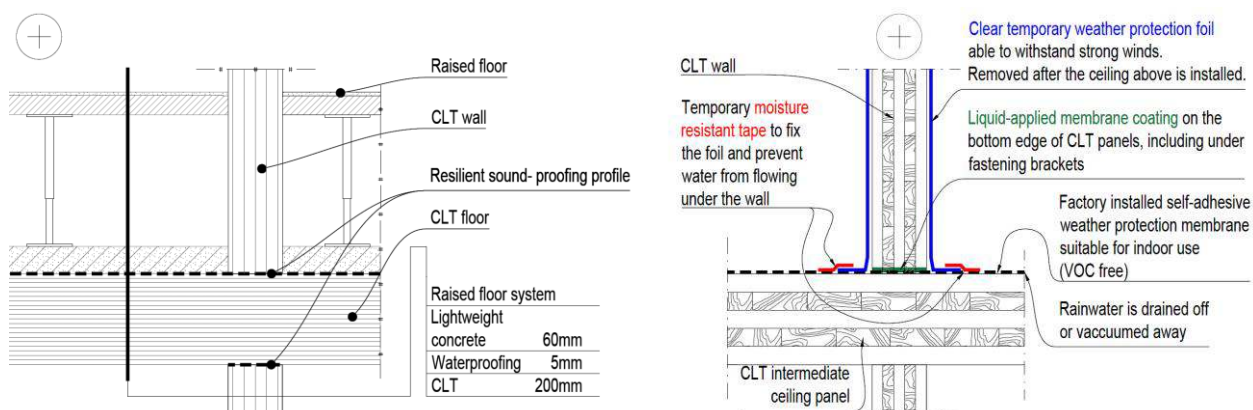
Fig. 8. Design drawing (left) of the intermediate ceiling to intermediate wall connection and our proposal (right) of wetting mitigation practices.

The same overall practice as described earlier should be followed with all the other junctions. Furthermore, the intermediate ceiling and roof panels must be covered with weather protection membranes (Fig. 8-12), because water could accumulate on the horizontal panels and cause critical wetting. The membrane used on the intermediate ceiling must be suitable for indoor use, i.e. not emitting harmful substances. The membranes on the horizontal

panels must be installed in the factory and all the connection joints and feed throughs must be taped with water resistant tape on site immediately after the installation of the CLT panels. The membranes must tolerate loads e.g. from walking and storing construction materials and from brushing or vacuuming off excess water. The excess water must not drip over the edges of the intermediate ceiling nor the edge of the roof. To ensure this, a temporary wooden slat must be installed in front of the window opening and on the perimeter of the roof (Fig. 10, 11).

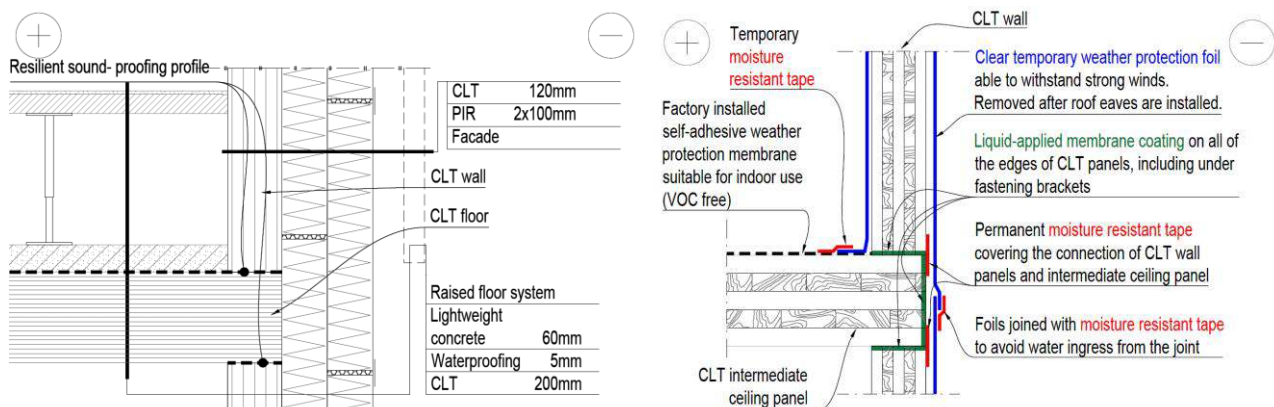
Fig. 9. Design drawing (left) of the intermediate ceiling to external wall connection and our proposal (right) of wetting mitigation practices.

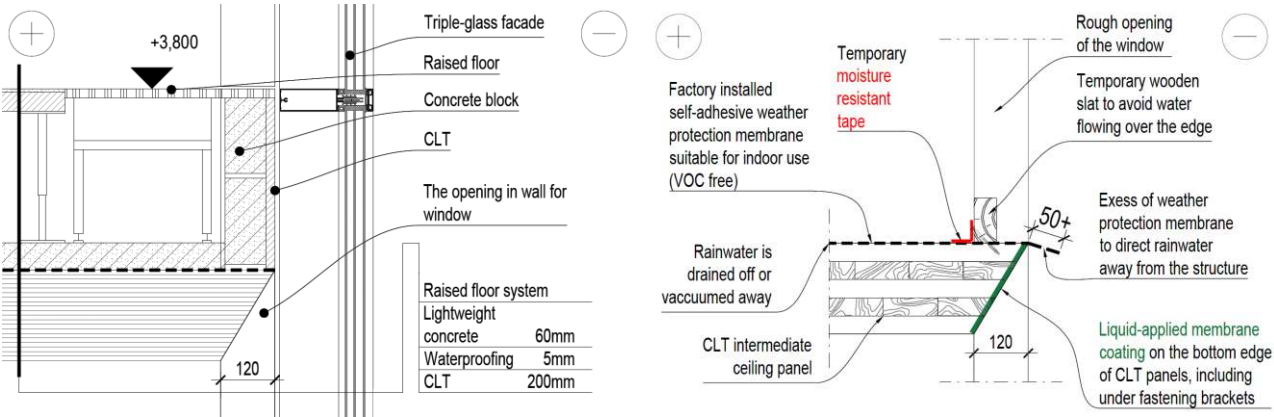
Fig. 10. Design drawing (left) of the intermediate ceiling to window connection and our proposal (right) of wetting mitigation practices.

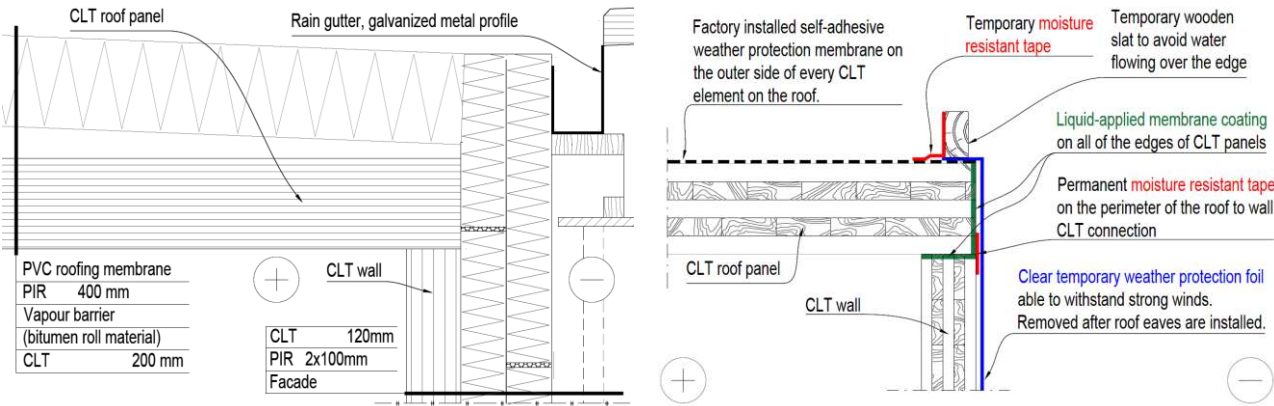
Fig. 11. Design drawing (left) of the roof to exterior wall connection and our proposal (right) of wetting mitigation practices.

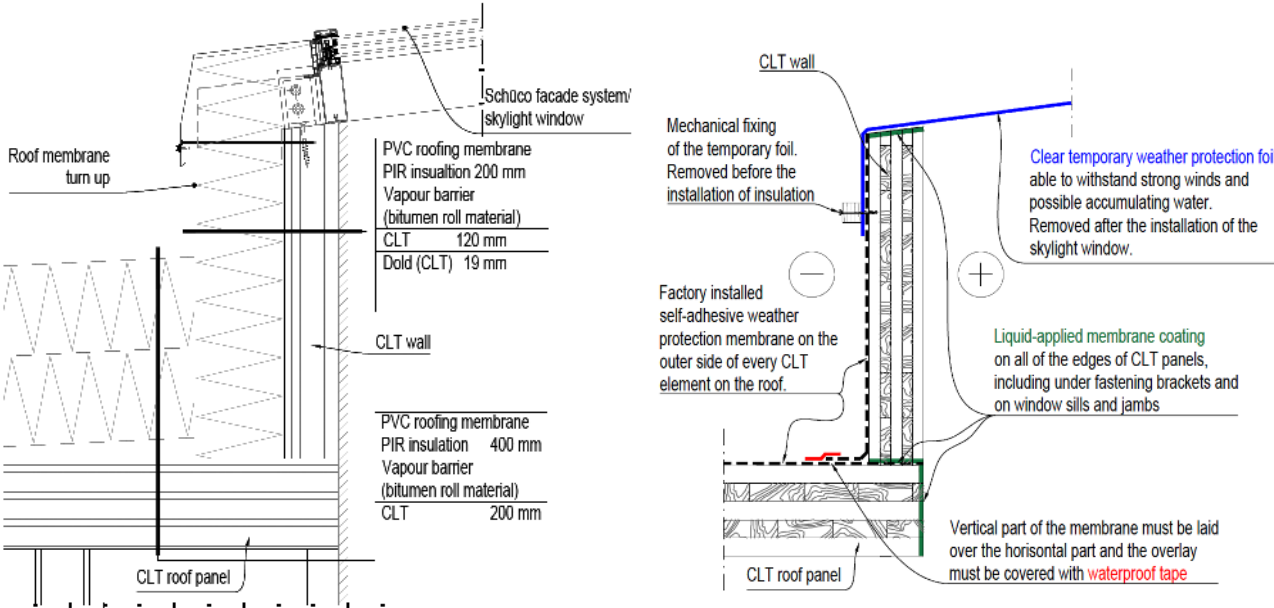
Fig. 12. Design drawing (left) of roof to skylight shaft connection and our proposal (right) of wetting mitigation practices.
