**Brief note**

## **IDENTIFICATION OF THE CAUSE OF THE STEM NECK FRACTURE IN THE HIP JOINT ENDOPROSTHESIS**

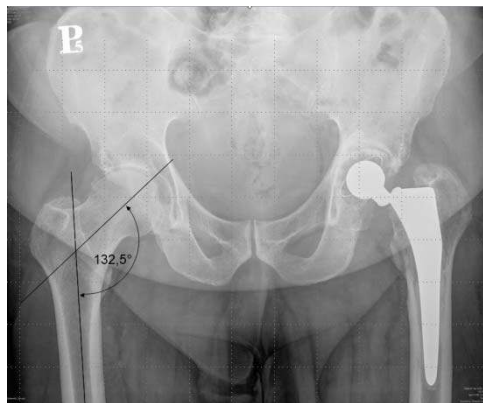
Fig.2. The X-ray image of the patient's hip zone at the Hospital Emergency Ward in 2014.

The analysed radiogram gives rise to certain doubts regarding the conditions of recreating the rotation axis of the implanted joint [19-21]. The rotation centre for the artificial joint is higher than the one for the natural joint. The tissue trauma could have caused a muscular contracture and some disturbances in the location of rotation centres for both joints. In the implant zone, there are no visible foci of osteolysis or loosening of the cement anchoring of the stem. The size of the stem is correct as, together with the cement, it fills the space between the inner walls of the cortical bone and the canal of the femoral bone. The location of the stem does not reveal any varus or valgus deformities. The anatomical angle between the head and the stem on the right is  $132.5^\circ$ , and the angle between the neck and the stem of the implanted Aura II stem is  $137.5^\circ$ . The size of the acetabulum is correct, too, without any evident signs of migration under the influence of locomotion stresses. The degree of the polyethylene acetabulum wear, measured using the distance of the dislocation between the centre of the endoprosthesis head and the centre of the acetabulum, is very small, below 0.1 mm. An external visual evaluation of the polished surface of the stem reveals extensive zones of corrosion in the medial and lateral bending of the stem, in the proximal section and in the conical part contacting the head (Fig.3). Observations of metal construction elements removed from patients do not show such advanced corrosion changes as the ones confirmed in the stem under examination. On the external surface of the head, there are numerous circumferential scratches that are in stark contrast with the smooth and polished head which remained in contact with body fluids and does not show any signs of corrosion (Fig.4). Moreover, there is a circumferential crack, perpendicular to the neck axis, which starts 3 mm from the edge of the fracture and the place where the fatigue fracture was initiated.

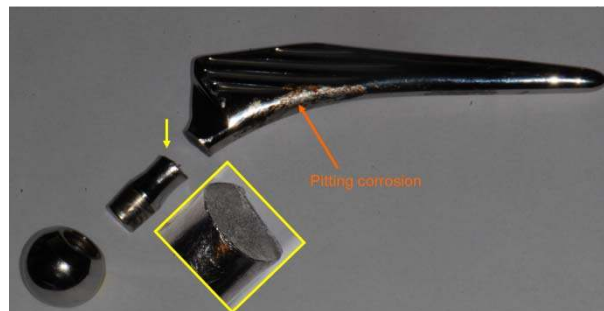
Fig.3. Fractured Aura II stem with the head removed from the patient's body.

What was the cause of the stem neck fracture? What additional circumstances brought about the notching effect and initiated the fracture? Direct observations indicate the presence of a defect in the stem neck (Figs 3, 4 and 7). The focus is visible in the fracture in both elements. On the external surface of the fractured neck, there is a deep scratch near the focus.

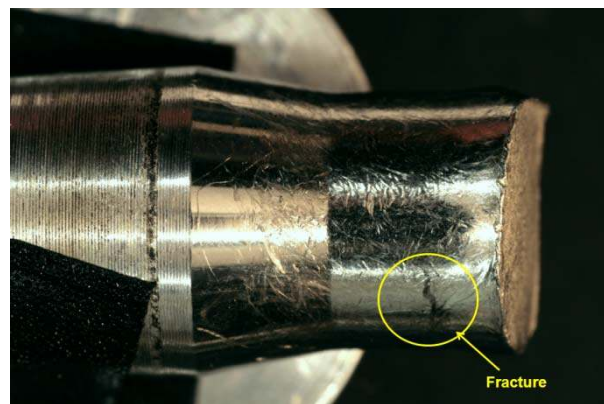
Fig.4. The surface layer of the fractured stem neck with numerous circumferential scratches and a crack in the close vicinity of the fracture initiation zone (focus).

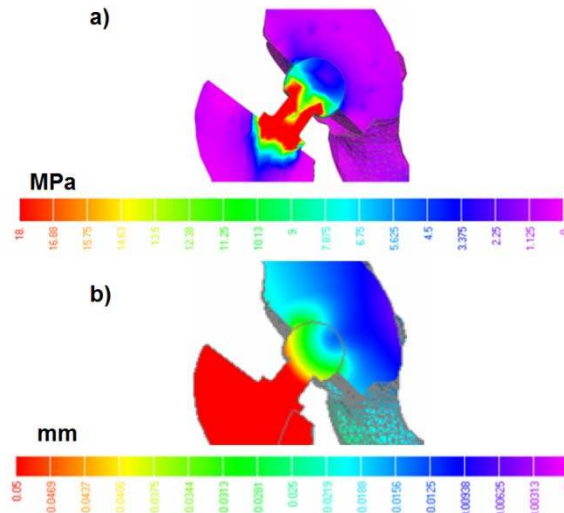
The analyses and numerical FEM analyses performed for the global model of bone structures and the endoprosthesis including the Aura II stem with the CoCr head,  $\varnothing 28$  mm, and the acetabulum,  $\varnothing 28$  mm x  $\varnothing 48$  mm, indicate that the geometry of the stem secures the transfer of locomotion loads (Fig.6). The exemplary build-up of the stresses in the stem neck of the maximum value of 18 MPa makes 5% of the possible load of this construction element considering the properties of the M30NW steel [24-28]. Maximum resultant microdislocations, of 0.05 mm, do not cause destruction changes in the stem stabilisation zone. The fundamental goal of developing a load-bearing structure of the hip joint endoprosthesis is to ensure resistance to fatigue-induced destruction. The performance load on the endoprosthesis stem puts this construction element (replacing the lost function of the femoral neck) in the stress zone below the level of

fatigue, which is the equivalent of the gigacycle fatigue range [29, 30]. It may be said that the stress values that occur during locomotion could not have caused fatigue-induced destruction.

Fig.6. FEM calculations in the hip zone model with the Aura II prosthesis in the position of standing on two legs (vertical cross-section): a) map of reduced stresses, b) resultant dislocations.

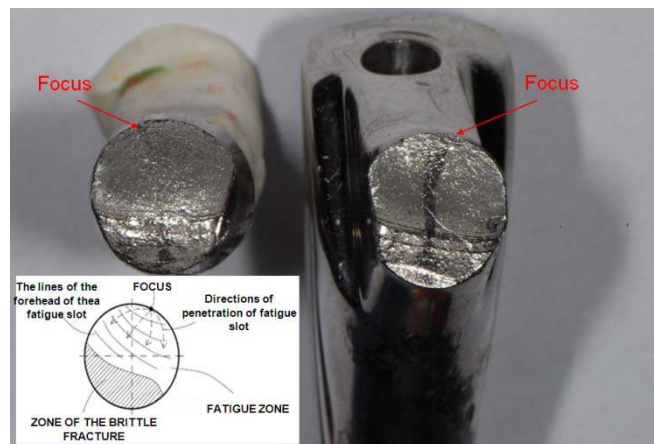
Fig.7. Surfaces of the stem neck fatigue fracture with the indication of the focus.

In the zone of the stem neck – the place of the technological defect – fatigue microcracks were initiated. Dislocation in the surface zone resulted in the creation of a slip plane and microcracks in the planes perpendicular to the load would develop into a macrocrack (Fig.7). The photograph shows the structures characteristic for a fatigue fracture: the focus, the focal zone, the fatigue zone, radial lines, the transition zone and the immediate fracture. The SEM analysis in the focus area may indicate that it was a defect which arose after forging, at the primary creation of the stem neck (Fig.8). It could be caused by microshrinkage that occurred in the manufacturing technology. There was a brittle fracture at the border of grains. The fracture was working and expanding in the physiological load conditions. The absence of stress relaxation at the top of the crack, because of the development of plastic deformations, caused further development of slip bands. The development of new slip bands resulted in further expansion of the crack and the rounding of its top.

Releasing the load caused a sharp top of the crack and, as a result, the expansion of the crack in the next load cycle. Because of the oxidation of the structures revealed in contact with systemic liquids, the process of corrosion developed more effectively. In the object under examination, the plastic deformation zones in the shape of stripes are located parallel to the direction of the crack development. Still, they were deformed even more by mutual dislocation of the fractured stem. The initiation of the neck crack at the visible forged layer of the material was stimulated by the stresses and corrosion caused by the entry of systemic fluids into the area of the microcrack development. The presence of the forged material layer resulted in the build-up of stresses and was the cause of the stem neck fracture (Fig.9). In forged elements, a microcrack may develop at the border between the stem and the reinforced layer. Without a doubt, the responsibility for this defect falls on the stem producer. For this kind of elements, an individual evaluation of the technological process in non-destructive tests should be carried out. Numerous areas affected by pitting corrosion on the external surface of the stem might indicate that the material used for its construction did not comply with the requirement of high resistance to corrosion declared by the steel producer.

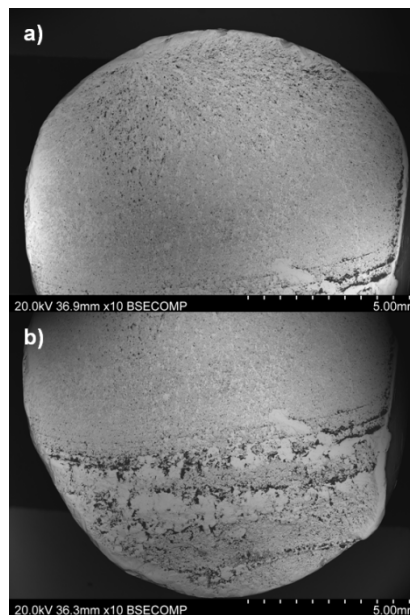
Fig.8. SEM images of the stem neck fatigue fracture in the ten-fold magnification: a) the area as seen from the focus, b) the fatigue zone and the immediate fracture zone.

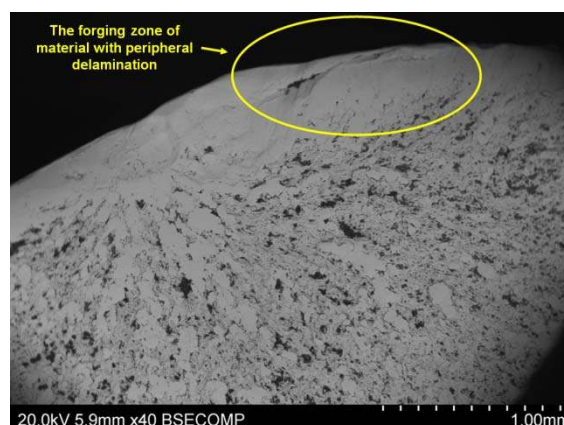
Fig.9. SEM images of the stem neck fatigue fracture with the location of the forging zone in the 40-fold magnification

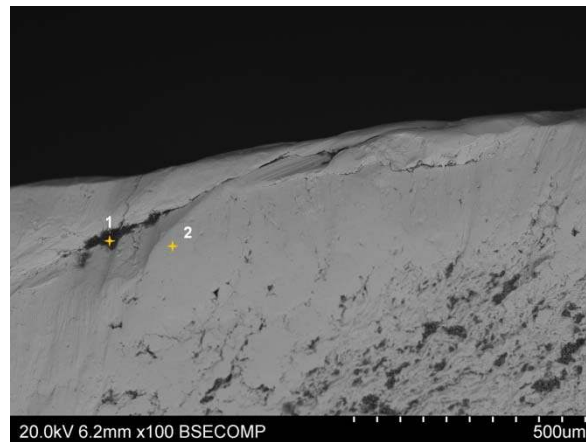
In order to confirm the time and cause of the crack development, a qualitative and quantitative analysis was performed in microareas (Figs 10 and 11). It was performed at point 1 – located in the delaminated space which developed as a result of forging (and, at the same time, the area that should be made of a solid material) and at point 2 – at the surface of the fracture (Tabs 3 and 4). At point 1, the levels of carbon, nitrogen and oxygen were significantly higher, while the levels of chromium and iron were lower than the ones reported by the material manufacturer. As compared to the percentage by weight of the M30NW austenitic steel, the following elements are present: aluminium, chromium, sulphur, potassium and calcium. Large contents of oxygen and carbon indicate the presence of oxides, respectively, that might have

caused the initial crack. At point 2, there are increased levels of carbon, nitrogen and oxygen, which are still lower than at point 1. The contents by weight of the elements that make austenitic steel, i.e., chromium, nickel, manganese and molybdenum, is approximately in line with the manufacturer's data. Both in point 1 and 2, there is aluminium and chromium in small amounts. Such elements as sulphur, chlorine, potassium and calcium, which do not occur in austenitic steel and are present in the delaminated space developed as a result of forging, prove the entry of systemic fluids and a defective technological process. The most probable process that led to the fatigue fracture of the neck of the Aura II stem under examination is the one related to material defects in the process of casting and forging (forging the material with delamination and the presence of brittle oxides and carbides), which caused a significant reduction in strength and resistance to corrosion.

Fig.10. A SEM image of the forging zone with the chemical composition analysis points marked.

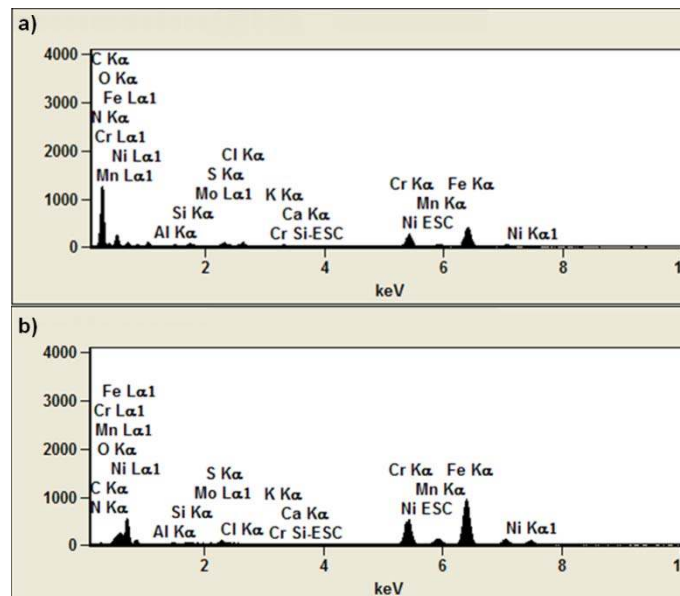
Fig.11. The chemical composition analysis in the stem neck: a) the forging zone - point 1, b) the brittle fracture zone – point 2.
